VEHICLE INSPECTION REPORT

DN21UJC

Vauxhall Corsa 1.2 Turbo SRi 5dr

nama
GRADE
4

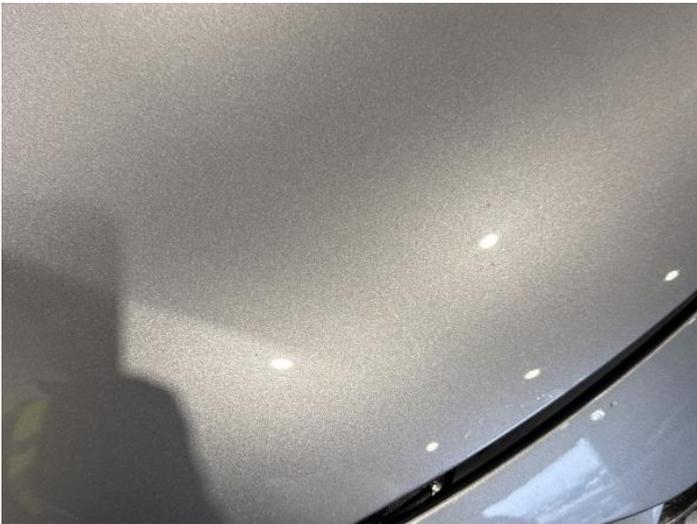
1: Bonnet
Chipped
1 To 5

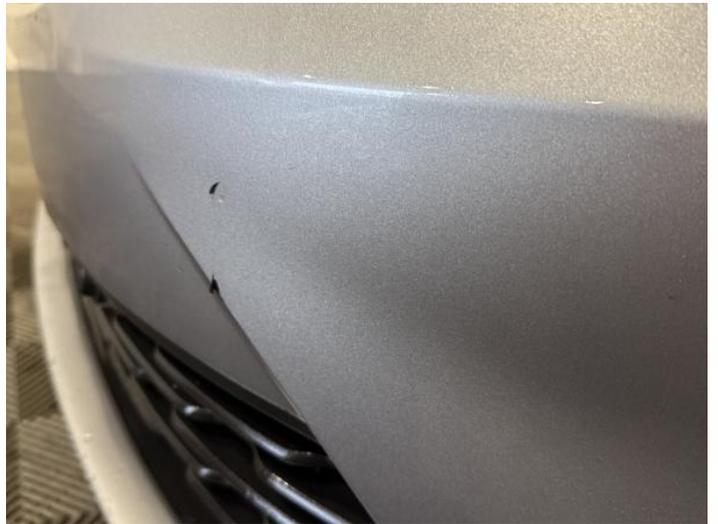
2: Bumper Front
Dented
With Paint Damage

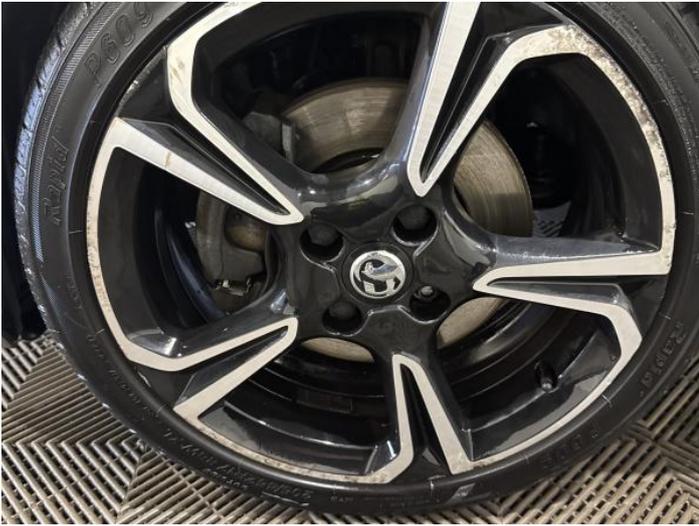
3: Wheel nsf
Scratched
Over 50mm

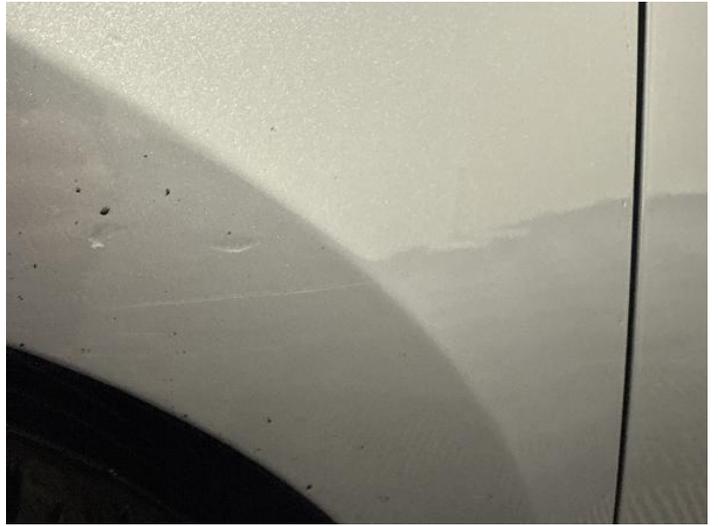
4: Wing nsf
Scratched
Over 25mm Thru Paint

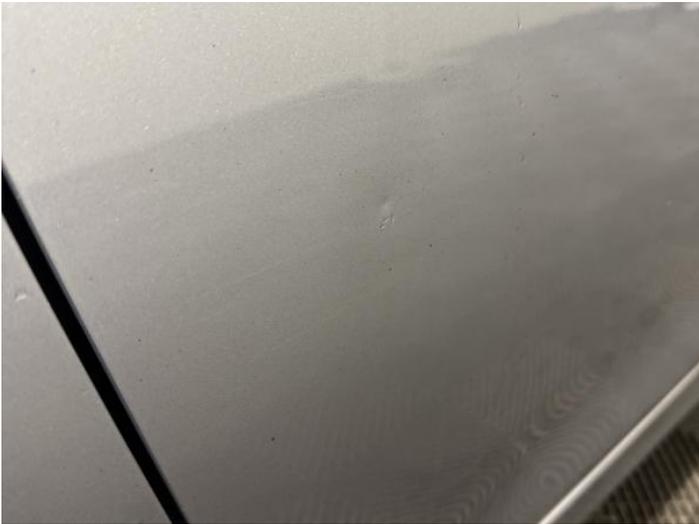
5: Door nsf
Dented
Between 10mm + 30mm

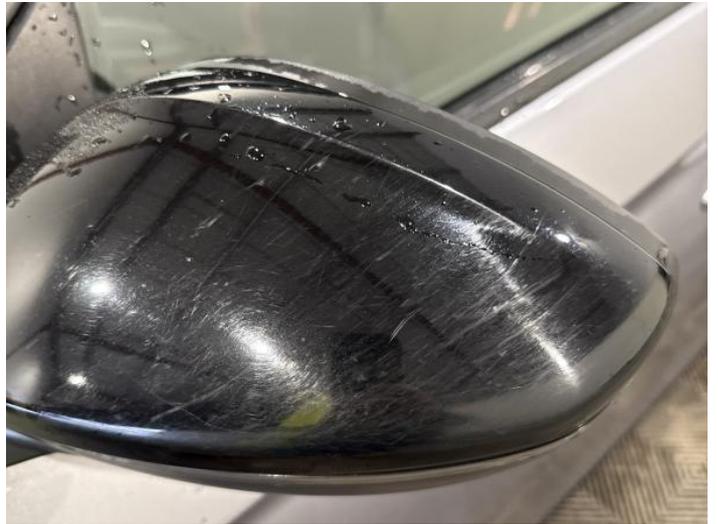
6: Door Mirror Assy nsf
Scratched (Painted)
UpTo 25mm Thru Paint

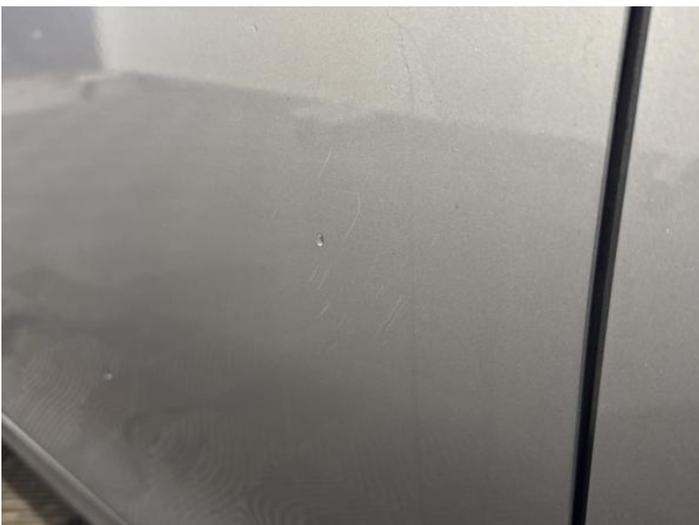
7: Door nsf
Scratched
Over 25mm Thru Paint

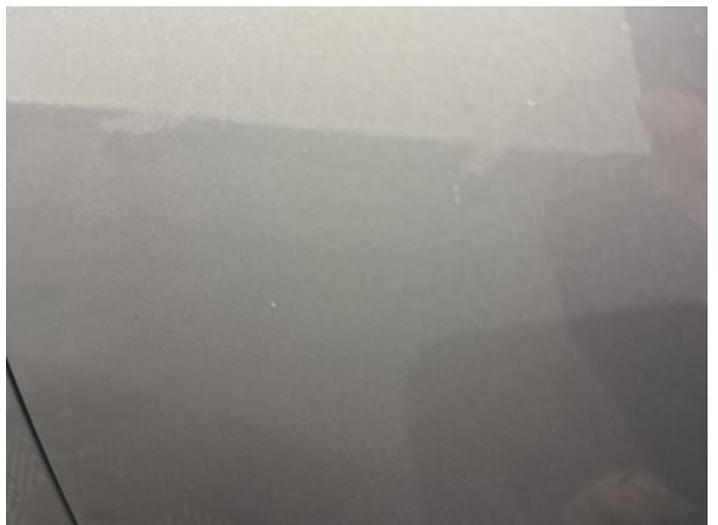
8: Door nsr
Chipped
1 To 5

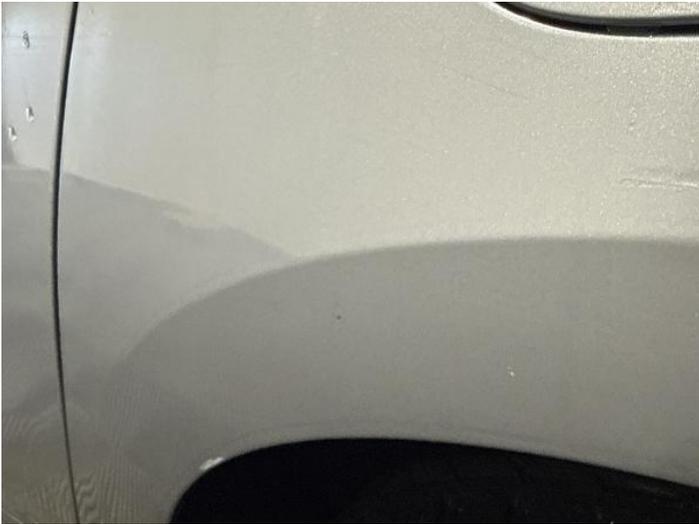
9: Qtr Panel nsr
Scratched
Over 25mm Thru Paint

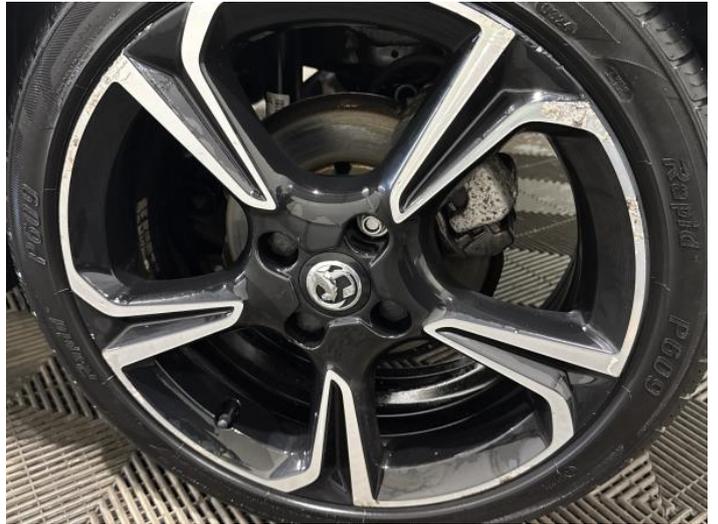
10: Wheel nsr
Scratched
Over 50mm

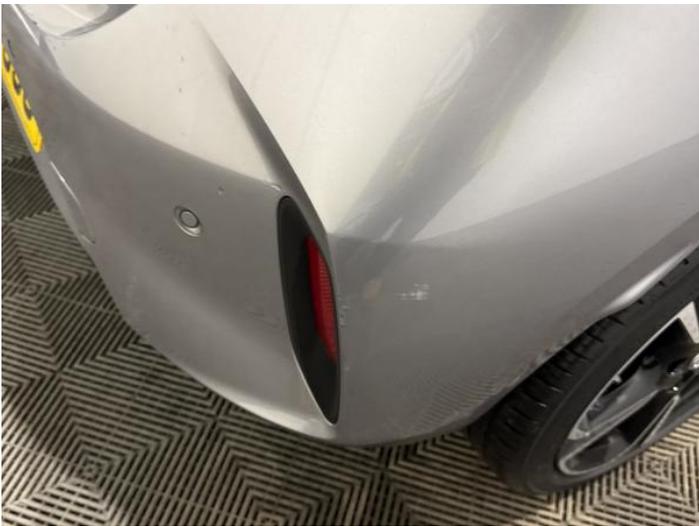
11: Bumper Rear
Scratched
Over 100mm Thru Paint

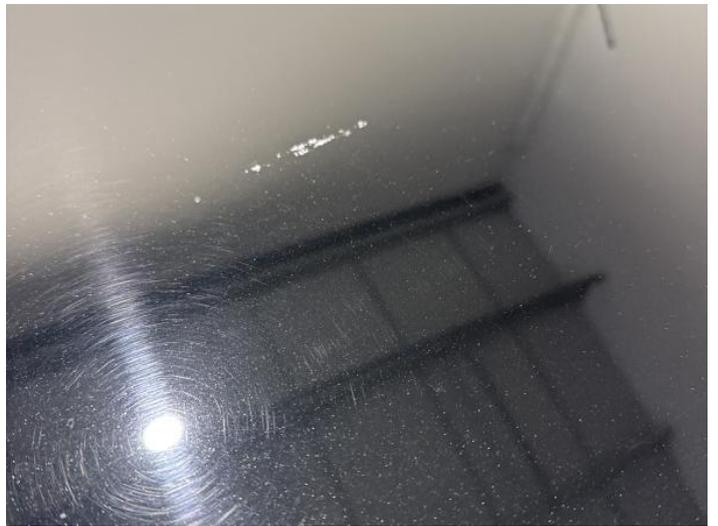
12: Roof
Scratched
Over 25mm Thru Paint

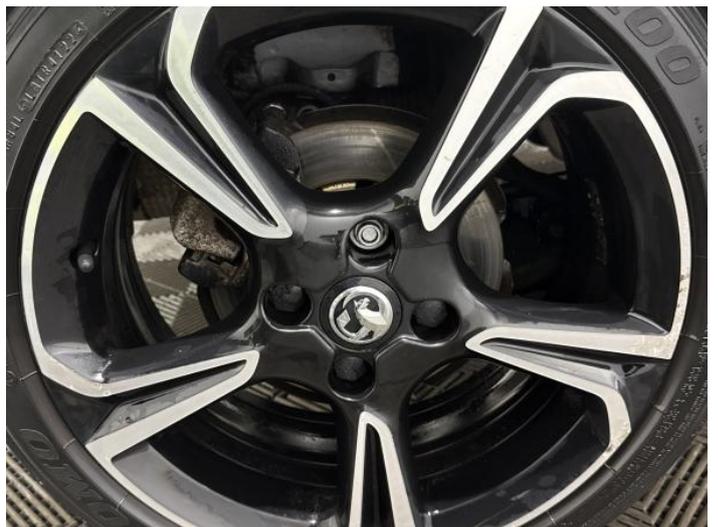
14: Wheel osr
Scratched
Over 50mm

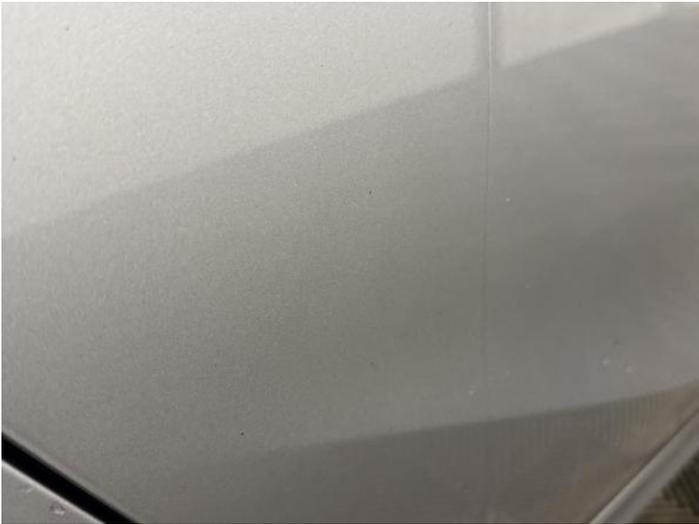
15: Door osr
Chipped
1 To 5

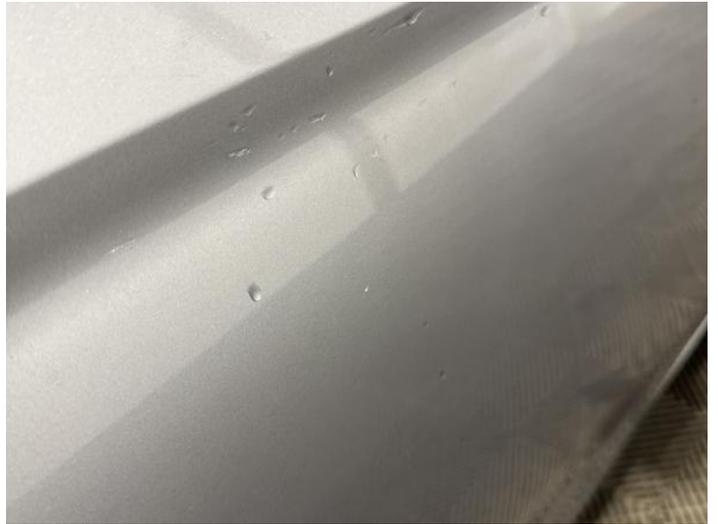
16: Door osf
Chipped
1 To 5

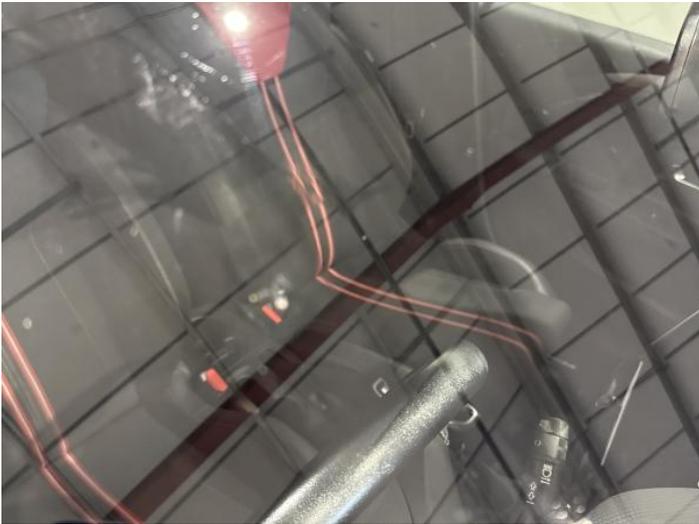
17: Screen Front
Chipped
Over 10mm

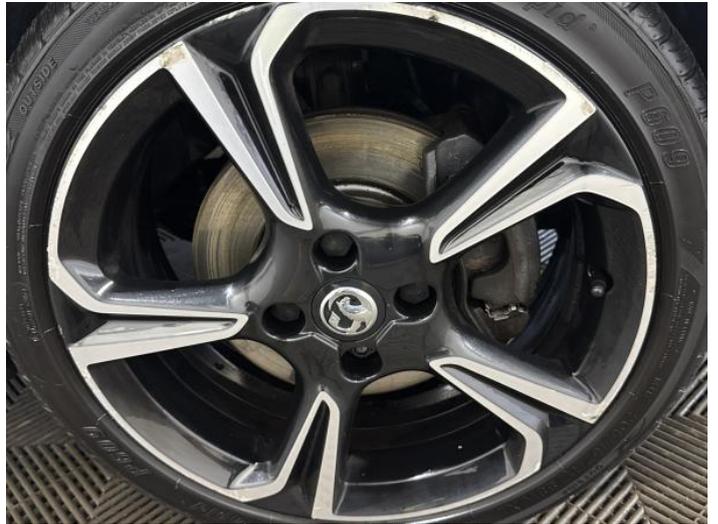
18: Wheel osf
Scratched
Over 50mm

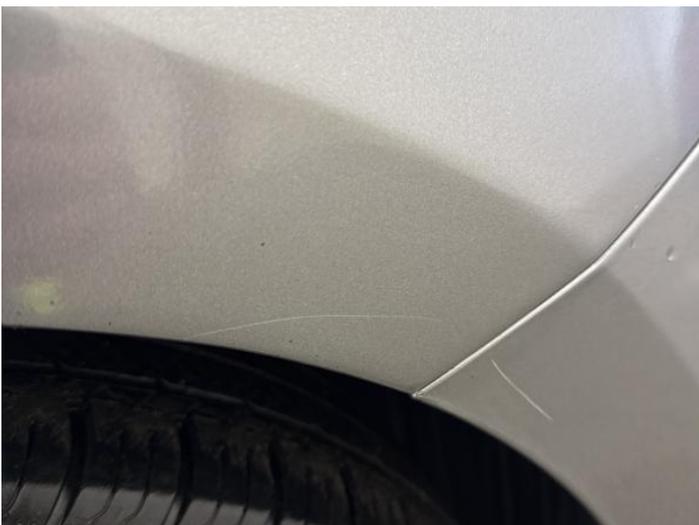
19: Wing osf
Scratched
Over 25mm Thru Paint
