VEHICLE INSPECTION REPORT

GU22WUA

Toyota Corolla 1.8 VVT-i Hybrid Design 5dr CVT

nama
GRADE
4

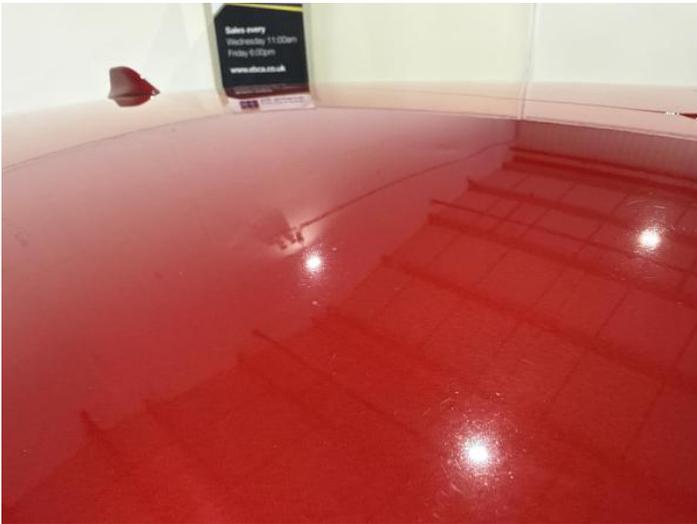
1: Roof
Dented
2 Or Less UpTo 10mm

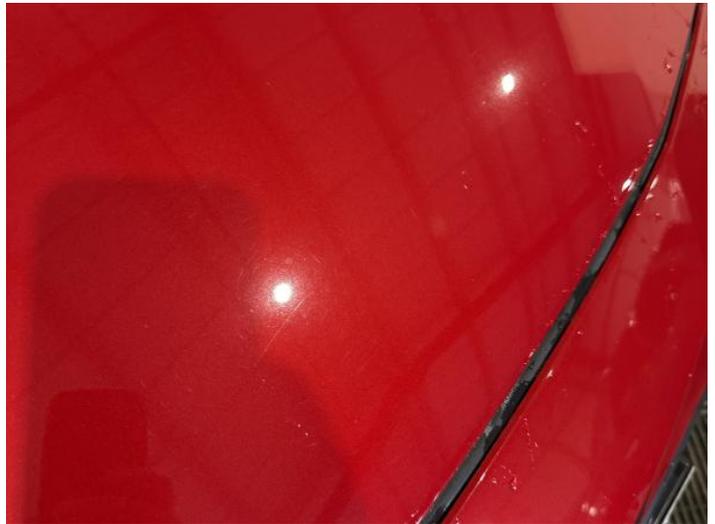
2: Bonnet
Chipped
1 To 5

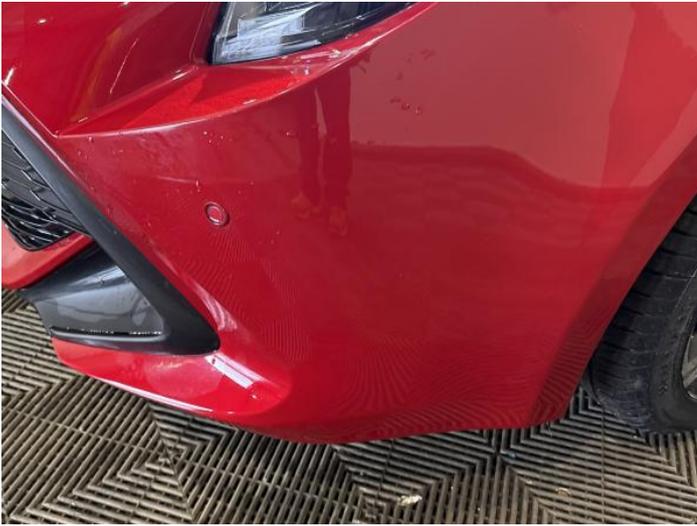
3: Bumper Front
Scratched
25 to 100mm Thru Paint

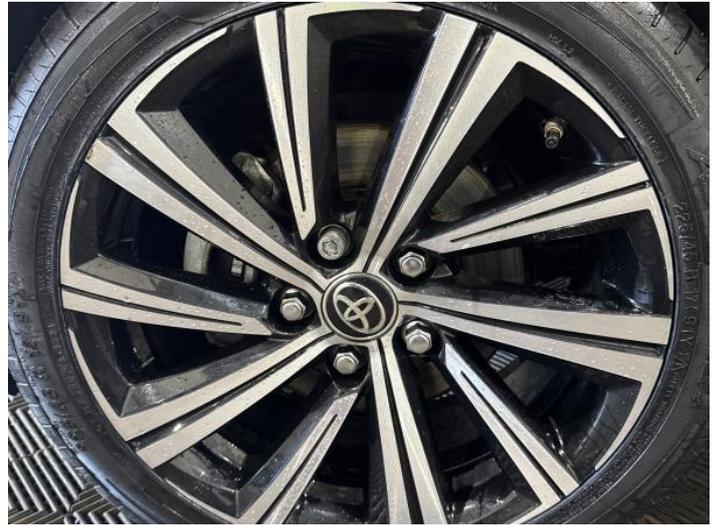
4: Wheel nsf
Scratched
Up To 50mm

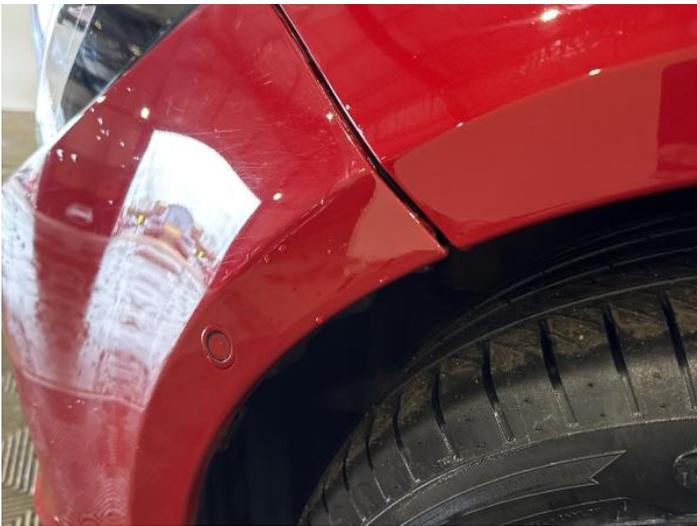
5: Bumper Front
Insecure
Action Required

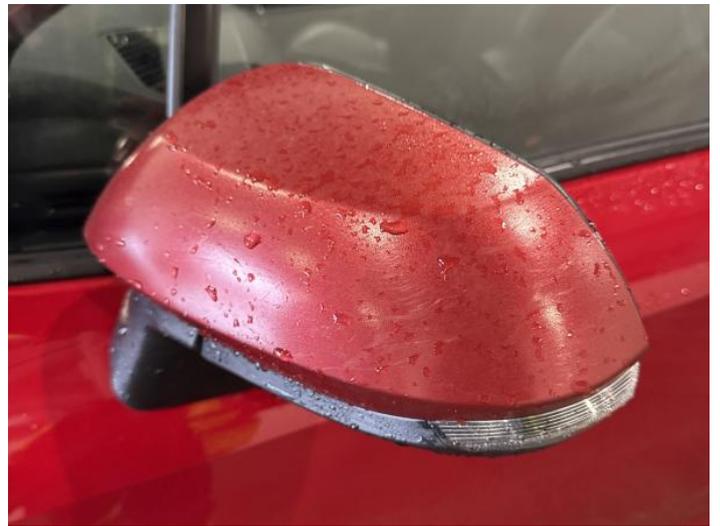
6: Door Mirror Assy nsf
Scratched (Painted)
Over 25mm Thru Paint

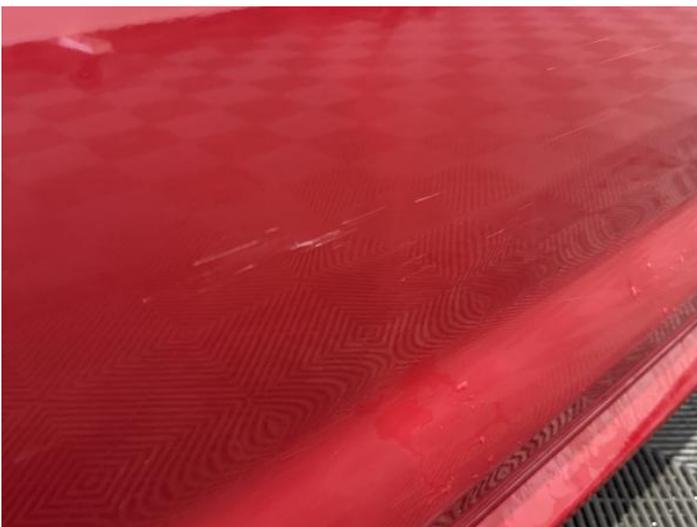
7: Door nsf
Scratched
Over 25mm Thru Paint

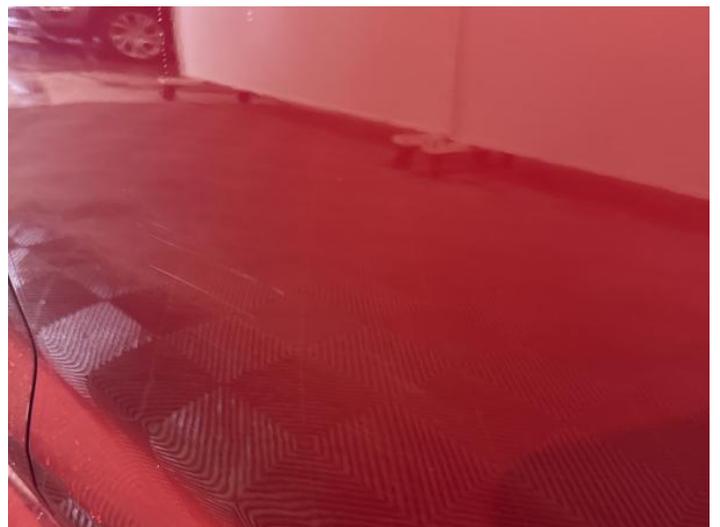
8: Door nsr
Scratched
Over 25mm Thru Paint

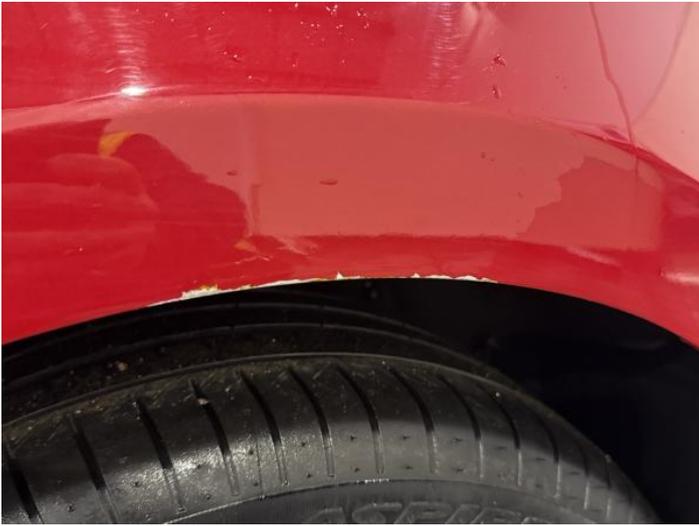
9: Qtr Panel nsr
Scratched
Over 25mm Thru Paint

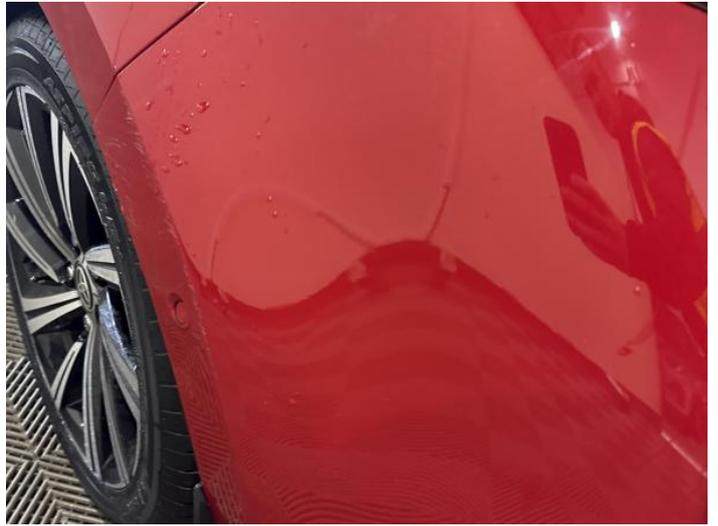
10: Bumper Rear
Scratched
25 to 100mm Thru Paint

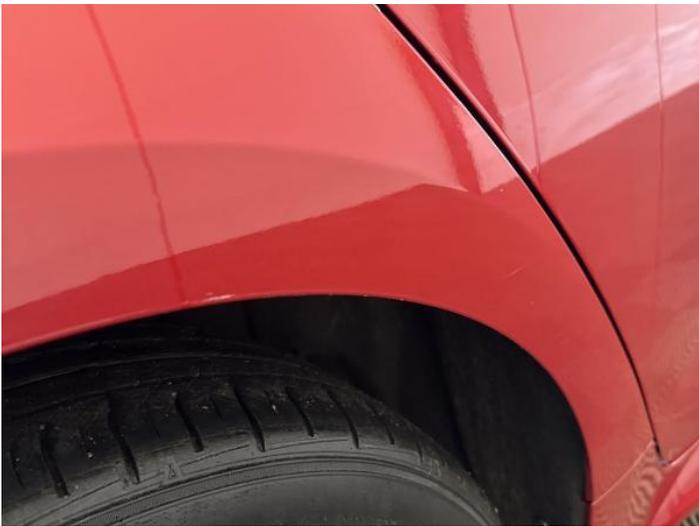
11: Qtr Panel osr
Scratched
Over 25mm Thru Paint

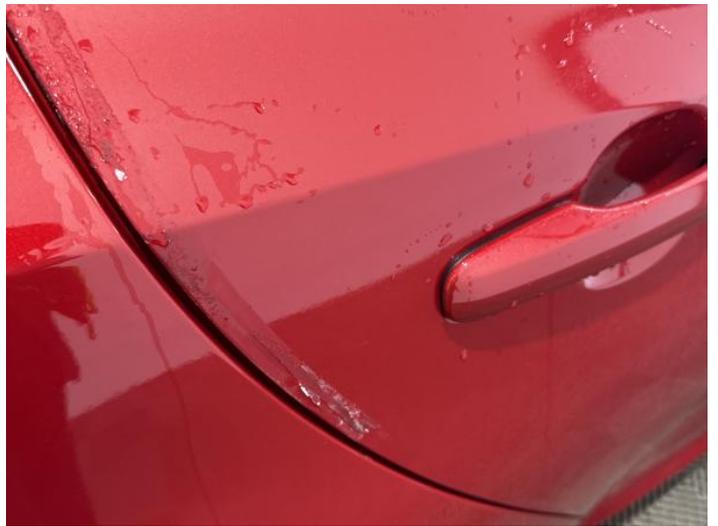
12: Door osr
Scratched
Over 25mm Thru Paint

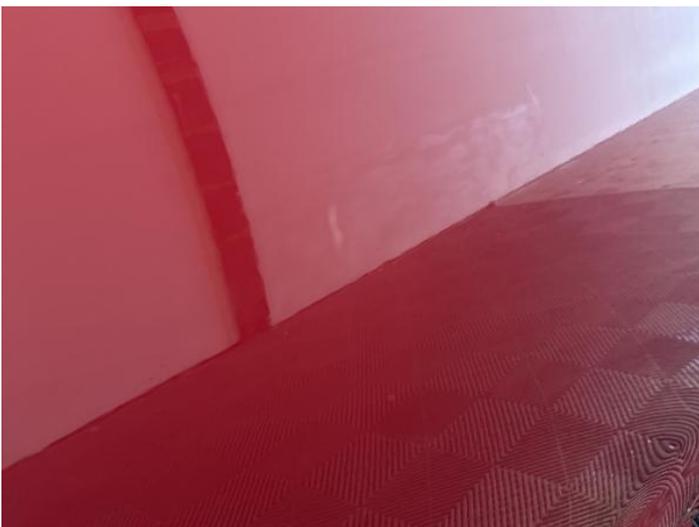
13: Door osf
Scratched
UpTo 25mm Thru Paint

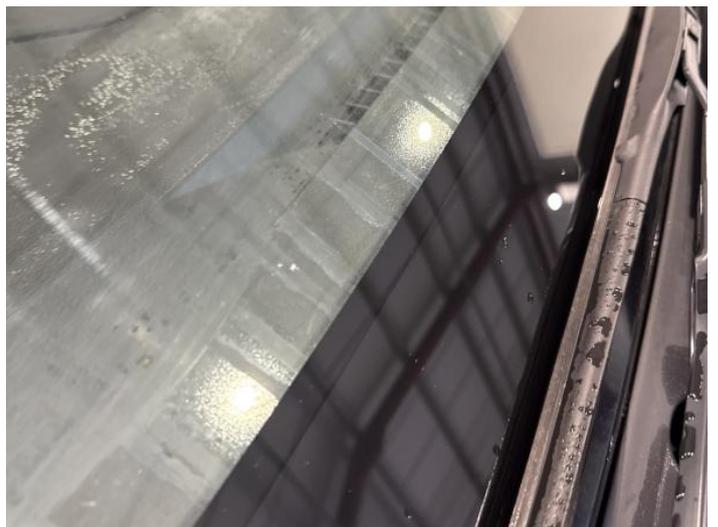
14: Screen Front
Chipped
UpTo 10mm

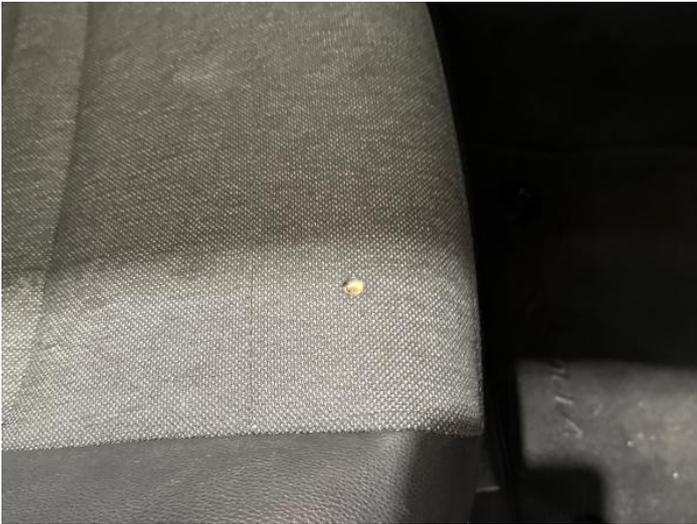
15: Seat Base Cover of
Burn
Over 3mm
