VEHICLE INSPECTION REPORT

DN71UXC

Peugeot 2008 100kW GT 50kWh 5dr Auto

nama
 GRADE
2

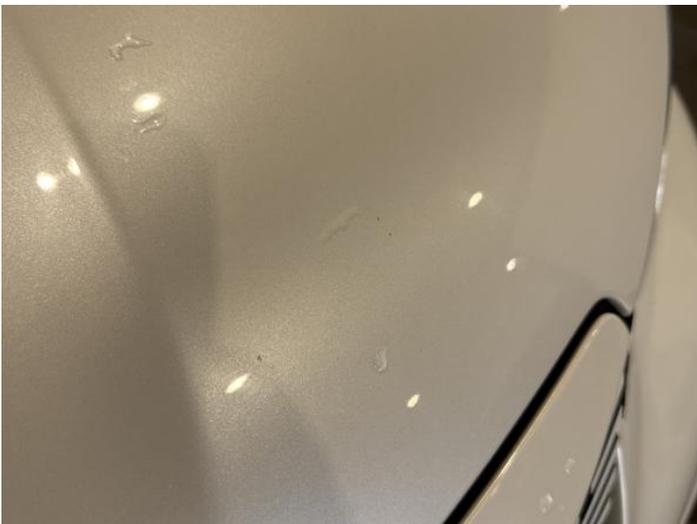
1: Bonnet
Chipped
1 To 5

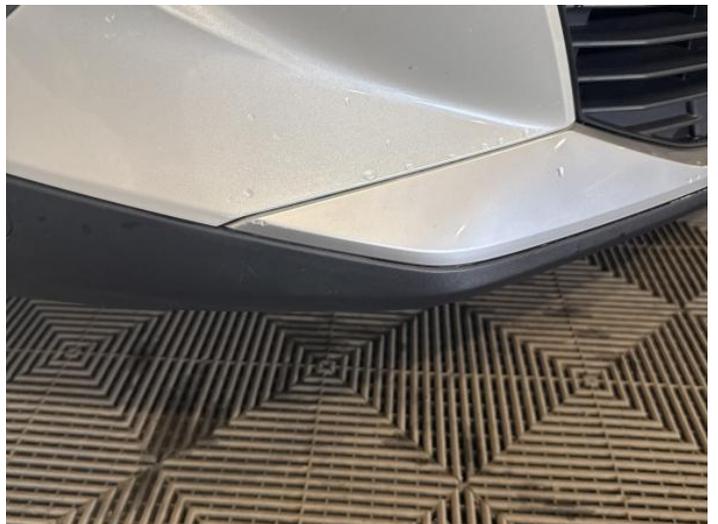
2: Bumper Front Moulding
Scratched (Painted)
Up To 25mm Thru Paint

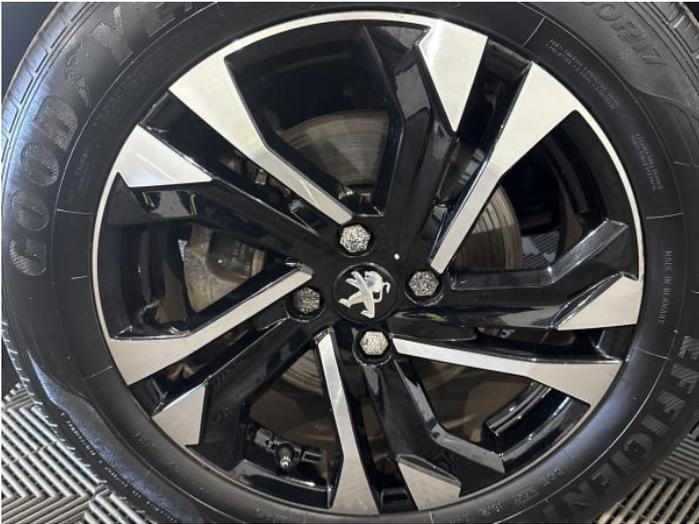
3: Wheel nsf
Scratched
Up To 50mm

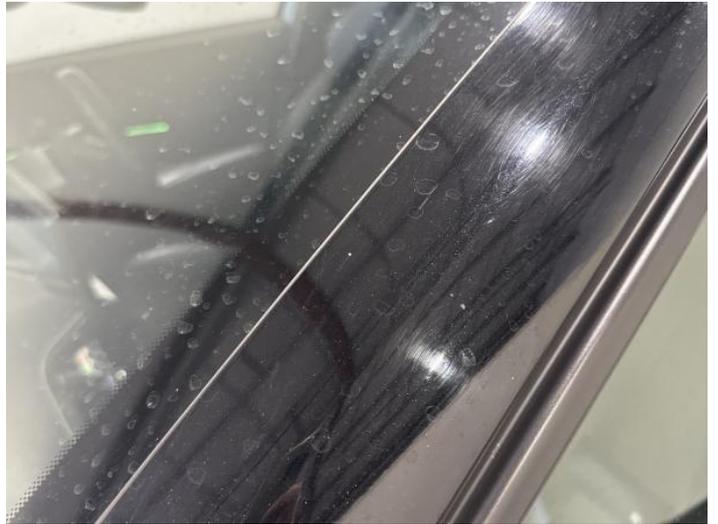
4: A Post ns
Chipped
1 To 5

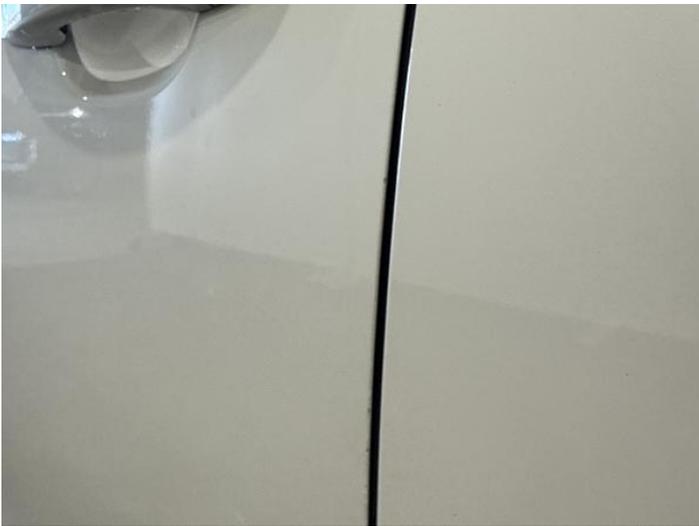
5: Door nsf
Chipped
Edge Chip

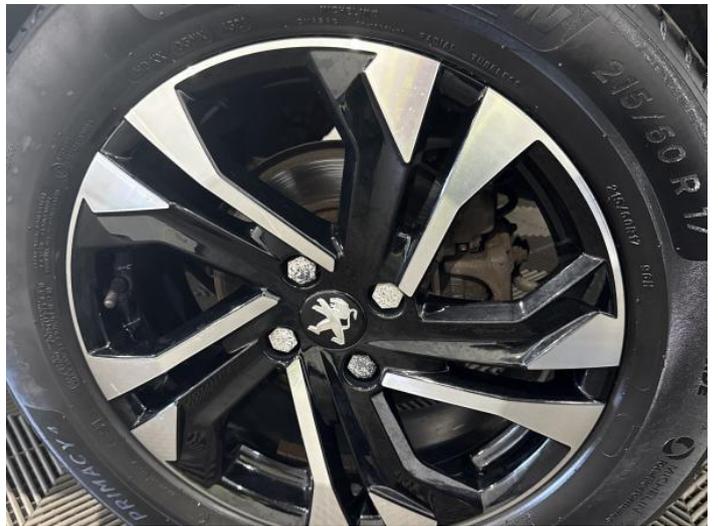
6: Wheel nsr
Scratched
Up To 50mm

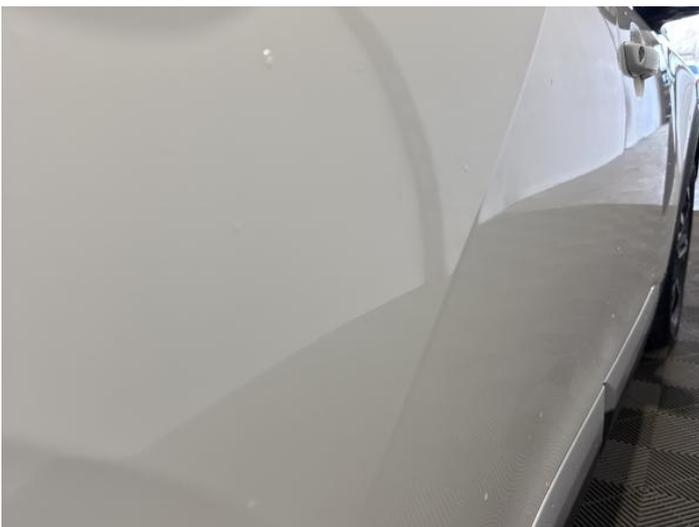
7: Door osr
Dented
2 Or Less UpTo 10mm

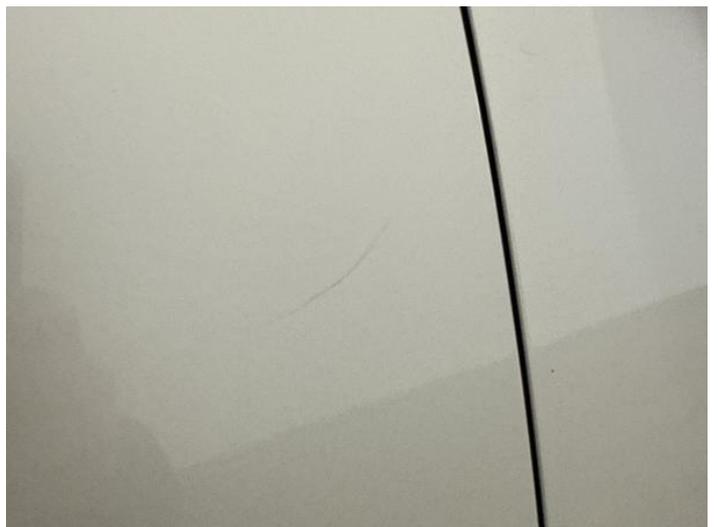
8: Door osr
Scratched
Over 25mm Not Thru Paint

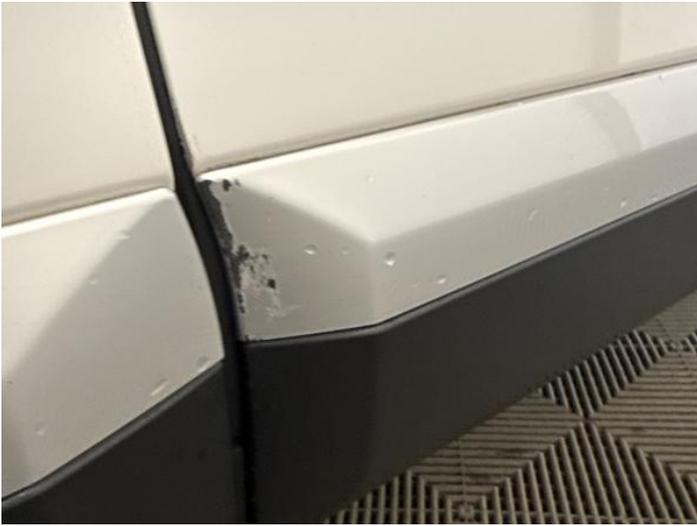
9: Door Moulding osf
Scratched (Painted)
Over 25mm Thru Paint

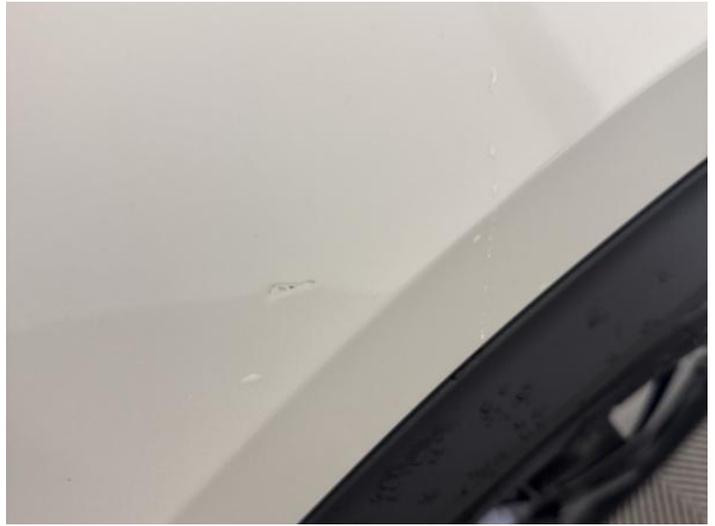
10: Wing osf
Scratched
UpTo 25mm Thru Paint
