VEHICLE INSPECTION REPORT

WF58MGU

Audi A3 2.0 TDI 5dr

nama
GRADE 5

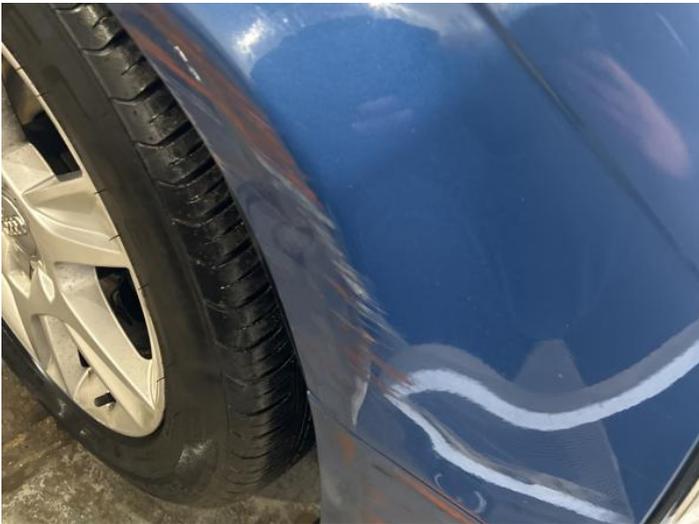
1: Wing of
Dented
With Paint Damage

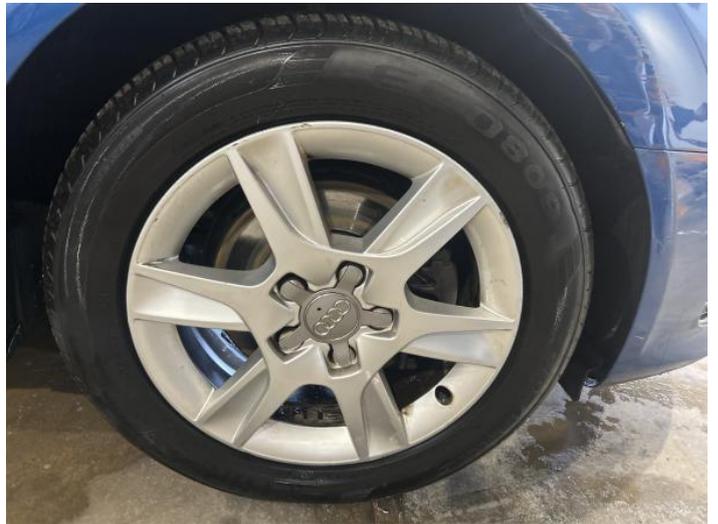
2: Wheel of
Scratched
Up To 50mm

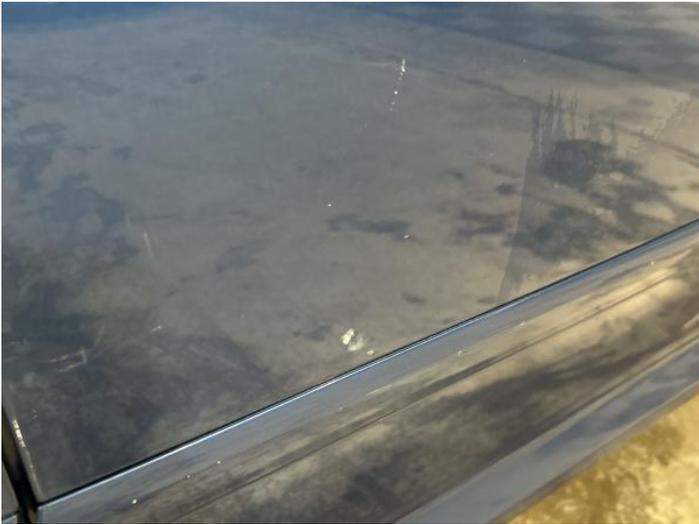
3: Door osf
Chipped
1 To 5

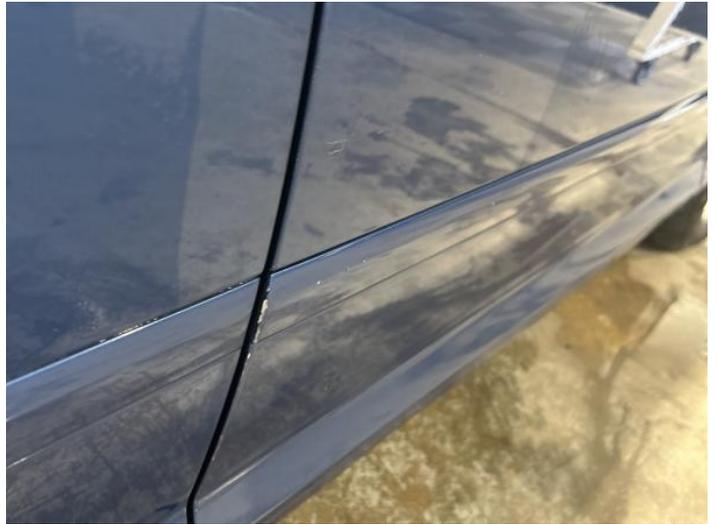
4: Door osf
Chipped
Edge Chip

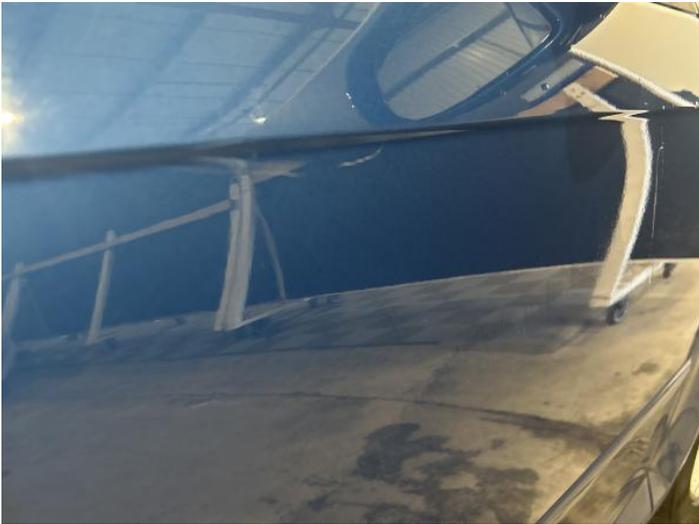
5: Door osf
Scratched
Over 25mm Not Thru Paint

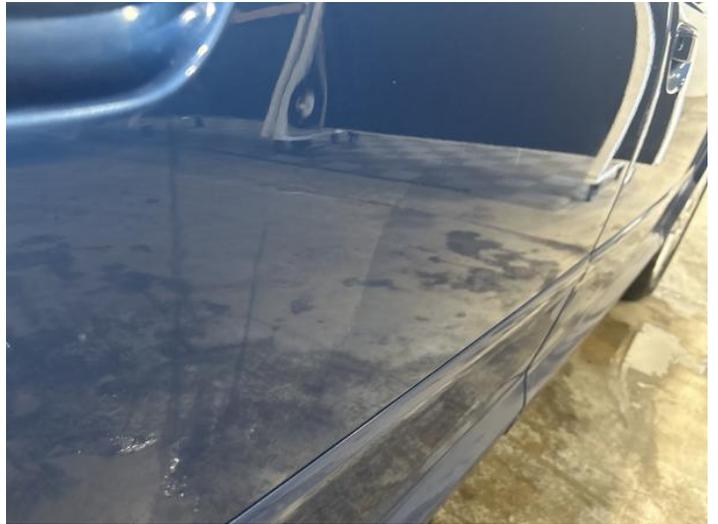
6: Door osr
Dented
2 Or Less Up To 10mm

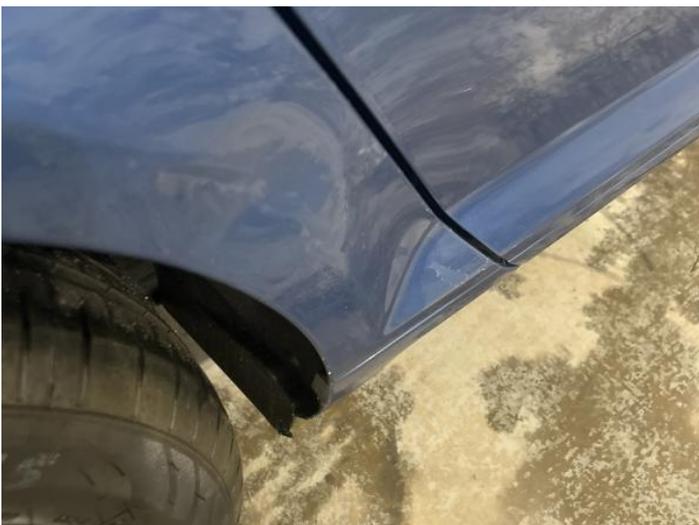
7: Qtr Panel osr
Dented
With Paint Damage

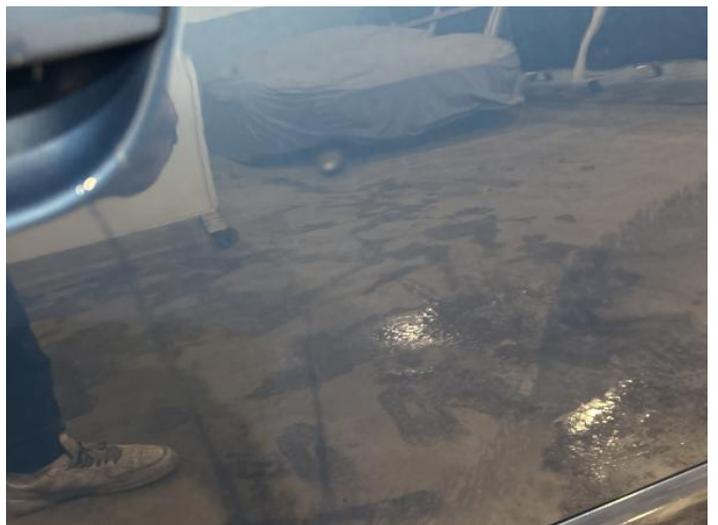
8: Door osr
Chipped
1 To 5

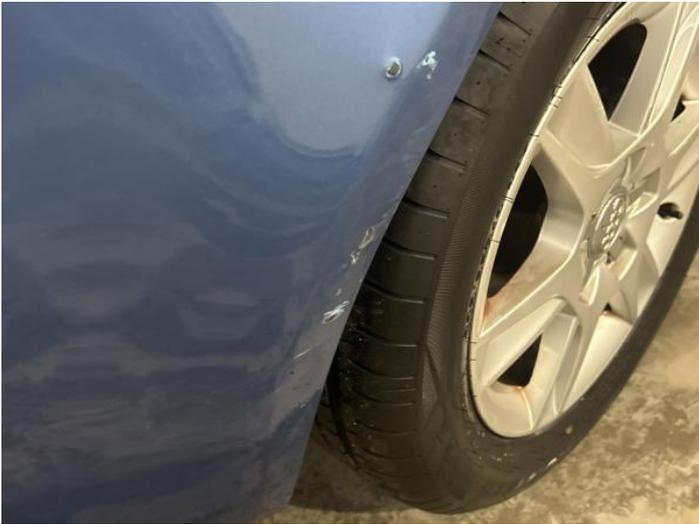
9: Bumper Rear
Scratched
25 to 100mm Thru Paint

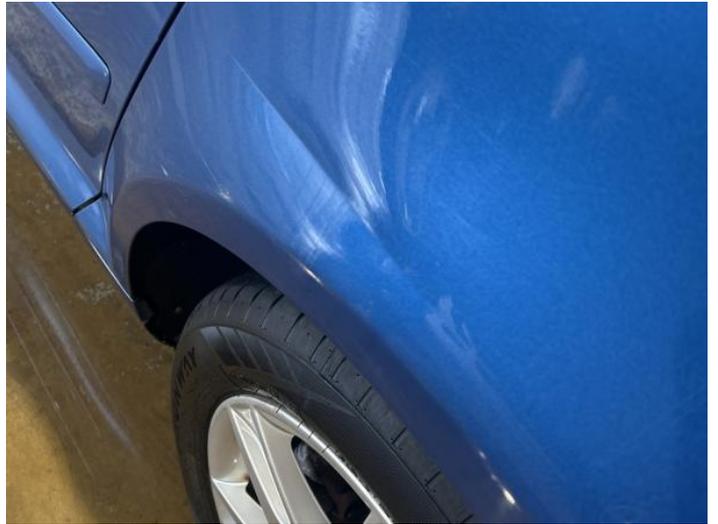
10: Qtr Panel nsr
Dented
Over 30mm

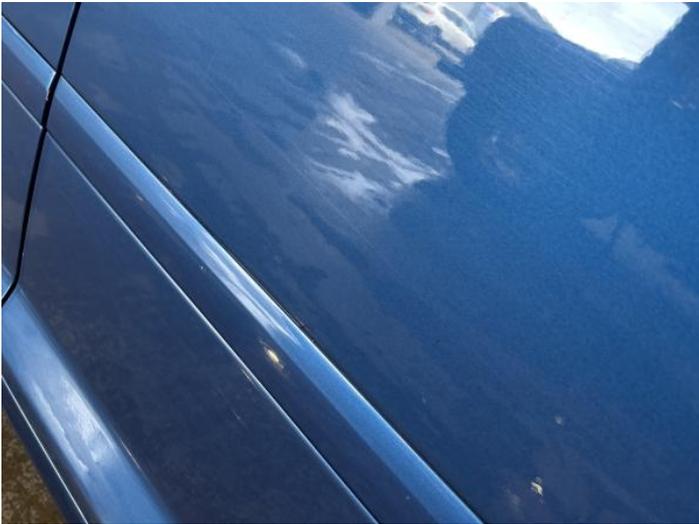
11: Door nsr
Scratched
Over 25mm Not Thru Paint

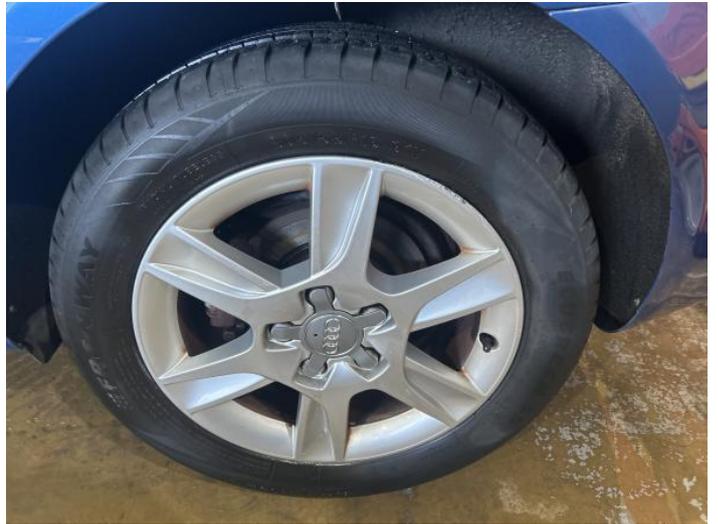
12: Wheel nsr
Scratched
Over 50mm

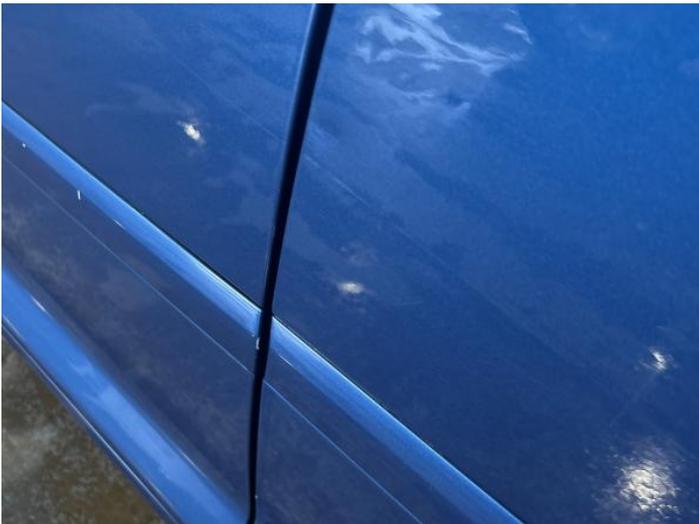
13: Door nsr
Dented
2 Or Less Up To 10mm

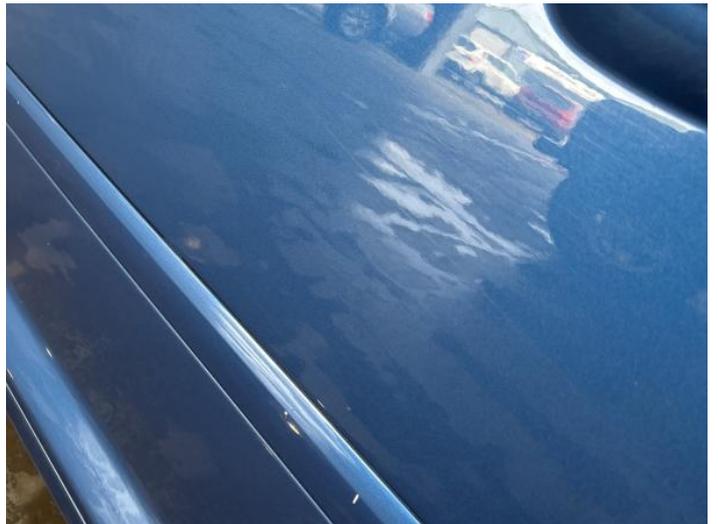
14: Door nsf
Scratched
Over 25mm Not Thru Paint

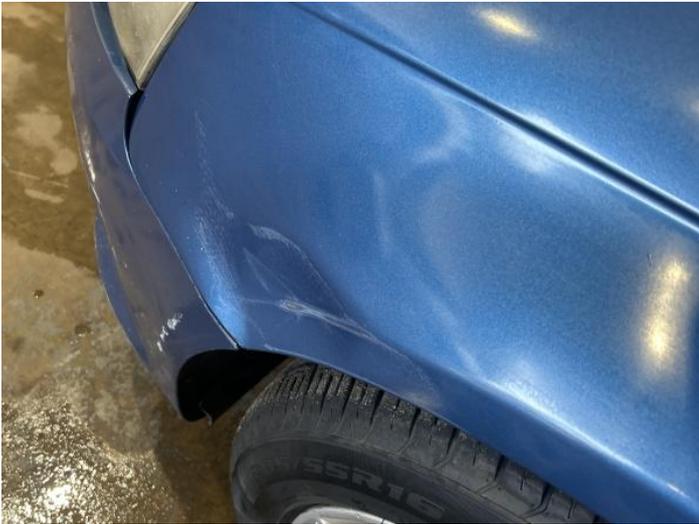
15: Wing nsf
Dented
With Paint Damage

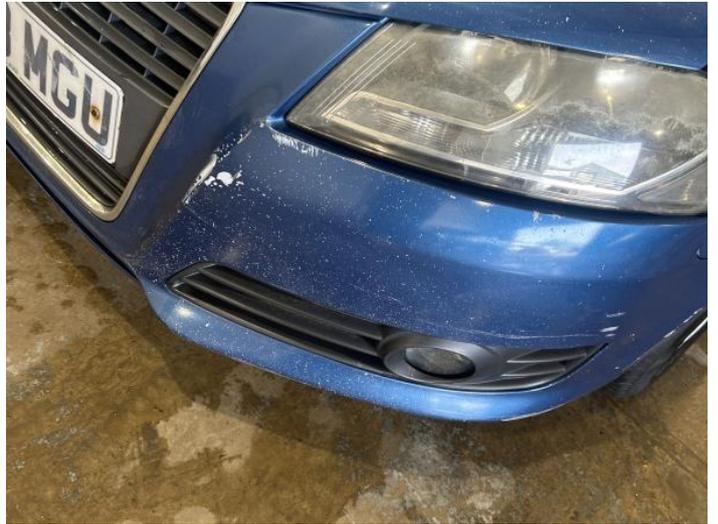
16: Bumper Front
Scratched
Over 100mm Thru Paint

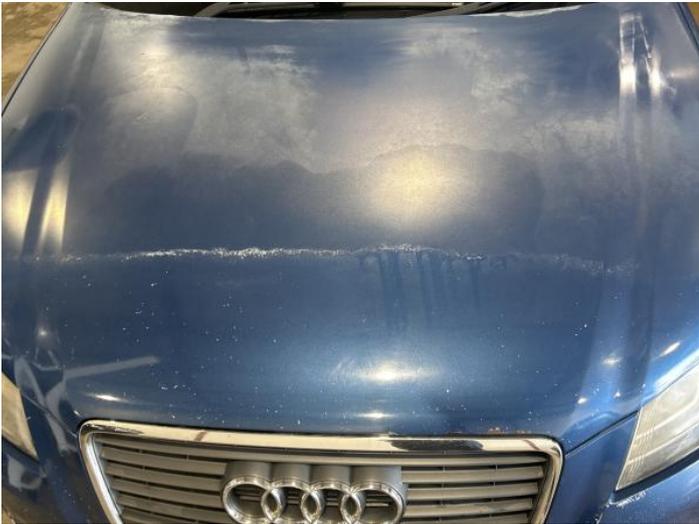
17: Bonnet
Poor Previous Repair
Paint Flake

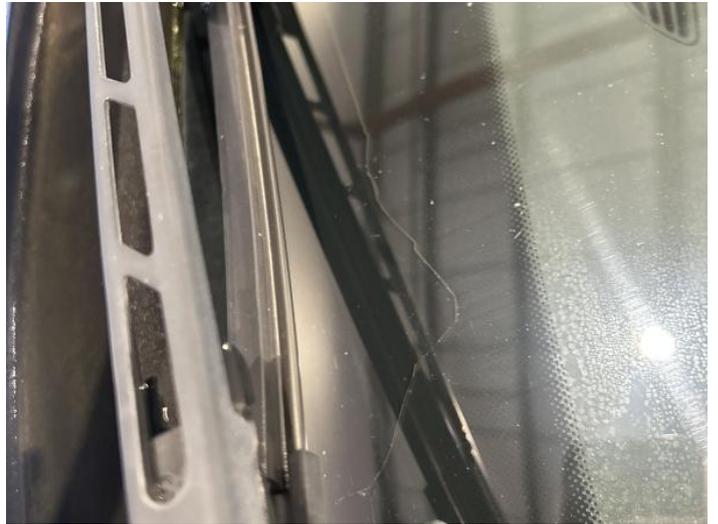
18: Screen Front
Cracked
Replace

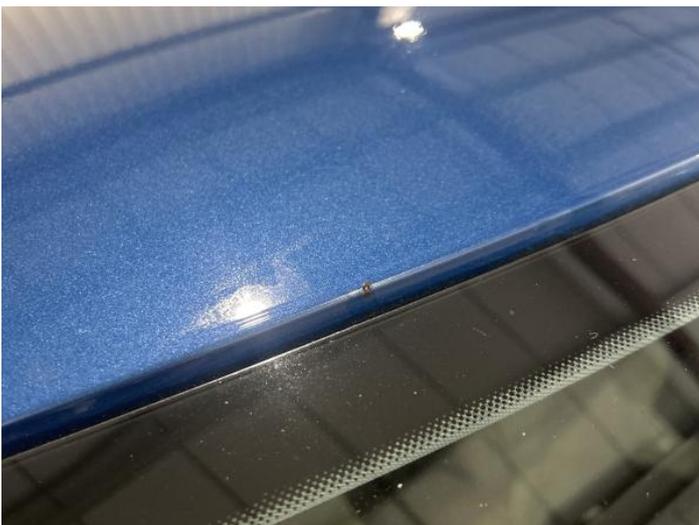
19: Roof
Chipped
1 To 5

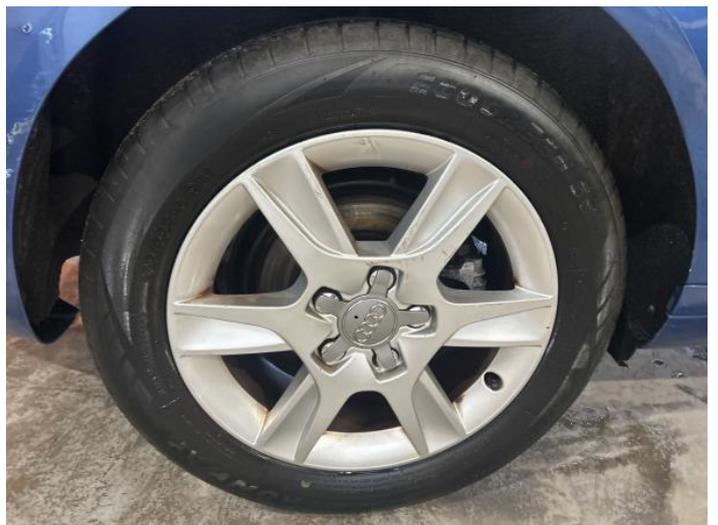
20: Wheel osr
Scratched
Over 50mm

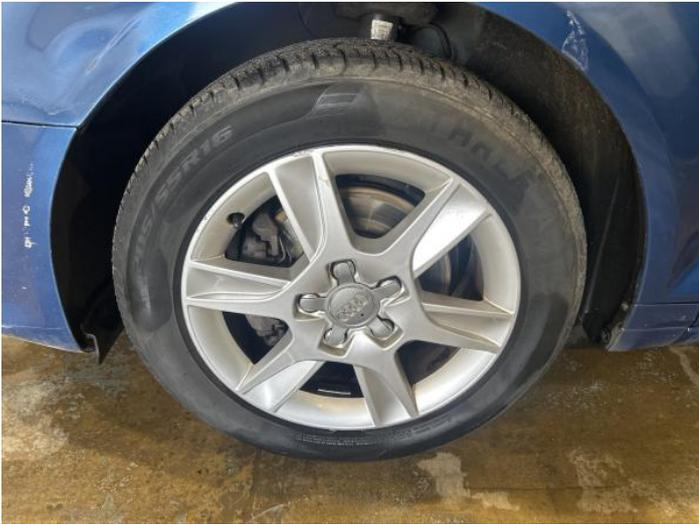
21: Wheel nsf
Scratched
Up To 50mm

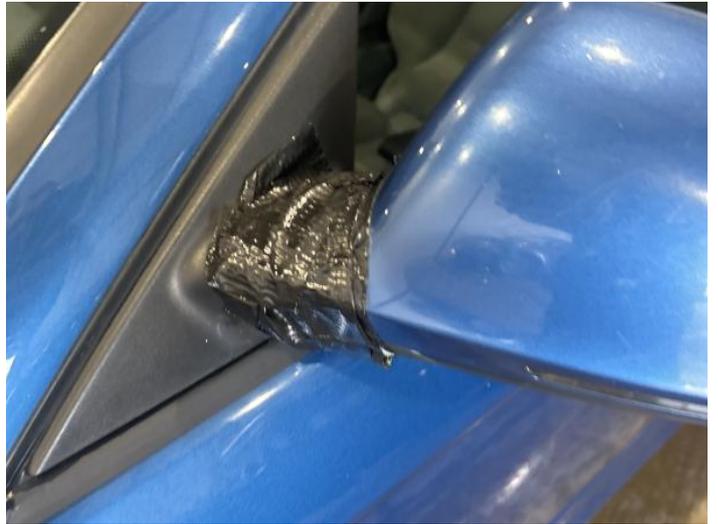
22: Door Mirror Assy nsf
Broken
Replace

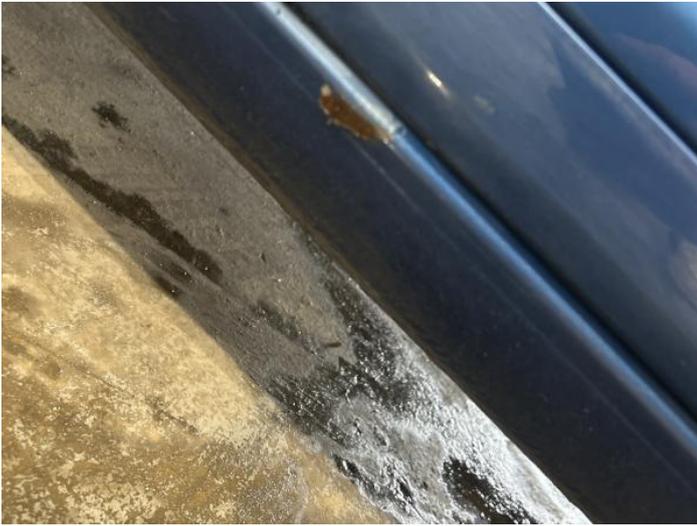
27: Sill os
Chipped
Over 5mm
