# VEHICLE INSPECTION REPORT

**GX68UJF**

## Citroen C3 1.6 BlueHDi 100 Feel 5dr

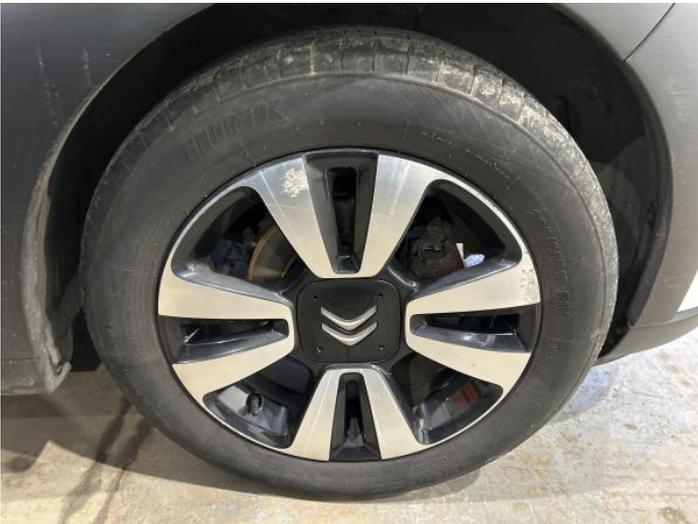
1: Wheel osf  
Corroded  
Light

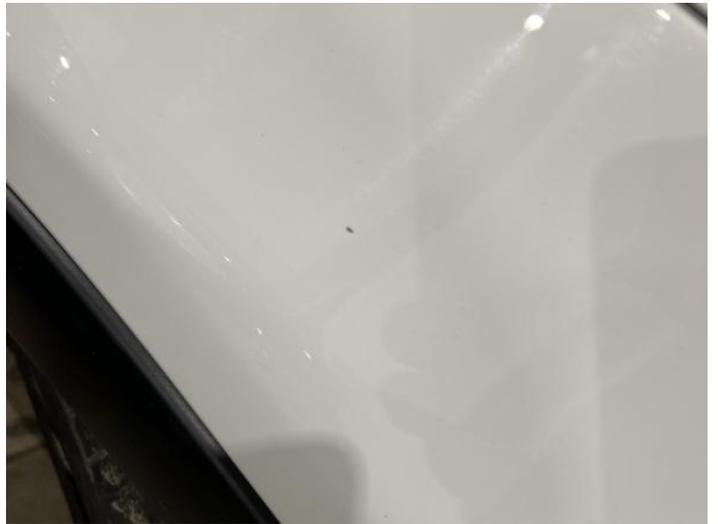
2: Wing osf  
Chipped  
1 To 5

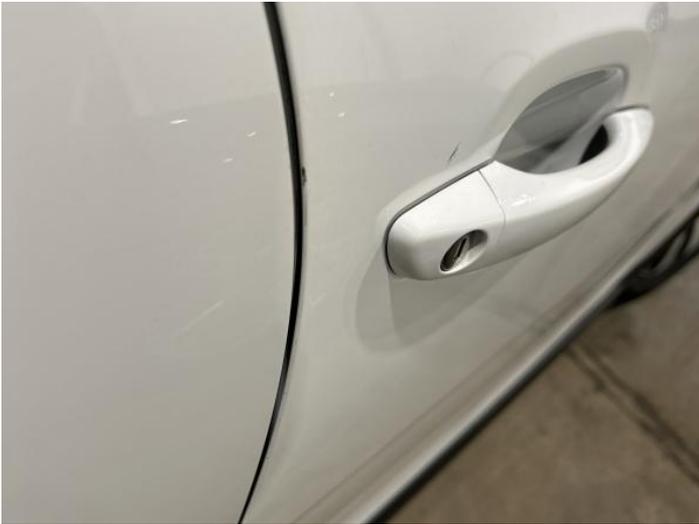
3: Door osf  
Chipped  
Edge Chip

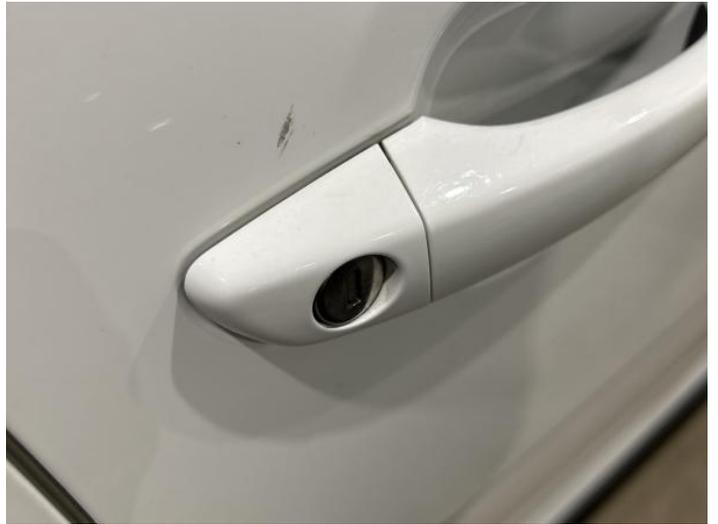
4: Door osf  
Scratched  
UpTo 25mm Not Thru Paint

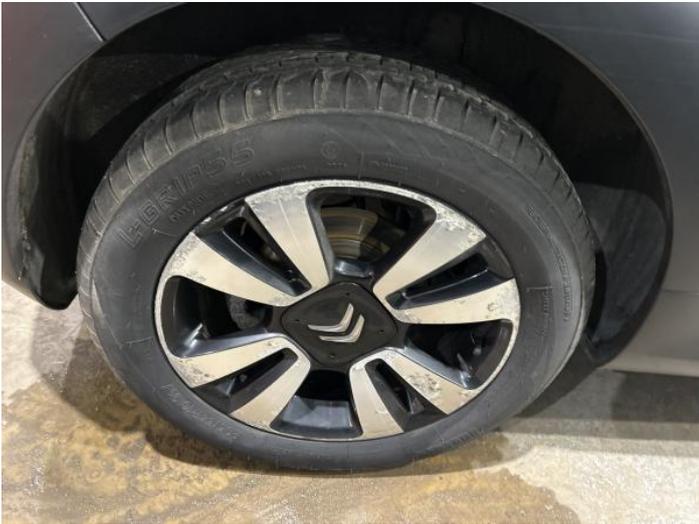
5: Wheel osr  
Corroded  
Light

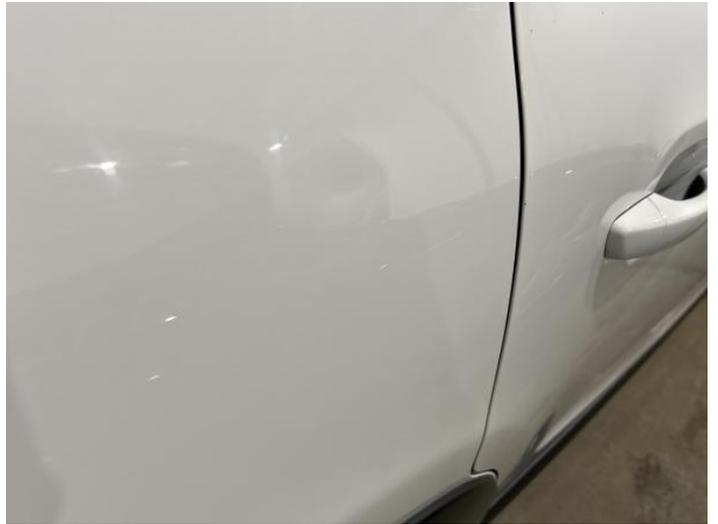
6: Qtr Panel osr  
Dented  
Between 10mm + 30mm

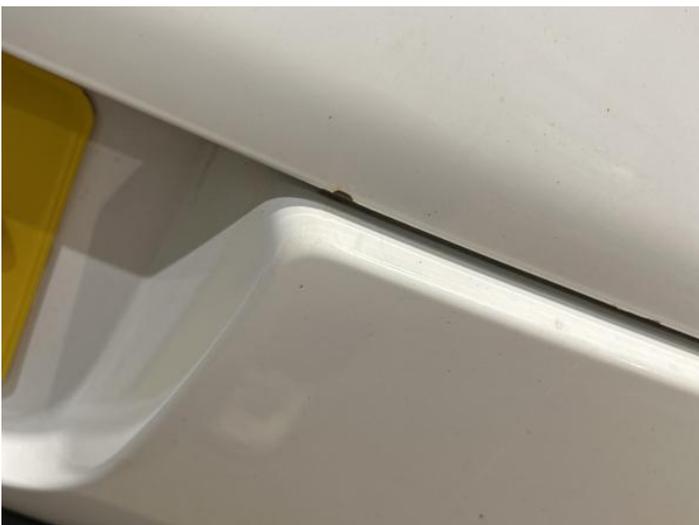
7: Tailgate  
Chipped  
1 To 5

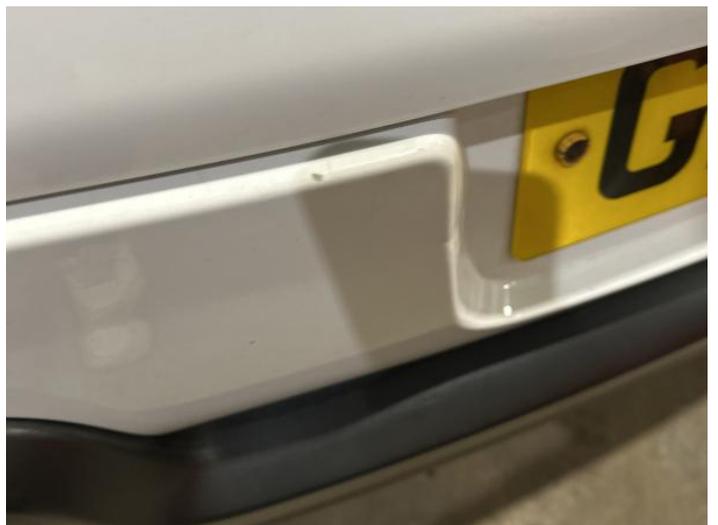
8: Bumper Rear  
Chipped  
1 To 5

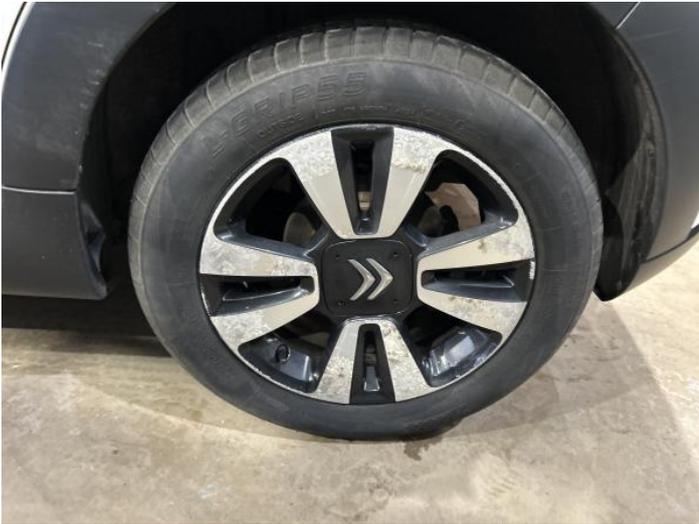
9: Wheel nsr  
Corroded  
Light

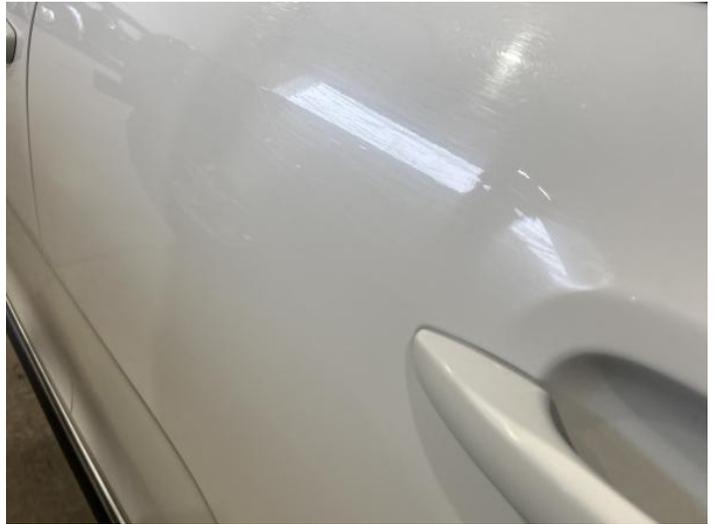
10: Door nsr  
Scratched  
Over 25mm Not Thru Paint

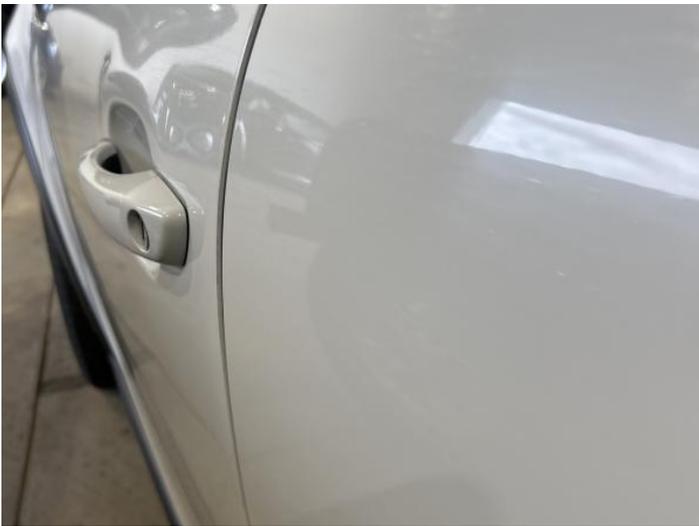
11: Door nsr  
Dented  
2 Or Less UpTo 10mm

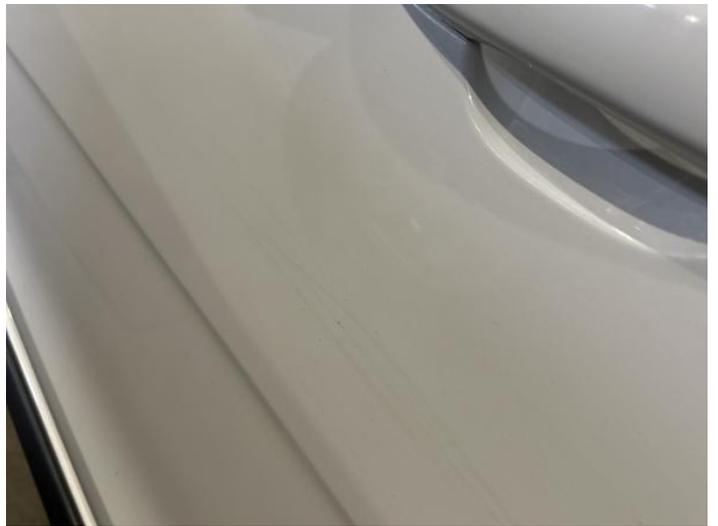
12: Door nsf  
Scratched  
Over 25mm Not Thru Paint

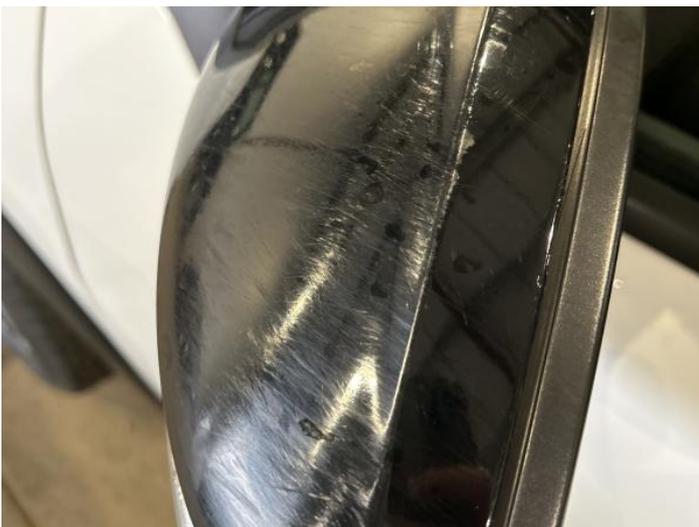
13: Door Mirror Assy nsf  
Scratched (Painted)  
Over 25mm Not Thru Paint

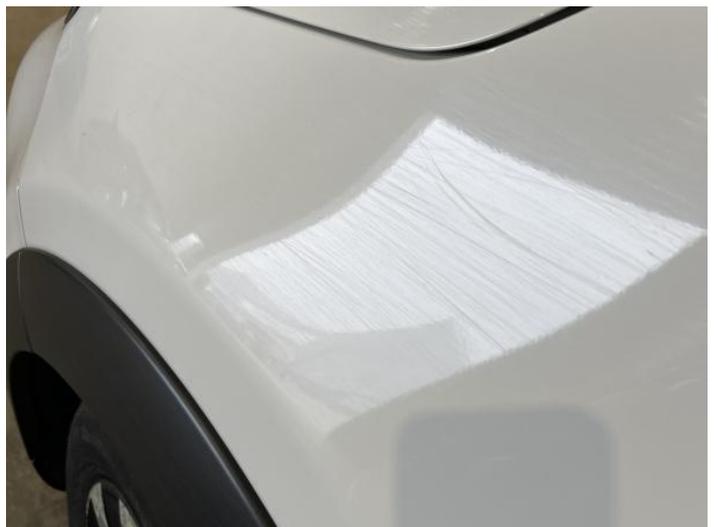
14: Wing nsf  
Scratched  
Over 25mm Not Thru Paint

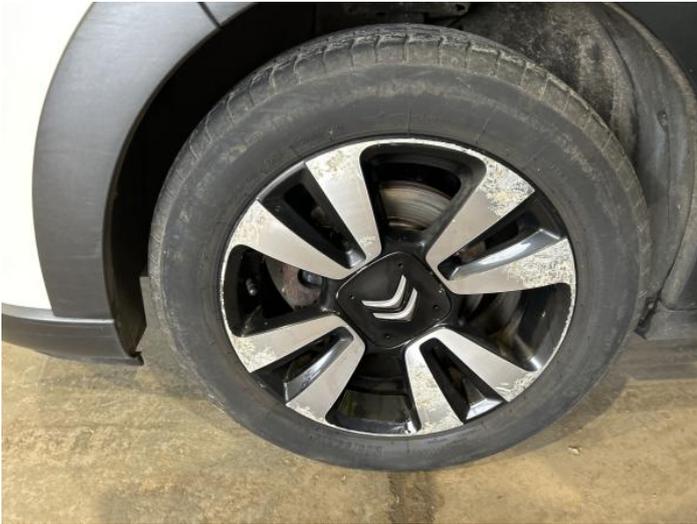
15: Wheel nsf  
Corroded  
Light

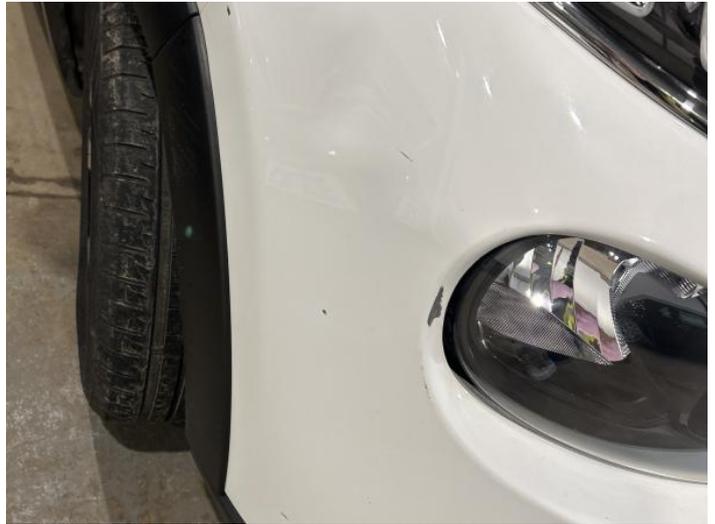
16: Bumper Front  
Scratched  
Over 100mm Thru Paint

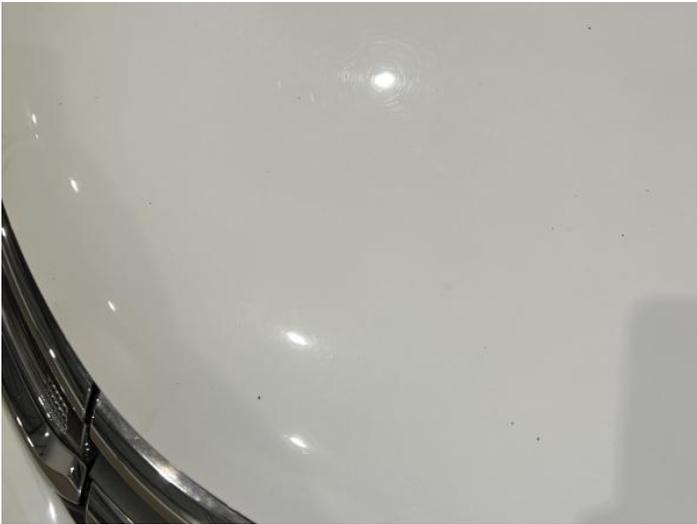
17: Bonnet  
Chipped  
Multiple Chips

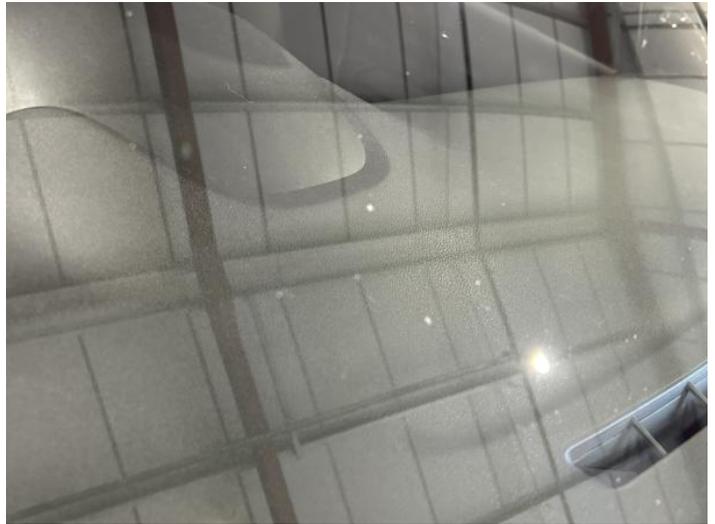
18: Screen Front  
Chipped  
UpTo 10mm
