VEHICLE INSPECTION REPORT

HK67XCN

Renault Kadjar 1.5 dCi Signature Nav 5dr EDC

nama
GRADE
4

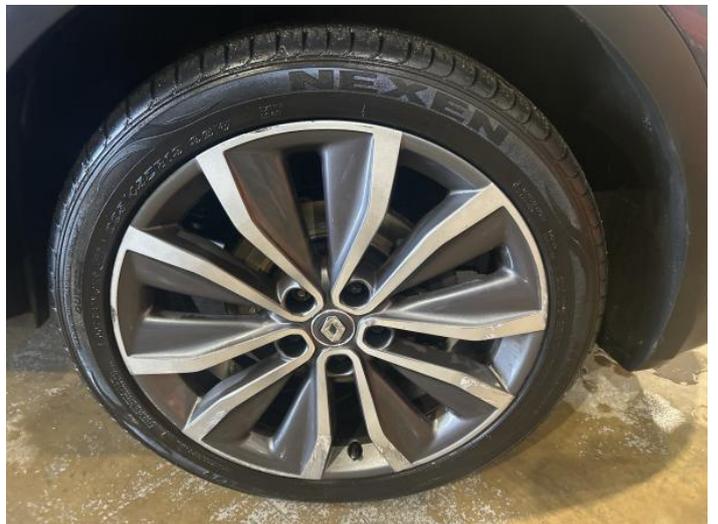
2: Wheel of
Scratched
Over 50mm

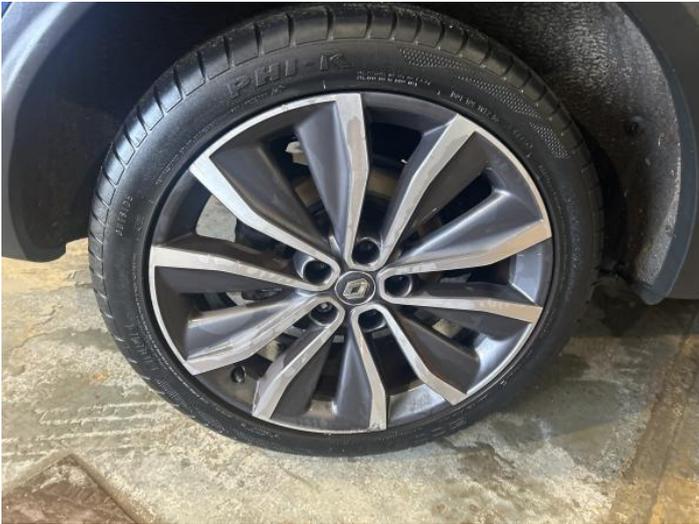
3: Wheel osr
Corroded
Light

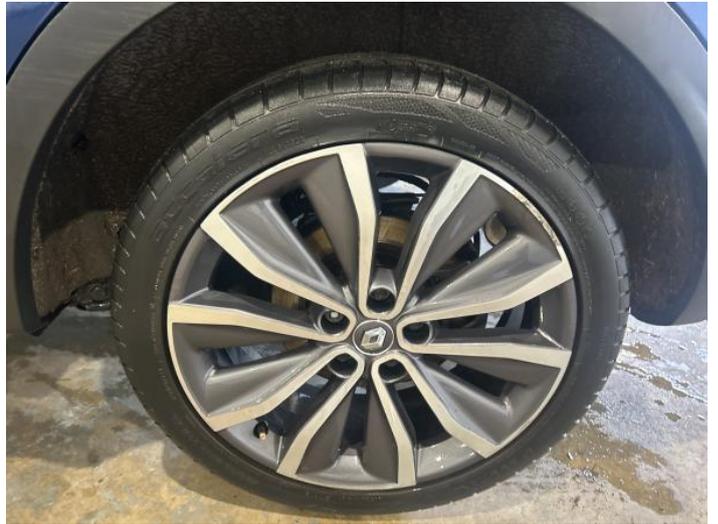
4: Wheel nsr
Corroded
Light

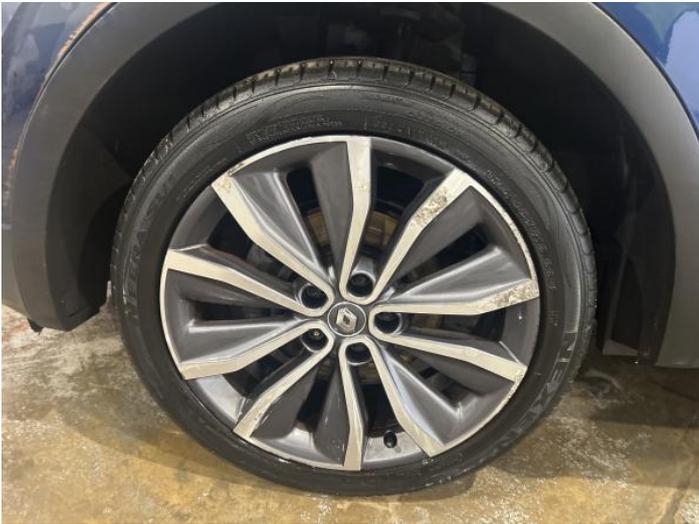
5: Wheel nsf
Corroded
Light

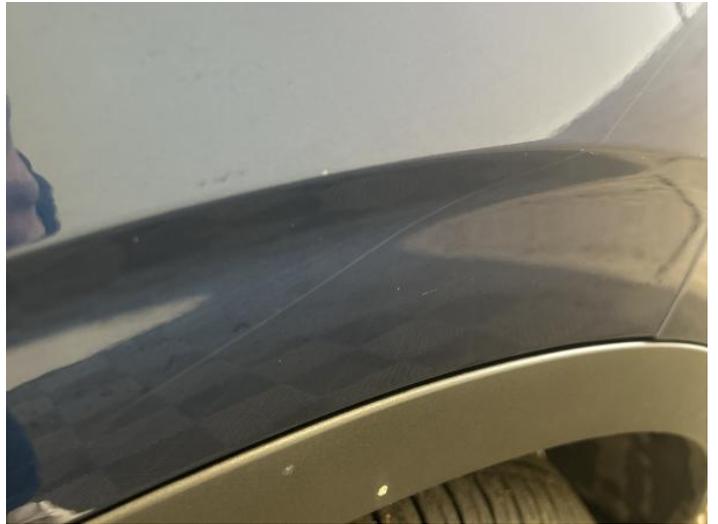
6: Wing osf
Chipped
1 To 5

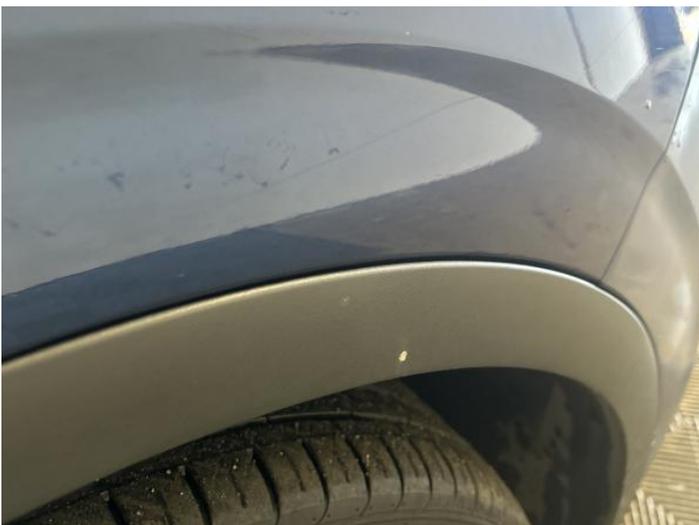
7: Wing osf
Scratched
Over 25mm Not Thru Paint

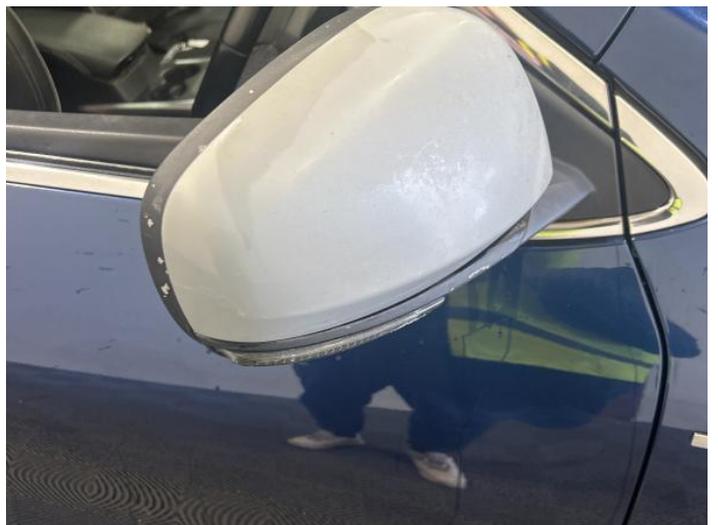
8: Door Mirror Assy osf
Scratched (Painted)
Over 25mm Thru Paint

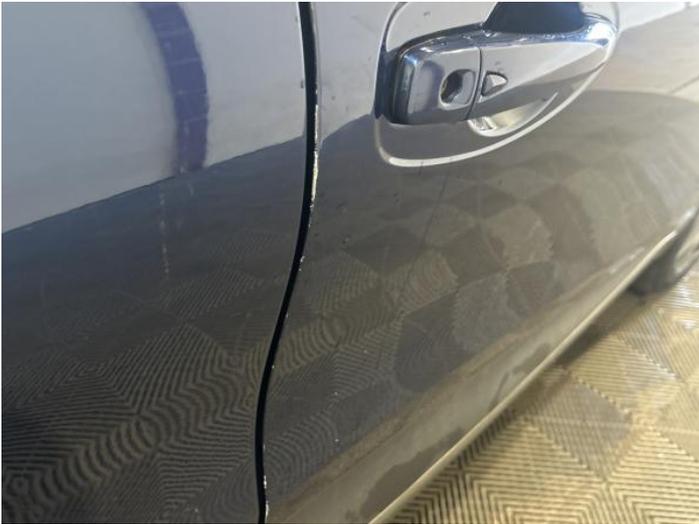
9: Door osf
Chipped
Edge Chip

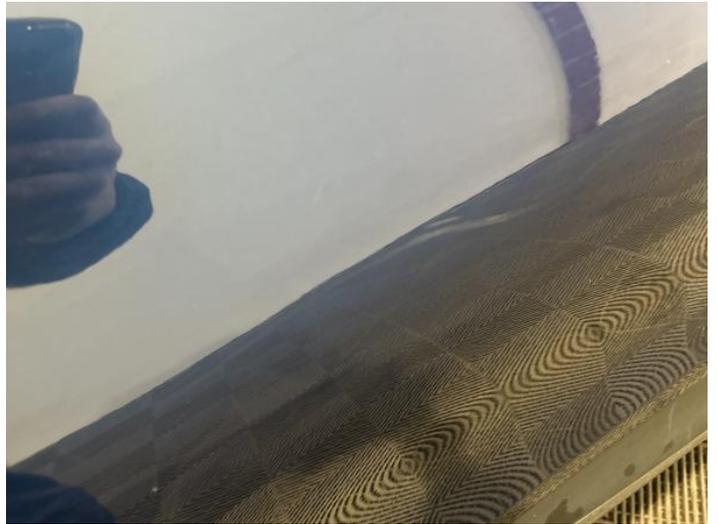
10: Door osr
Scratched
Over 25mm Not Thru Paint

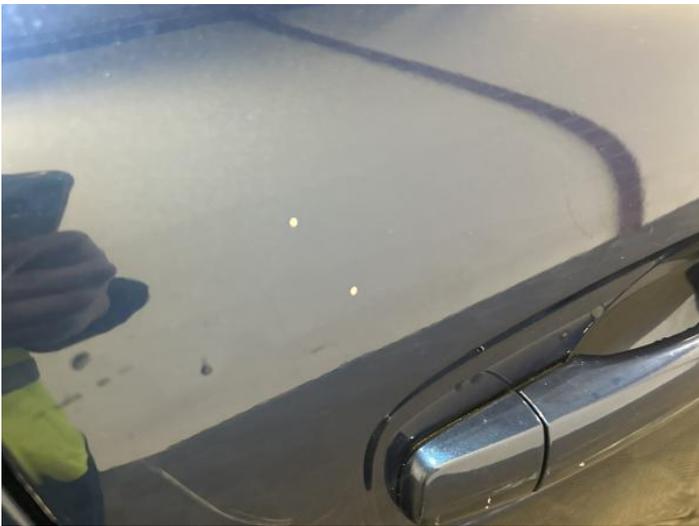
11: Door osr
Chipped
Edge Chip

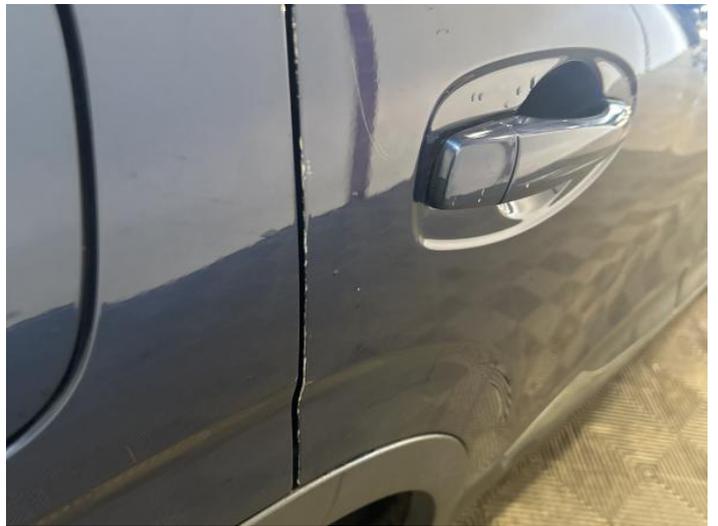
12: Door osr
Chipped
Edge Chip

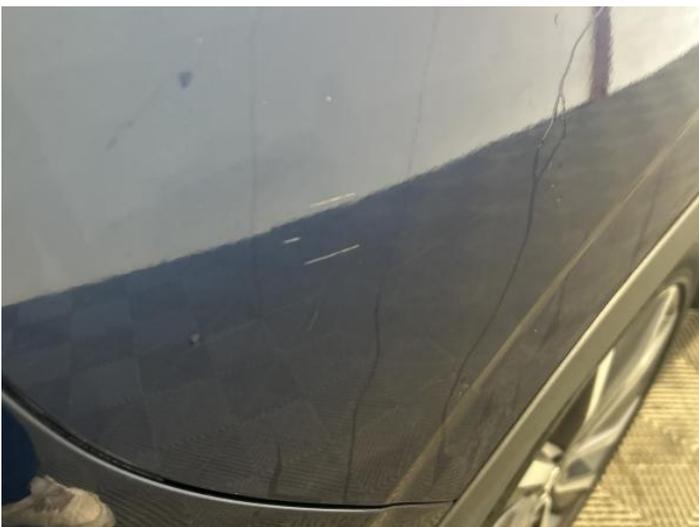
13: Qtr Panel osr
Scratched
Up To 25mm Thru Paint

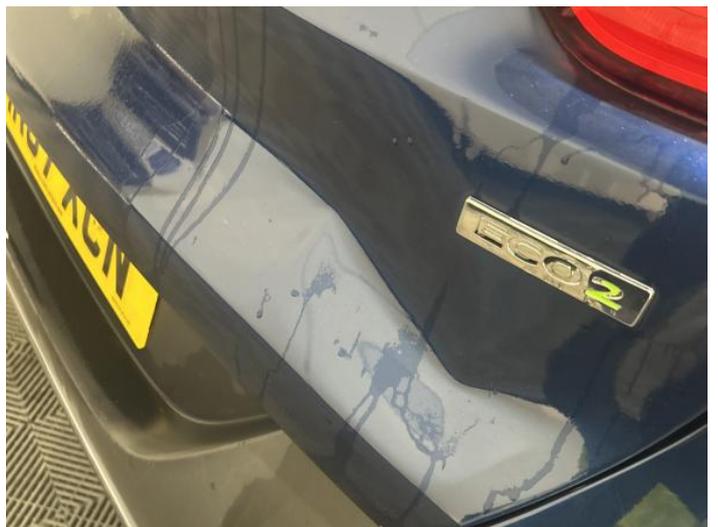
14: Tailgate
Dented
Over 30mm

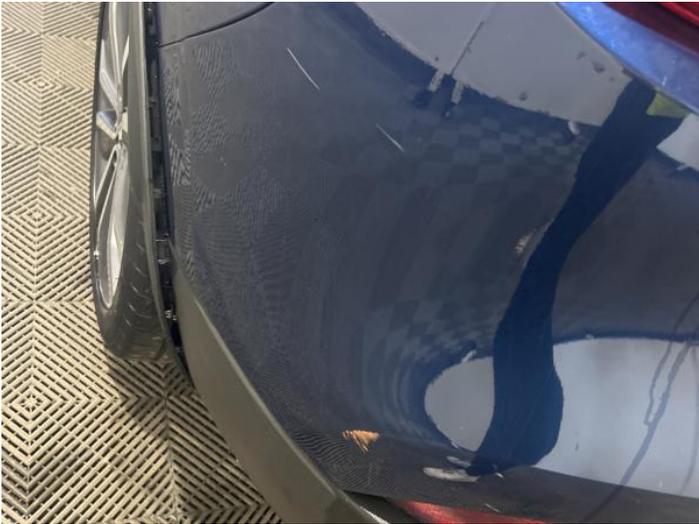
15: Bumper Rear
Scratched
25 to 100mm Thru Paint

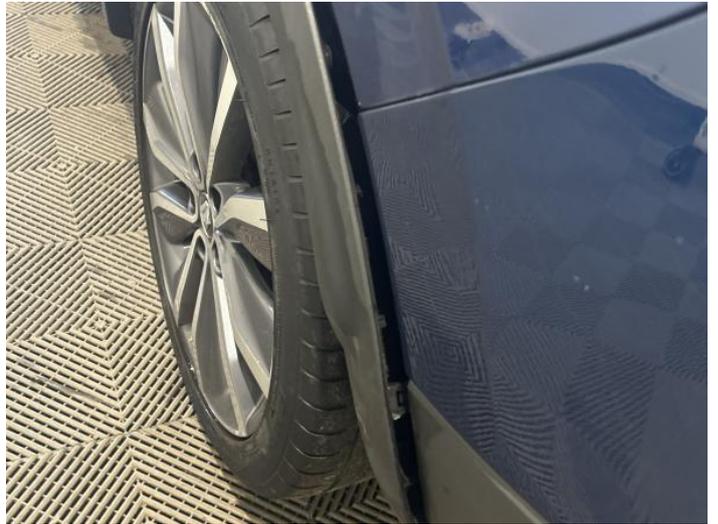
16: Qtr Panel Moulding ns
Broken
Replace

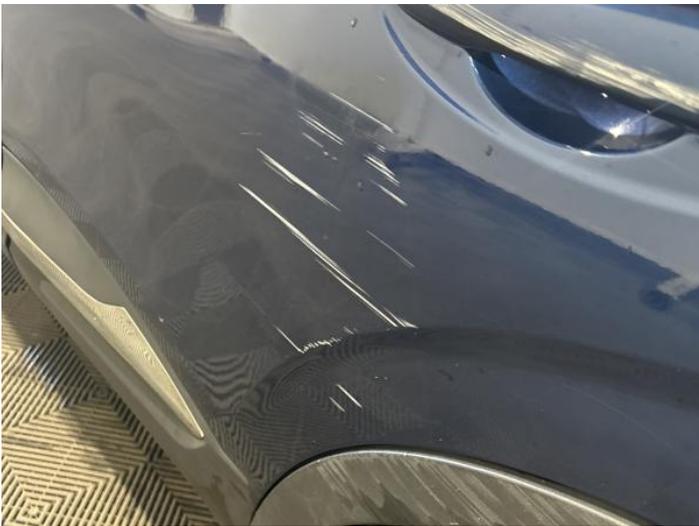
17: Door nsr
Scratched
Over 25mm Thru Paint

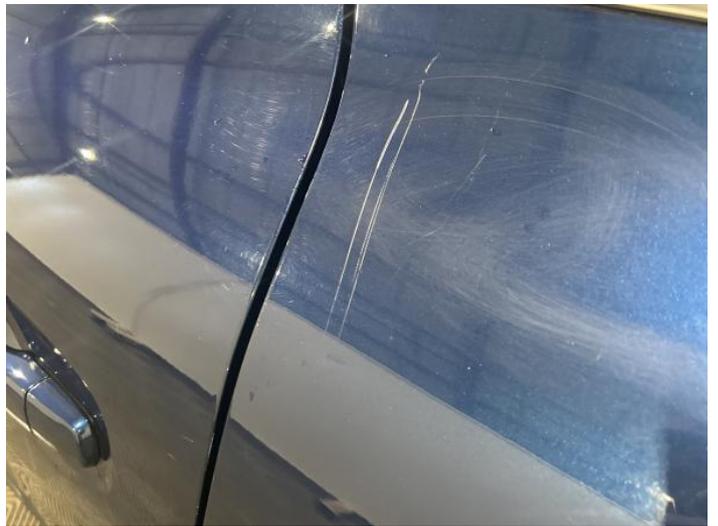
18: Qtr Panel nsr
Scratched
Over 25mm Thru Paint

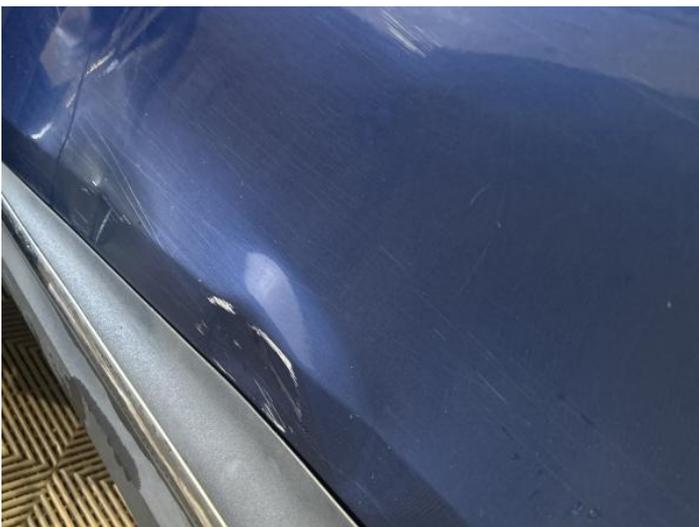
19: Door nsf
Dented
With Paint Damage

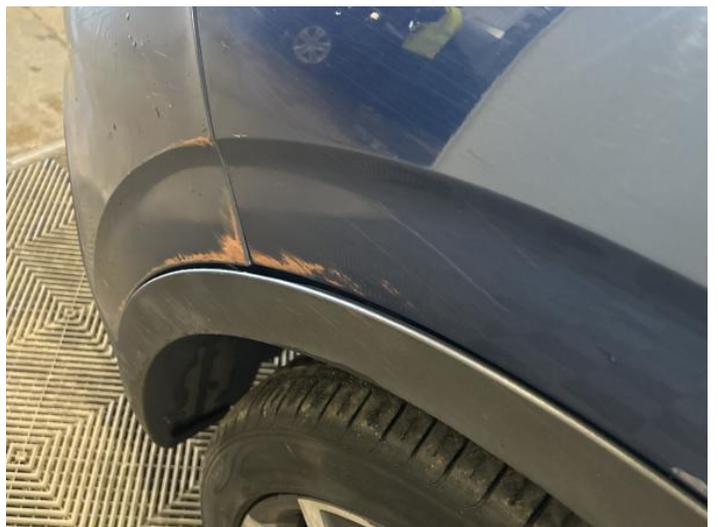
20: Wing nsf
Dented
With Paint Damage

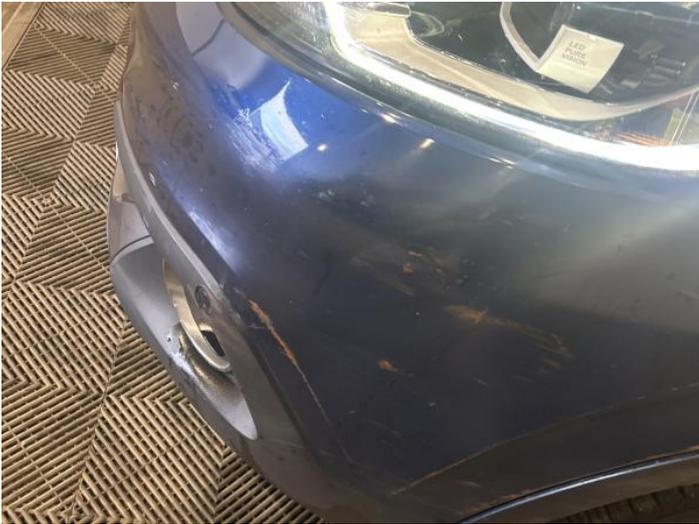
21: Bumper Front
Poor Previous Repair
Poor Paint

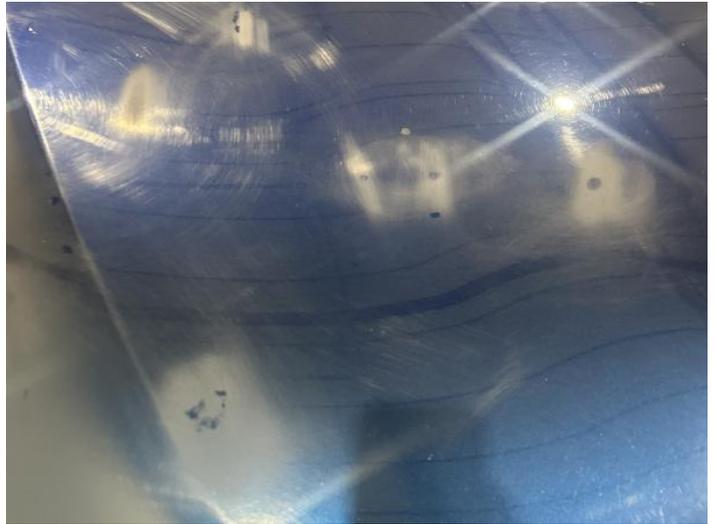
22: Bonnet
Poor Previous Repair
Poor Paint

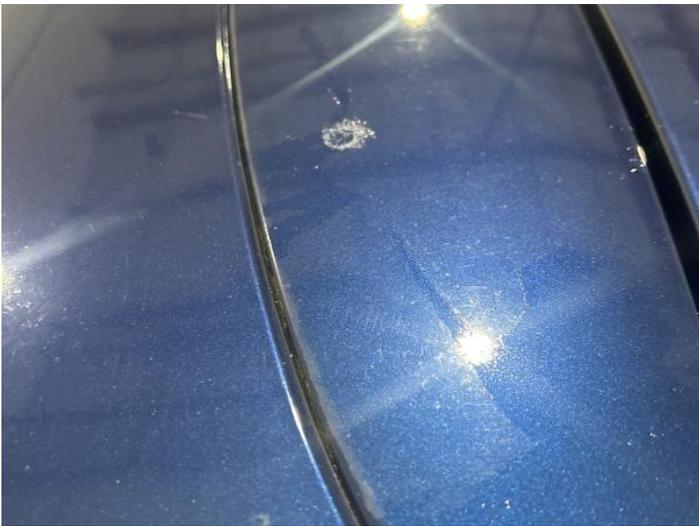
23: Boot Lid
Poor Previous Repair
Paint Flake

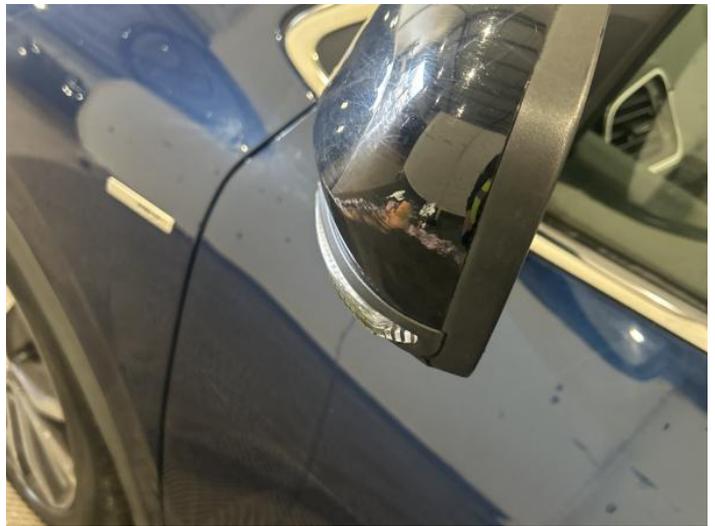
24: Door Mirror Assy nsf
Scratched (Painted)
Over 25mm Thru Paint
