VEHICLE INSPECTION REPORT

YS14DXP

Ford Grand C-Max 1.6 TDCi Titanium 5dr

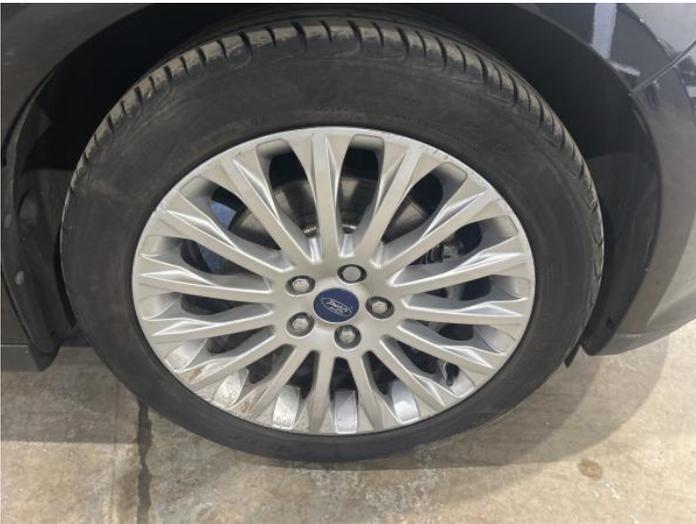
1: Wheel osf
Scratched
Over 50mm

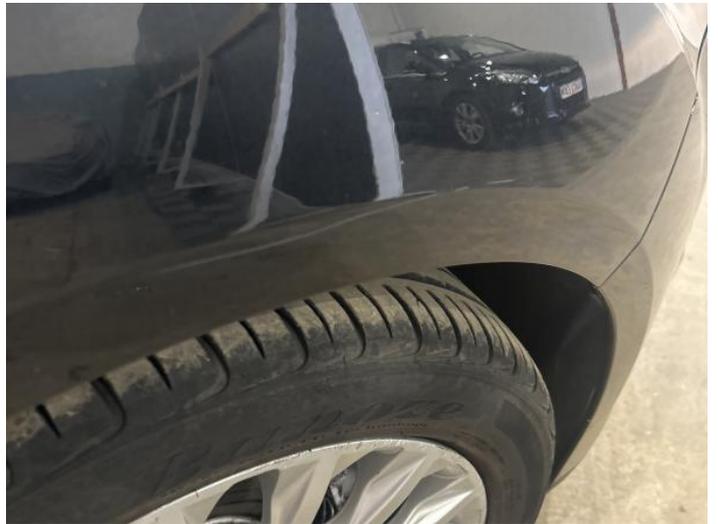
2: Wing osf
Scratched
Over 25mm Not Thru Paint

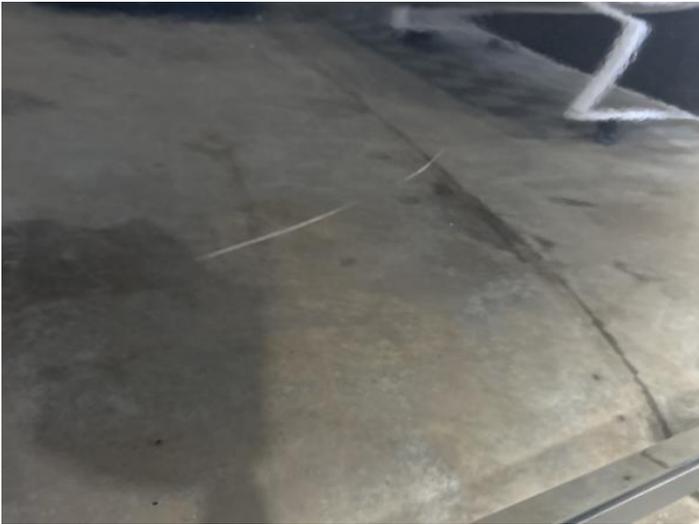
3: Door osf
Scratched
Over 25mm Thru Paint

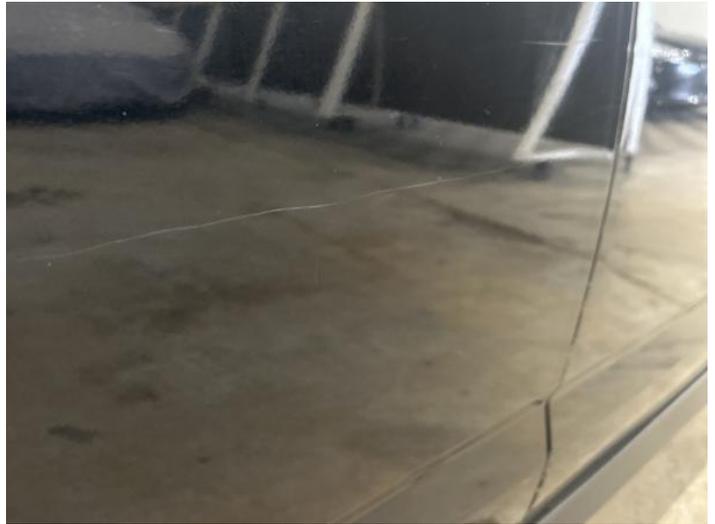
4: Door osr
Scratched
Over 25mm Not Thru Paint

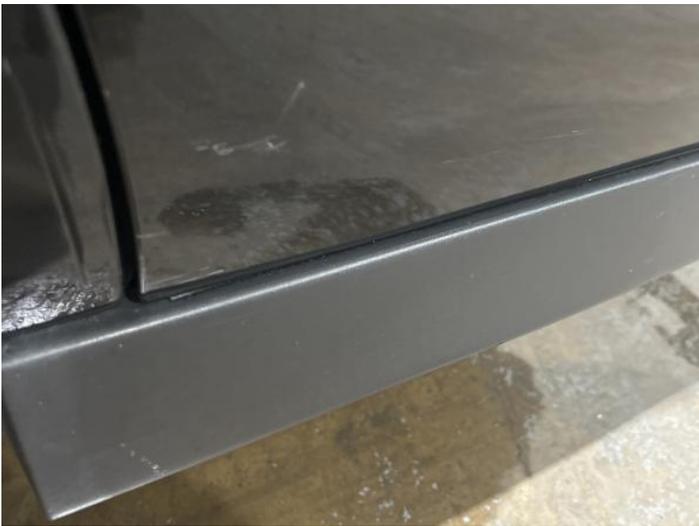
5: Door osr
Scratched
UpTo 25mm Thru Paint

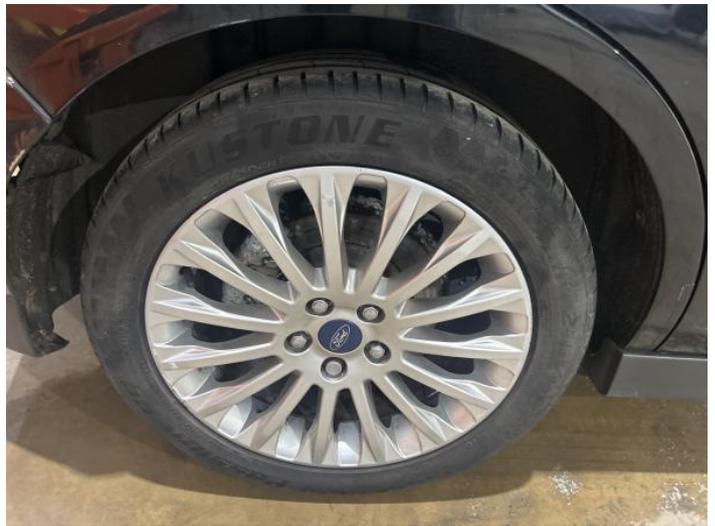
6: Wheel osr
Scratched
Over 50mm

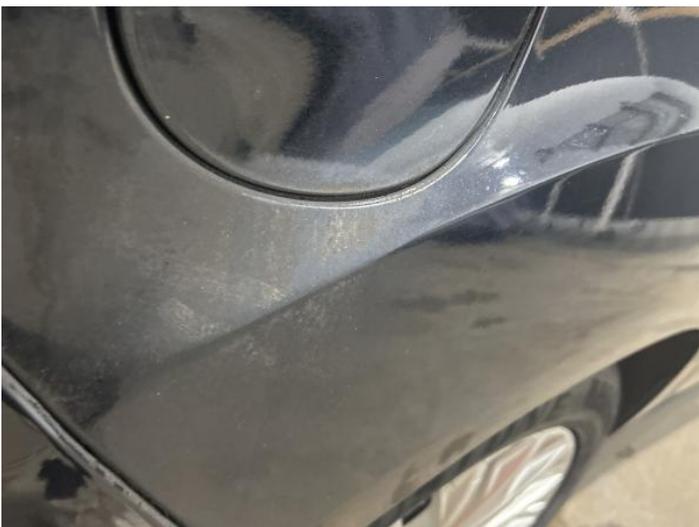
7: Qtr Panel osr
Poor Previous Repair
Poor Paint

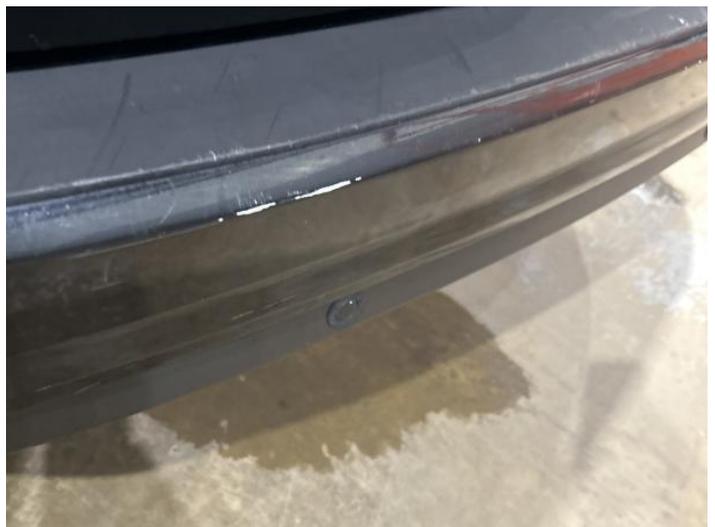
8: Bumper Rear
Scratched
Over 100mm Thru Paint

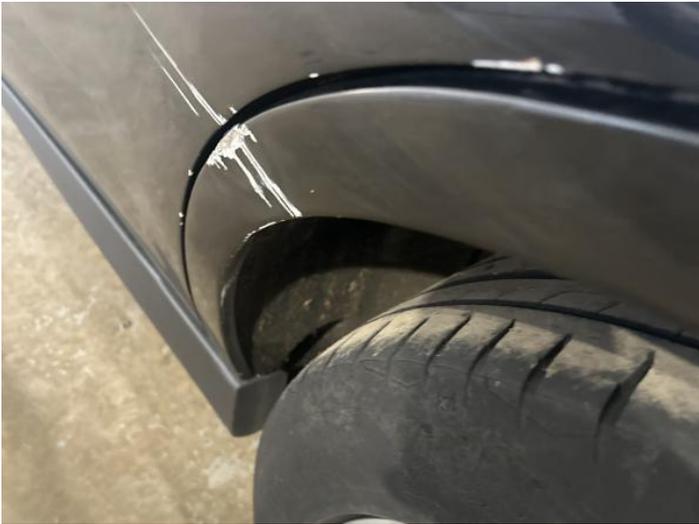
9: Qtr Panel nsr
Dented
With Paint Damage

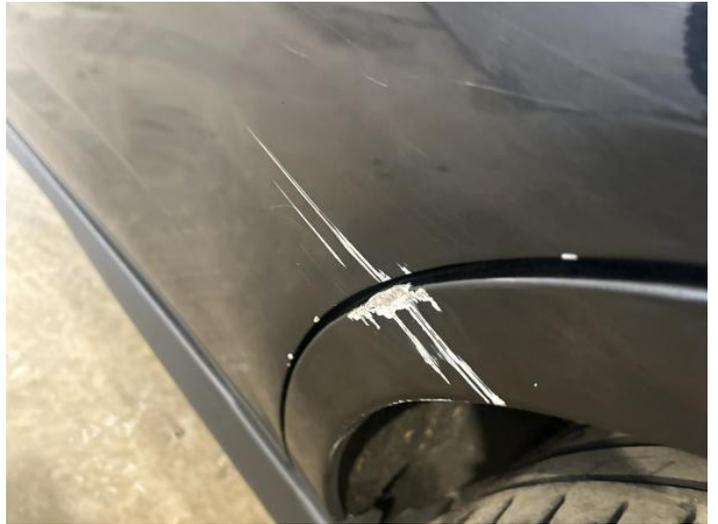
10: Door nsr
Scratched
Over 25mm Thru Paint

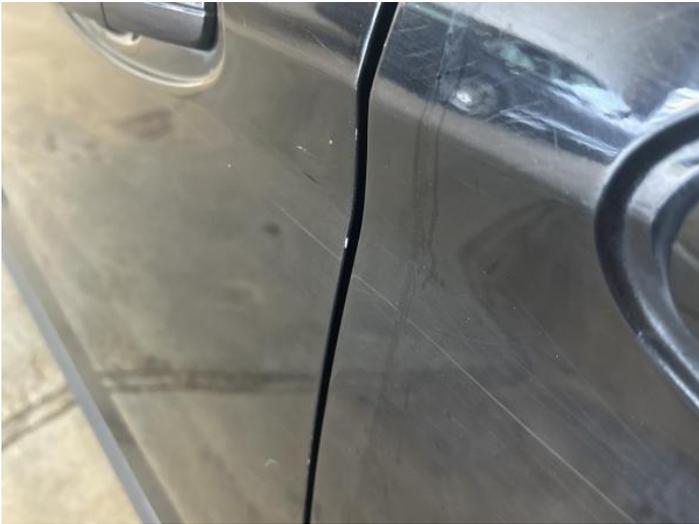
11: Door nsf
Chipped
Edge Chip

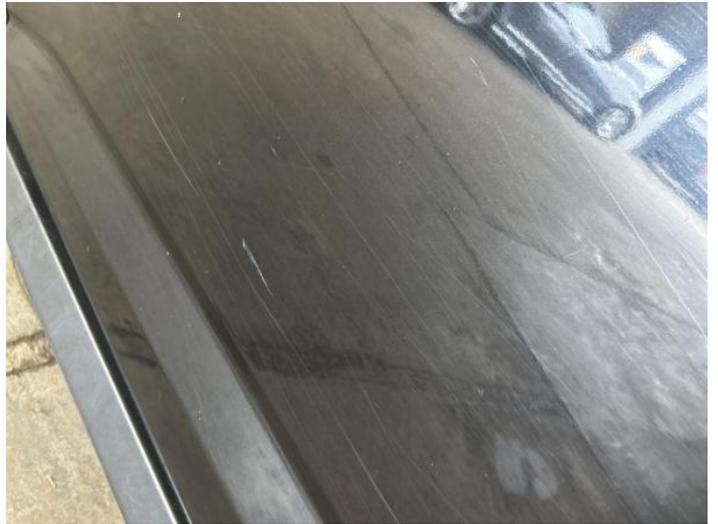
12: Door nsf
Scratched
Over 25mm Not Thru Paint

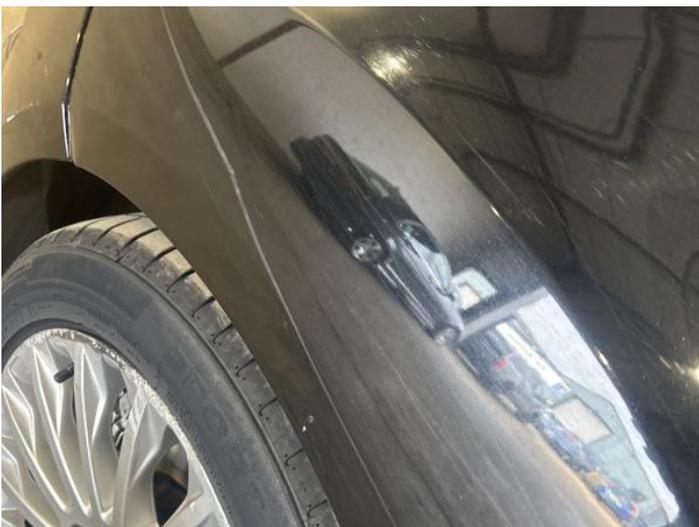
13: Wing nsf
Scratched
Over 25mm Not Thru Paint

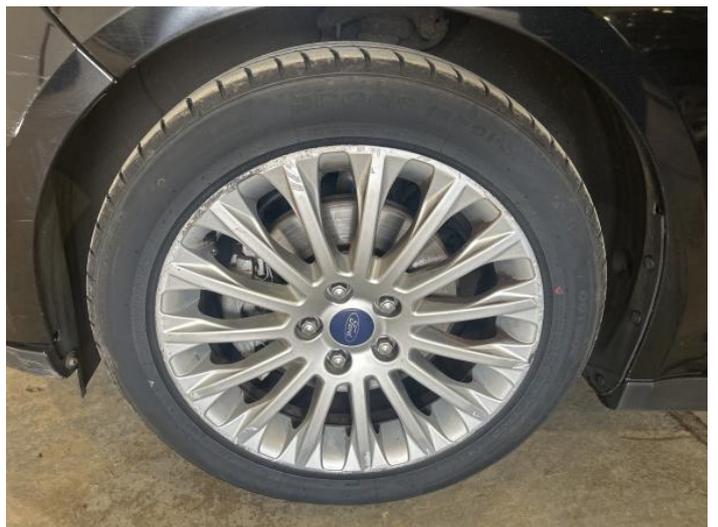
14: Wheel nsf
Scratched
Over 50mm

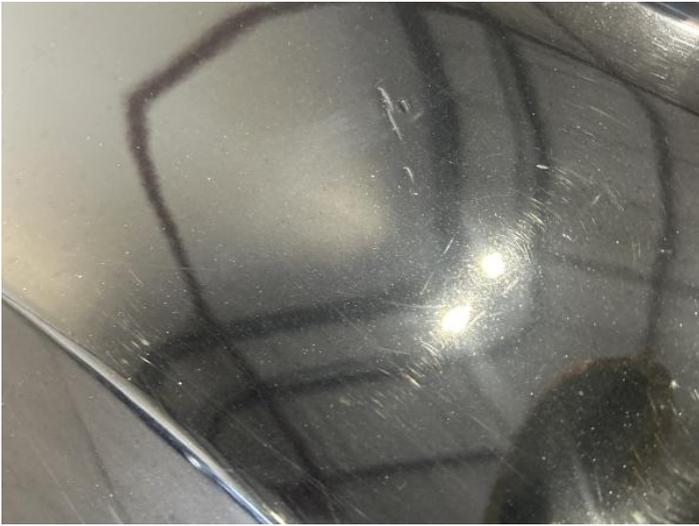
15: Wing nsf
Scratched
UpTo 25mm Thru Paint

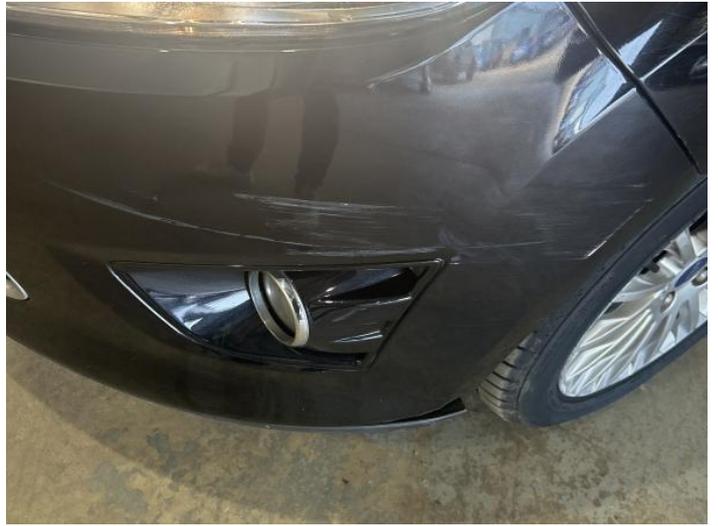
16: Bumper Front
Scratched
Over 100mm Thru Paint

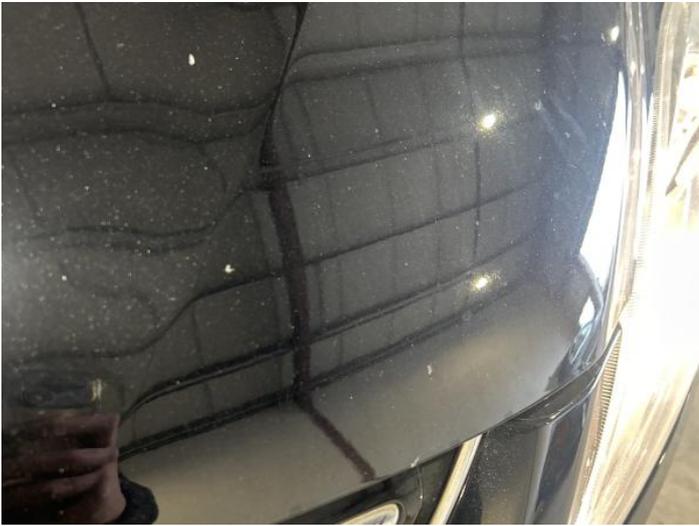
17: Bonnet
Chipped
1 To 5

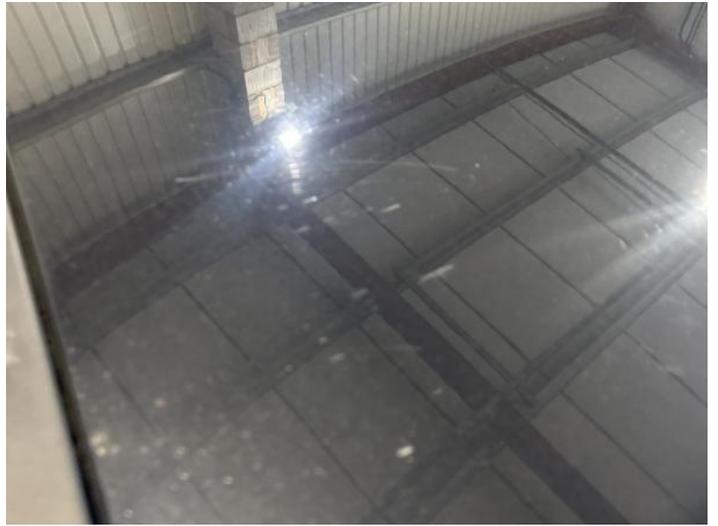
18: Roof
Scratched
Over 25mm Not Thru Paint

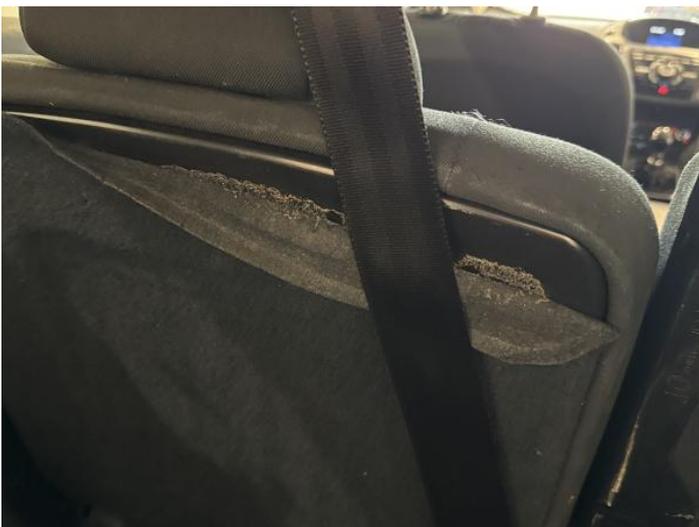
19: Seat Back Cover nsr
Torn
Over 3mm
