VEHICLE INSPECTION REPORT

VX15UEK

Kia Sportage 1.7 CRDi ISG 2 5dr

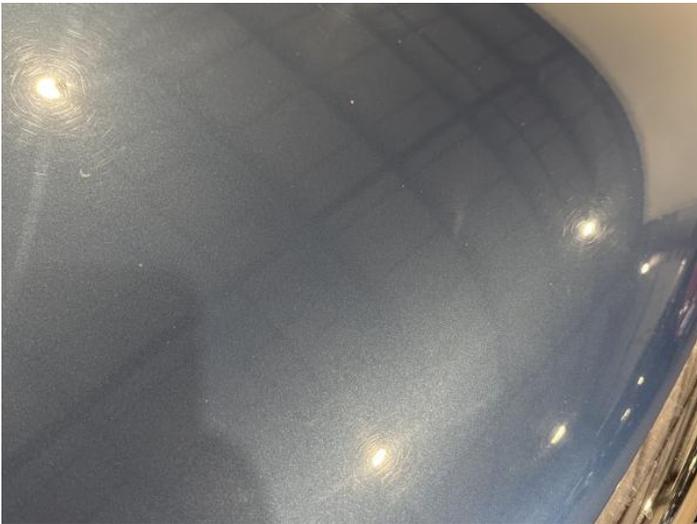
1: Bonnet
Chipped
Multiple Chips

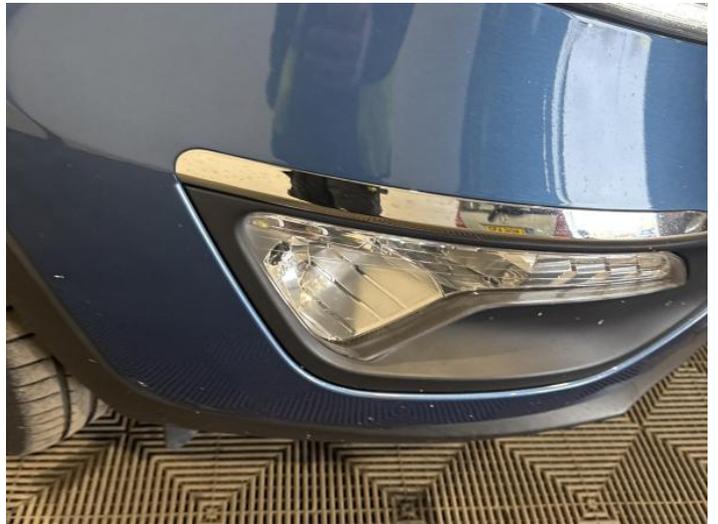
2: Bumper Front
Chipped
Multiple Chips

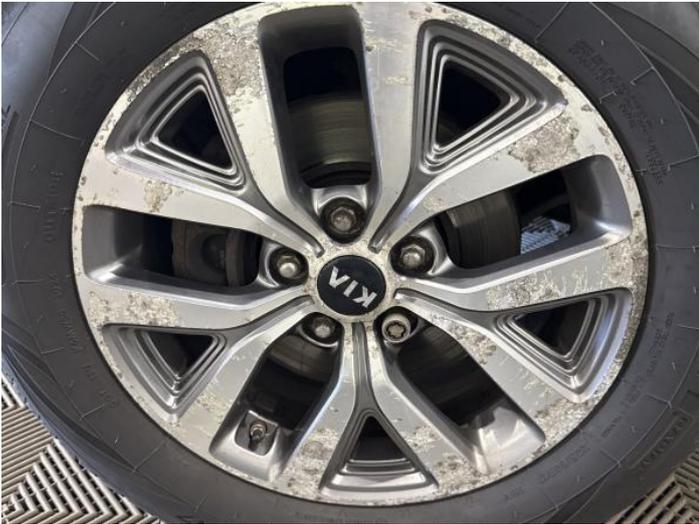
3: Wheel nsf
Scratched
Over 50mm

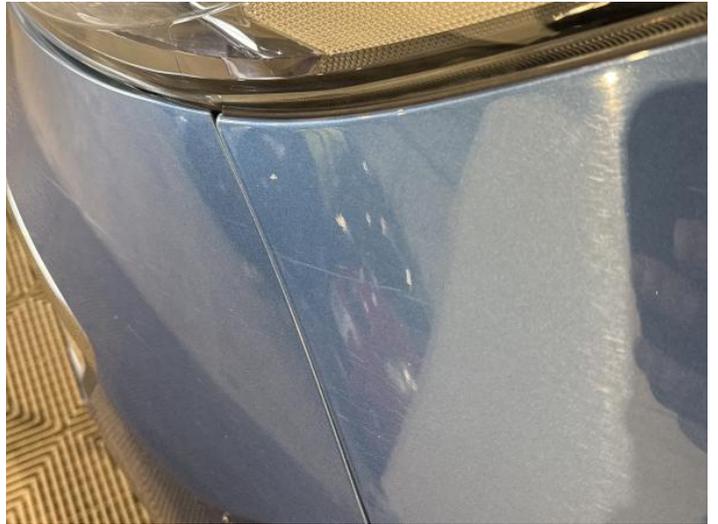
4: Wing nsf
Chipped
1 To 5

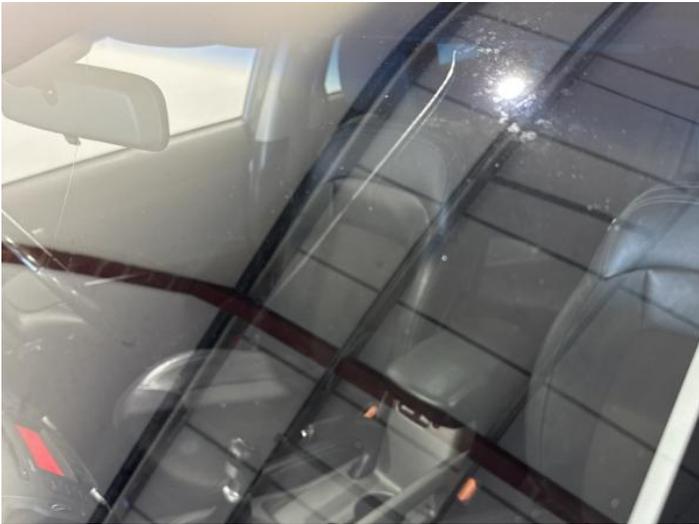
5: Screen Front
Cracked
Replace

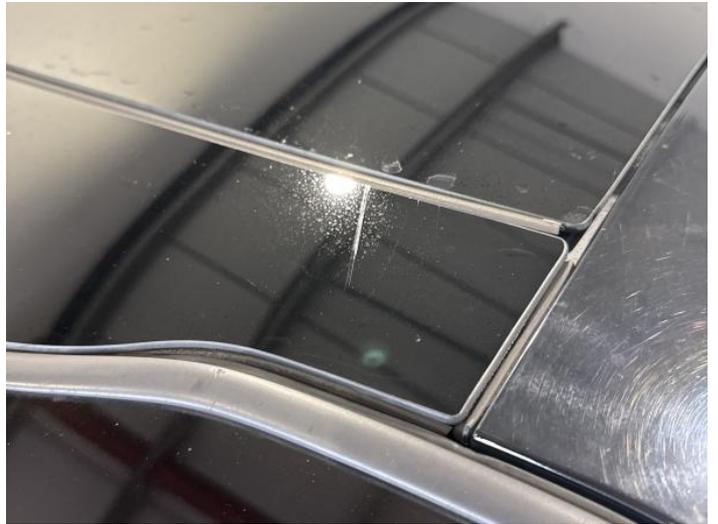
6: Roof
Scratched
UpTo 25mm Thru Paint

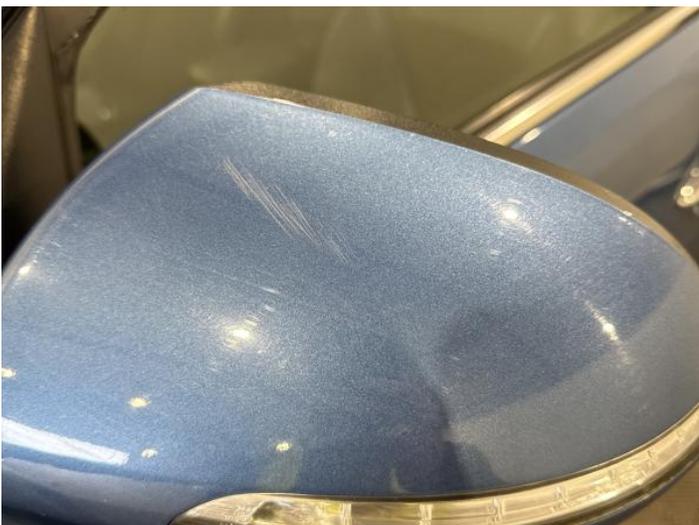
7: Door Mirror Assy nsf
Scratched (Painted)
Over 25mm Thru Paint

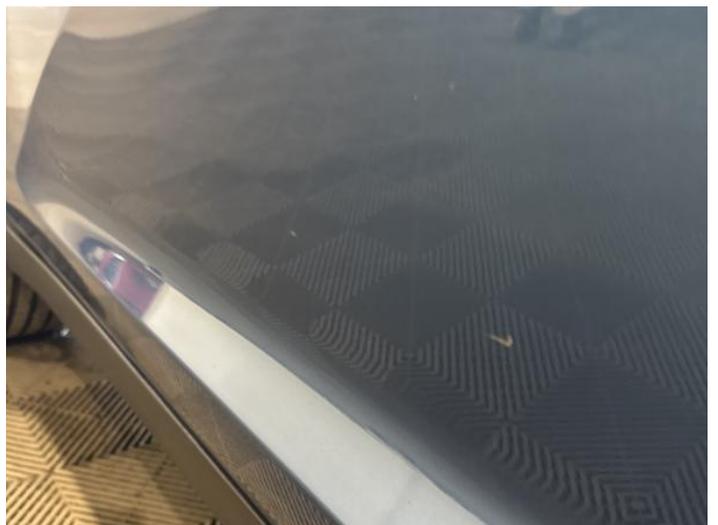
8: Door nsf
Dented
Between 10mm + 30mm

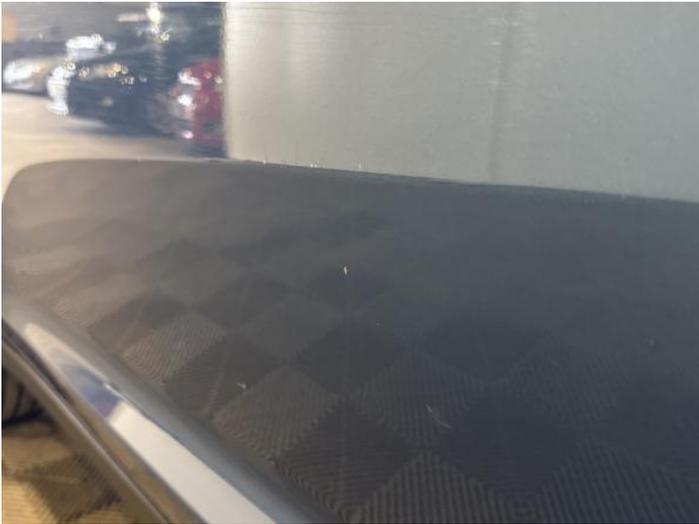
9: Door nsf
Chipped
Multiple Chips

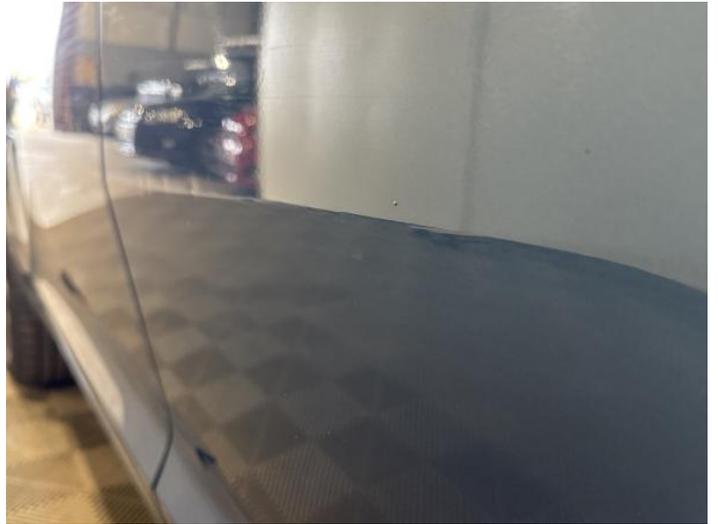
10: Door nsr
Dented
Over 30mm

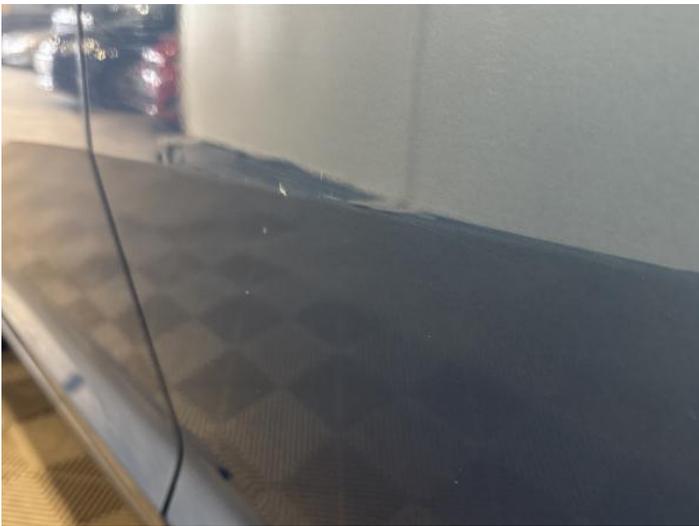
11: Door nsr
Chipped
Multiple Chips

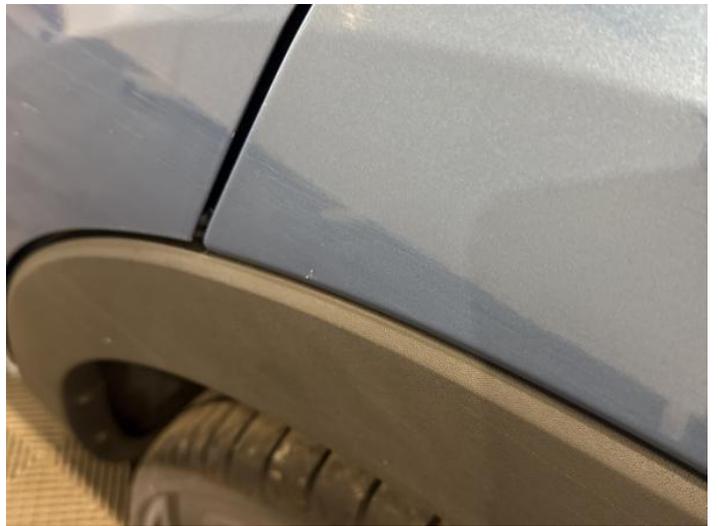
12: Qtr Panel nsr
Chipped
1 To 5

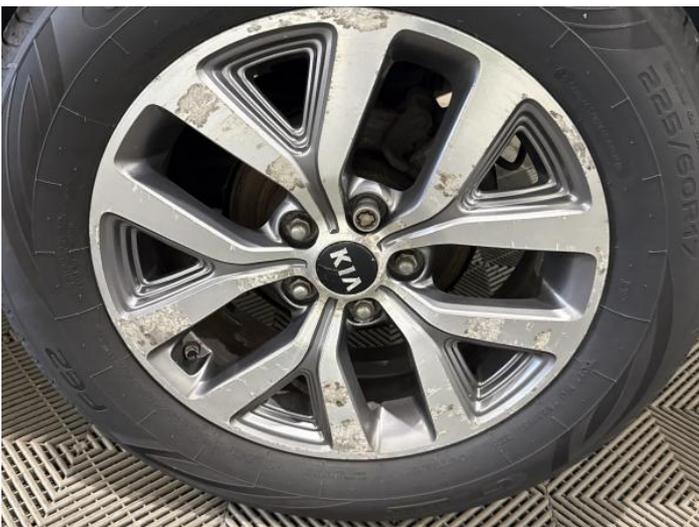
13: Wheel nsr
Scratched
Over 50mm

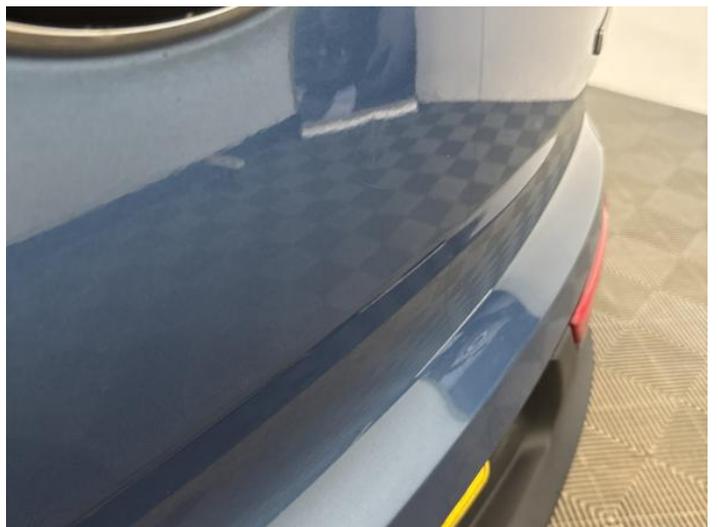
14: Tailgate
Dented
Over 30mm

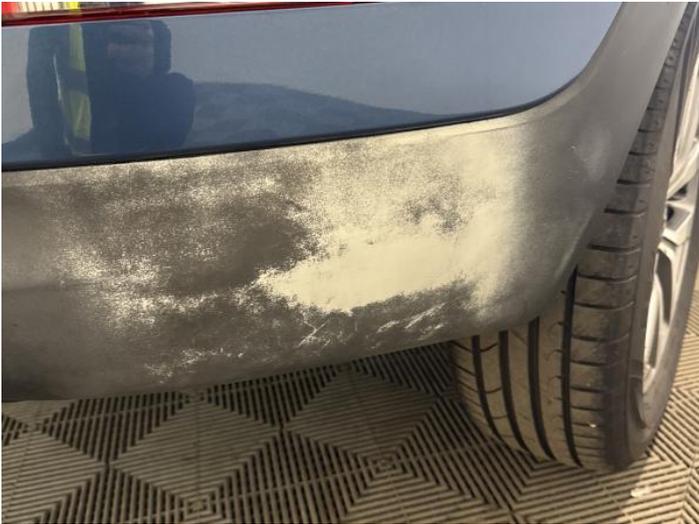
15: Bumper Rear Moulding
Scuffed (Unpainted)
Over 100mm

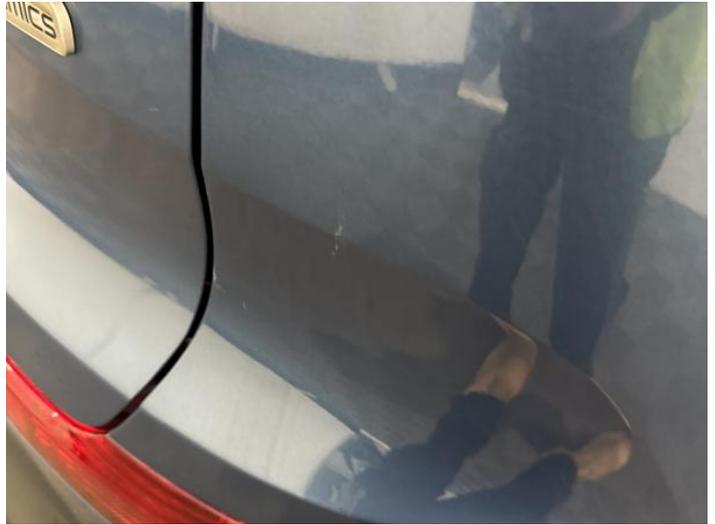
16: Bumper Rear
Scratched
Up To 25mm Thru Paint

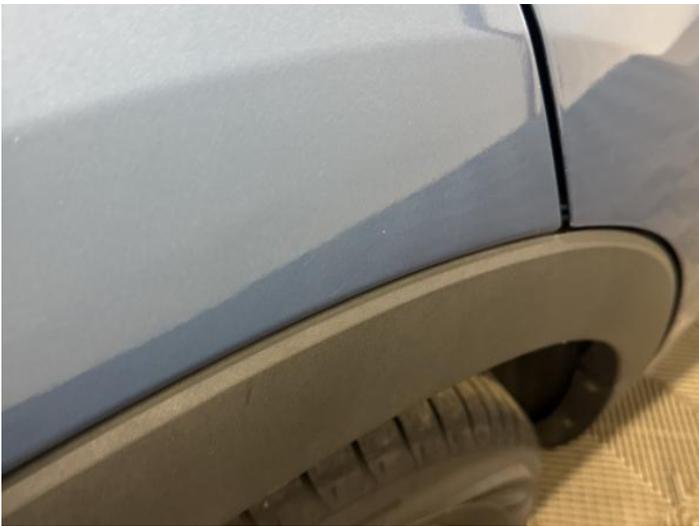
17: Qtr Panel osr
Scratched
Up To 25mm Thru Paint

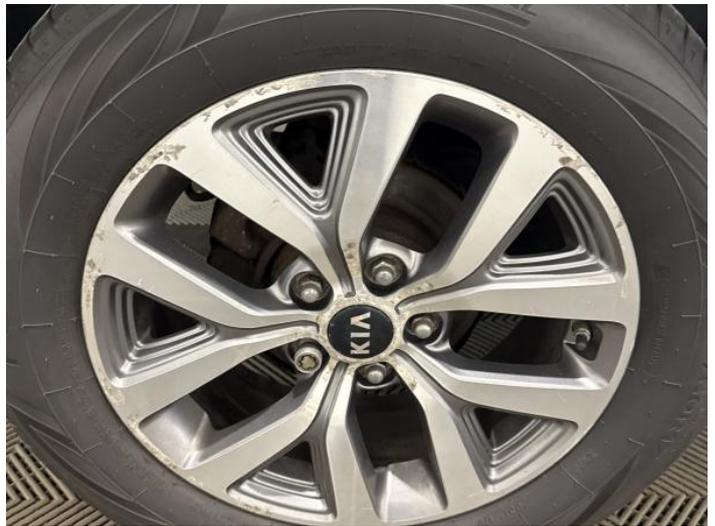
18: Wheel osr
Scratched
Over 50mm

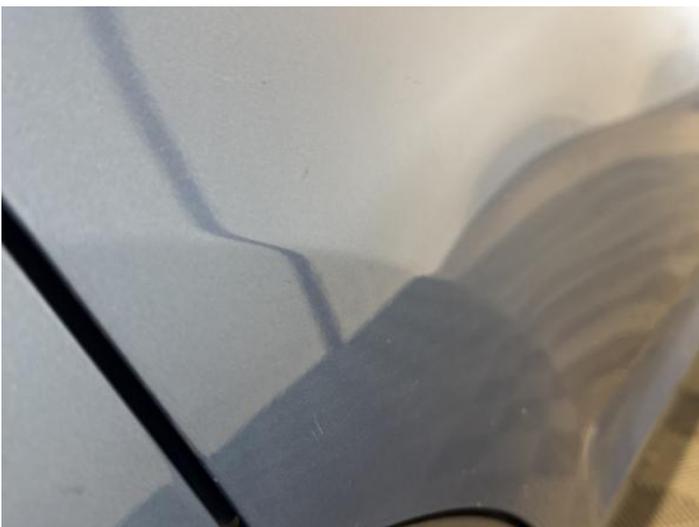
19: Door osr
Dented
With Paint Damage

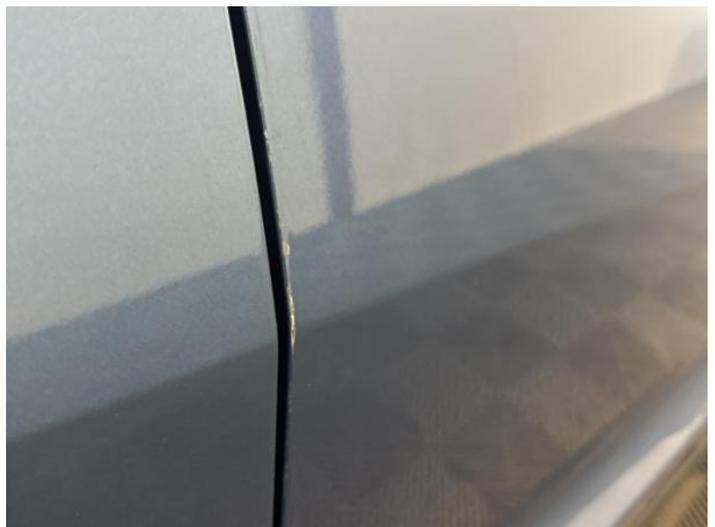
20: Door osf
Chipped
Edge Chip

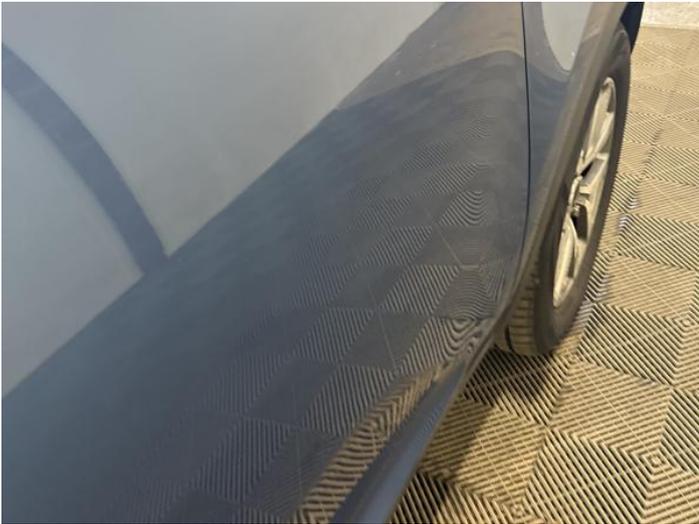
21: Door osf
Dented
Over 30mm

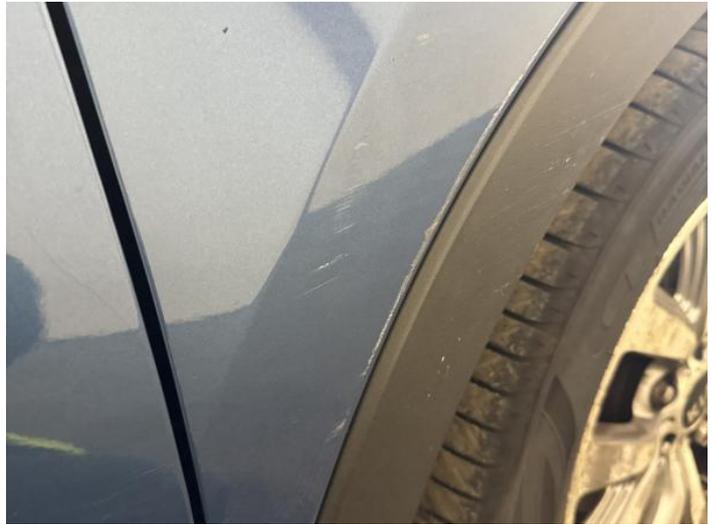
22: Wing osf
Scratched
Over 25mm Thru Paint

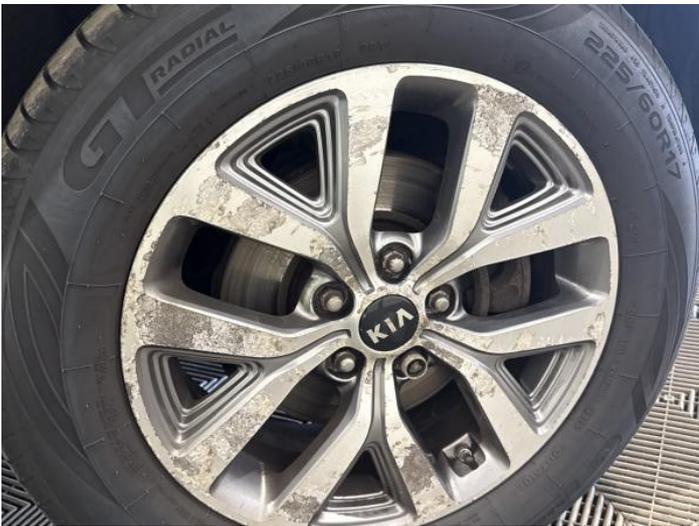
23: Wheel osf
Scratched
Over 50mm
