# VEHICLE INSPECTION REPORT

**LS65EYV**

## Nissan Juke 1.6 [94] Visia 5dr

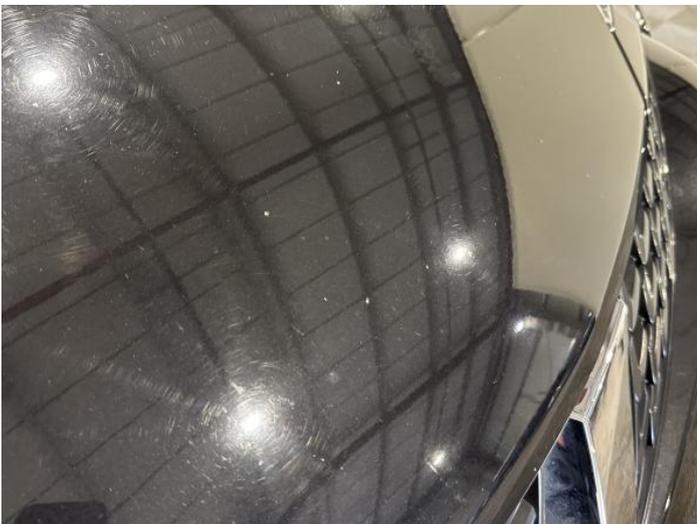
1: Bonnet  
Chipped  
Multiple Chips

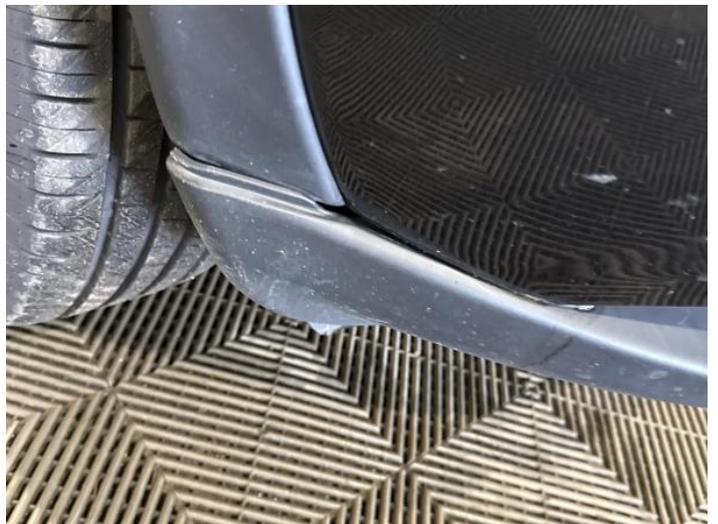
2: Bumper Front Moulding  
Scuffed (Unpainted)  
UpTo 100mm

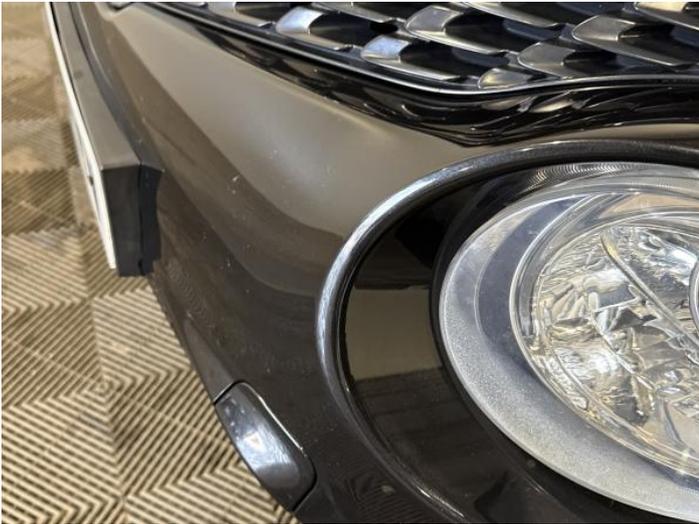
3: Bumper Front  
Chipped  
Multiple Chips

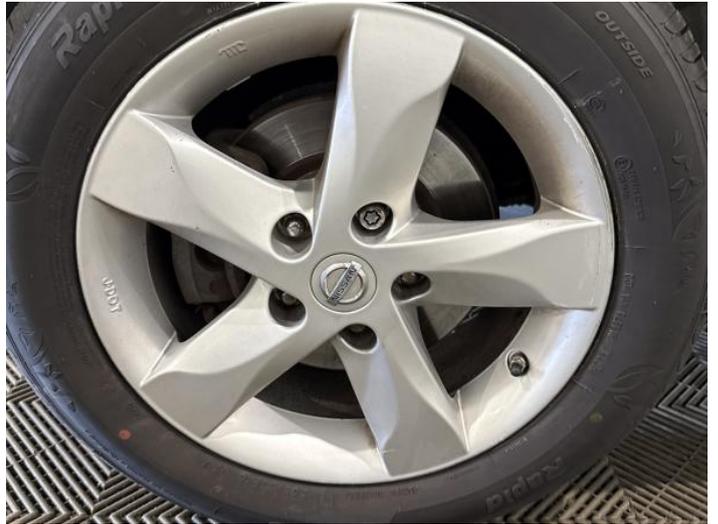
4: Wheel nsf  
Scratched  
Over 50mm

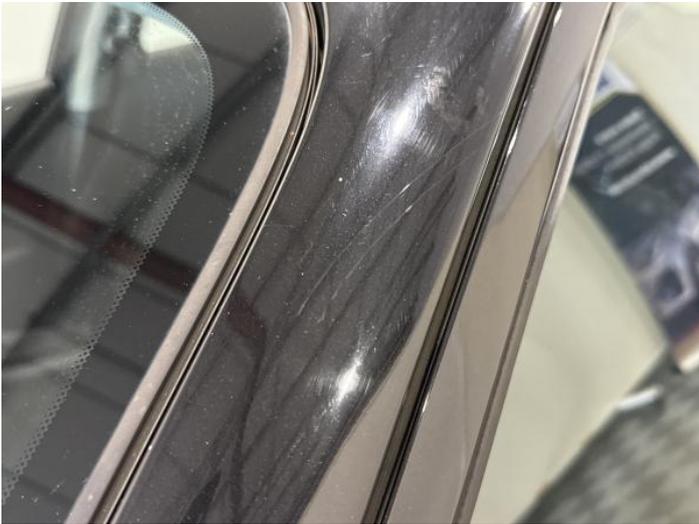
5: A Post ns  
Chipped  
1 To 5

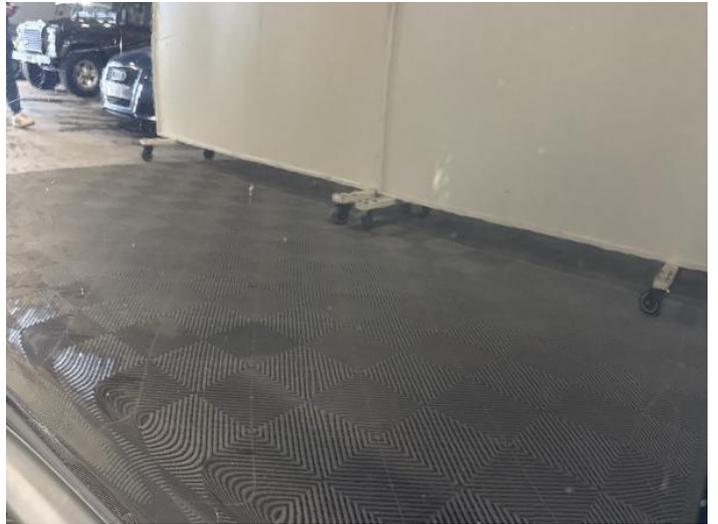
6: Door nsf  
Dented  
With Paint Damage

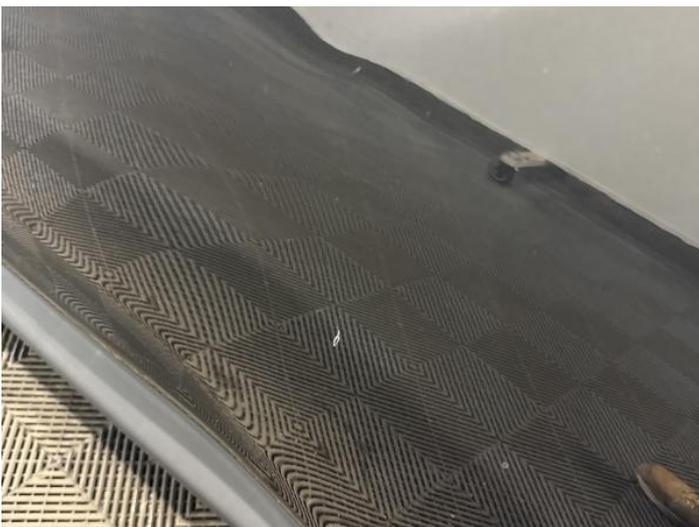
7: Door nsr  
Scratched  
Over 25mm Thru Paint

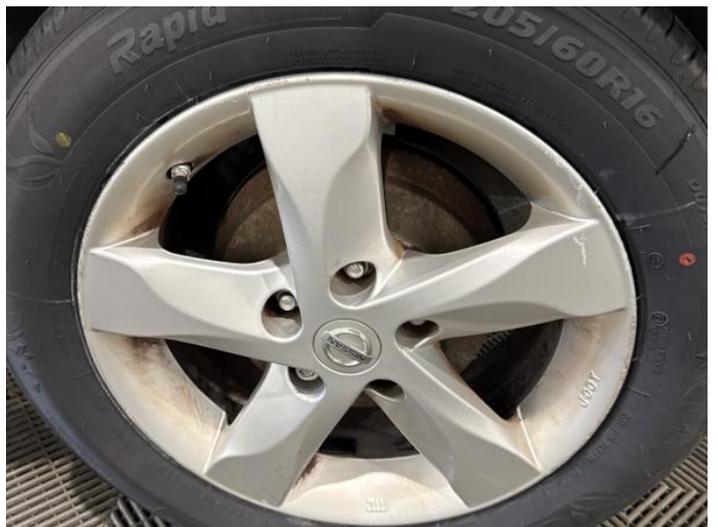
8: Wheel nsr  
Scratched  
Over 50mm

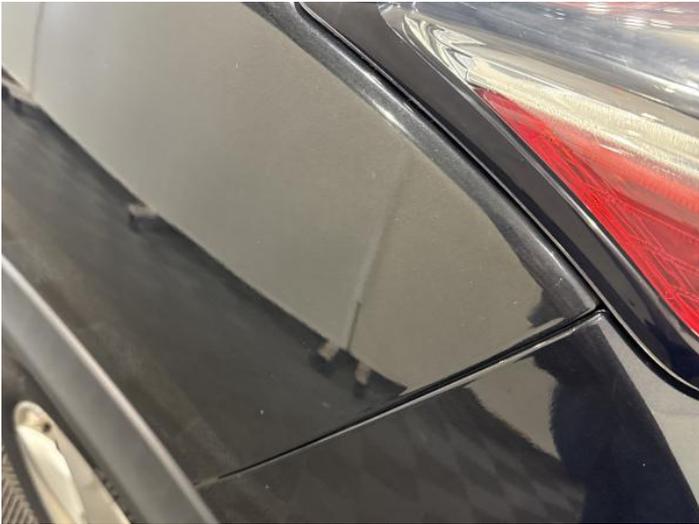
9: Qtr Panel nsr  
Scratched  
Over 25mm Thru Paint

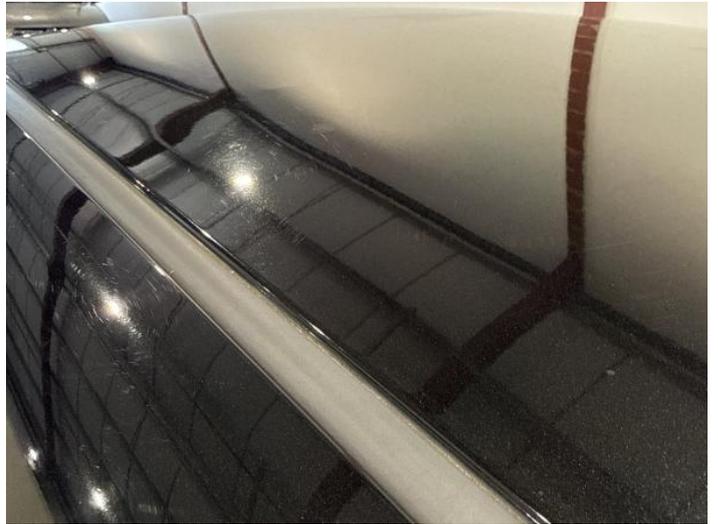
10: Roof  
Dented  
Over 30mm

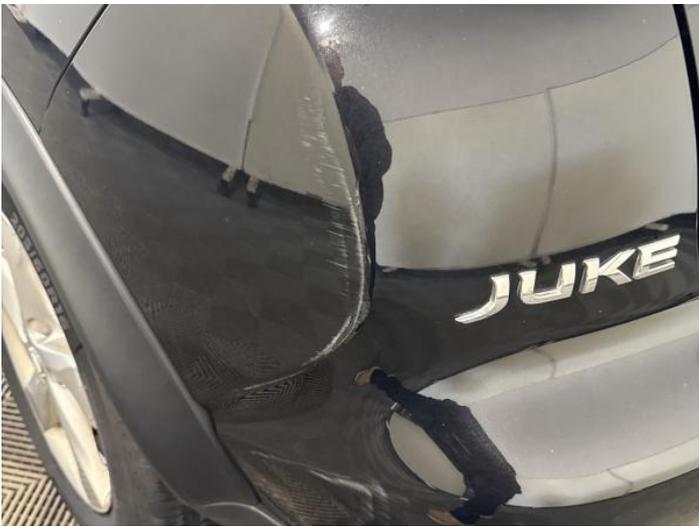
11: Bumper Rear  
Scratched  
25 to 100mm Thru Paint

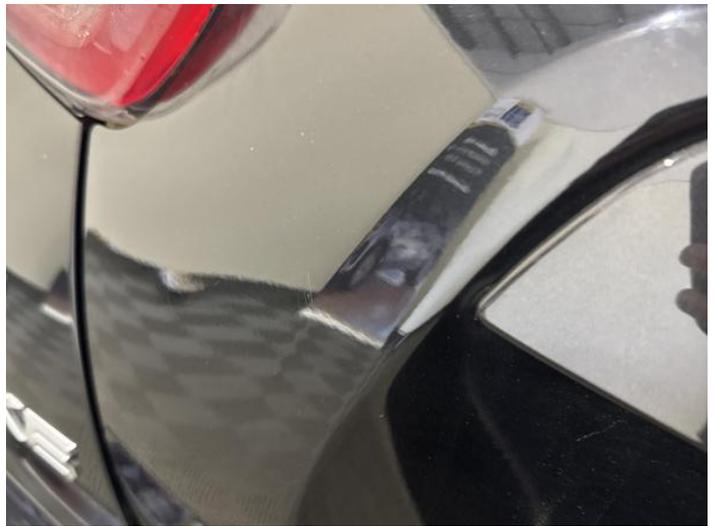
12: Tailgate  
Scratched  
UpTo 25mm Thru Paint

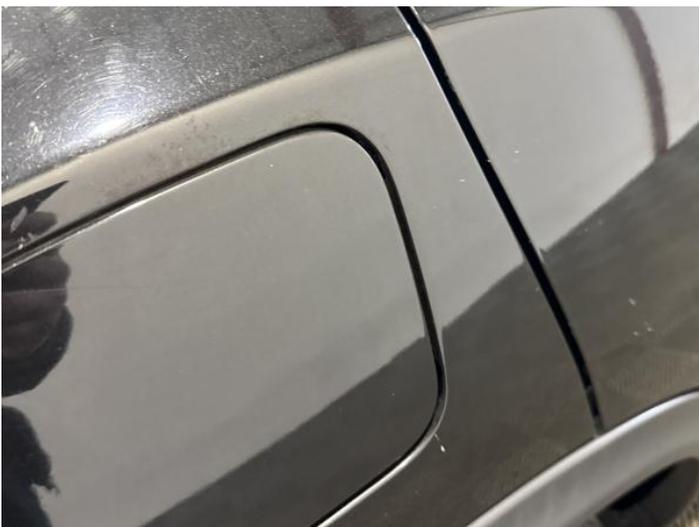
13: Qtr Panel osr  
Scratched  
Over 25mm Thru Paint

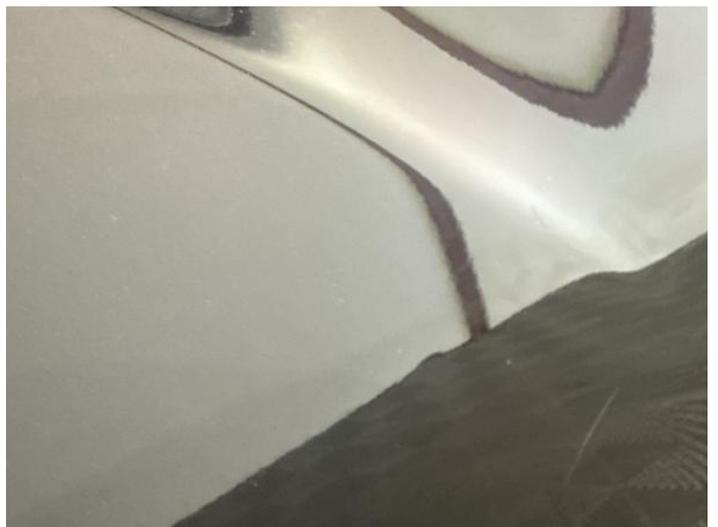
14: Door nsr  
Dented  
Between 10mm + 30mm

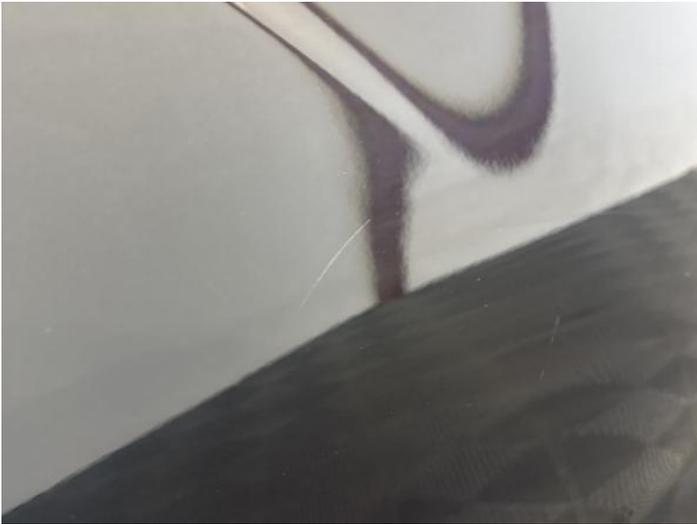
15: Door nsr  
Scratched  
Over 25mm Thru Paint

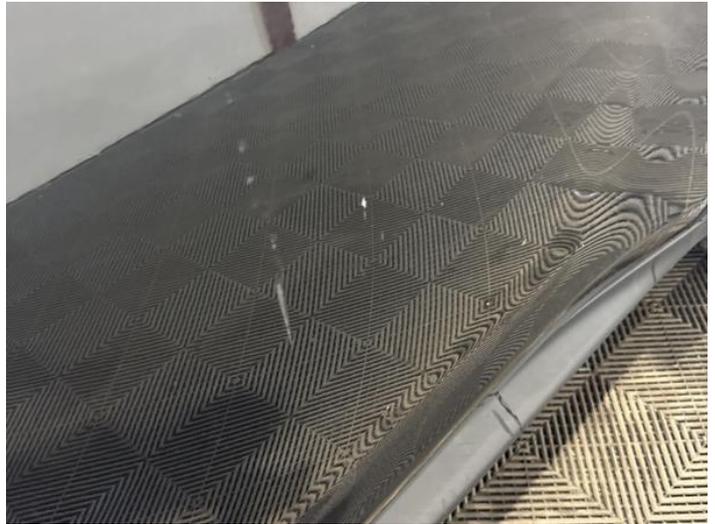
16: Door nsf  
Scratched  
Over 25mm Thru Paint

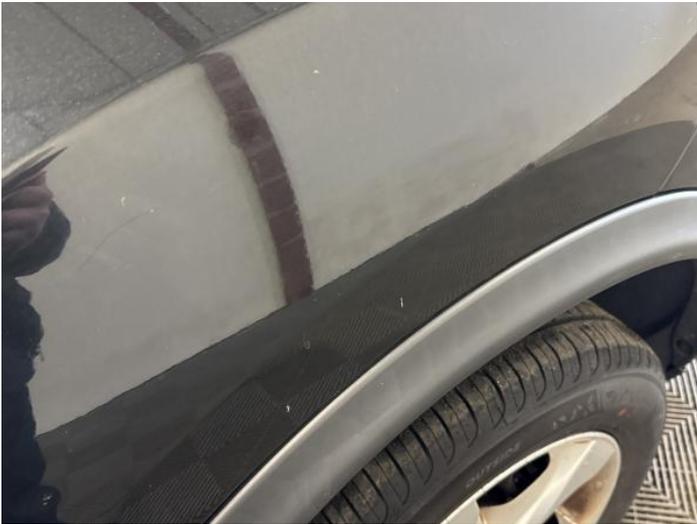
17: Wing osf  
Chipped  
Multiple Chips

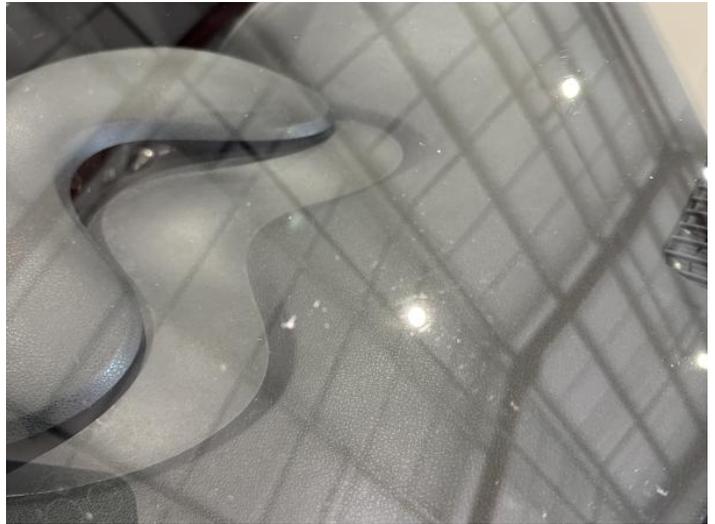
18: Screen Front  
Chipped  
UpTo 10mm
