VEHICLE INSPECTION REPORT

KV19MXA

Citroen Berlingo 1.2 PureTech Flair M 5dr

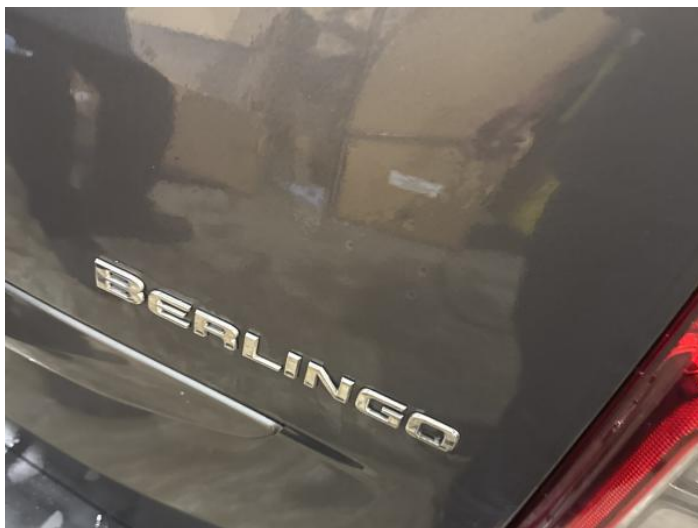
1: Boot Lid
Chipped
1 To 5

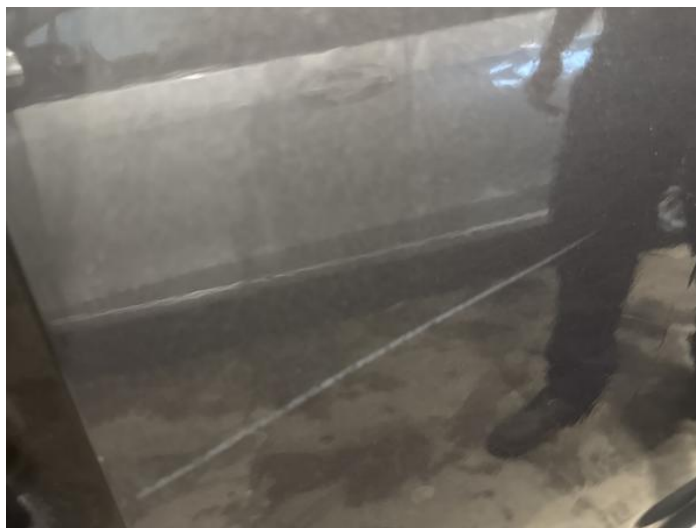
2: Door or
Dented
With Paint Damage

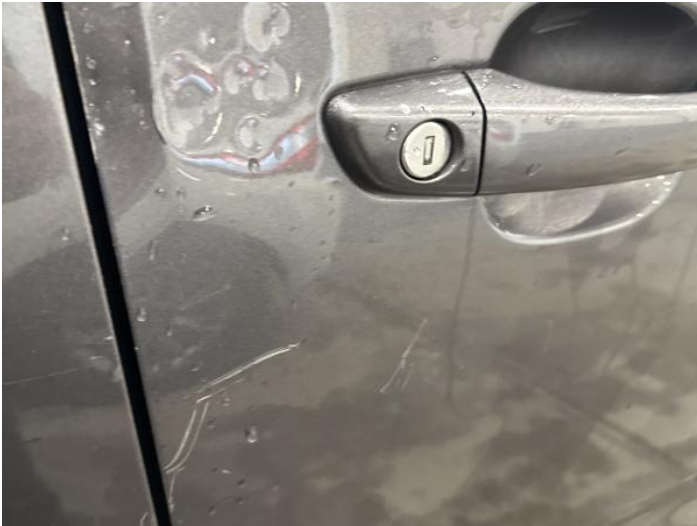
3: Door osf
Dented
With Paint Damage

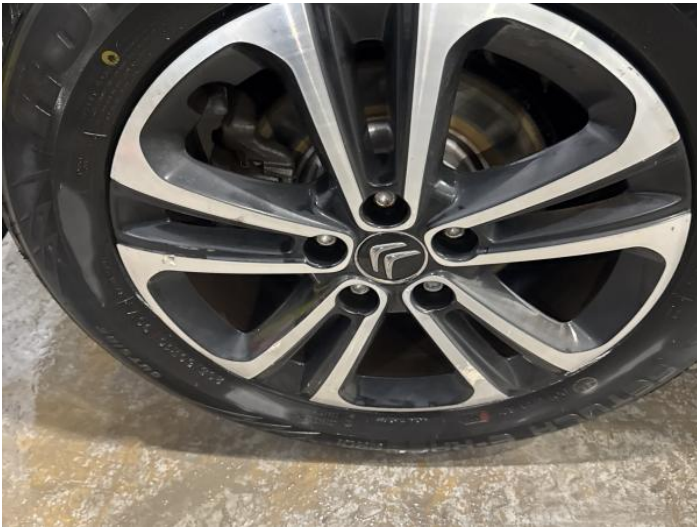
5: Wheel osr
Scratched
Over 50mm

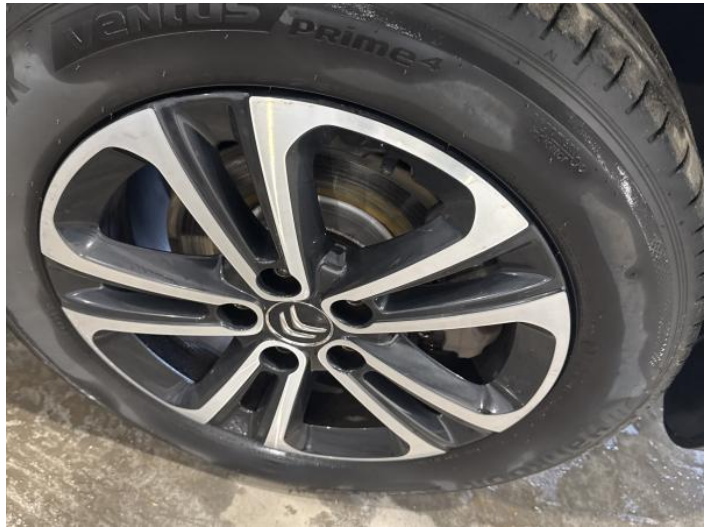
6: Wheel osf
Scratched
Up To 50mm

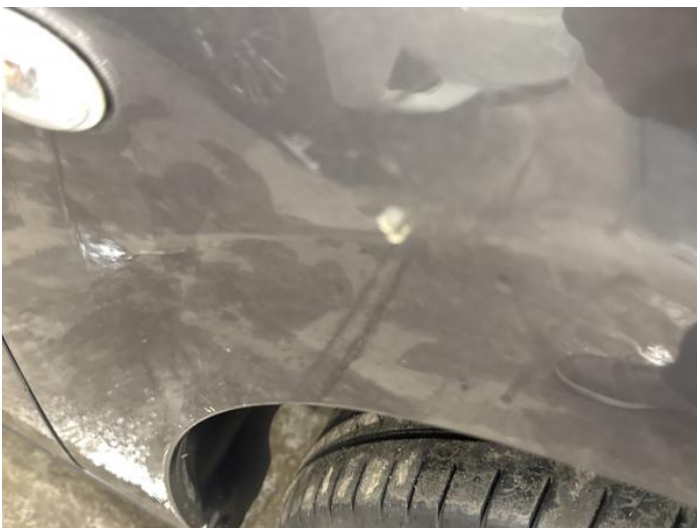
7: Wing osf
Scratched
Over 25mm Thru Paint

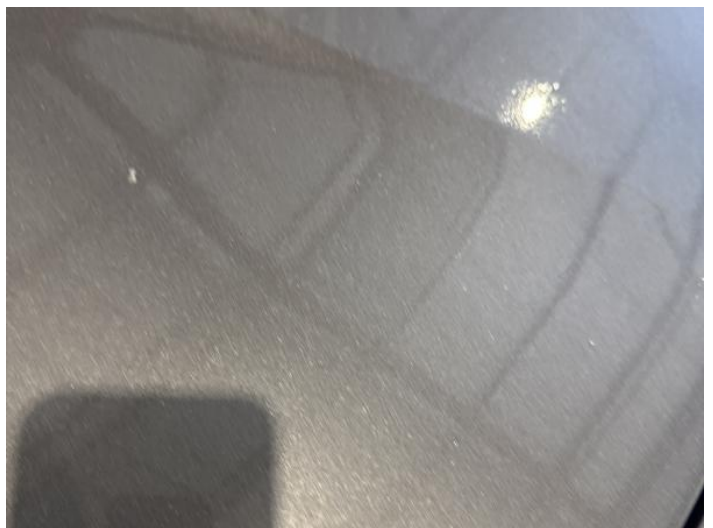
8: Bonnet
Chipped
1 To 5

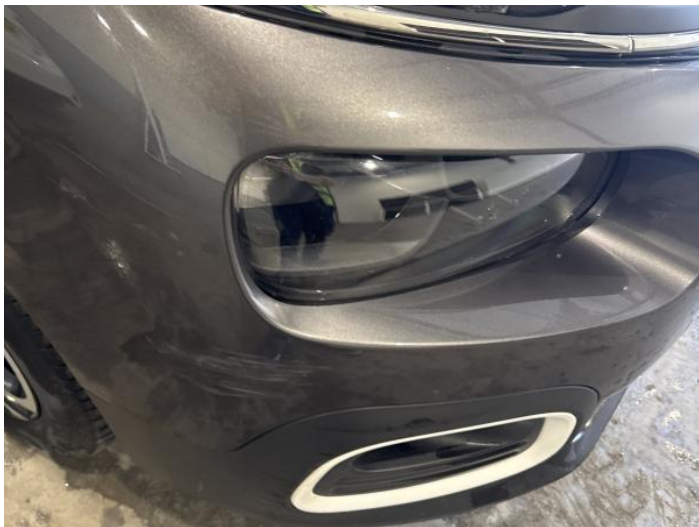
9: Bumper Front
Scratched
25 to 100mm Thru Paint

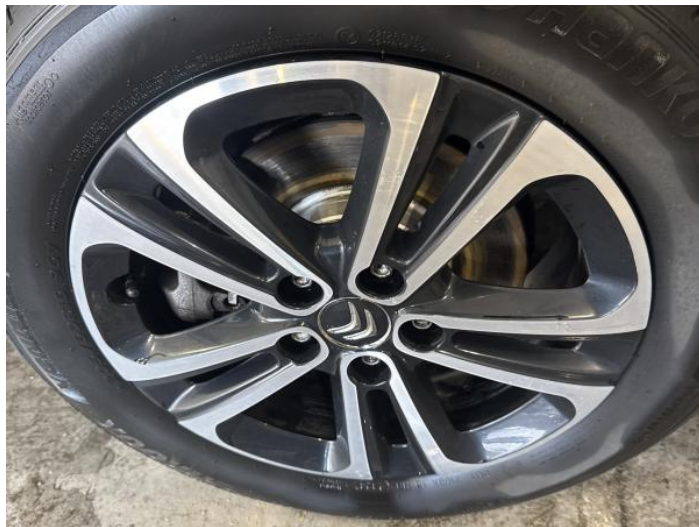
12: Wheel nsf
Scratched
Up To 50mm

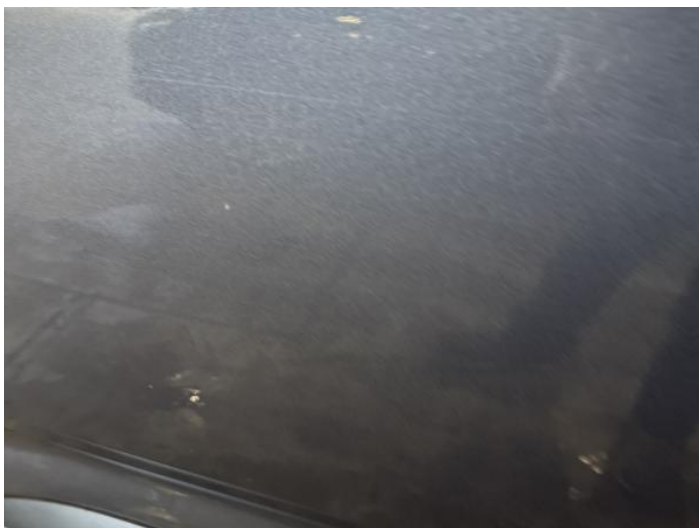
13: Door nsf
Chipped
1 To 5

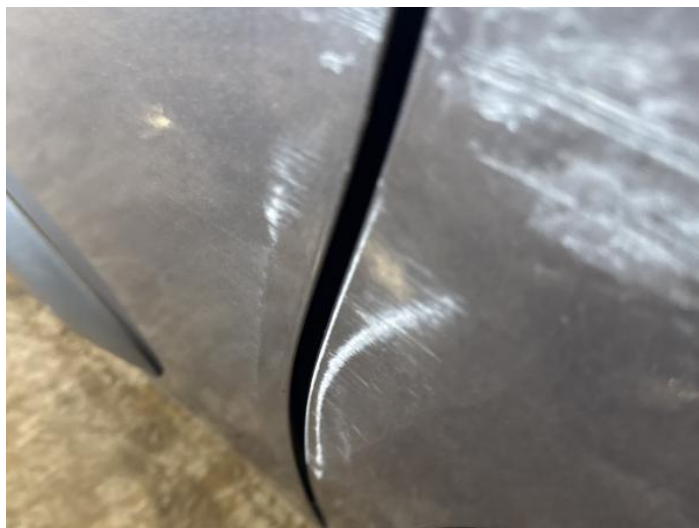
14: Door osf
Dented
With Paint Damage

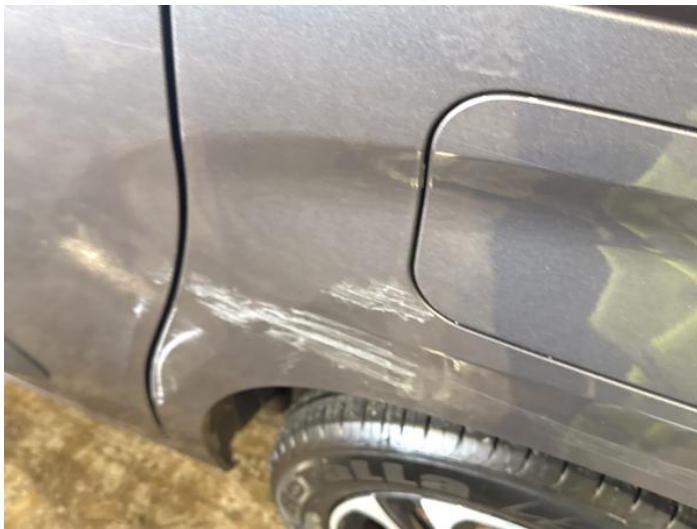
15: Qtr Panel nsr
Dented
With Paint Damage

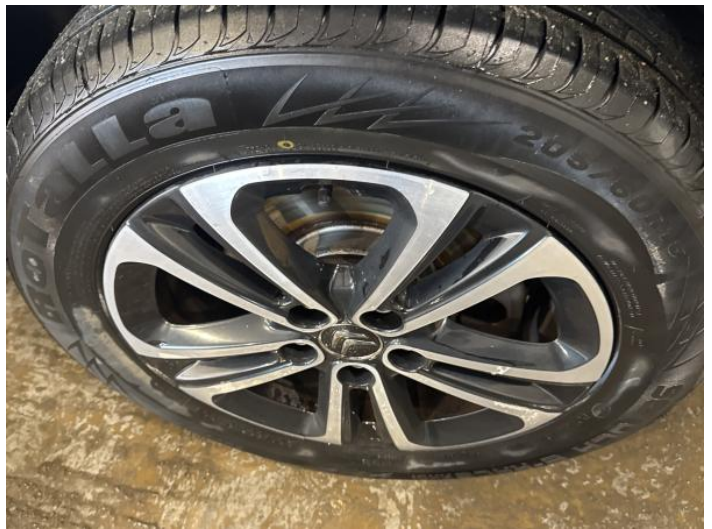
16: Wheel nsr
Scratched
Over 50mm
