# VEHICLE INSPECTION REPORT

**KP64WJL**

## Peugeot 208 1.0 VTi Active 5dr

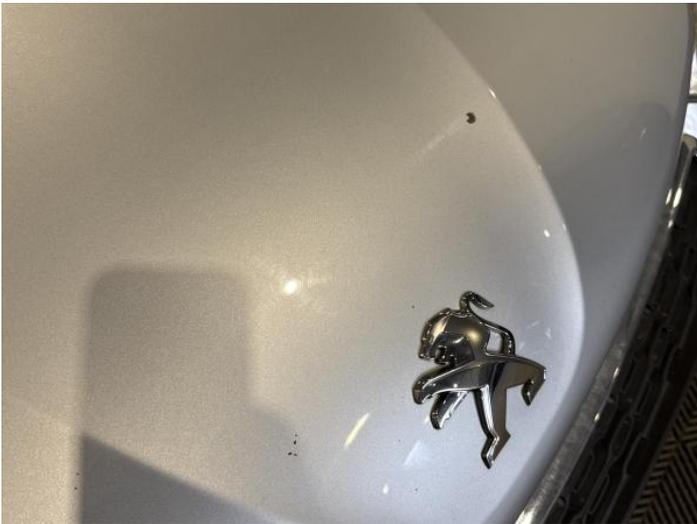
1: Bonnet  
Chipped  
Multiple Chips

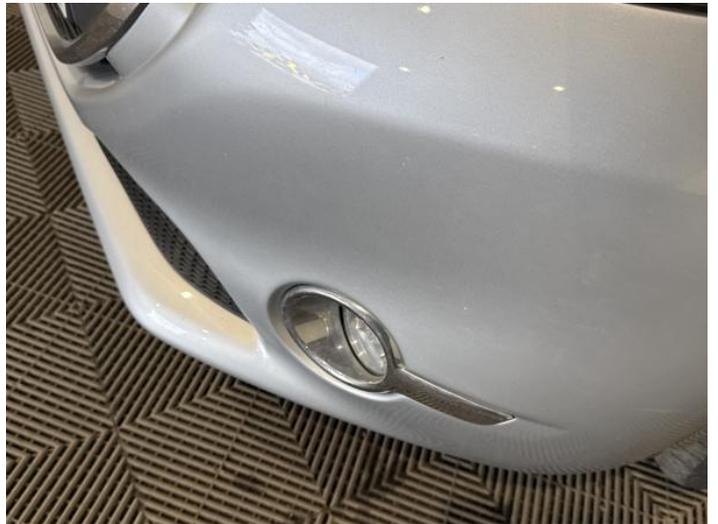
2: Bumper Front  
Chipped  
Multiple Chips

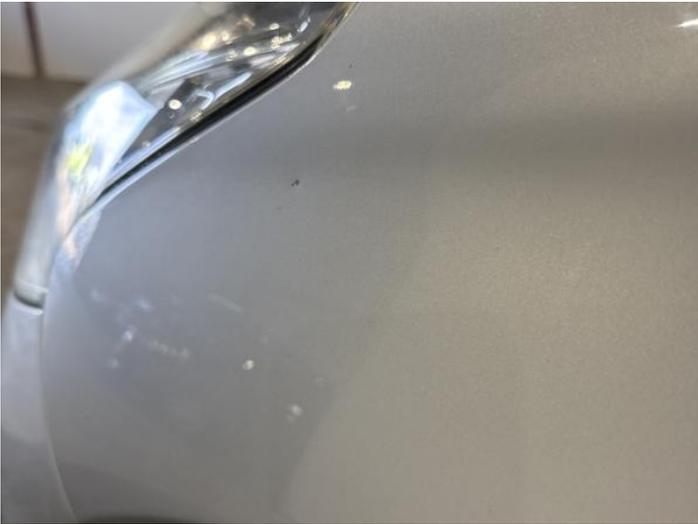
3: Wing nsf  
Chipped  
1 To 5

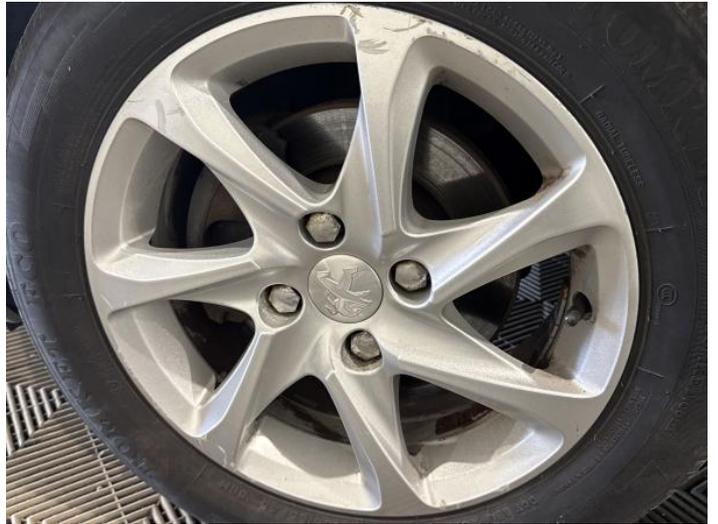
4: Wheel nsf  
Scratched  
Over 50mm

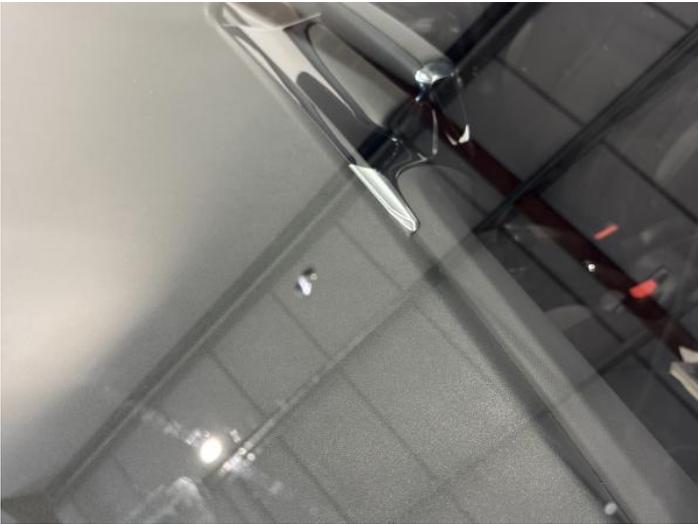
5: Screen Front  
Chipped  
Over 10mm

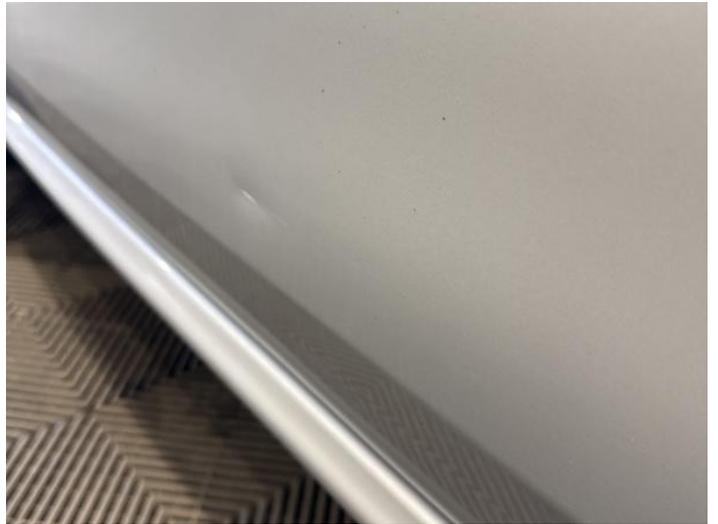
6: Door nsf  
Dented  
Over 30mm

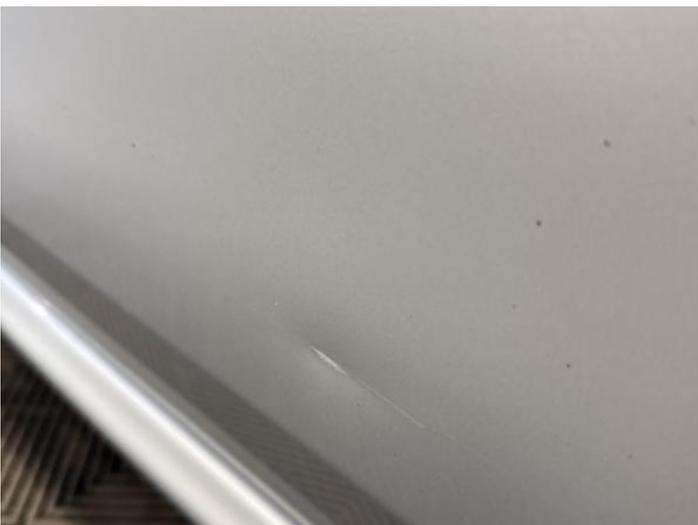
7: Door nsf  
Scratched  
Up To 25mm Thru Paint

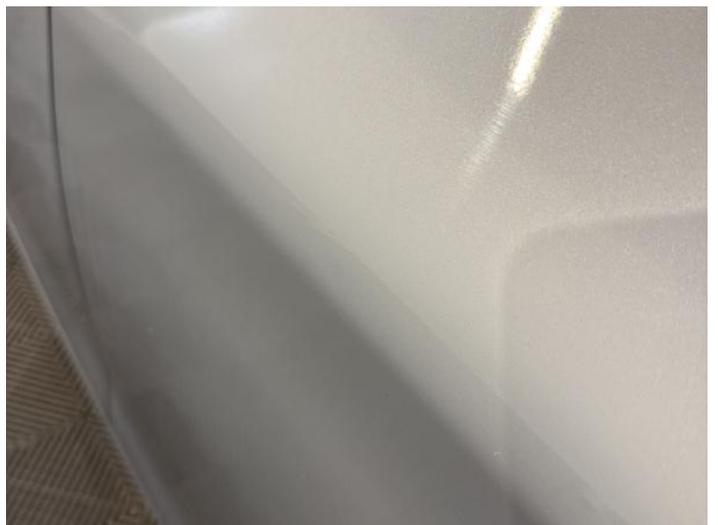
8: Door nsr  
Dented  
Between 10mm + 30mm

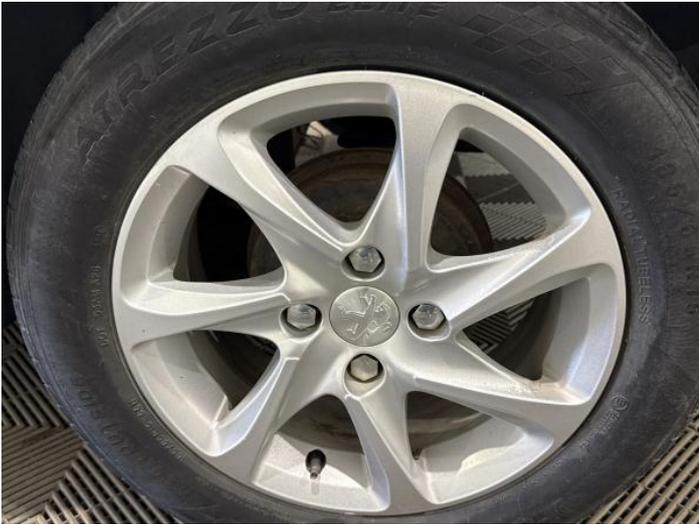
9: Wheel nsr  
Corroded  
Light

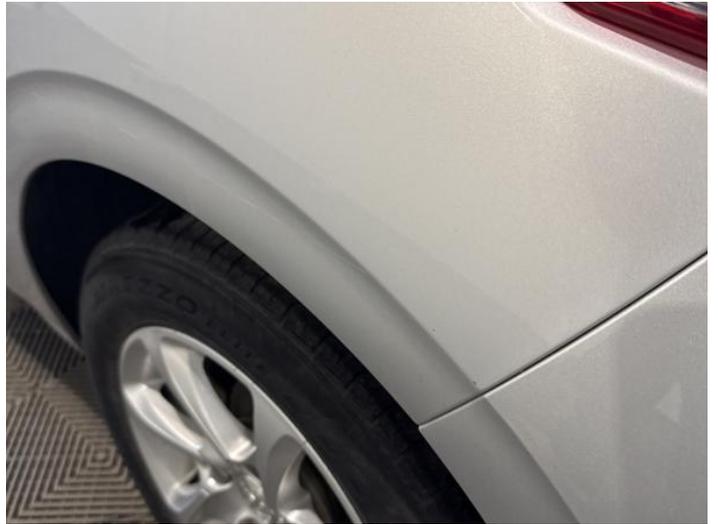
10: Qtr Panel nsr  
Scratched  
Over 25mm Thru Paint

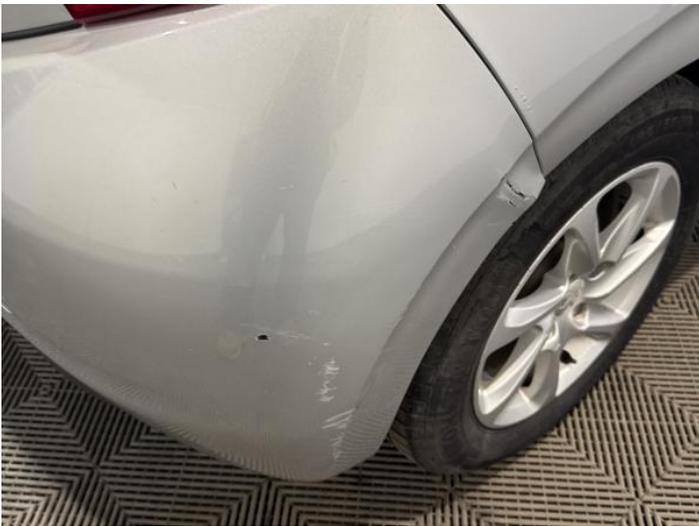
11: Bumper Rear  
Dented  
With Paint Damage

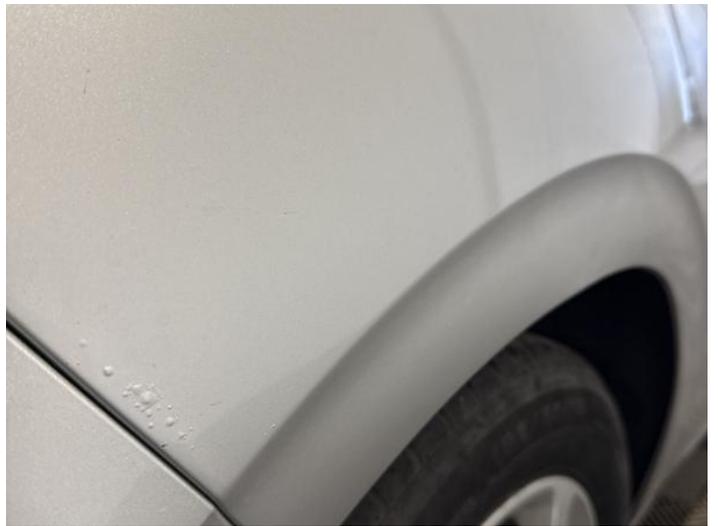
12: Qtr Panel osr  
Poor Previous Repair  
Rippled Up To 30%

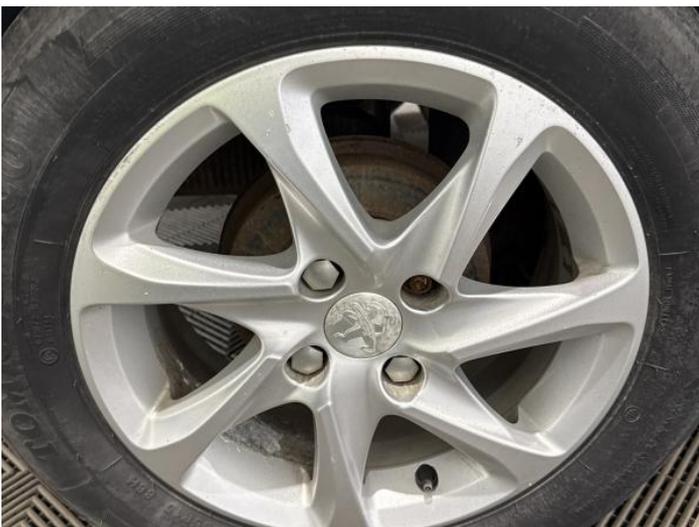
13: Wheel osr  
Scratched  
Over 50mm

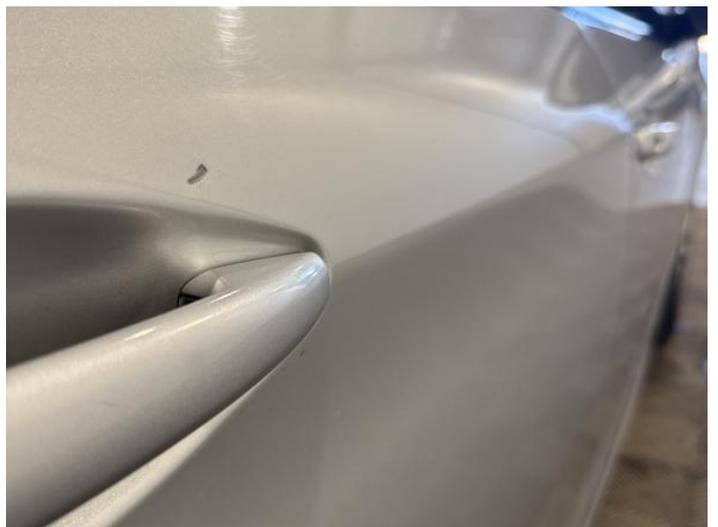
14: Door osr  
Poor Previous Repair  
Rippled Up To 30%

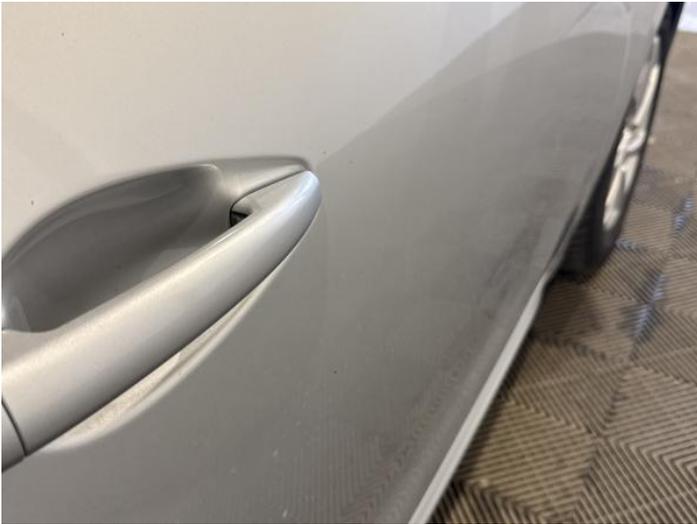
15: Door osf  
Dented  
Over 30mm

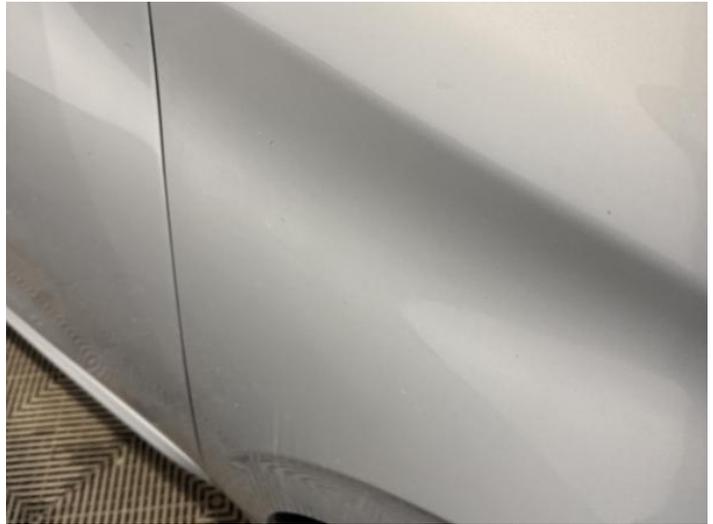
16: Wing osf  
Scratched  
Over 25mm Thru Paint
