# VEHICLE INSPECTION REPORT

**CU19YRG**

## Vauxhall Insignia 2.0 Turbo D SRi Vx-line Nav 5dr

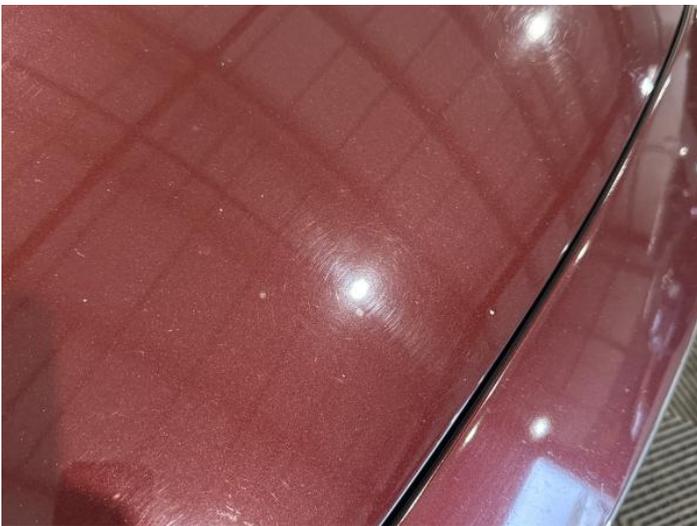
1: Bonnet  
Chipped  
Multiple Chips

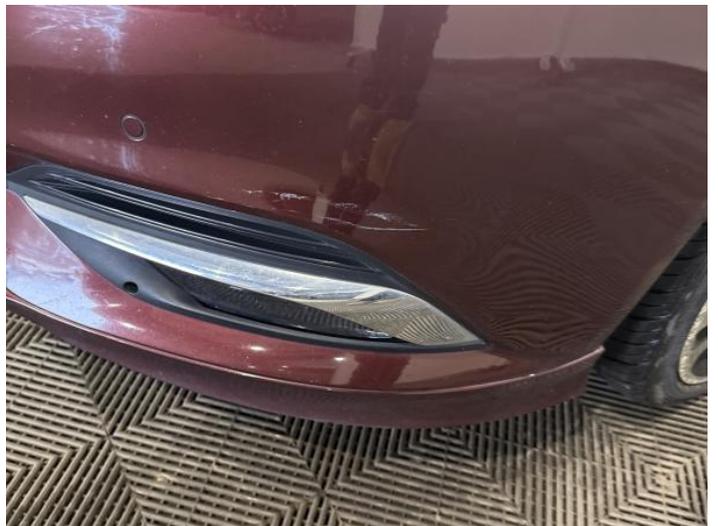
2: Bumper Front  
Scratched  
25 to 100mm Thru Paint

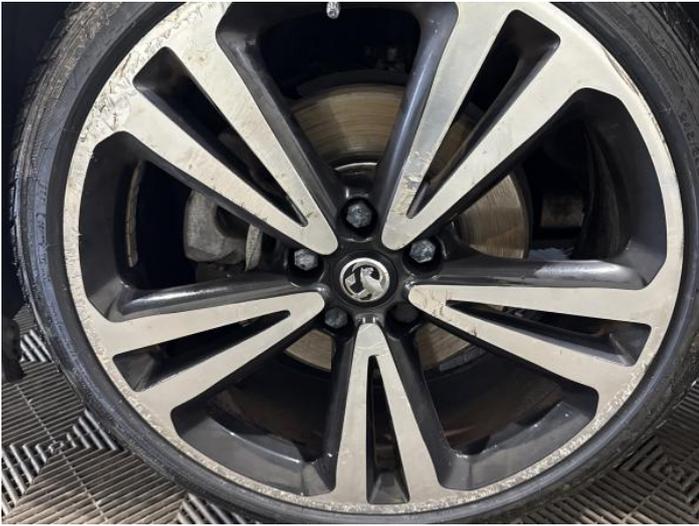
3: Wheel nsf  
Scratched  
Over 50mm

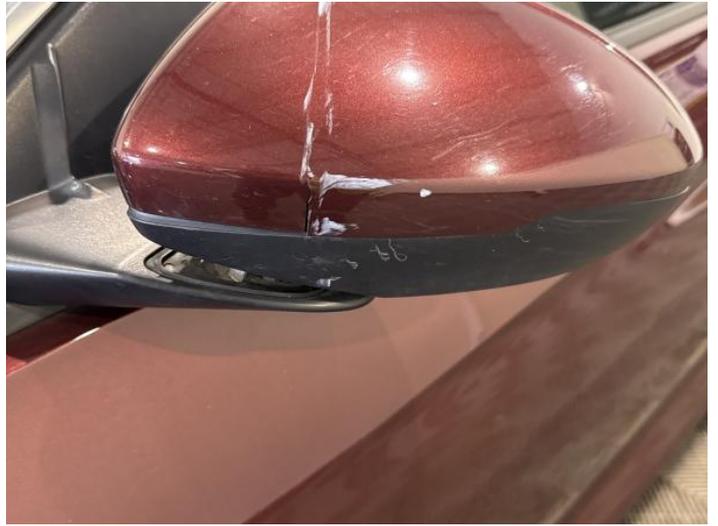
4: Door Mirror Assy nsf  
Broken  
Replace

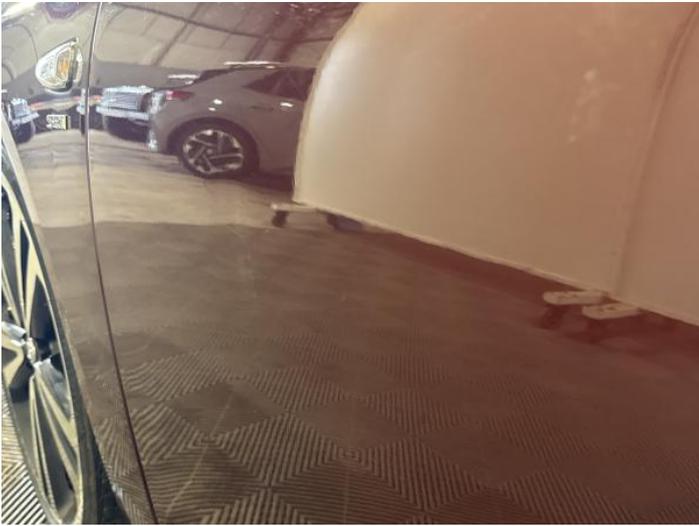
5: Door nsf  
Dented  
With Paint Damage

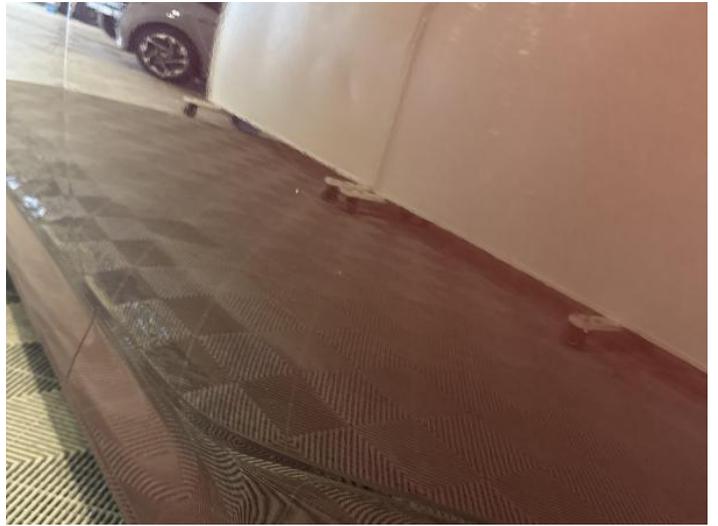
6: Door nsr  
Dented  
Between 10mm + 30mm

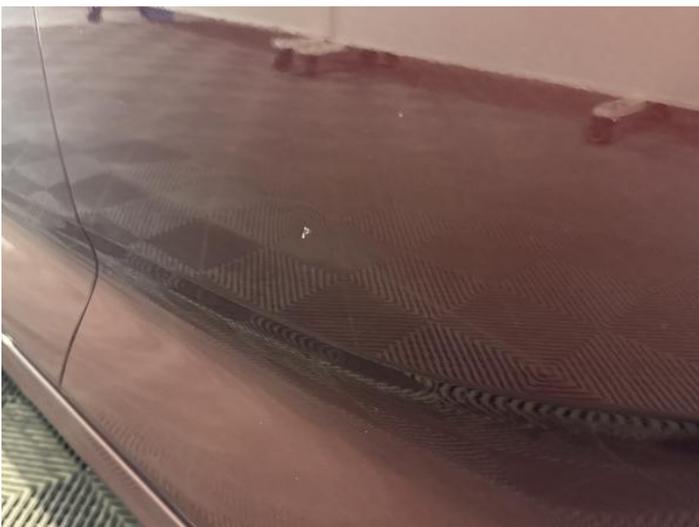
7: Door nsr  
Chipped  
1 To 5

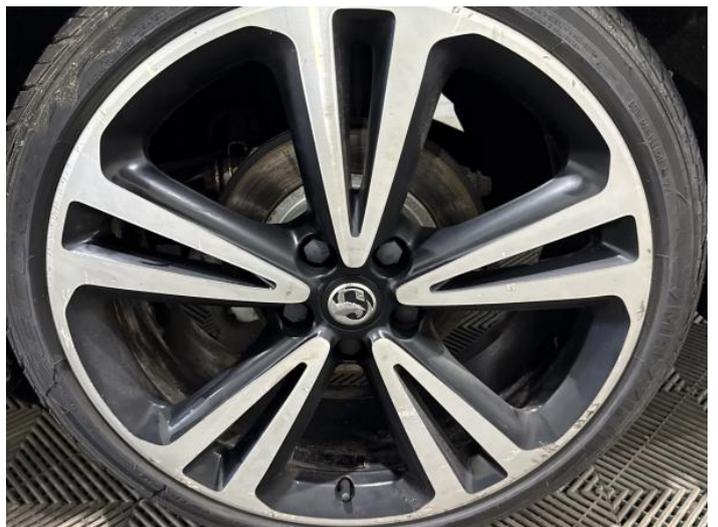
8: Wheel nsr  
Scratched  
Over 50mm

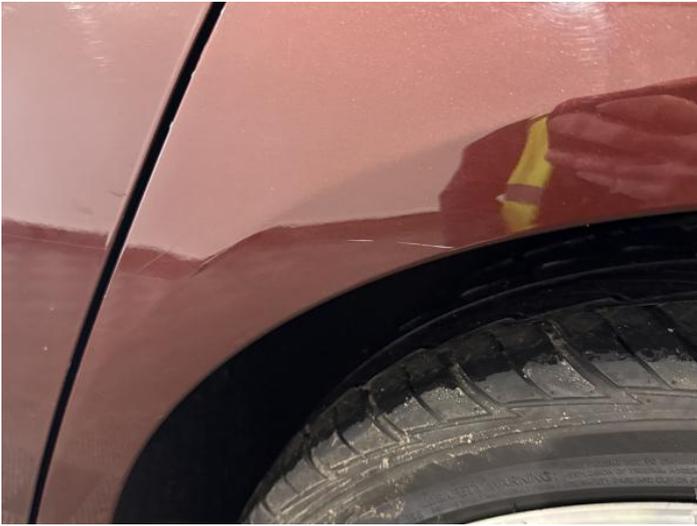
9: Qtr Panel nsr  
Scratched  
Over 25mm Thru Paint

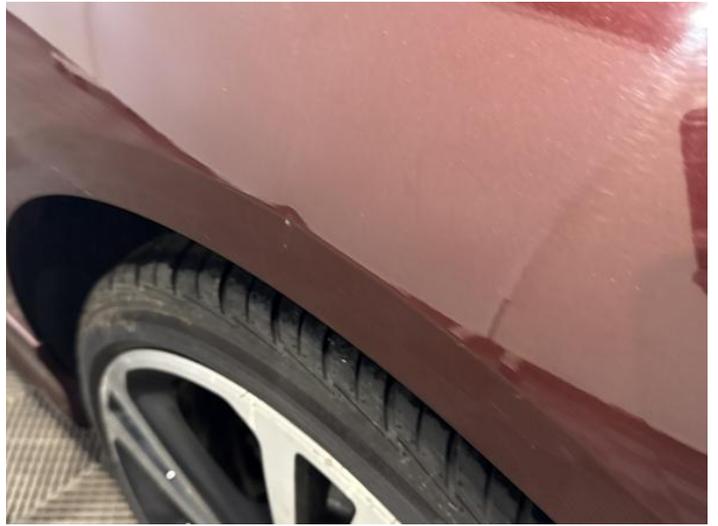
10: Qtr Panel nsr  
Dented  
Between 10mm + 30mm

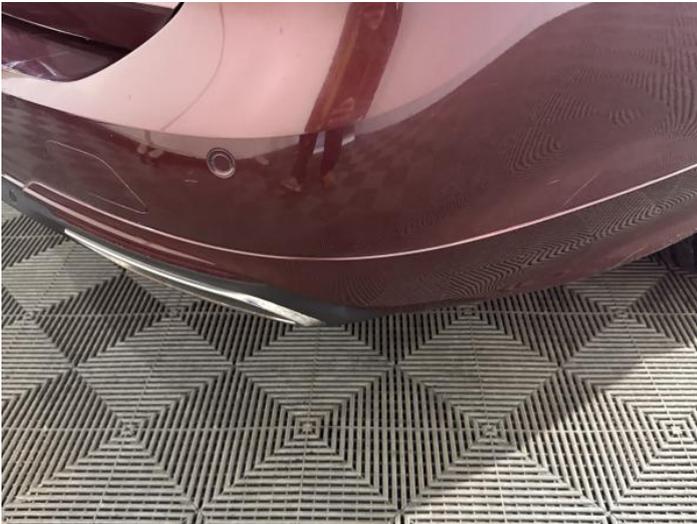
11: Bumper Rear  
Scratched  
Over 100mm Thru Paint

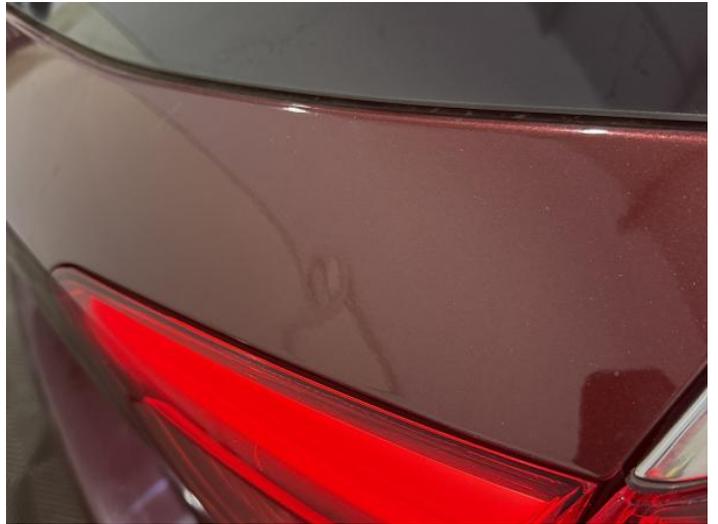
12: Tailgate  
Dented  
2 Or Less Up To 10mm

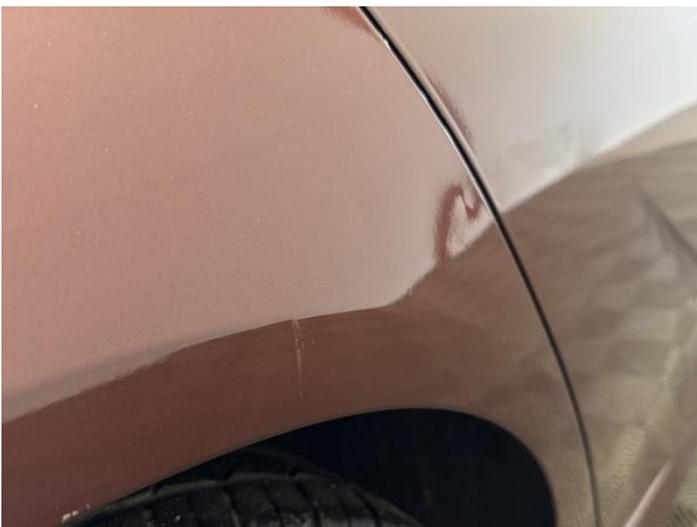
13: Qtr Panel osr  
Dented  
Between 10mm + 30mm

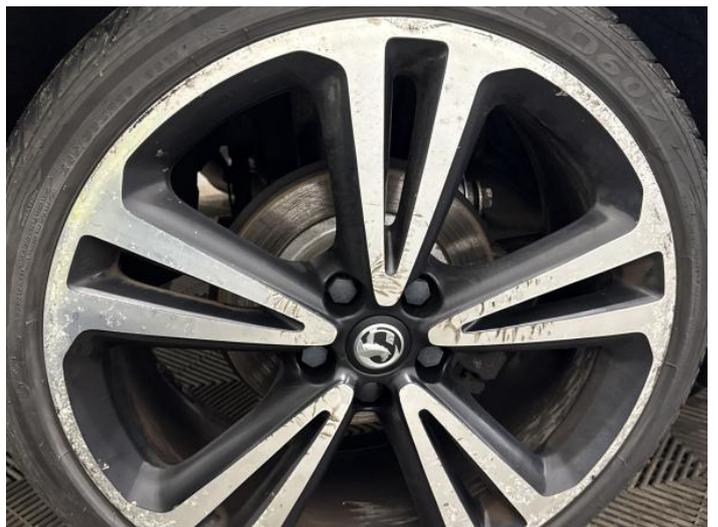
14: Wheel osr  
Scratched  
Over 50mm

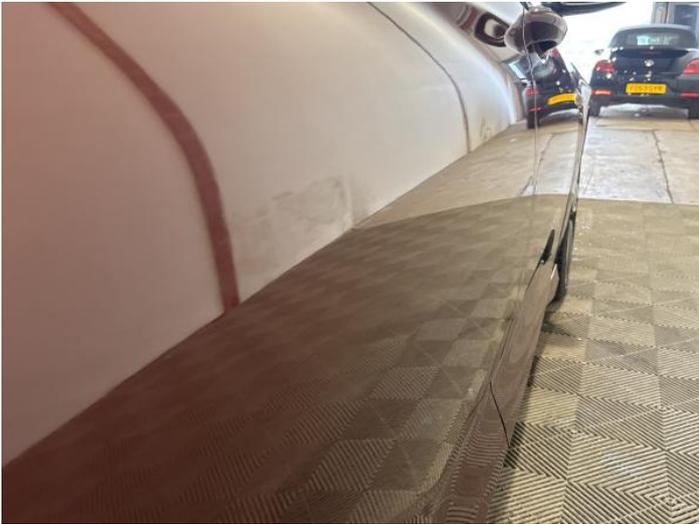
15: Door osr  
Poor Previous Repair  
Rippled UpTo 30%

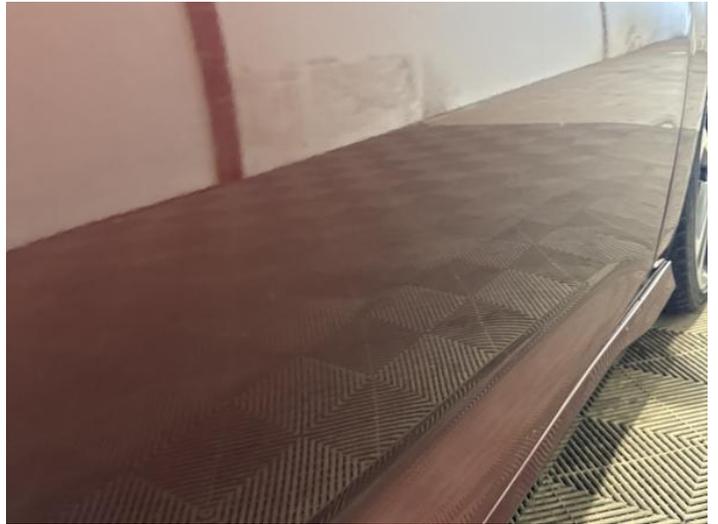
16: Door osf  
Poor Previous Repair  
Rippled UpTo 30%

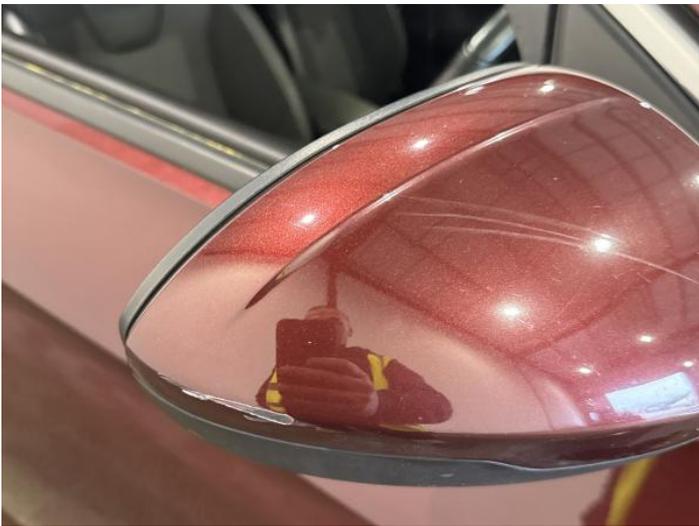
17: Door Mirror Assy osf  
Scratched (Painted)  
Over 25mm Thru Paint

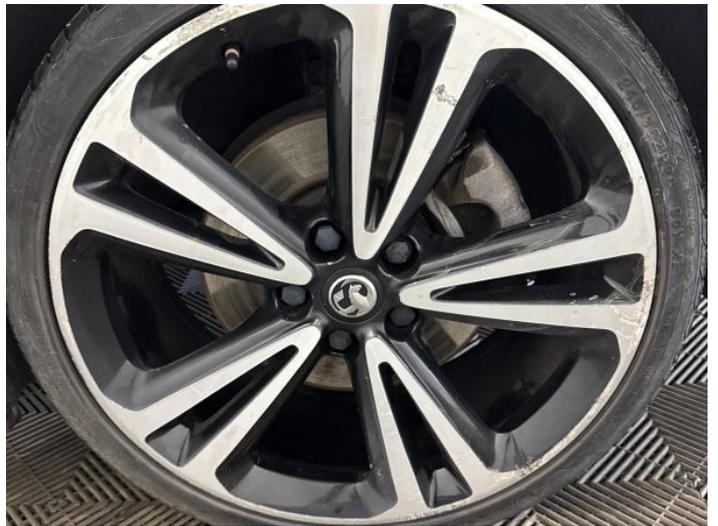
18: Wheel osf  
Scratched  
Over 50mm

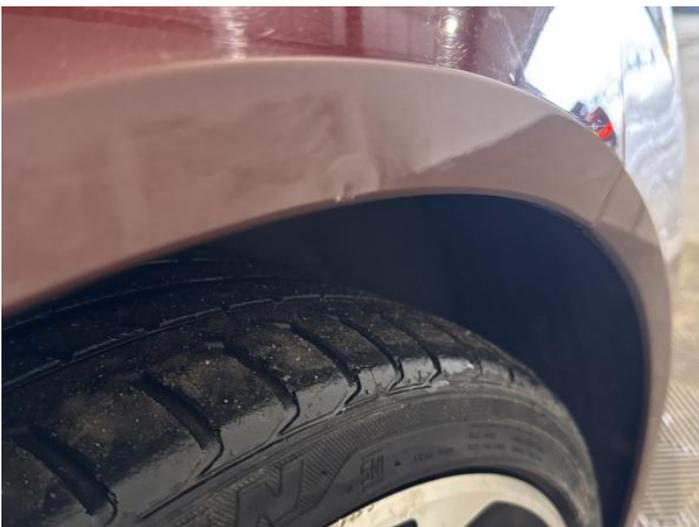
19: Wing osf  
Dented  
2 Or Less UpTo 10mm

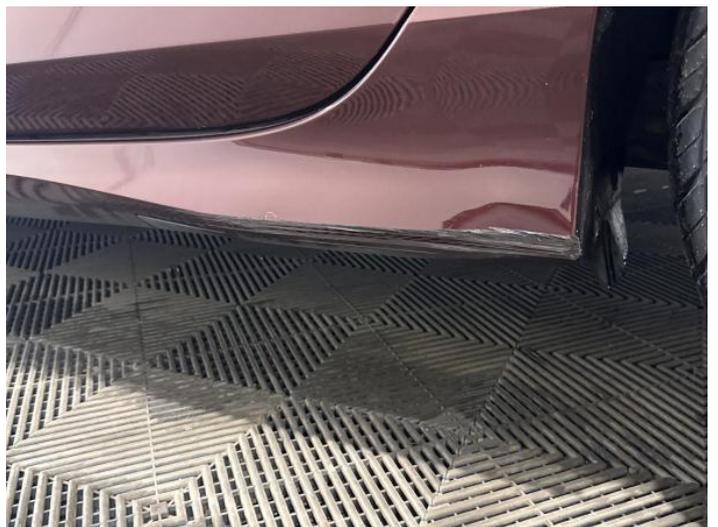
20: Sill Panel Trim ns  
Scratched (Painted)  
Over 25mm Thru Paint
