VEHICLE INSPECTION REPORT

AK09HCJ

Ford Fiesta 1.25 Zetec 5dr [82]

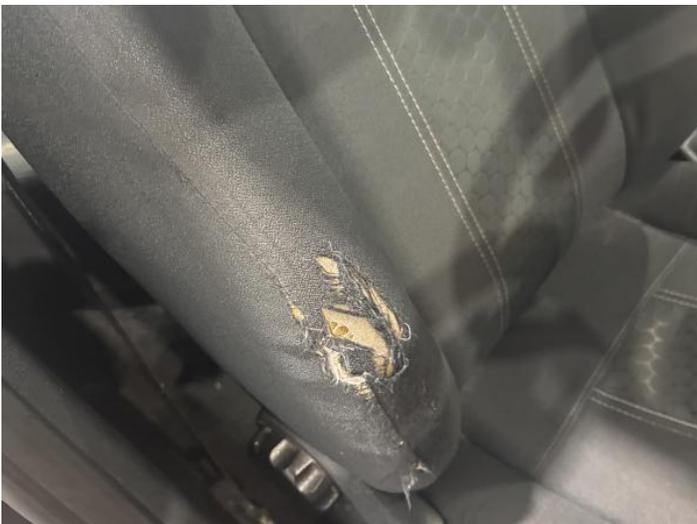
1: Seat Back Cover of
Holed
Over 3mm

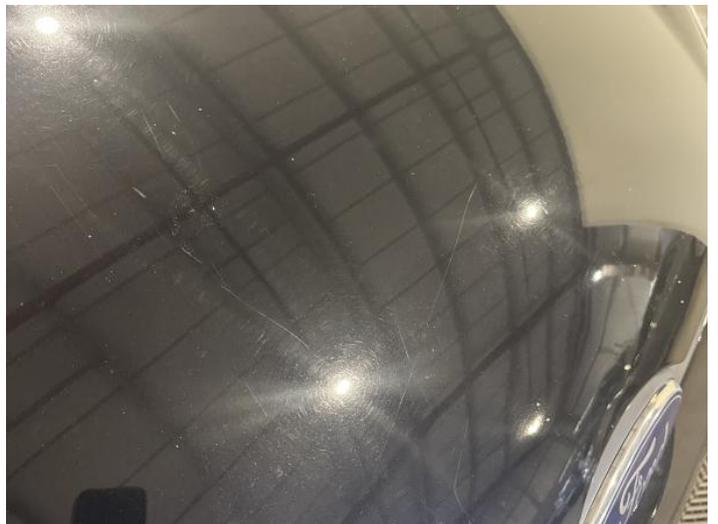
2: Bonnet
Scratched
Over 25mm Thru Paint

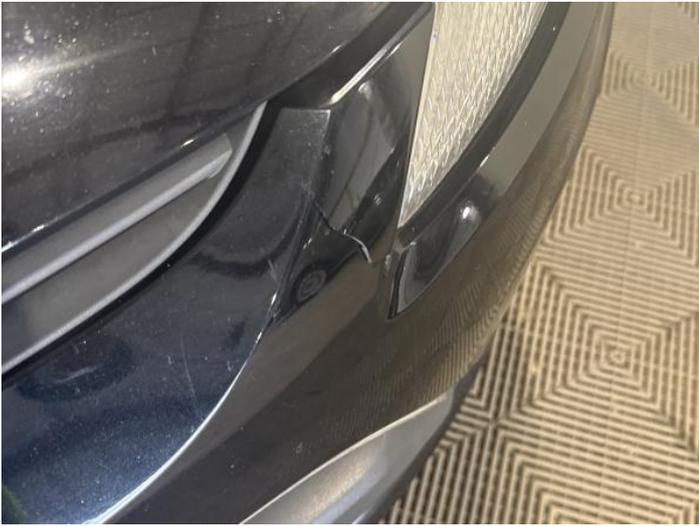
3: Bumper Front
Cracked
Over 25mm

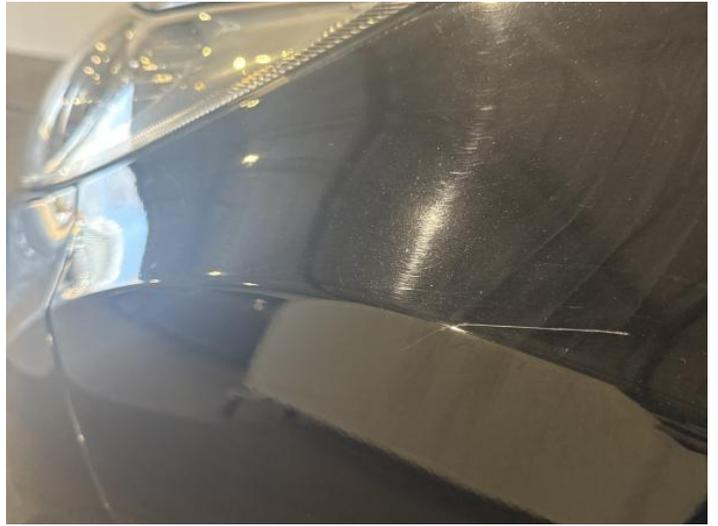
4: Wing nsf
Scratched
Over 25mm Thru Paint

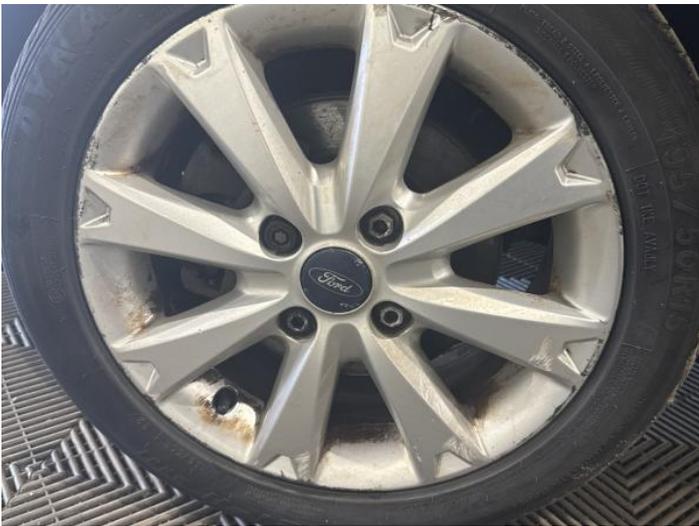
5: Wheel nsf
Scratched
Over 50mm

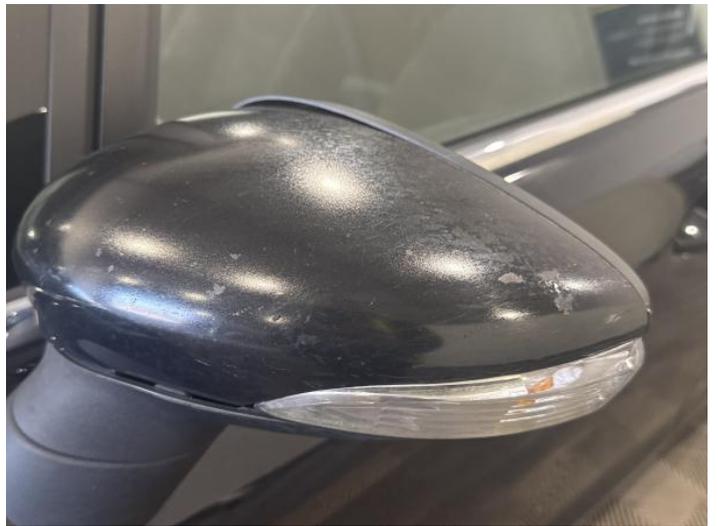
6: Door Mirror Assy nsf
Broken
Replace

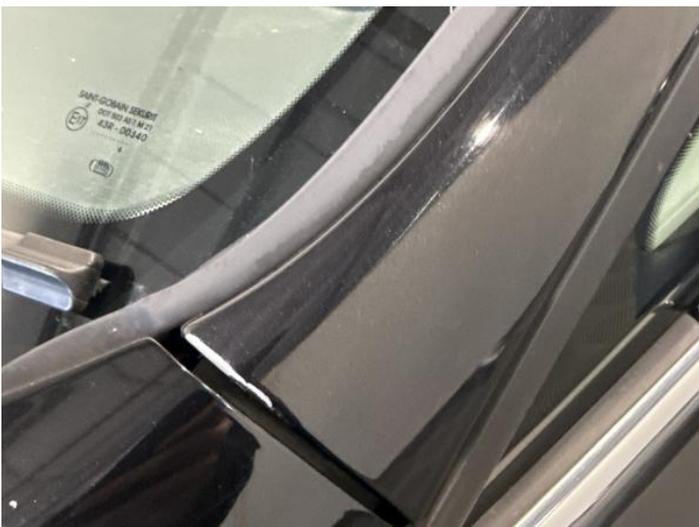
7: A Post ns
Scratched
Up To 25mm Thru Paint

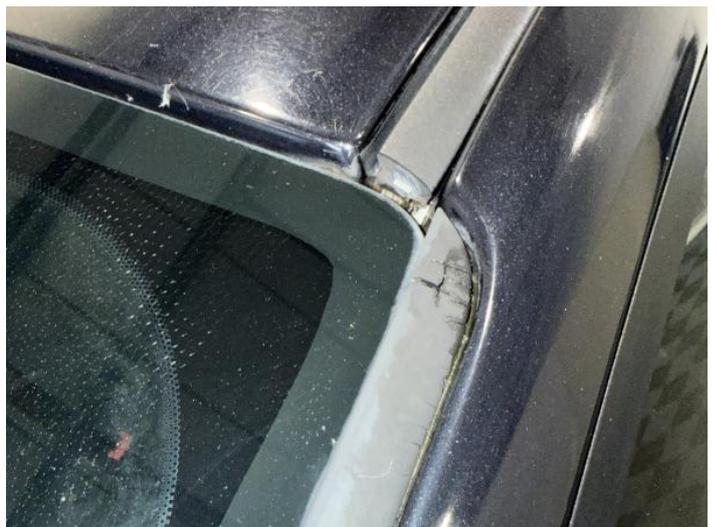
8: Aperture Seal nsf
Broken
Replace

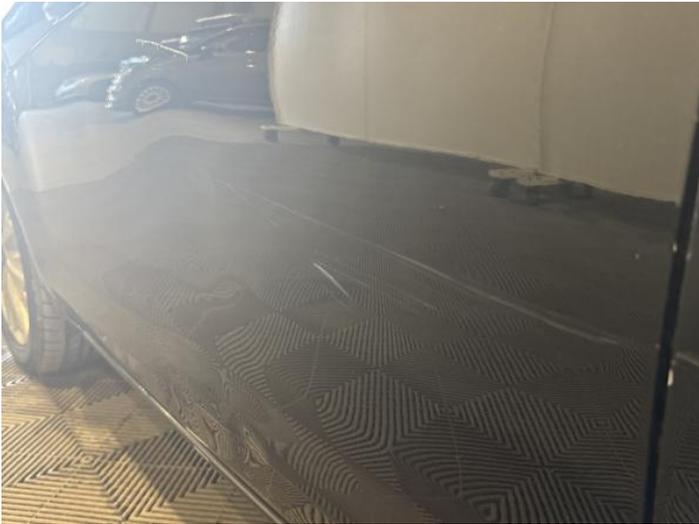
9: Door nsf
Dented
With Paint Damage

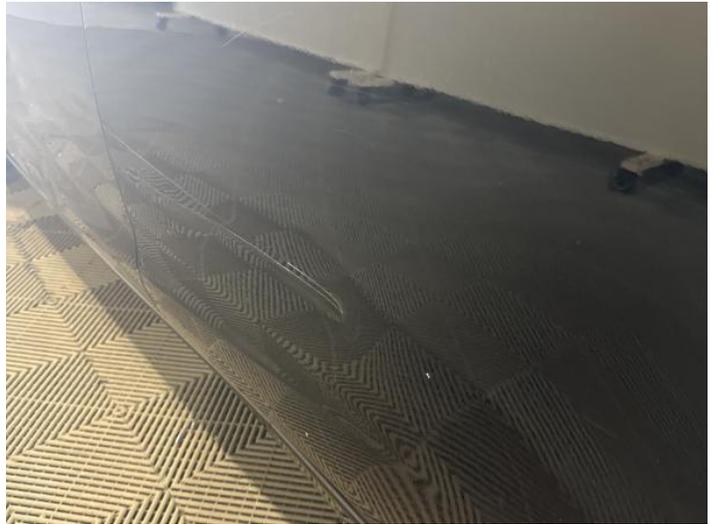
10: Door nsr
Dented
With Paint Damage

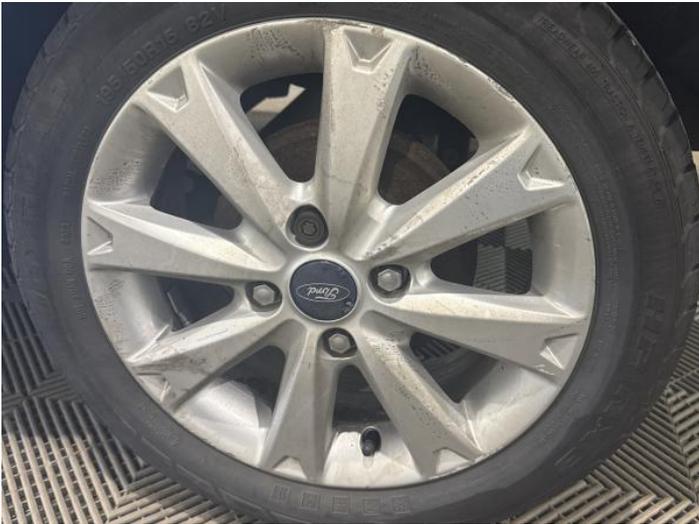
11: Wheel nsr
Scratched
Over 50mm

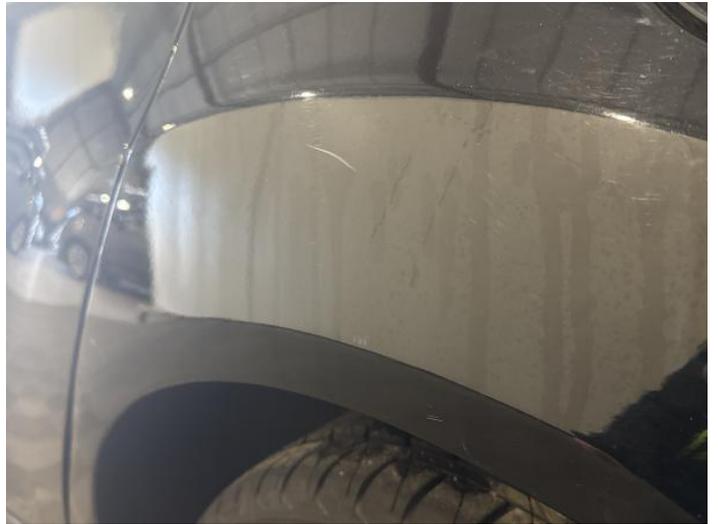
12: Qtr Panel nsr
Poor Previous Repair
Rippled Up To 30%

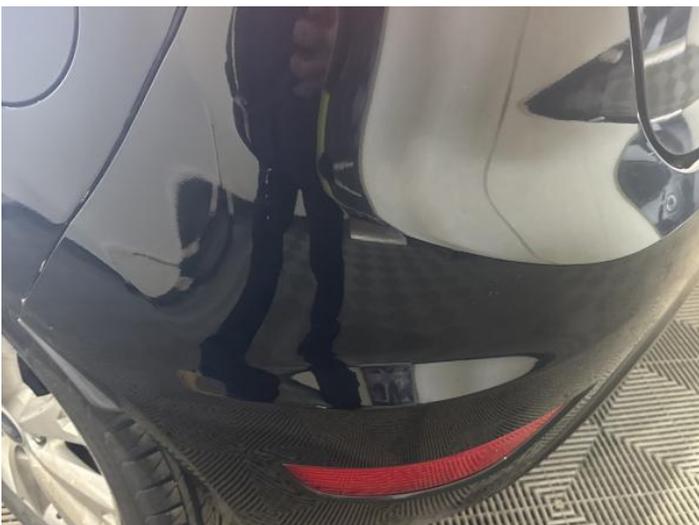
13: Bumper Rear
Scratched
25 to 100mm Thru Paint

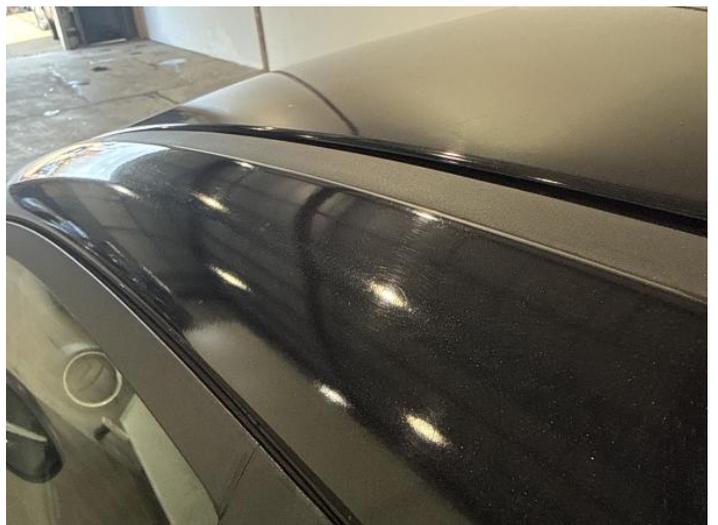
14: A Post ns
Dented
Between 10mm + 30mm

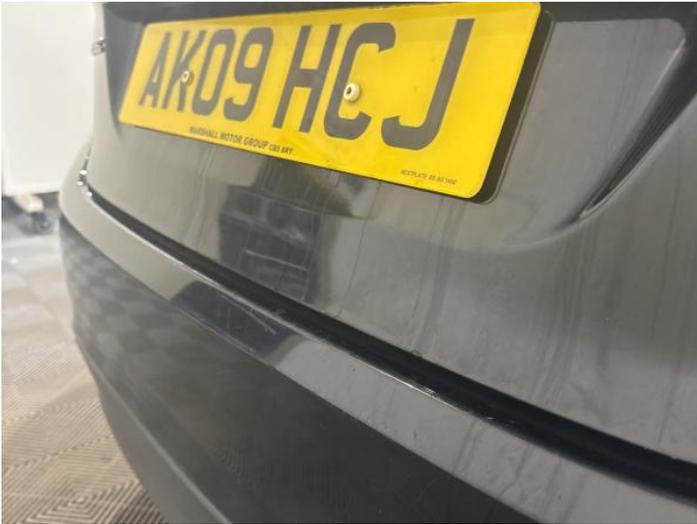
15: Tailgate
Dented
Between 10mm + 30mm

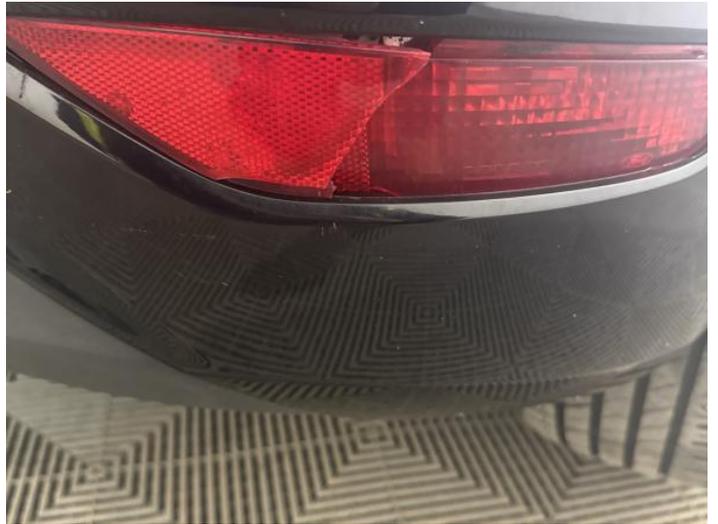
16: Bumper Reflector osr
Broken
Replace

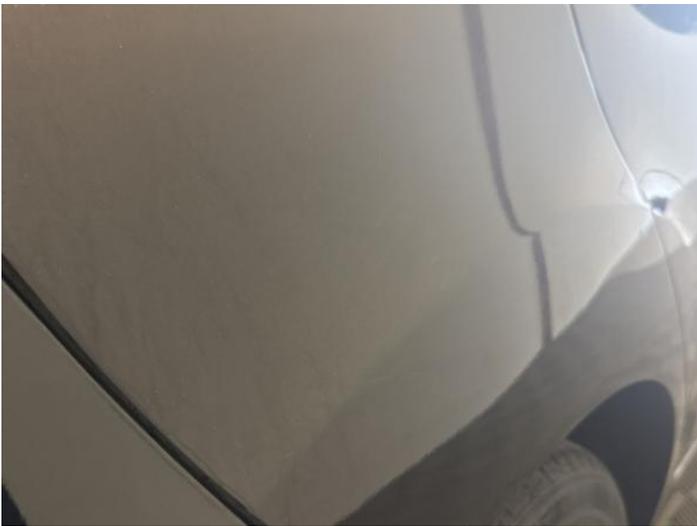
17: Qtr Panel osr
Dented
With Paint Damage

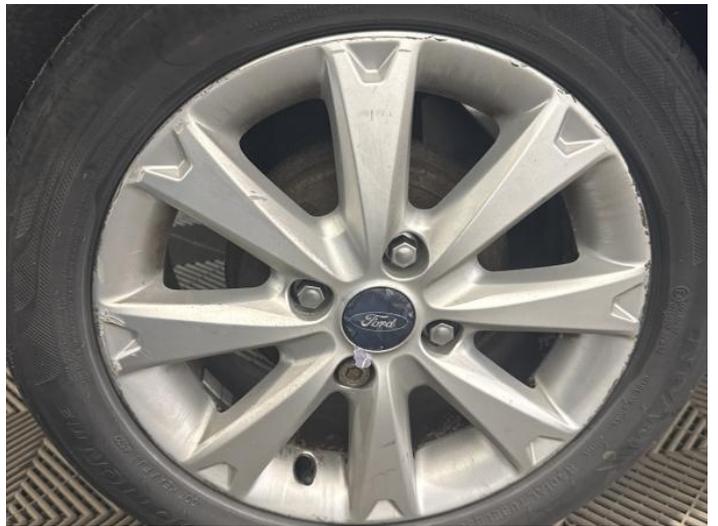
18: Wheel osr
Scratched
Over 50mm

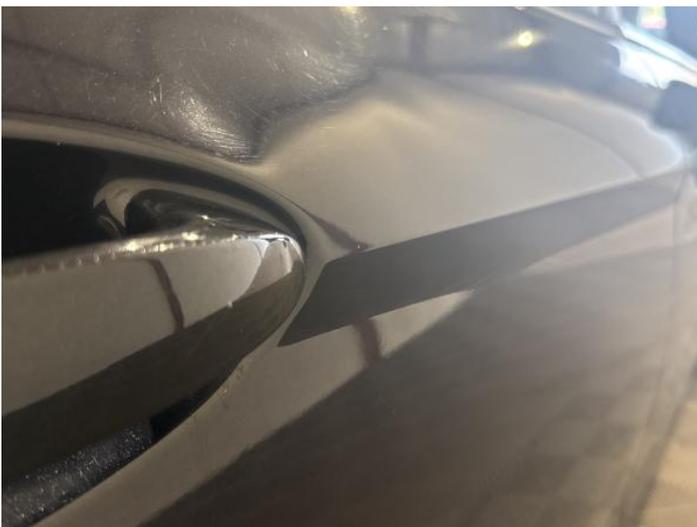
19: Door osr
Dented
Over 30mm

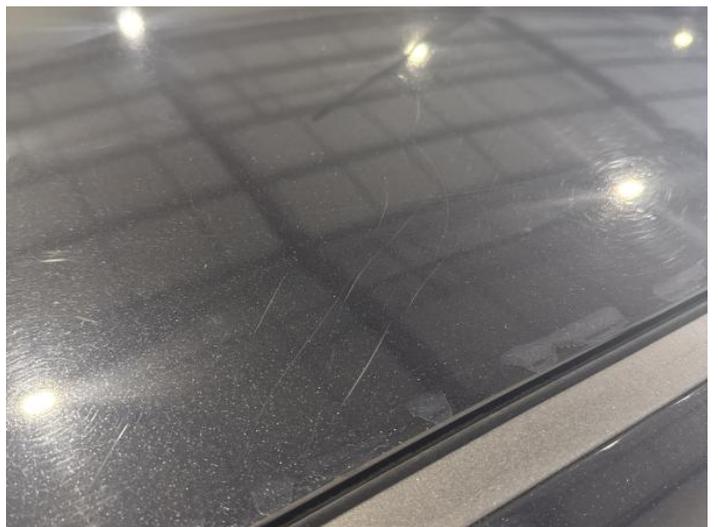
20: Roof
Scratched
Over 25mm Thru Paint

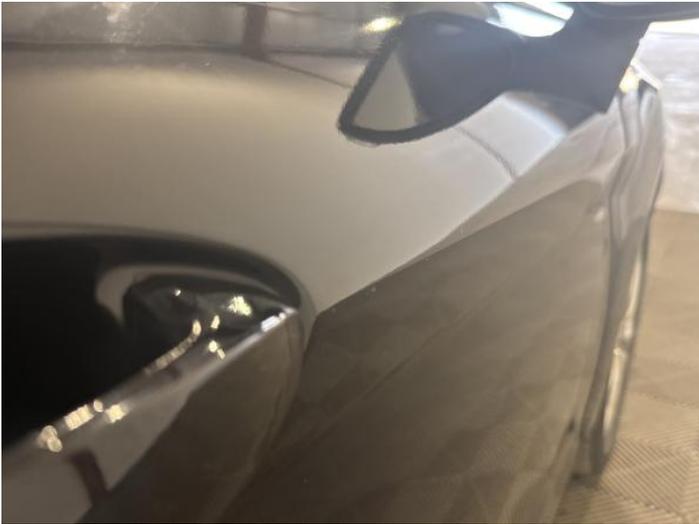
21: Door osf
Dented
With Paint Damage

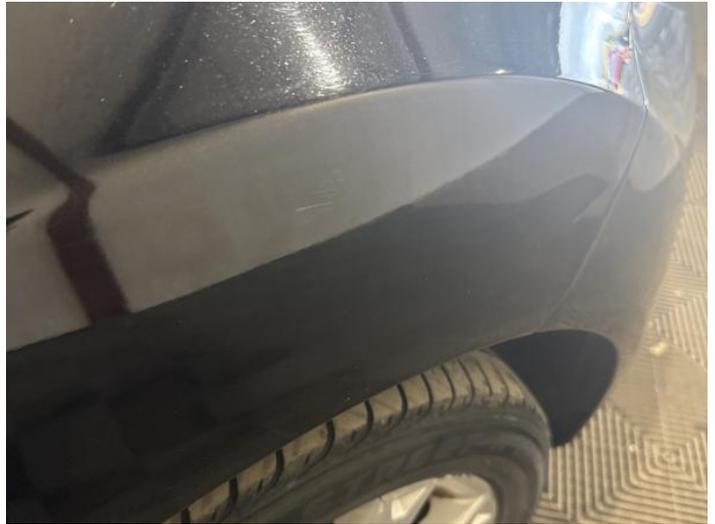
22: Wing osf
Scratched
Over 25mm Thru Paint

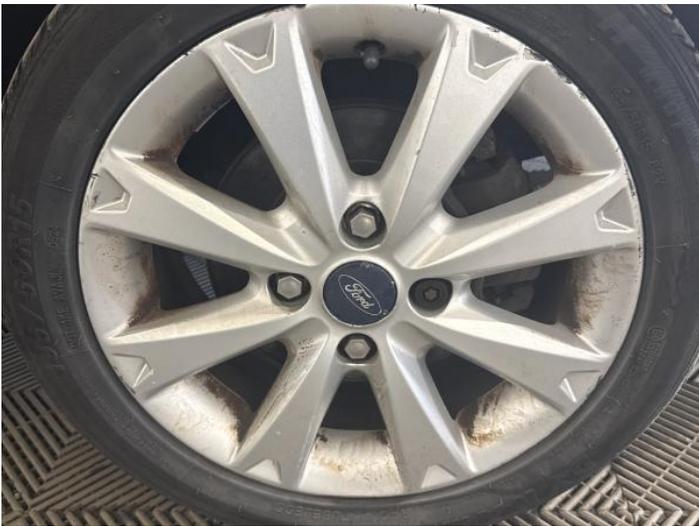
23: Wheel osf
Scratched
Over 50mm

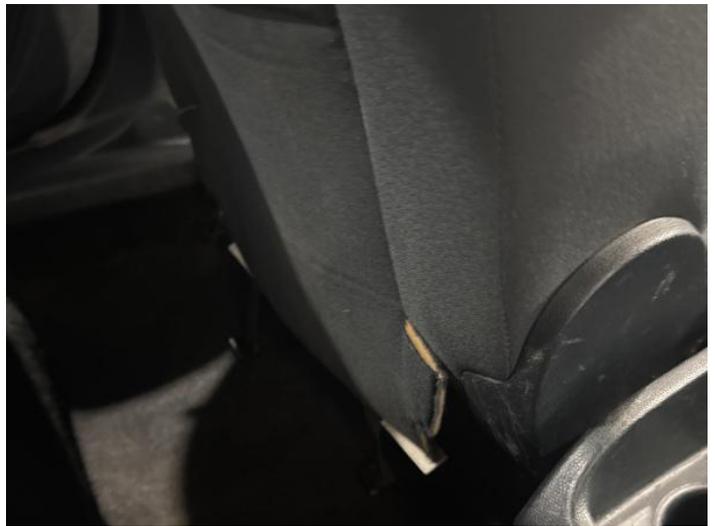
24: Seat Back Cover nsf
Scuffed
Over 25mm

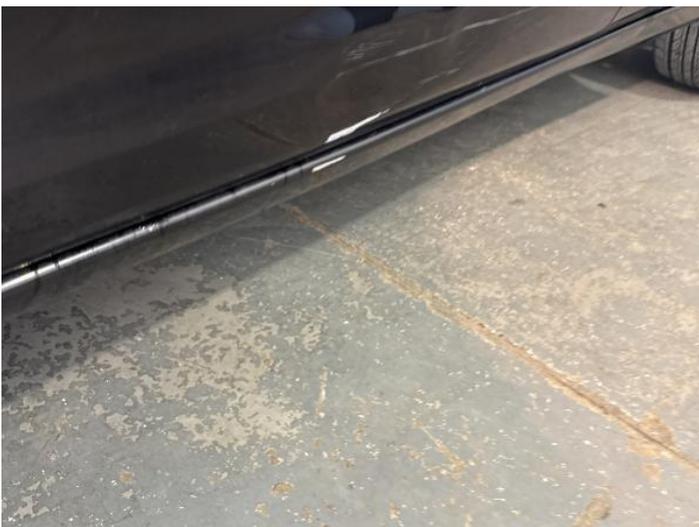
25: Sill ns
Scratched
Over 25mm Thru Paint
