VEHICLE INSPECTION REPORT

GU16CMY

Toyota Auris 1.2T Design 5dr

nama
GRADE
4

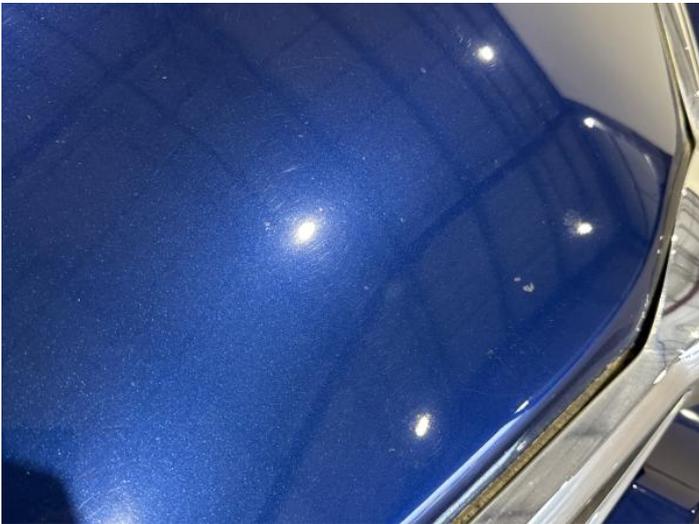
1: Bonnet
Chipped
Multiple Chips

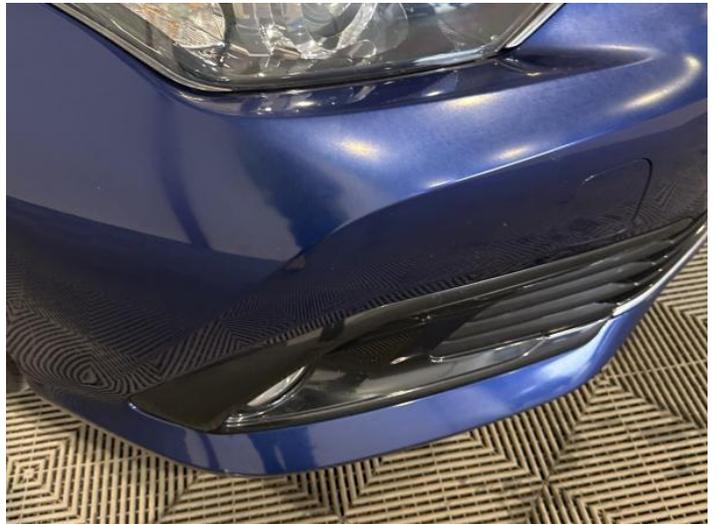
2: Bumper Front
Poor Previous Repair
Poor Paint

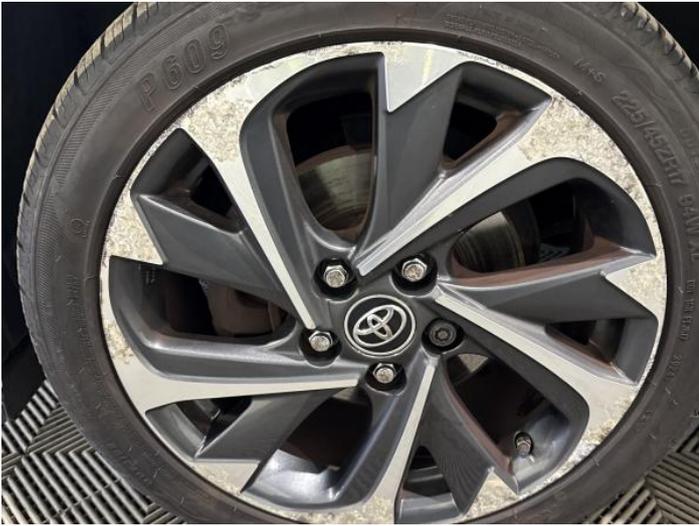
3: Wheel nsf
Scratched
Over 50mm

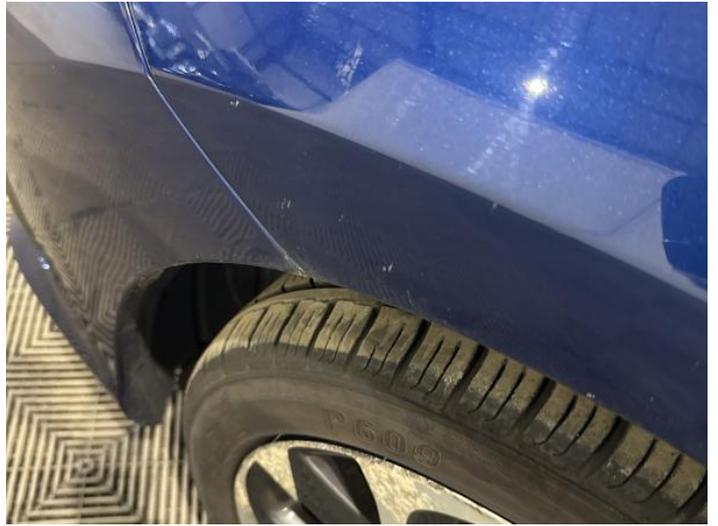
4: Wing nsf
Chipped
1 To 5

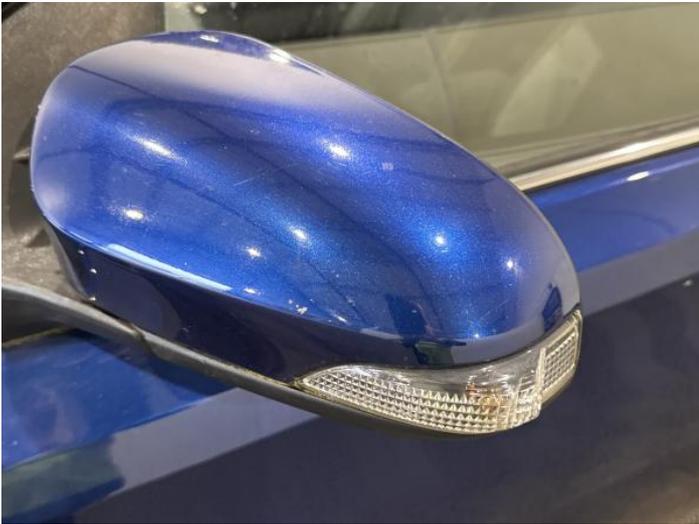
5: Door Mirror Assy nsf
Scratched (Painted)
UpTo 25mm Thru Paint

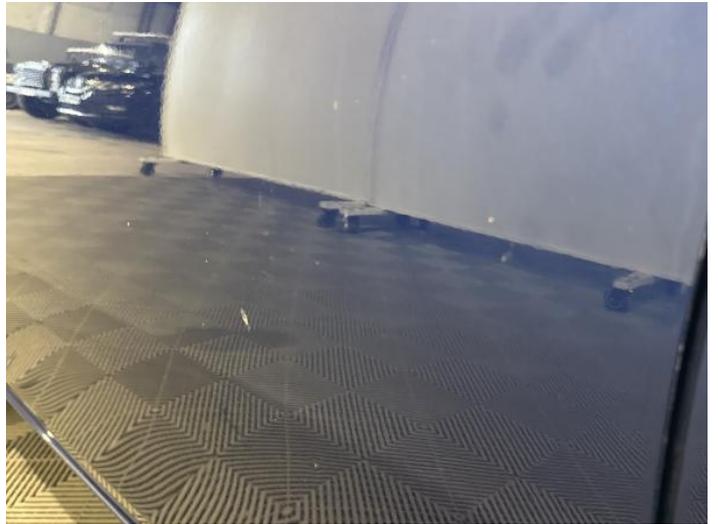
6: Door nsf
Chipped
Multiple Chips

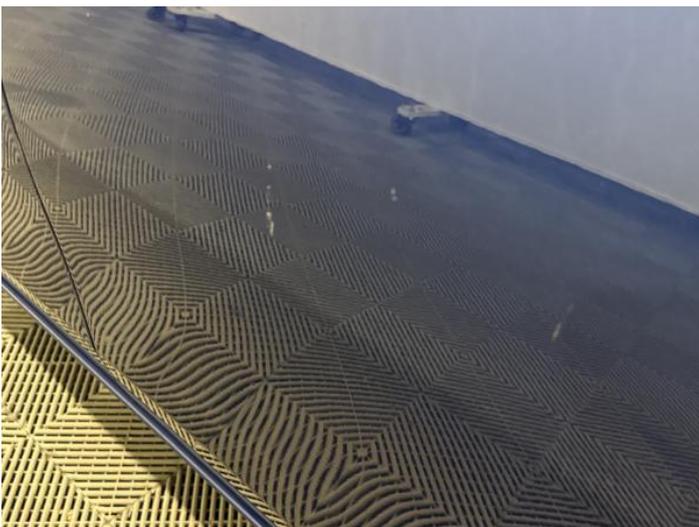
7: Door nsr
Scratched
Over 25mm Thru Paint

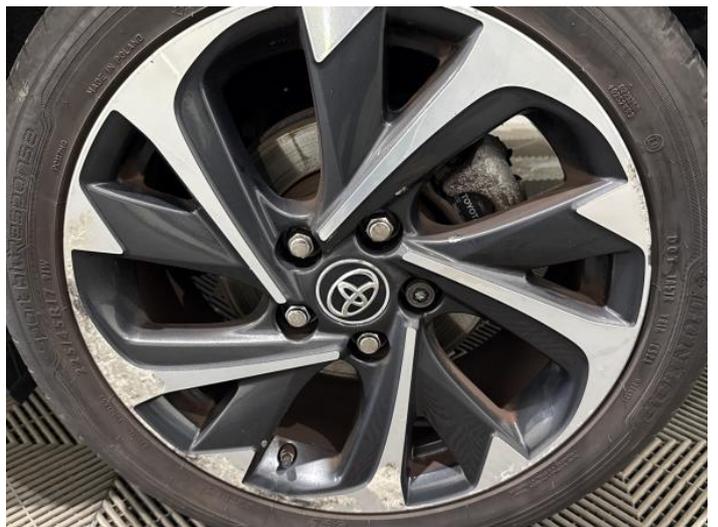
8: Wheel nsr
Scratched
Over 50mm

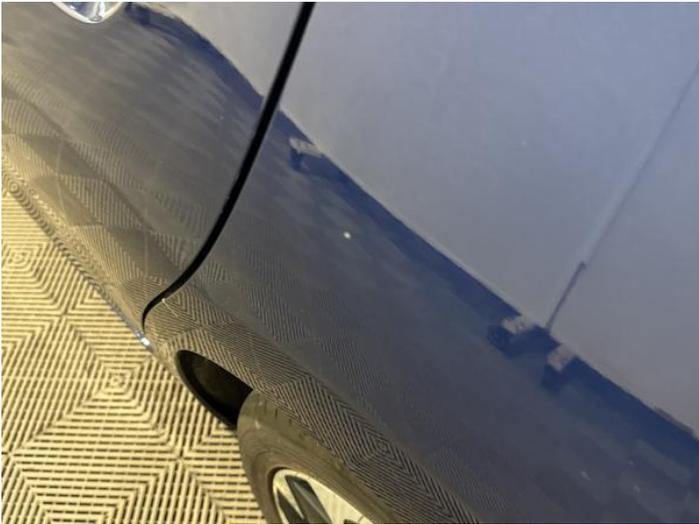
9: Qtr Panel nsr
Chipped
1 To 5

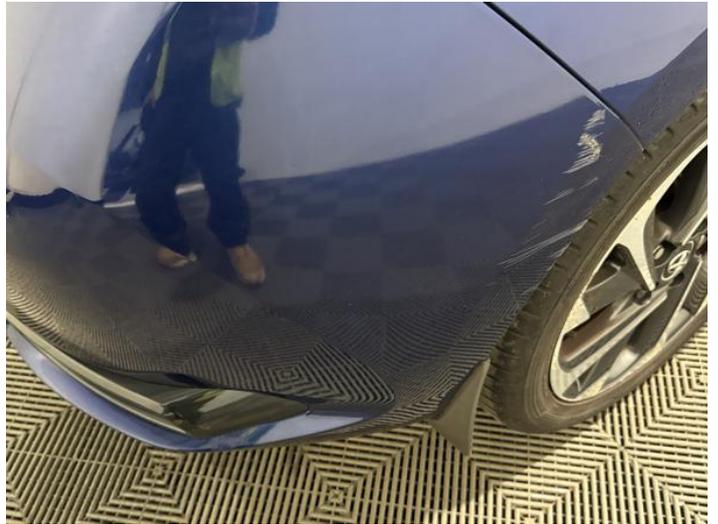
10: Bumper Rear
Scratched
Over 100mm Thru Paint

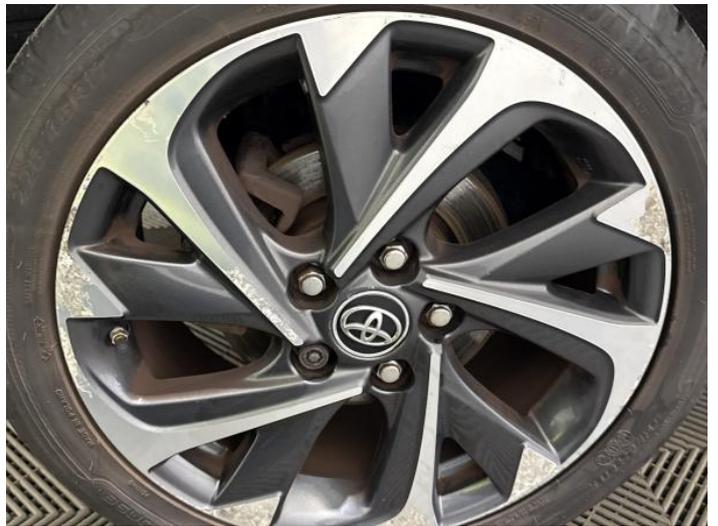
12: Wheel osr
Scratched
Over 50mm

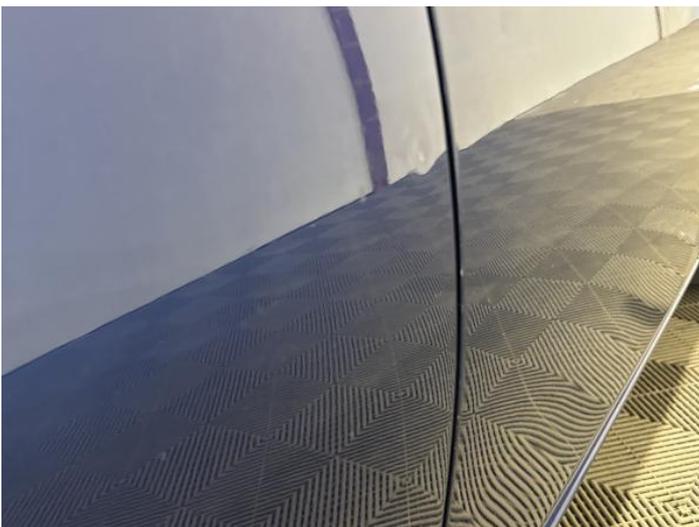
13: Door osr
Dented
Between 10mm + 30mm

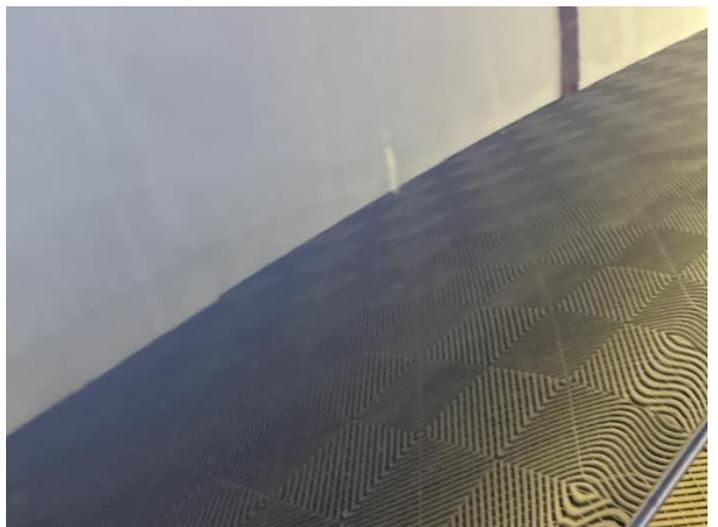
14: Door osr
Scratched
Up To 25mm Thru Paint

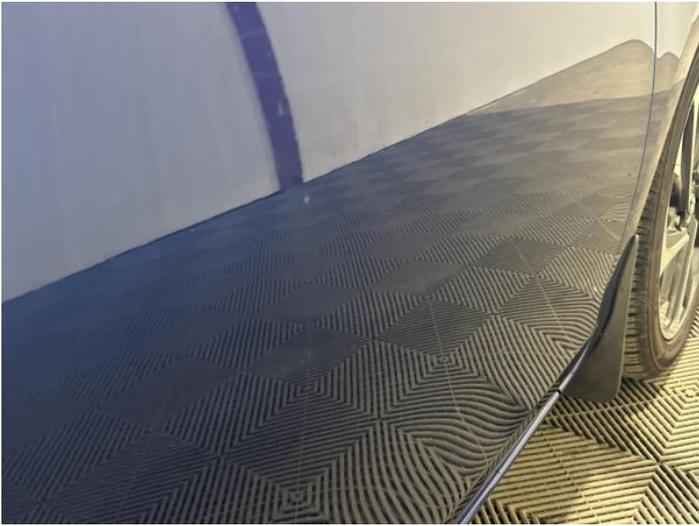
15: Door osf
Chipped
1 To 5

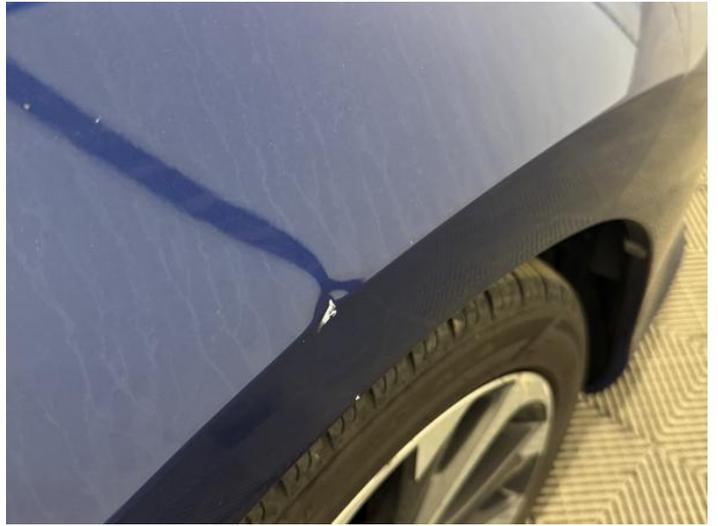
16: Wing osf
Dented
Between 10mm + 30mm

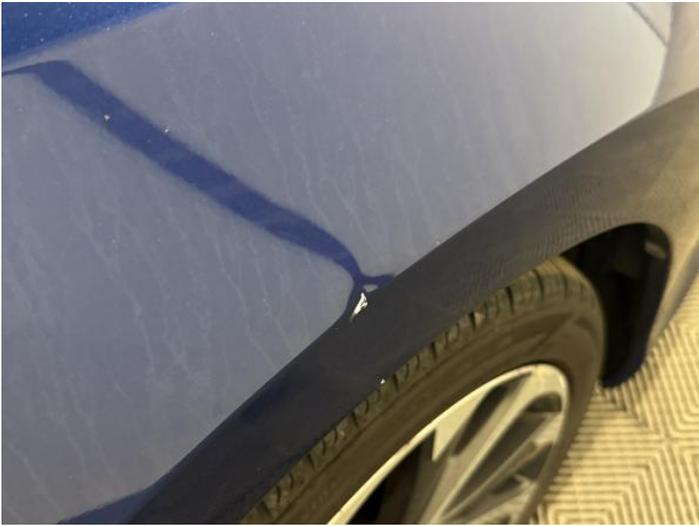
17: Wing osf
Scratched
Up To 25mm Thru Paint

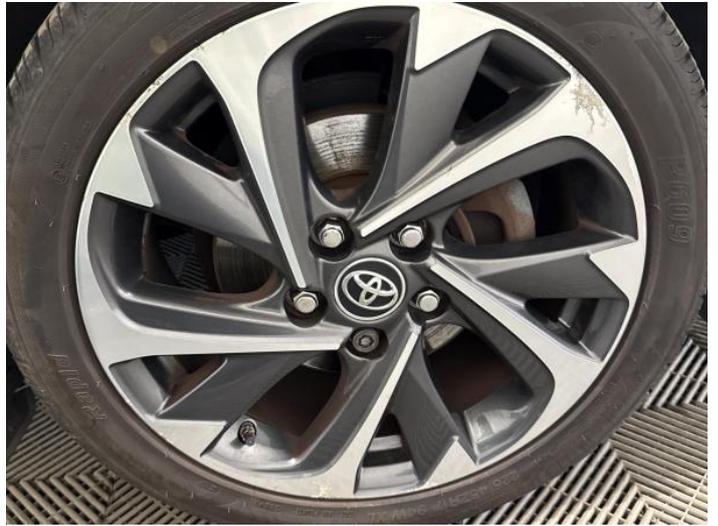
18: Wheel osf
Scratched
Over 50mm

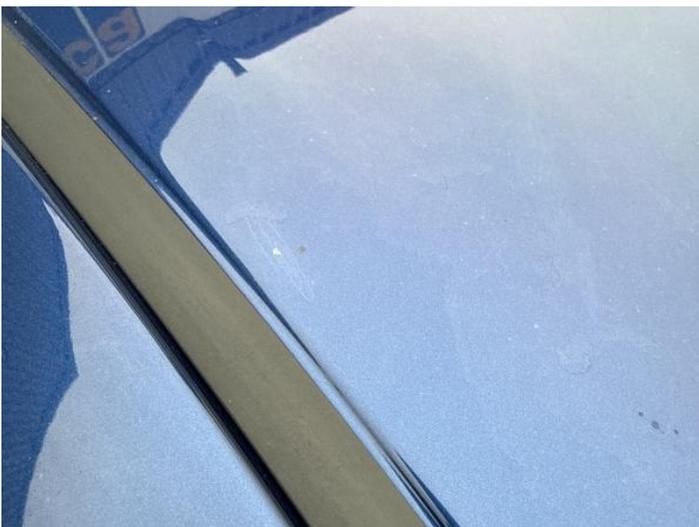
19: Roof
Chipped
1 To 5
