VEHICLE INSPECTION REPORT

GV64DSZ

Toyota Yaris 1.33 VVT-i Icon 5dr CVT

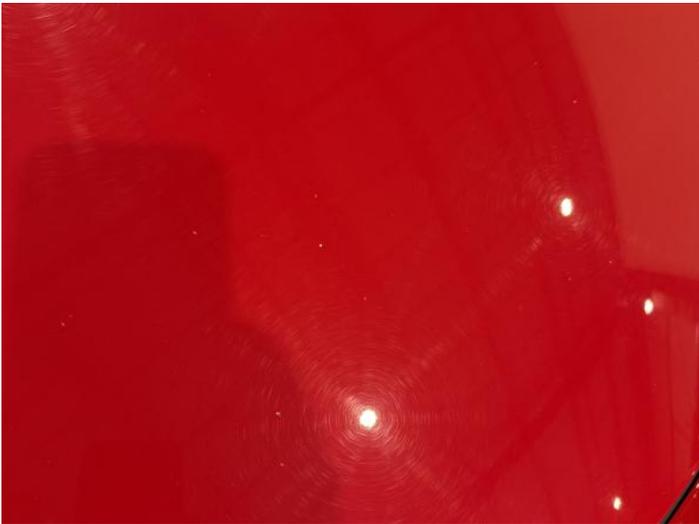
1: Bonnet
Chipped
Multiple Chips

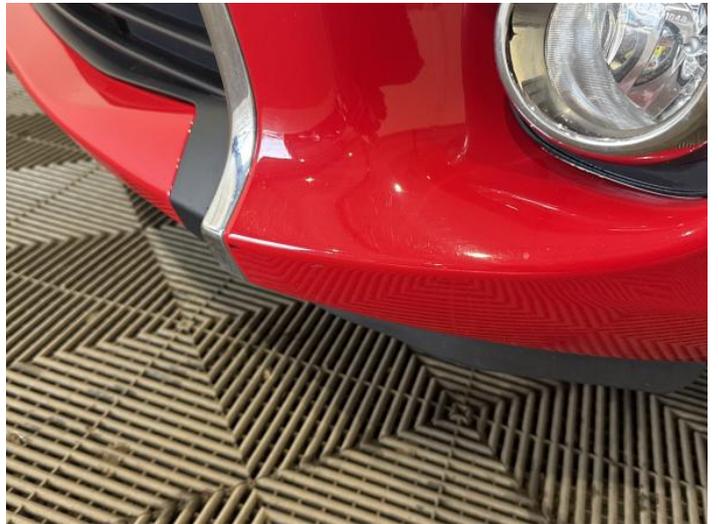
2: Bumper Front
Scratched
UpTo 25mm Thru Paint

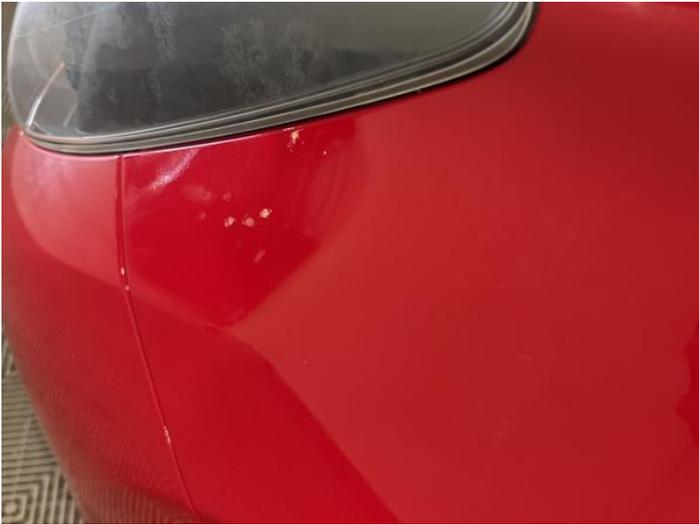
3: Wing nsf
Chipped
1 To 5

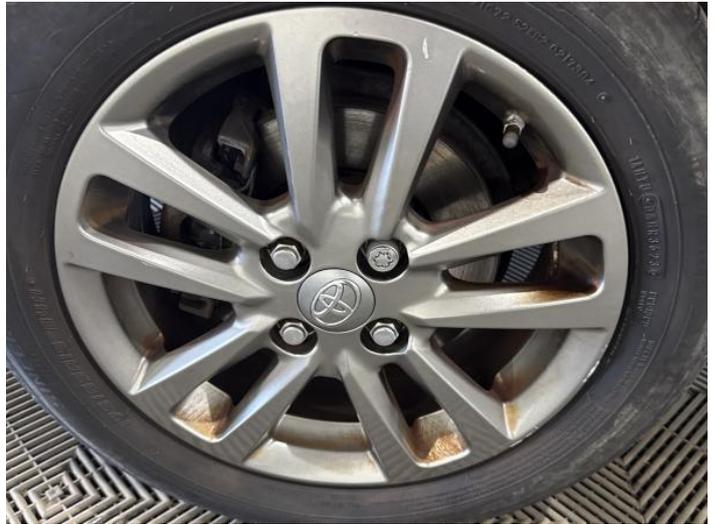
4: Wheel nsf
Scratched
Over 50mm

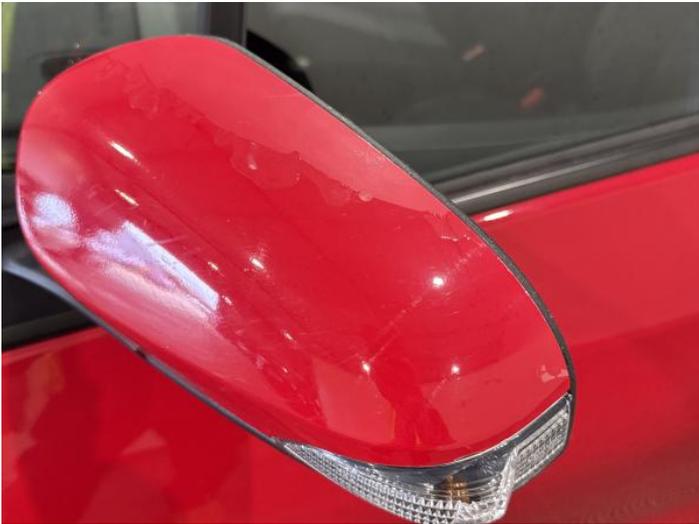
5: Door Mirror Assy nsf
Scratched (Painted)
Over 25mm Thru Paint

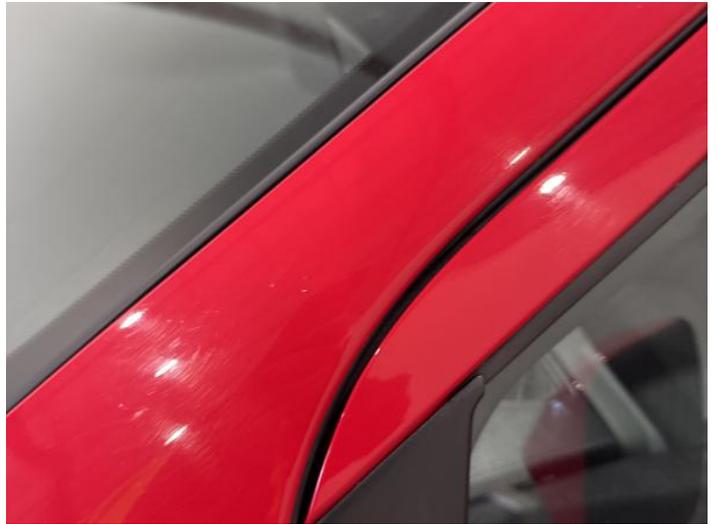
6: A Post ns
Chipped
1 To 5

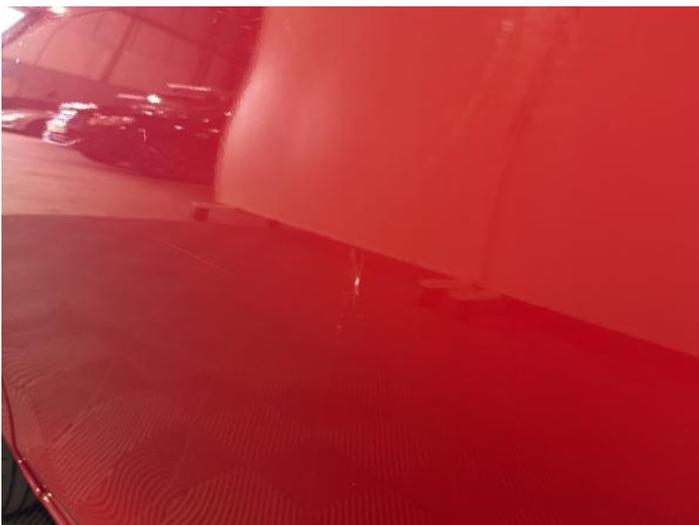
7: Door nsf
Scratched
Over 25mm Thru Paint

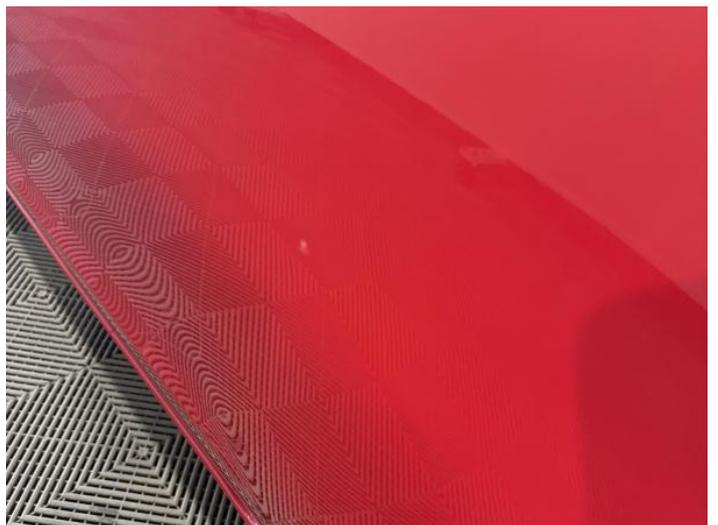
8: Door nsr
Chipped
1 To 5

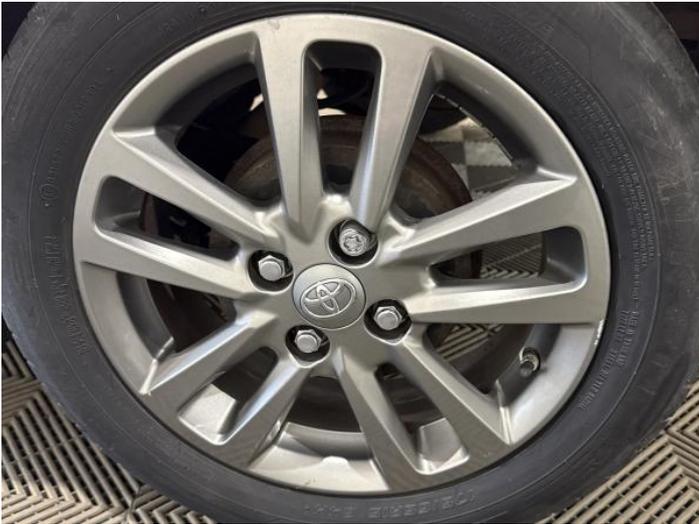
9: Wheel nsr
Scratched
Up To 50mm

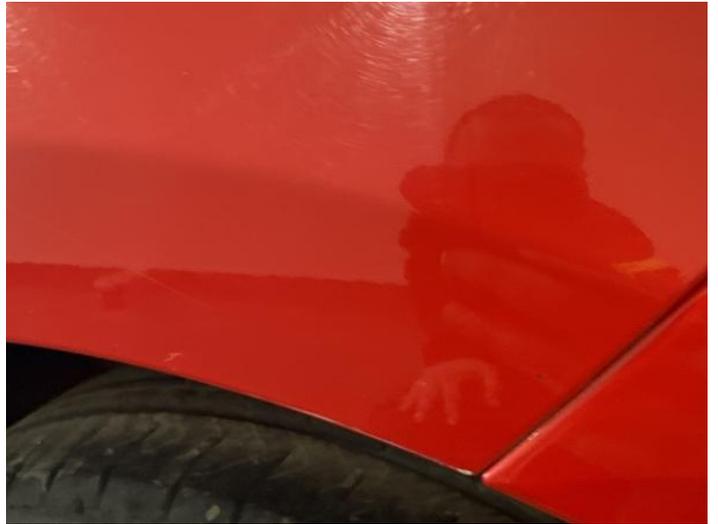
10: Qtr Panel nsr
Scratched
Up To 25mm Thru Paint

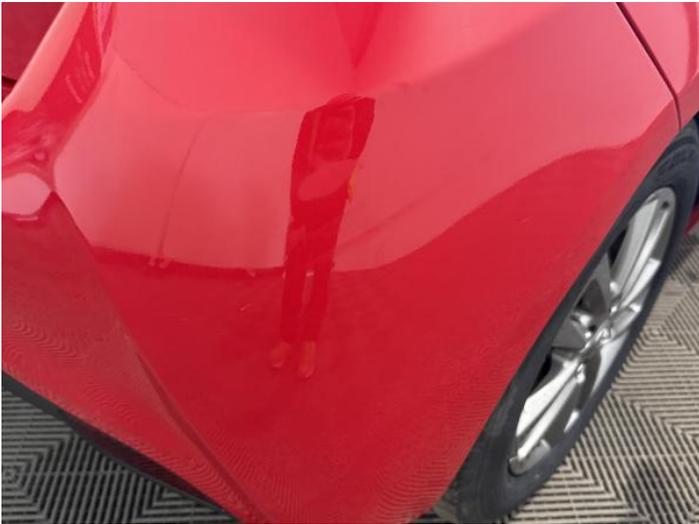
11: Bumper Rear
Scratched
Over 100mm Thru Paint

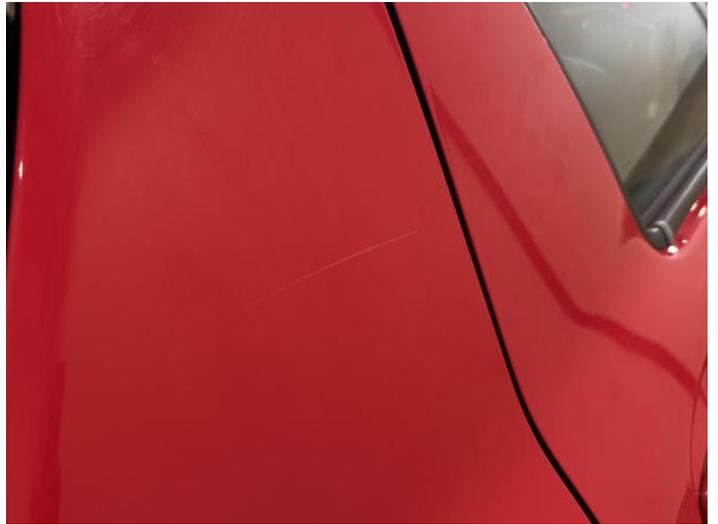
12: Qtr Panel osr
Scratched
Over 25mm Thru Paint

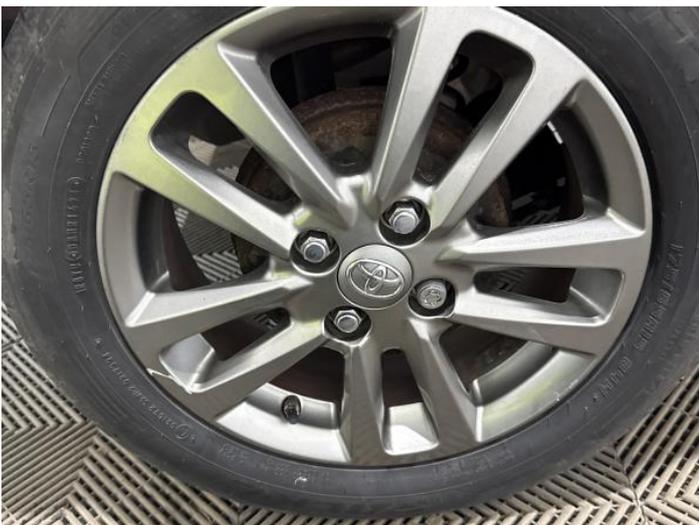
13: Wheel osr
Scratched
Up To 50mm

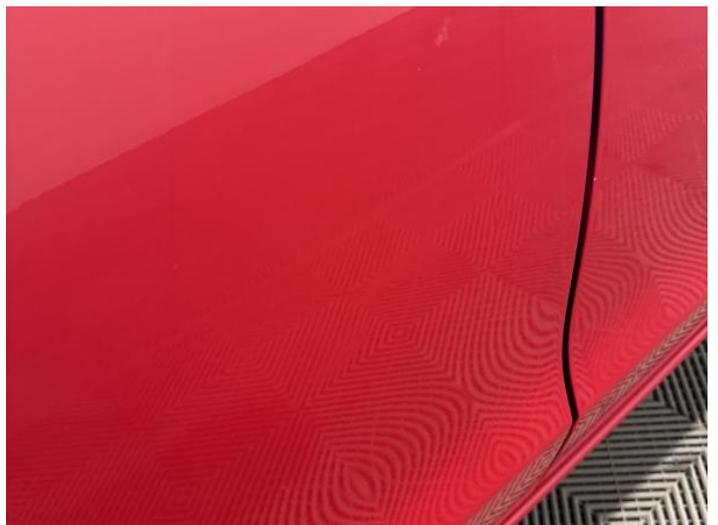
14: Door osr
Scratched
Over 25mm Thru Paint

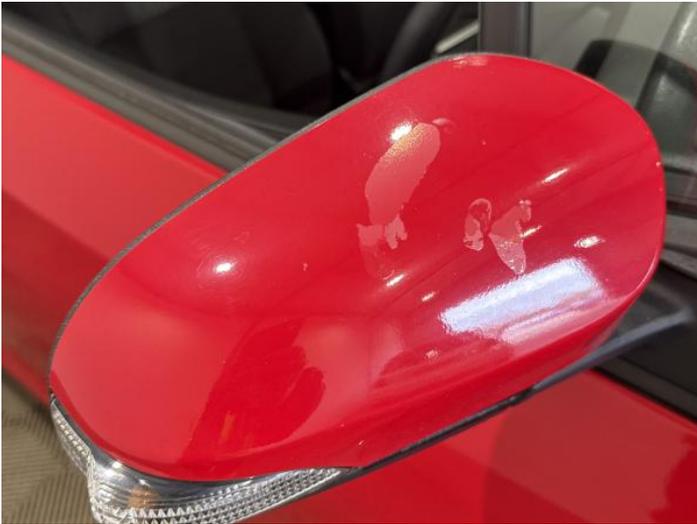
15: Door Mirror Assy osf
 Scratched (Painted)
 Over 25mm Thru Paint

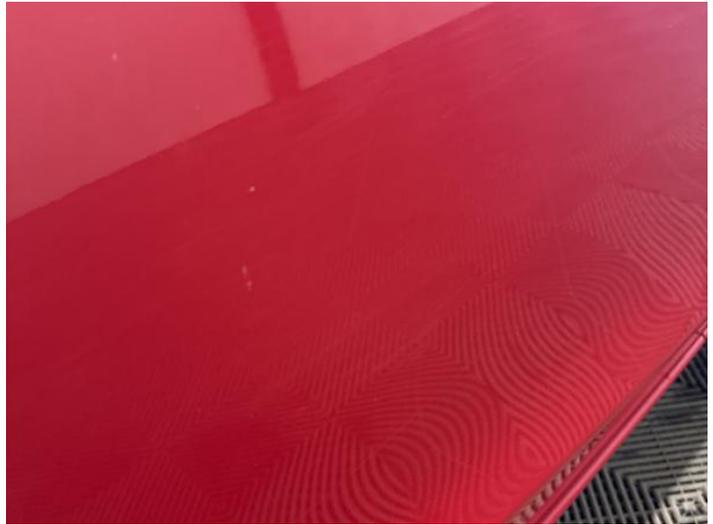
16: Door osf
 Scratched
 Over 25mm Thru Paint

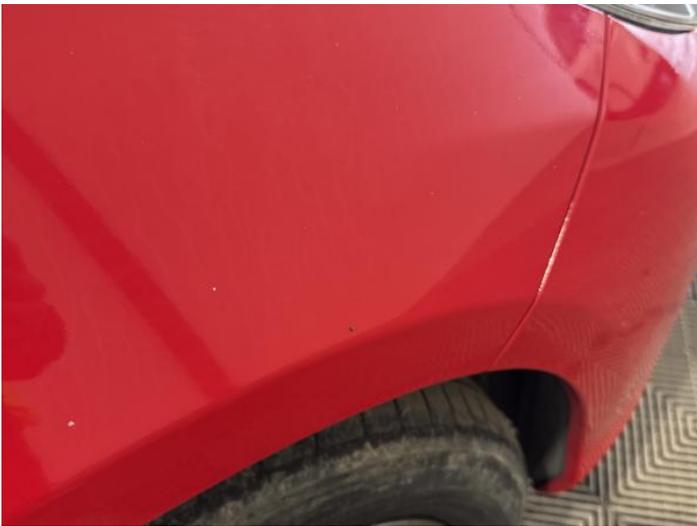
17: Wing osf
 Chipped
 1 To 5
