# VEHICLE INSPECTION REPORT

**GY67DWJ**

## Volkswagen Tiguan 2.0 TSi 180 4Motion SEL 5dr DSG

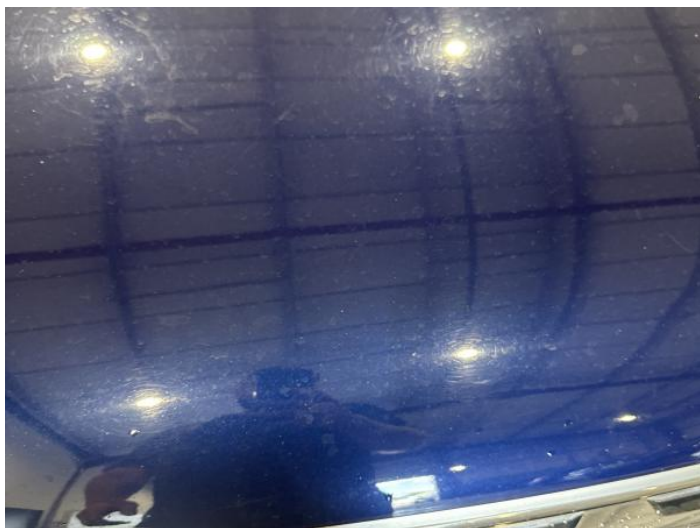
1: Bonnet  
Chipped  
1 To 5

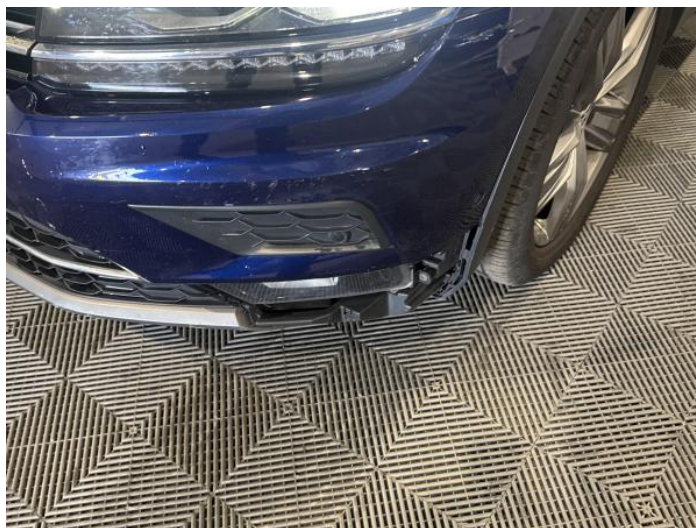
2: Bumper Front  
Scratched  
Over 100mm Thru Paint

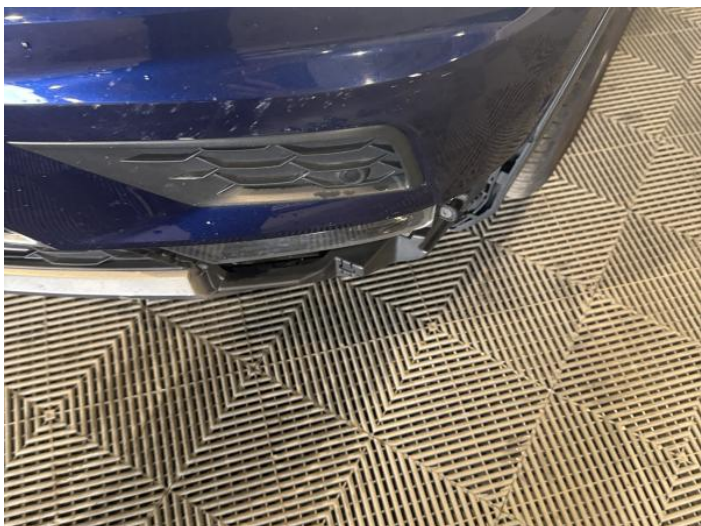
3: Bumper Front Moulding  
Broken  
Replace

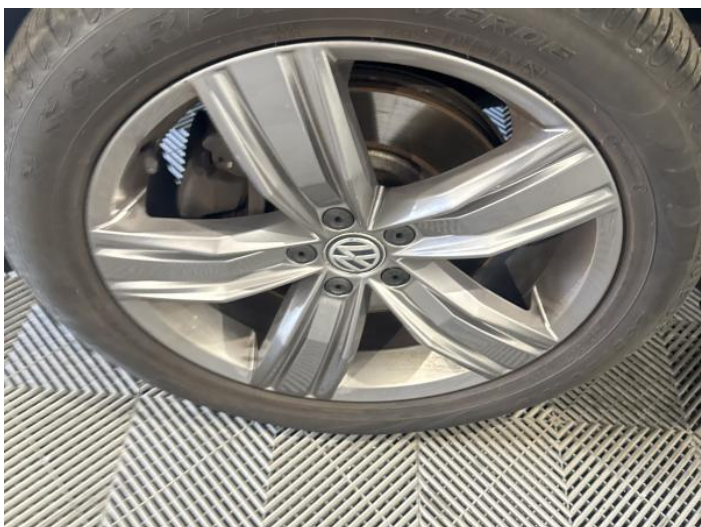
5: Wheel nsf  
Scratched  
Up To 50mm

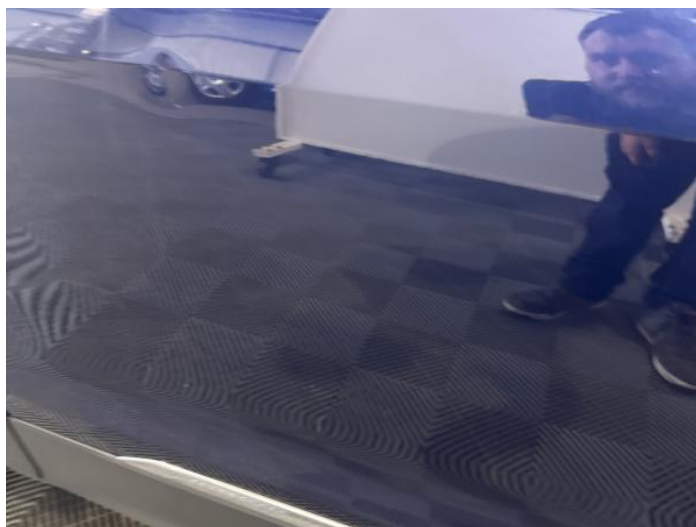
6: Door nsf  
Dented  
Over 30mm

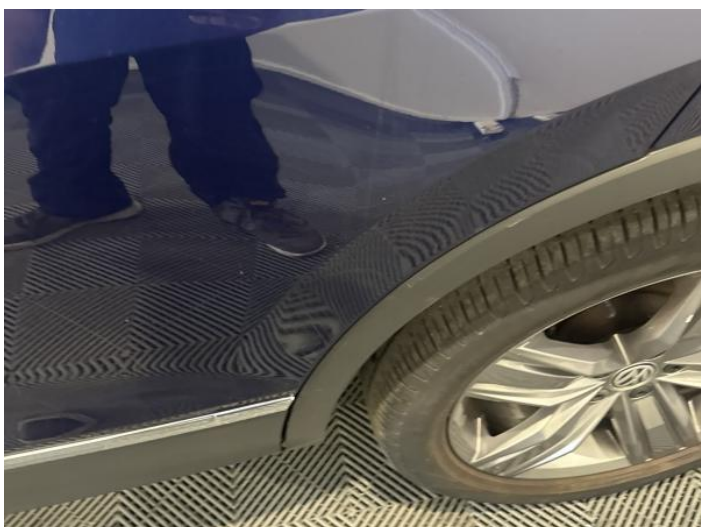
7: Door nsr  
Chipped  
1 To 5

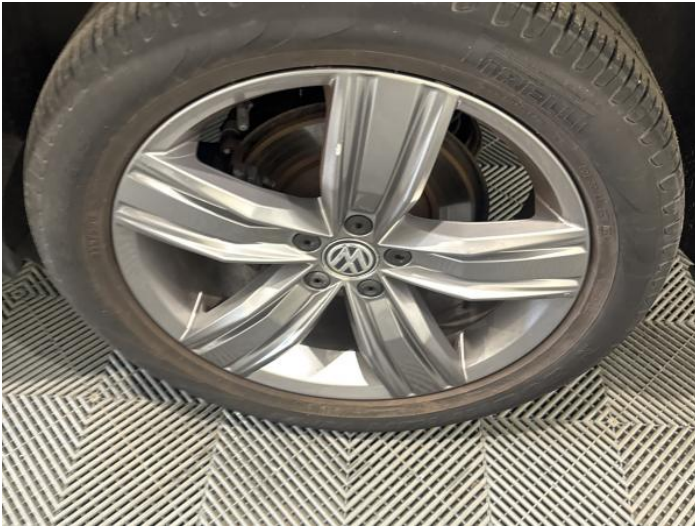
9: Wheel nsr  
Scratched  
Over 50mm

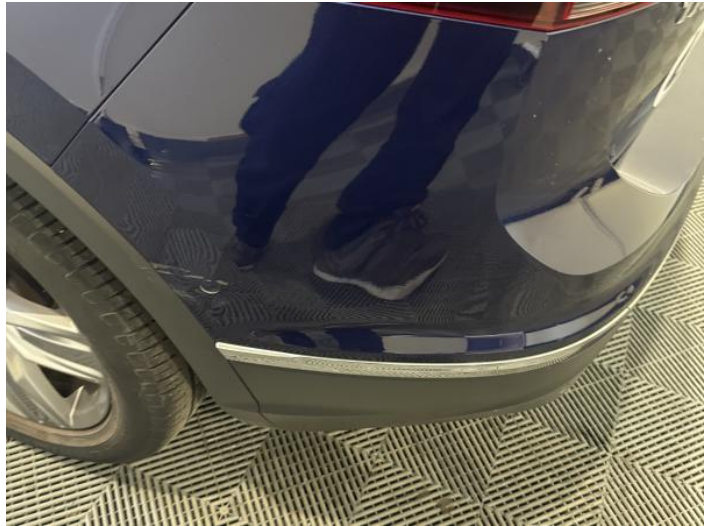
10: Bumper Rear  
Scratched  
Over 100mm Thru Paint

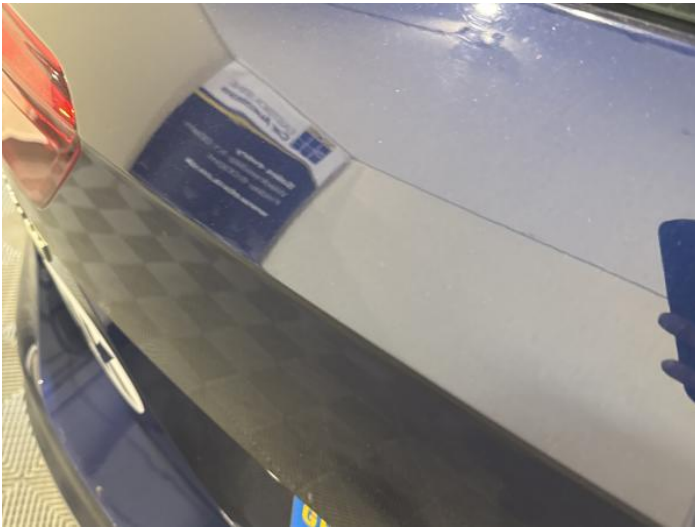
11: Boot Lid  
Dented  
Over 2 UpTo 10mm

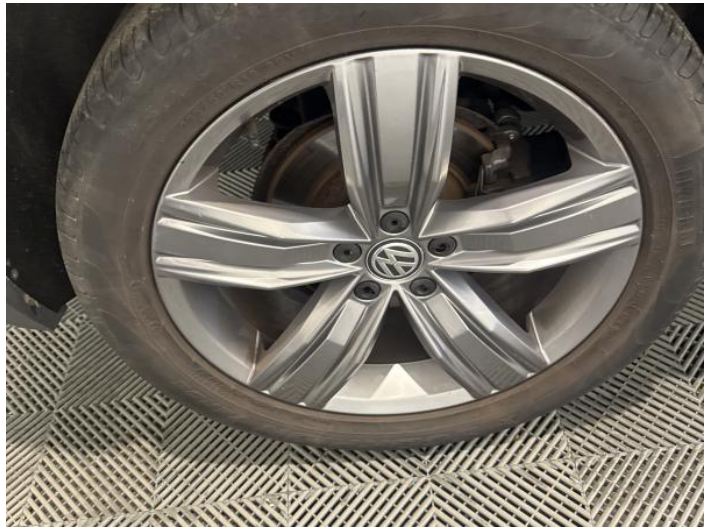
12: Wheel osr  
Scratched  
Up To 50mm

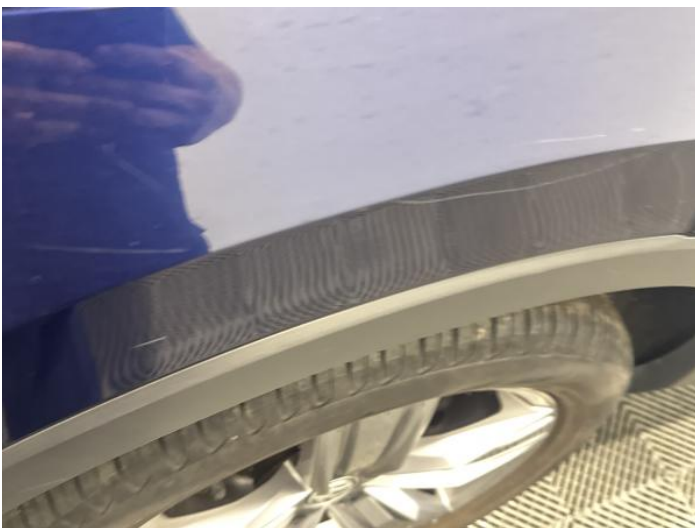
13: Qtr Panel osr  
Scratched  
Over 25mm Thru Paint

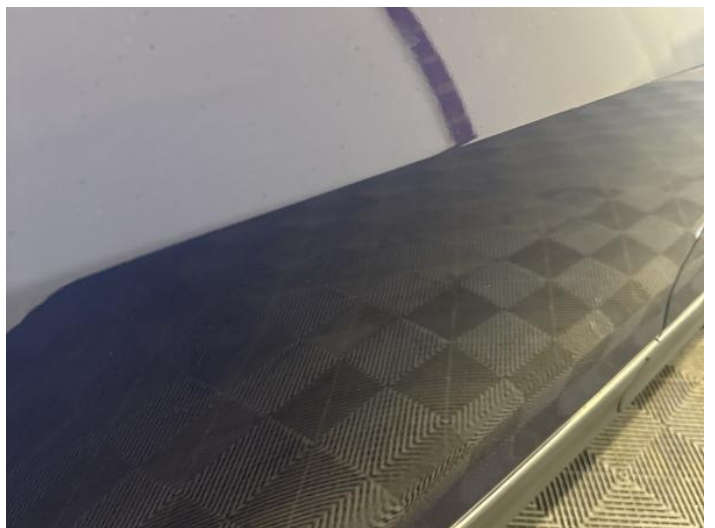
14: Door osr  
Dented  
Over 30mm

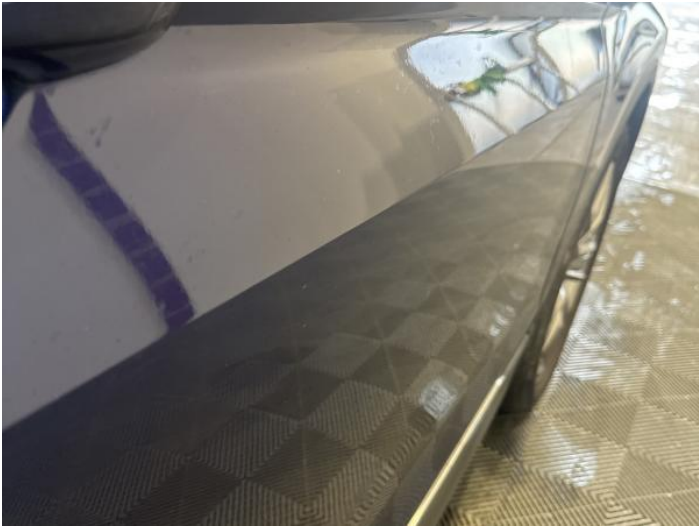
15: Door osf  
Dented  
Over 2 UpTo 10mm

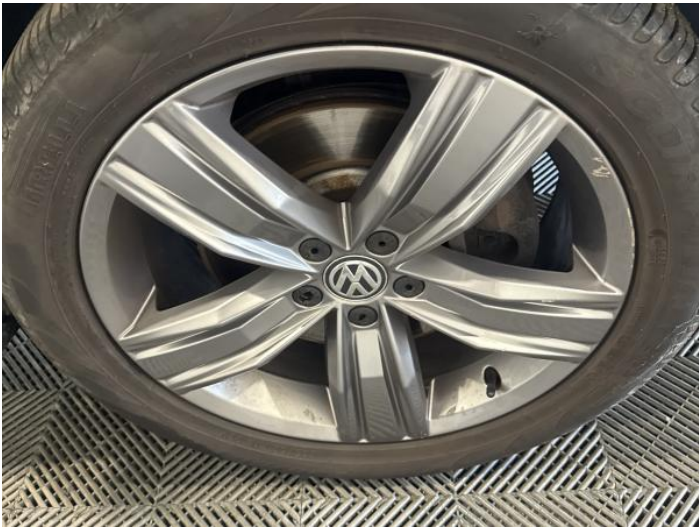
17: Wheel osf  
Scratched  
Over 50mm
