VEHICLE INSPECTION REPORT

YC57MHY

BMW 3 Series 318i SE 4dr

nama
GRADE
4

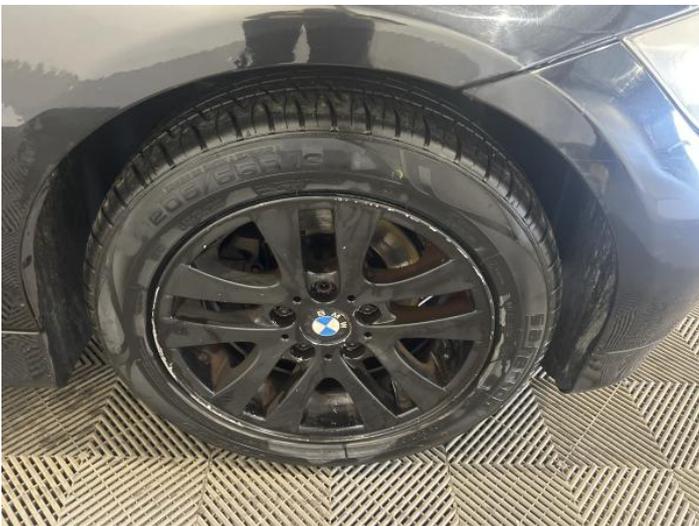
1: Wheel of
Scratched
Over 50mm

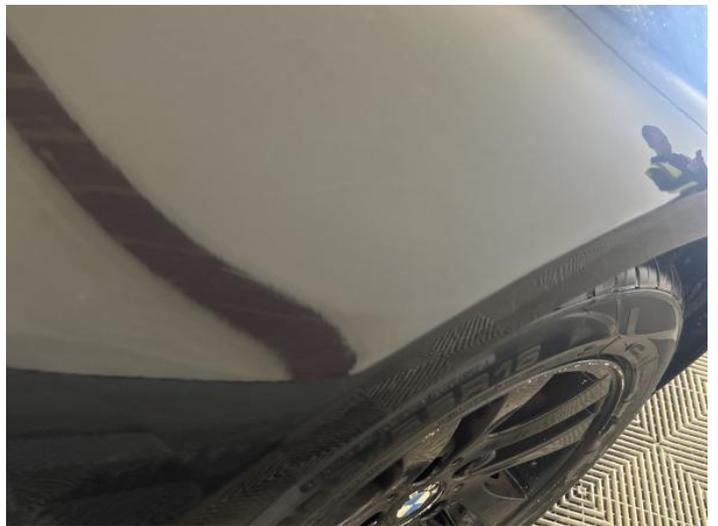
2: Wing of
Scratched
Over 25mm Not Thru Paint

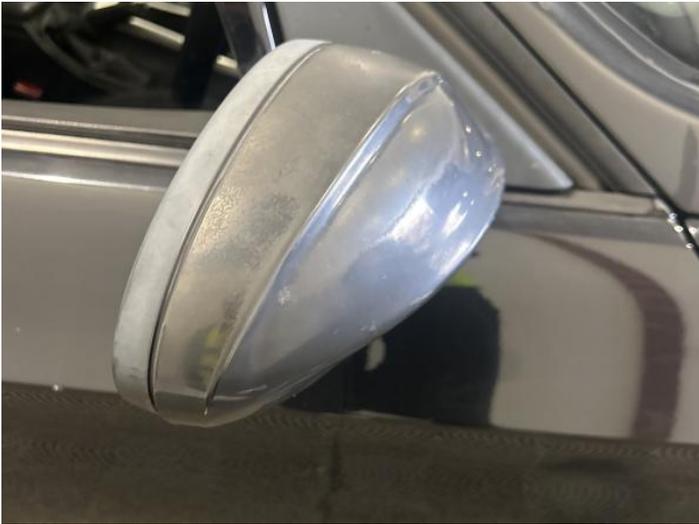
3: Door Mirror Assy osf
Scratched (Painted)
Over 25mm Thru Paint

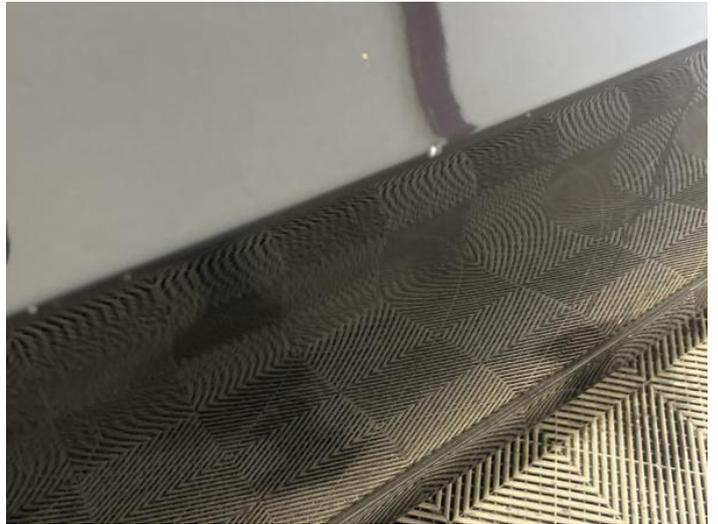
4: Door osf
Chipped
1 To 5

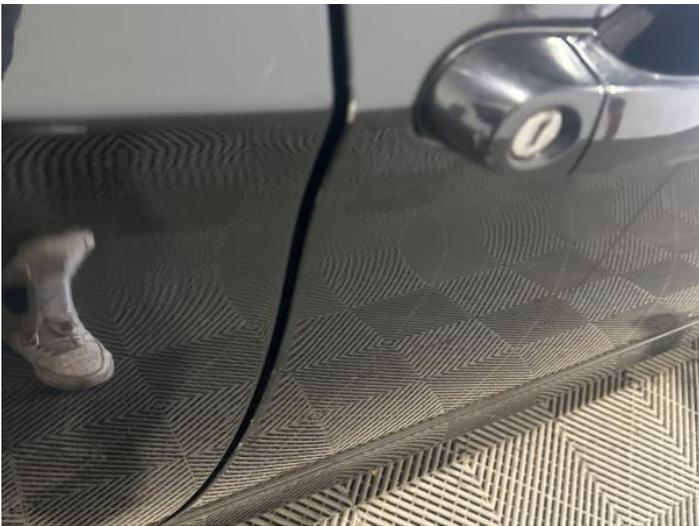
5: Door osf
Chipped
Edge Chip

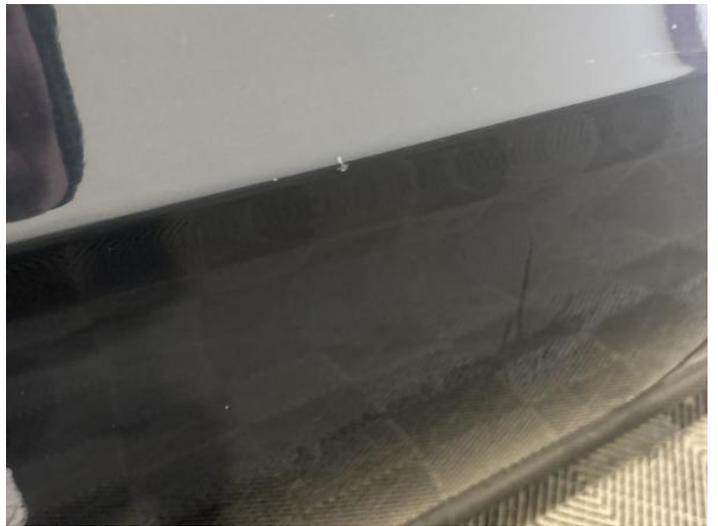
6: Door osr
Chipped
1 To 5

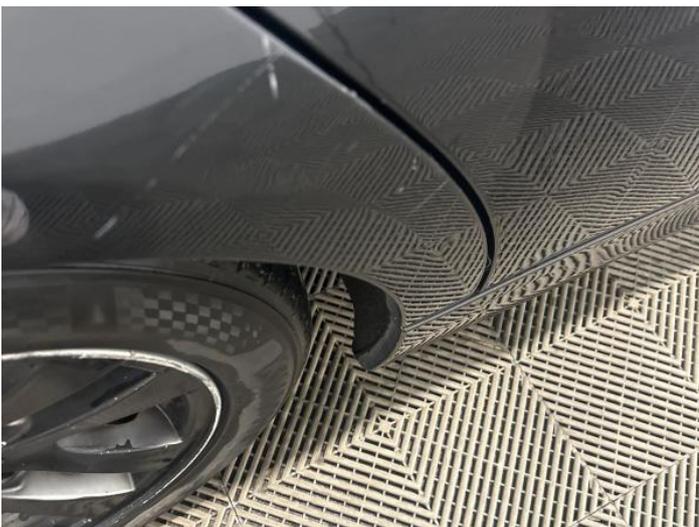
7: Qtr Panel osr
Scratched
Over 25mm Thru Paint

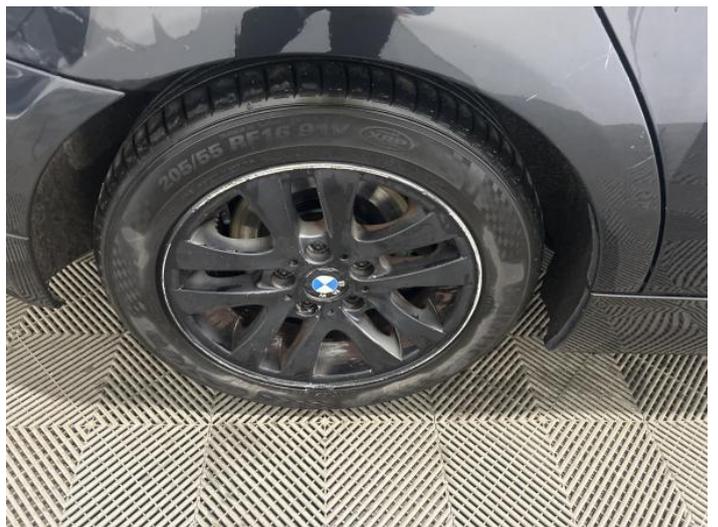
8: Wheel osr
Scratched
Over 50mm

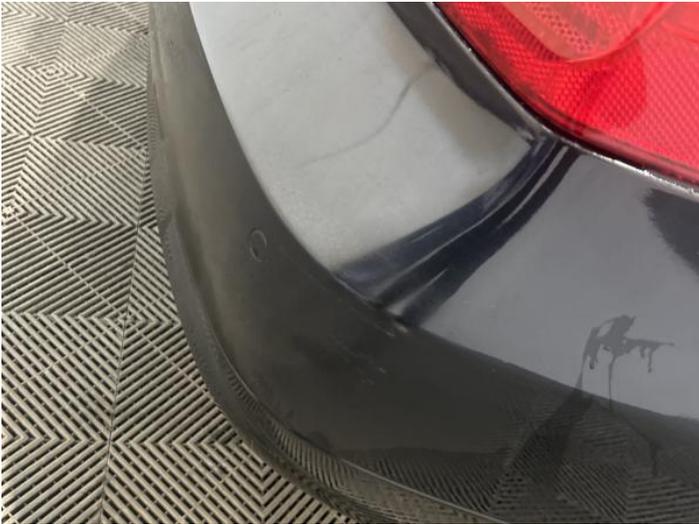
9: Bumper Rear
Poor Previous Repair
Poor Paint

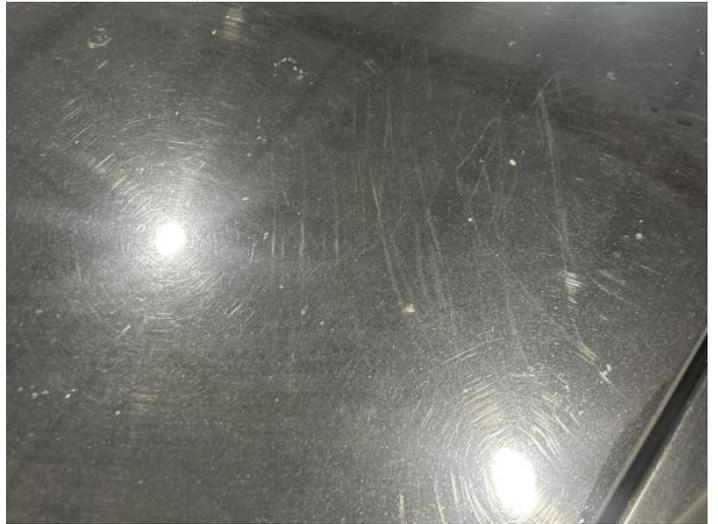
10: Tailgate
Scratched
Over 25mm Not Thru Paint

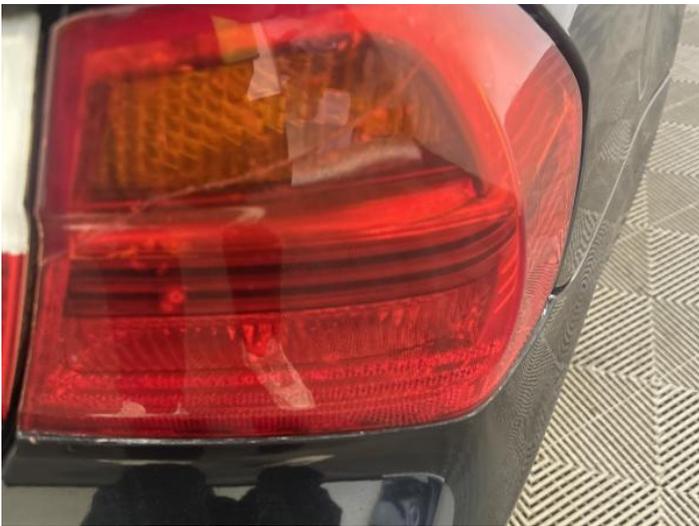
11: Lamp osr
Broken
Replace

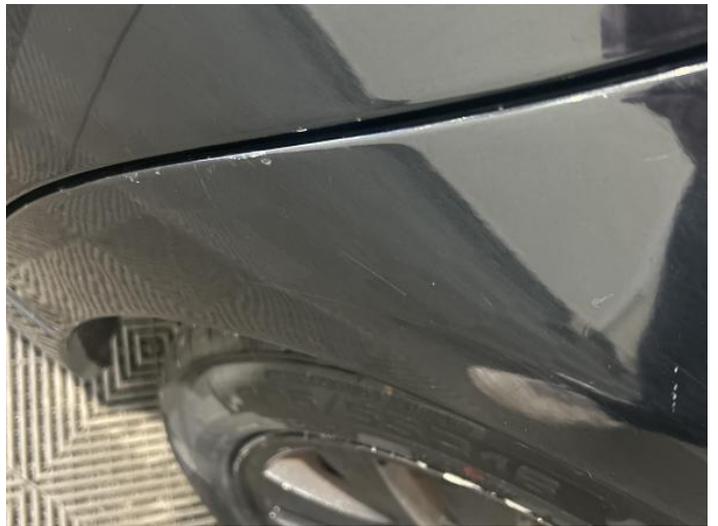
12: Qtr Panel nsr
Chipped
1 To 5

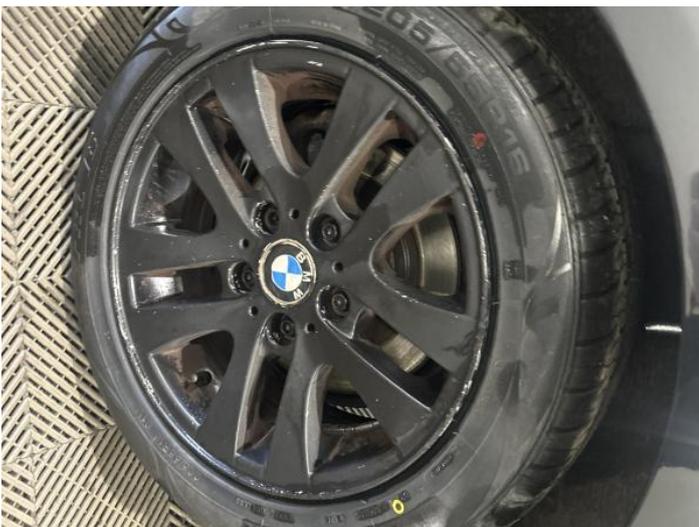
13: Wheel nsr
Scratched
Over 50mm

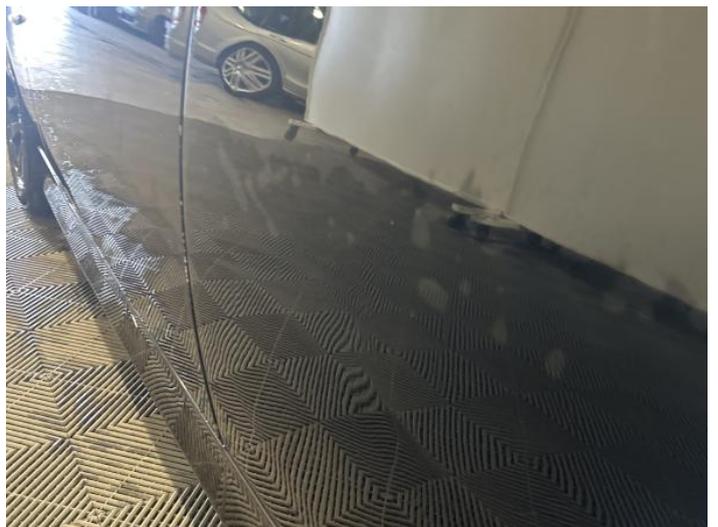
14: Door nsr
Dented
Over 30mm

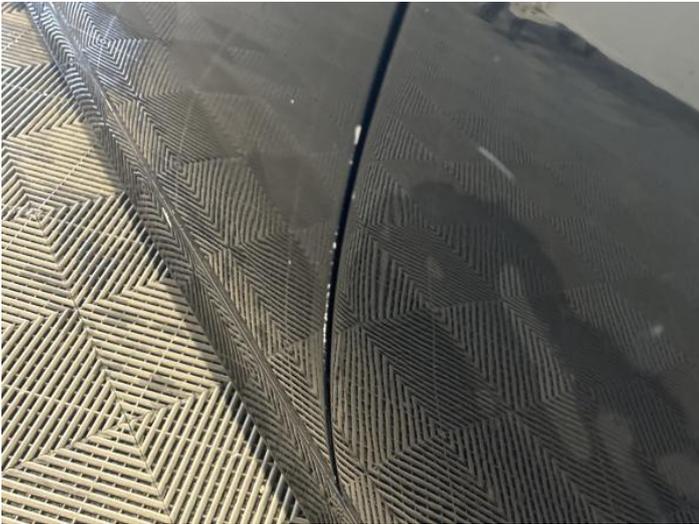
15: Door nsf
Chipped
Edge Chip

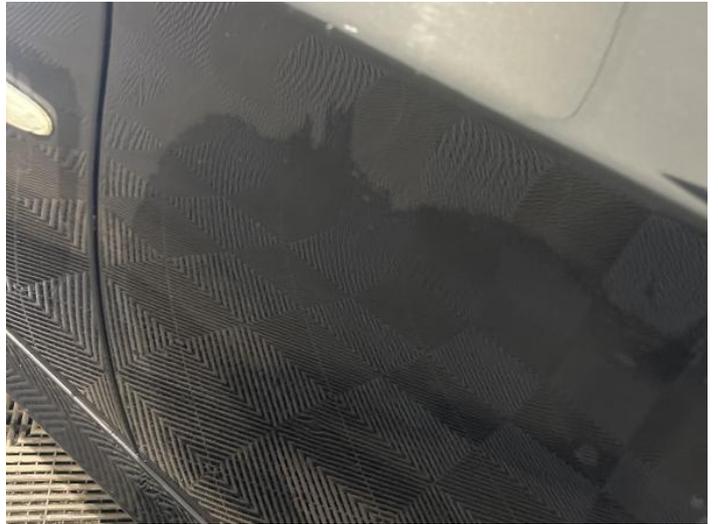
16: Door nsf
Chipped
1 To 5

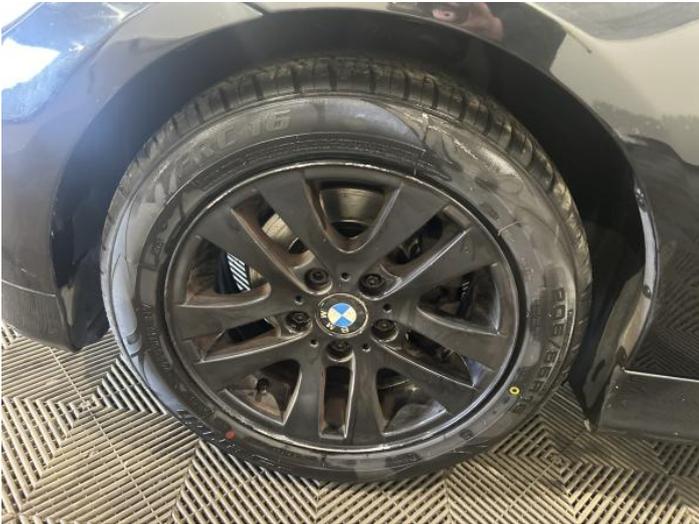
17: Wheel nsf
Scratched
Over 50mm

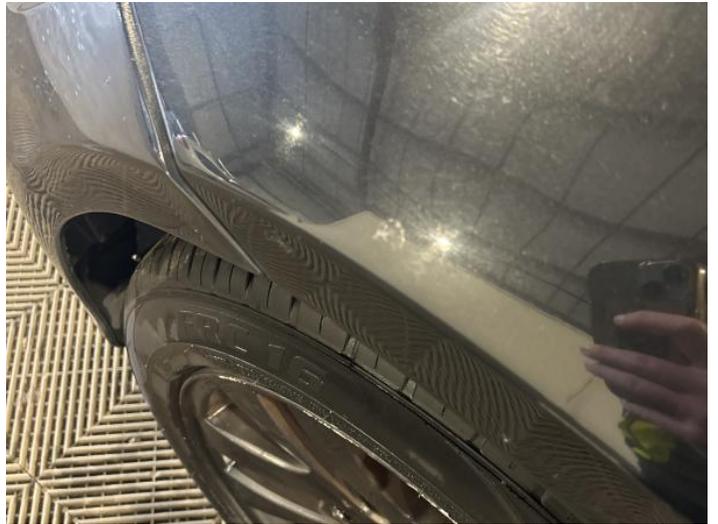
18: Wing nsf
Chipped
1 To 5

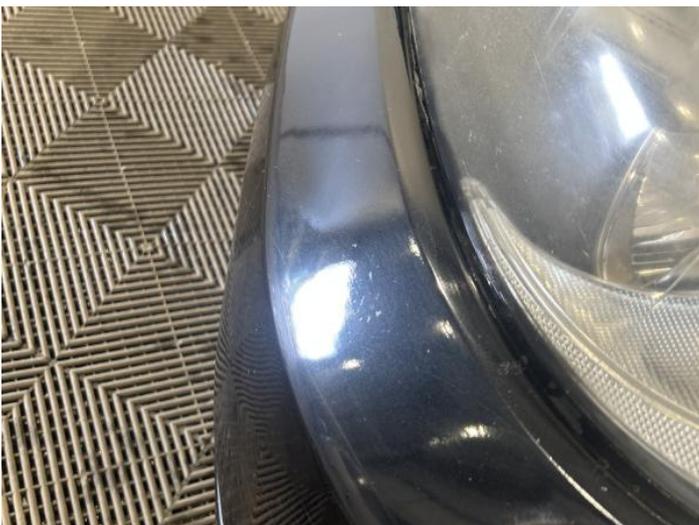
19: Bumper Front
Poor Previous Repair
Poor Paint

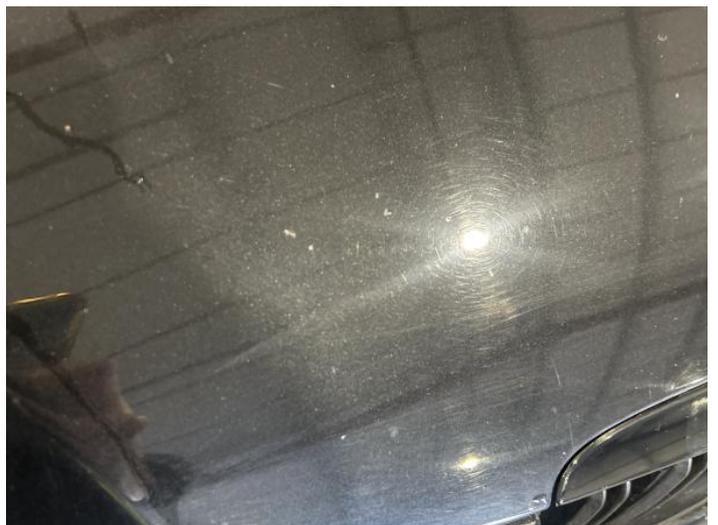
20: Bonnet
Chipped
1 To 5

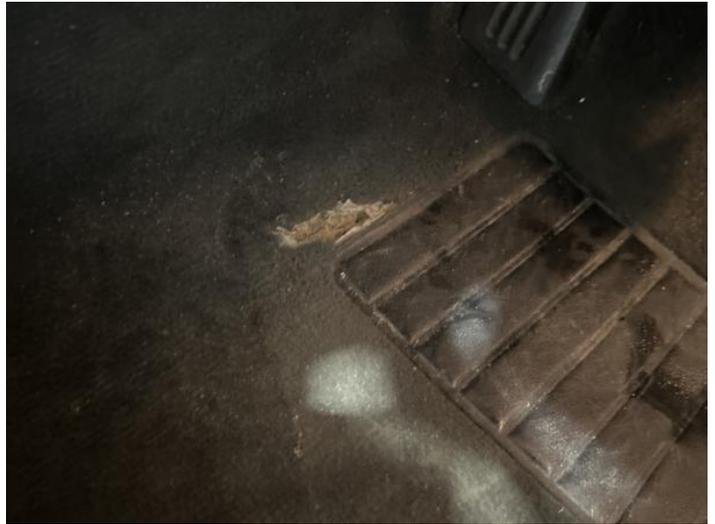
22: Carpets Front
Holed
Over 3mm
