VEHICLE INSPECTION REPORT

AF14KNJ

Dacia Sandero 1.2 16V Ambiance 5dr

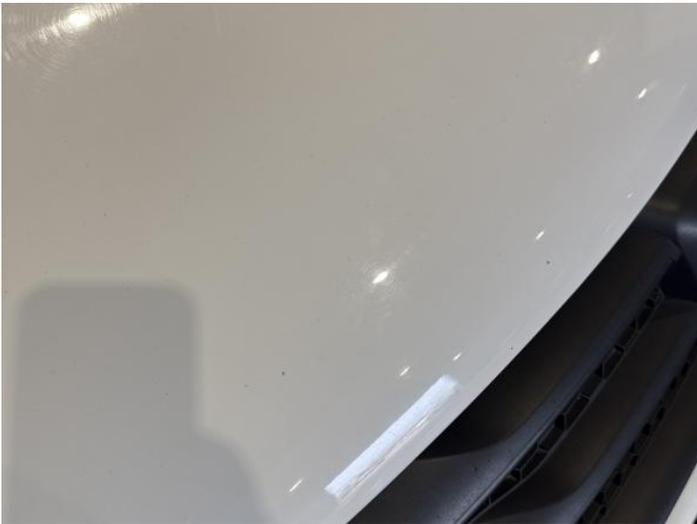
1: Bonnet
Chipped
1 To 5

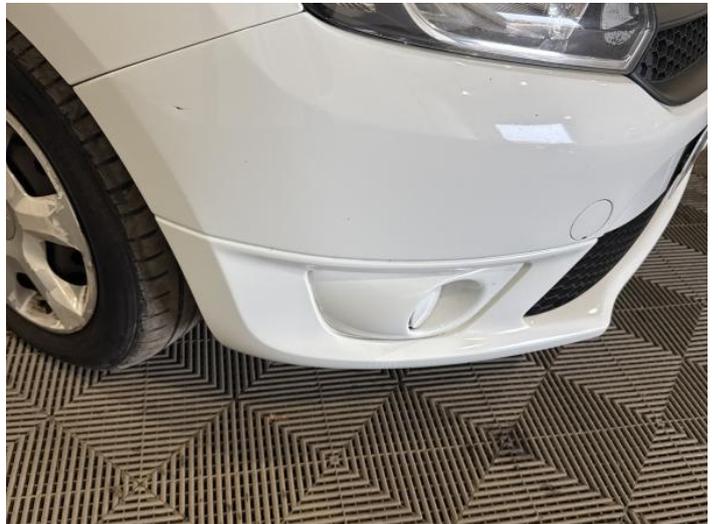
2: Bumper Front
Scratched
25 to 100mm Thru Paint

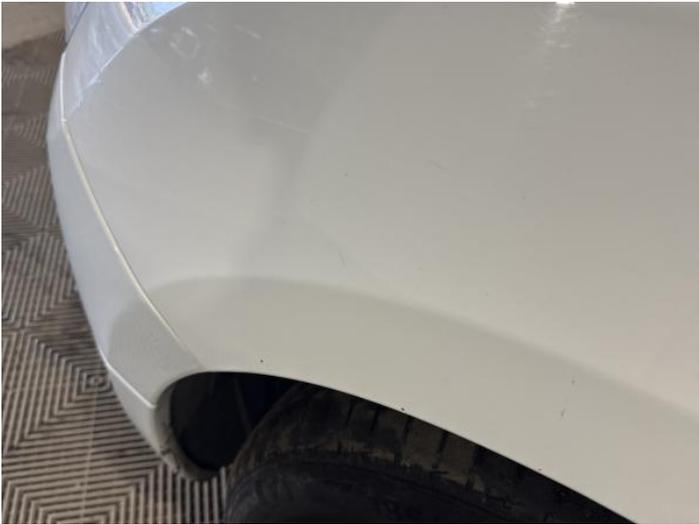
3: Wing nsf
Scratched
UpTo 25mm Thru Paint

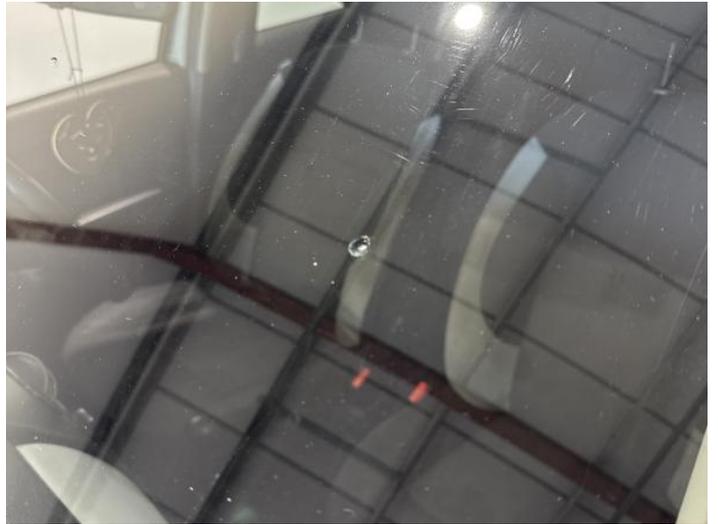
4: Screen Front
Chipped
Over 10mm

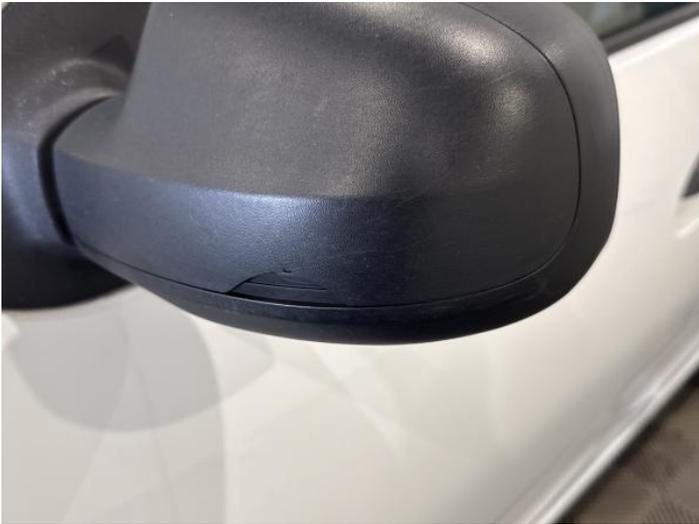
5: Door Mirror Assy nsf
Broken
Replace

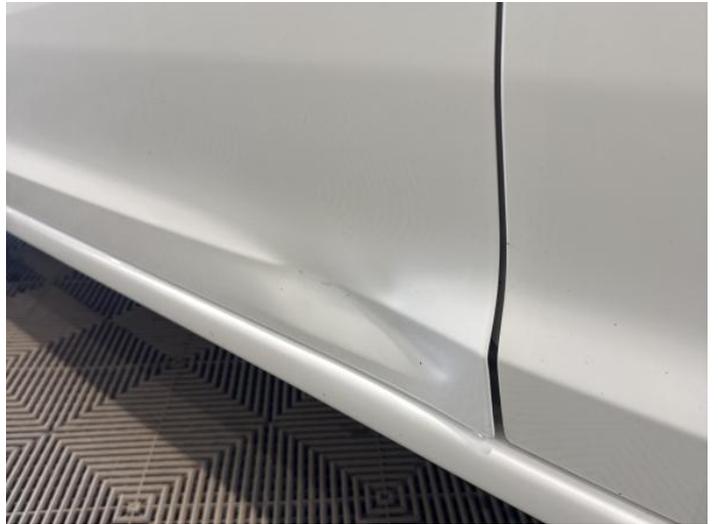
6: Door nsf
Dented
Over 30mm

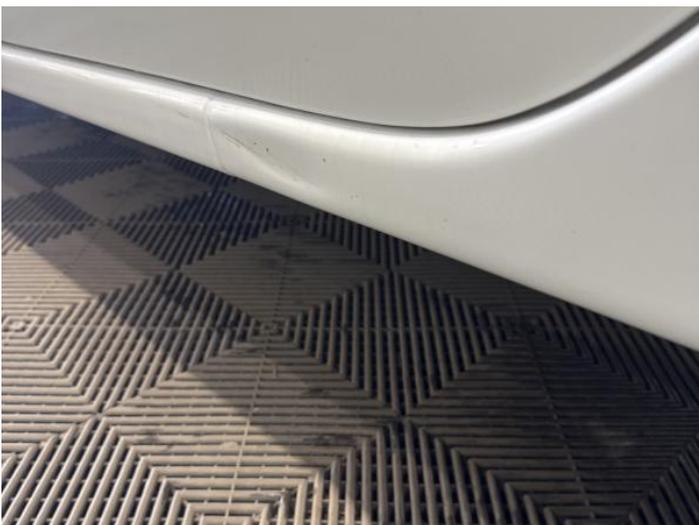
7: Sill ns
Dented
Over 30mm

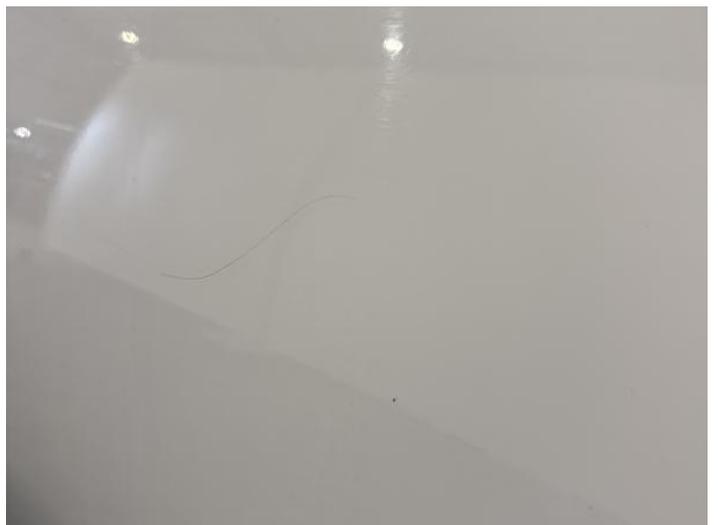
8: Door nsr
Scratched
Over 25mm Thru Paint

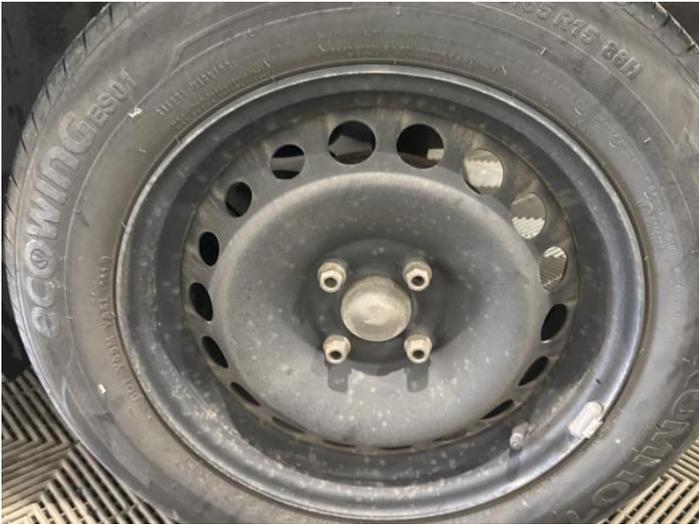
9: Wheel Trim nsr
Missing
Replace

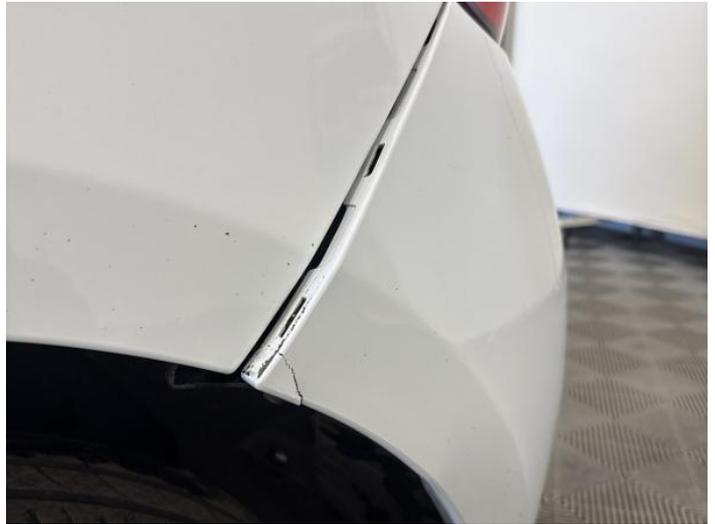
10: Bumper Rear
Cracked
UpTo 25mm

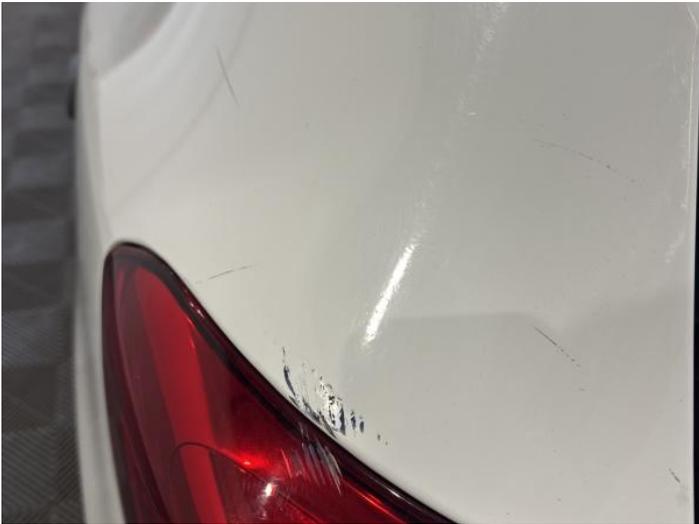
11: Qtr Panel nsr
Scratched
Over 25mm Thru Paint

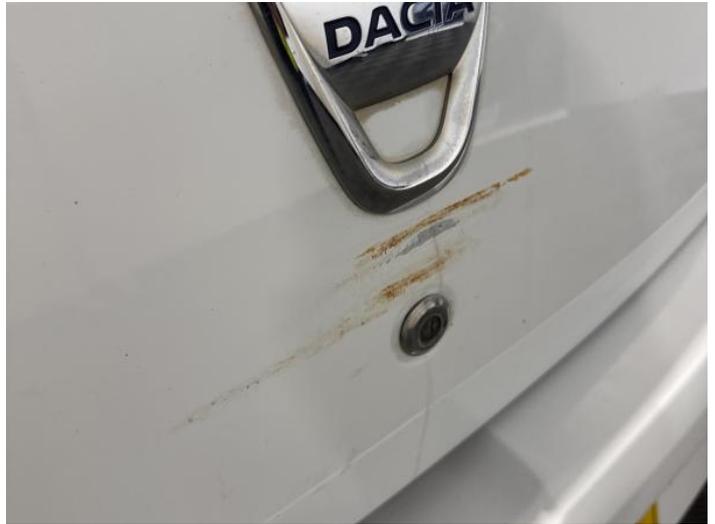
12: Tailgate
Dented
With Paint Damage

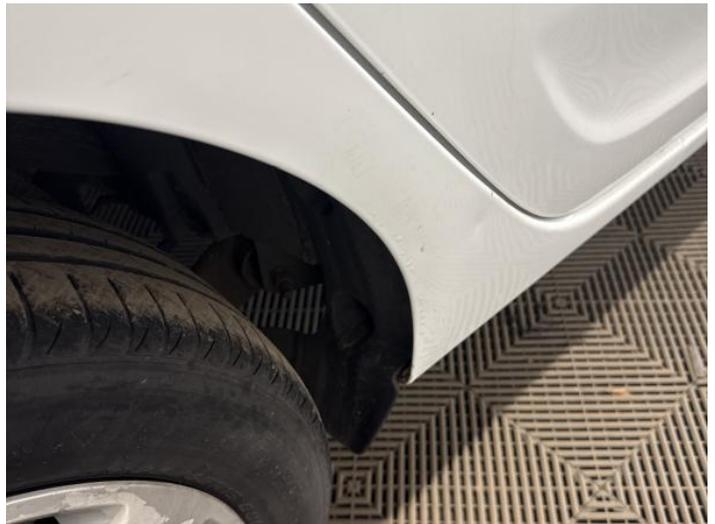
14: Qtr Panel osr
Dented
With Paint Damage

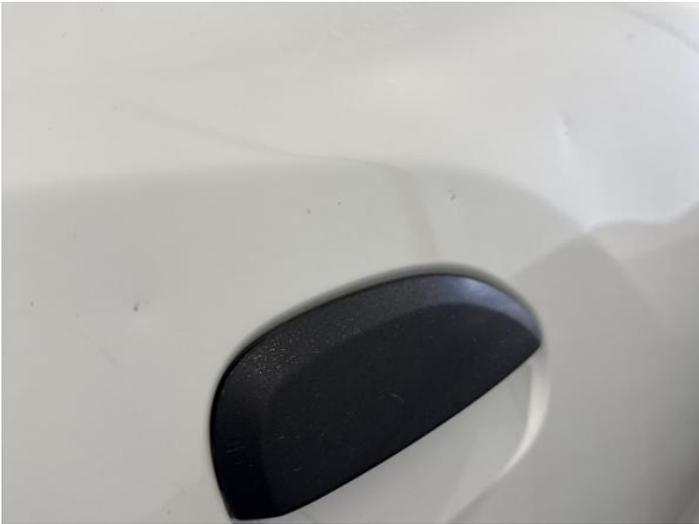
15: Door osr
Dented
Between 10mm + 30mm

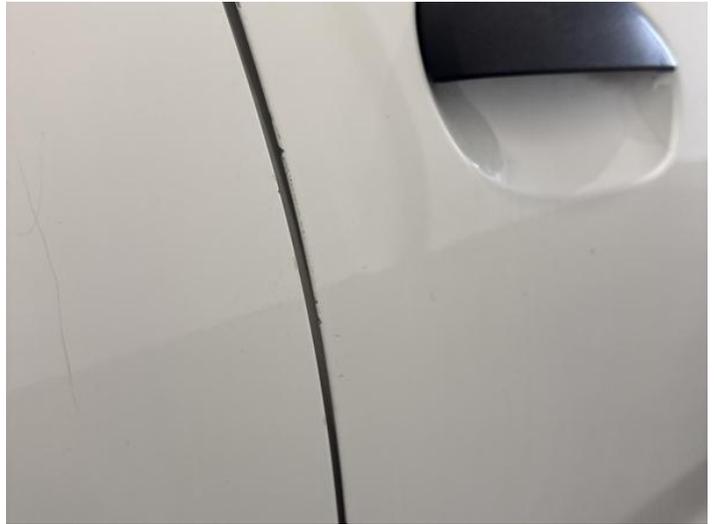
16: Door osf
Chipped
Edge Chip

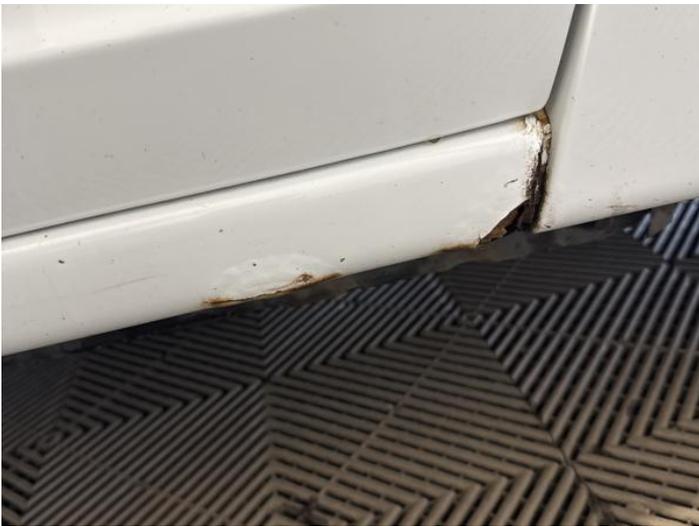
17: Sill os
Rusted
Holed

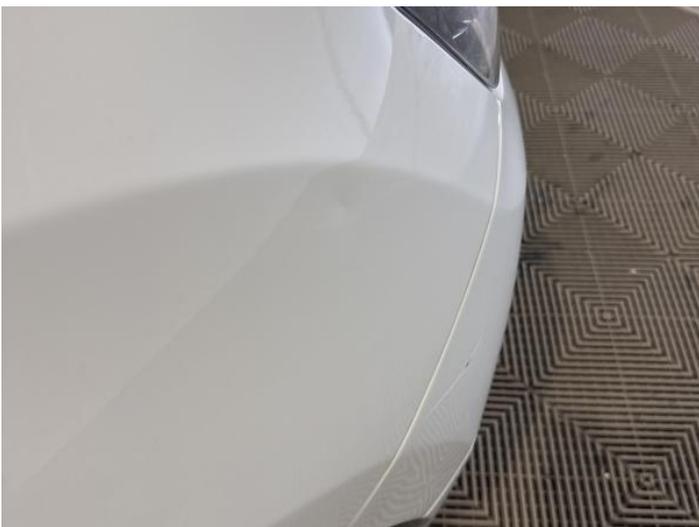
19: Wing osf
Dented
Between 10mm + 30mm

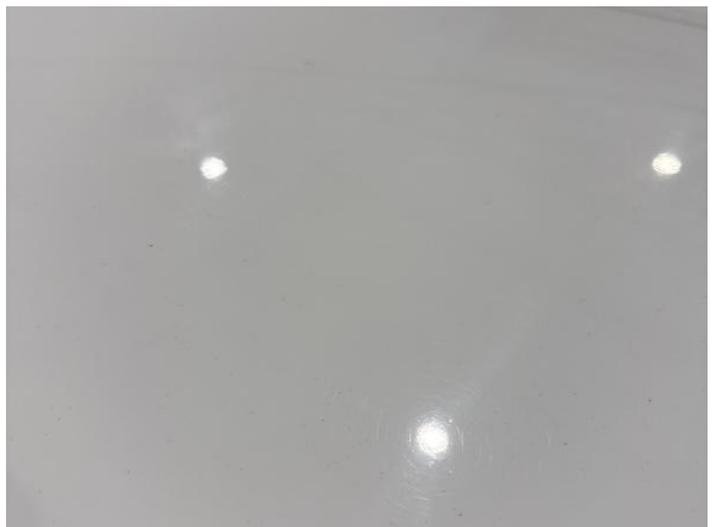
20: Roof
Dented
Over 30mm

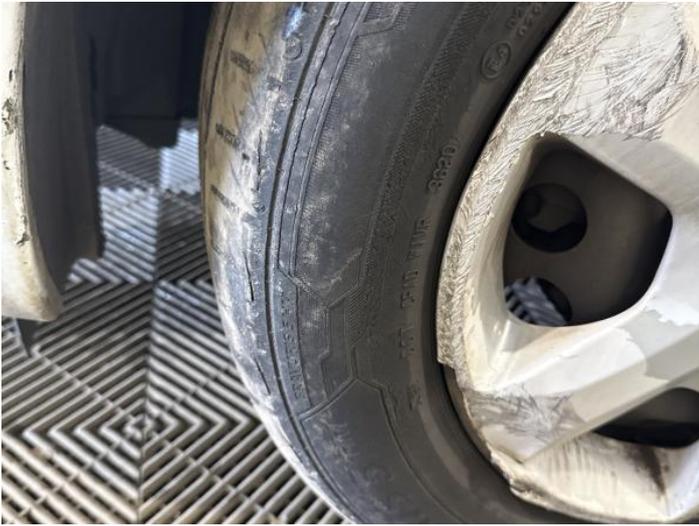
NSF	BARUM	Damaged
NSR	KUMHO	5.0mm
OSF	BARUM	2.0mm
OSR	HANKOOK	4.0mm
Spare

21: Tyre nsf
 Damaged
 Replace

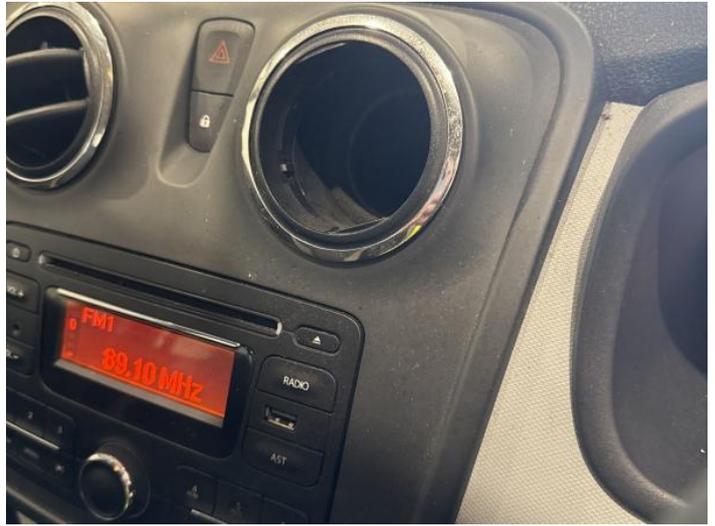
22: Air Vents osf
 Missing
 Replace
