VEHICLE INSPECTION REPORT

GX16KLF

Toyota Yaris 1.33 VVT-i Design 5dr

nama
 GRADE
3

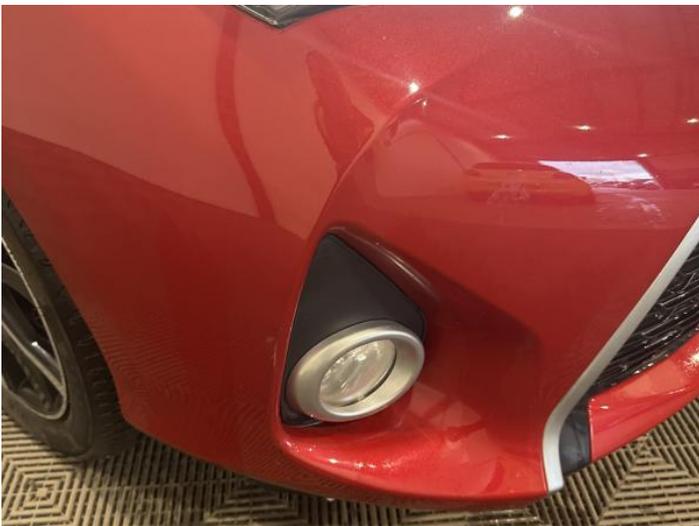
1: Bumper Front
Scratched
25 to 100mm Thru Paint

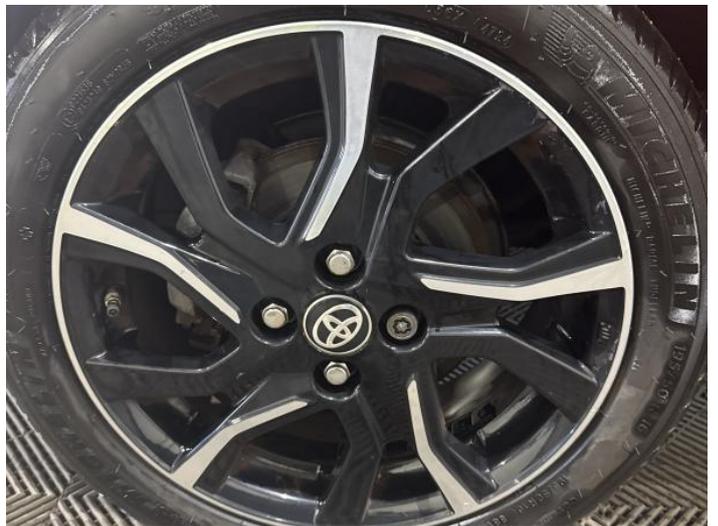
2: Wheel nsf
Scratched
Up To 50mm

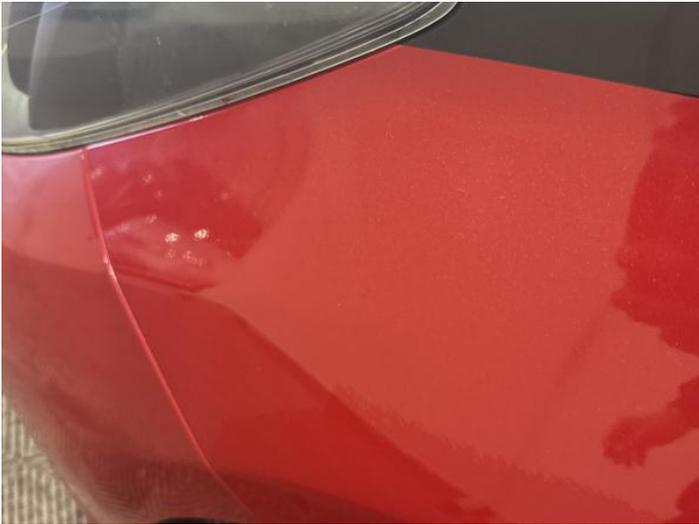
3: Wing nsf
Chipped
1 To 5

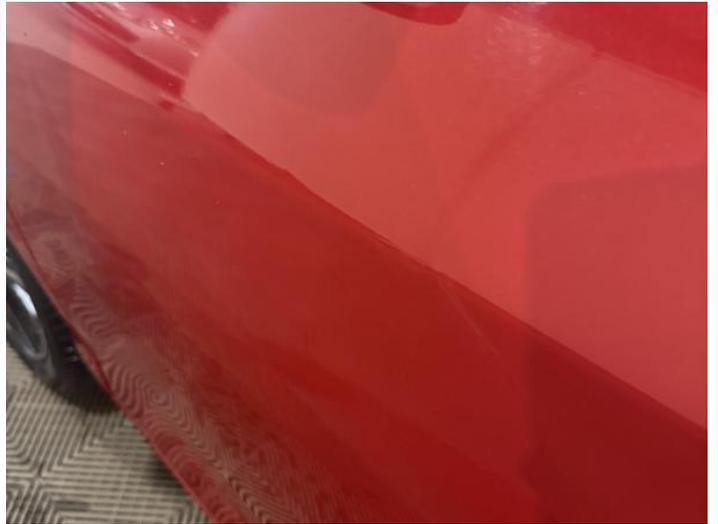
4: Door nsf
Dented
Between 10mm + 30mm

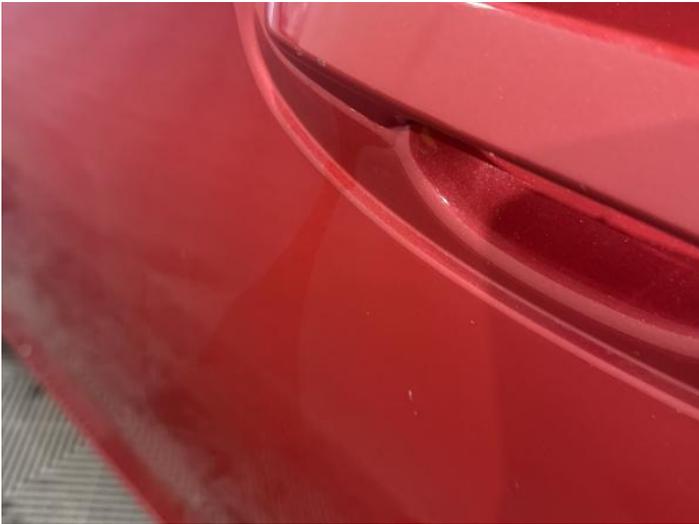
5: Door nsf
Scratched
Over 25mm Thru Paint

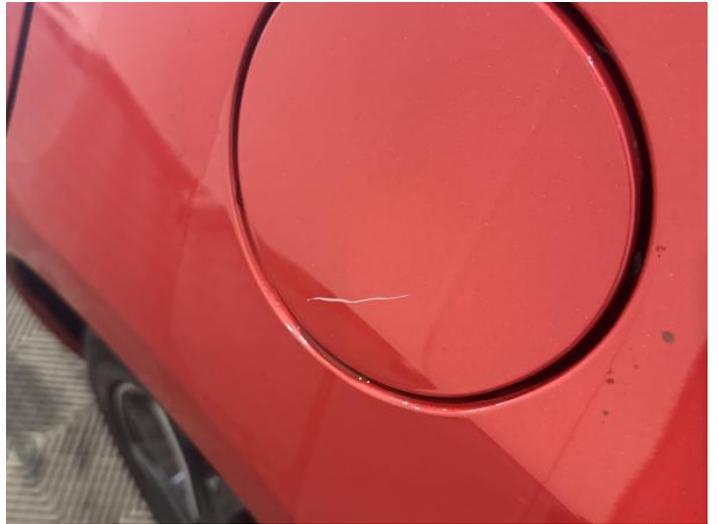
6: Qtr Panel nsr
Scratched
Over 25mm Thru Paint

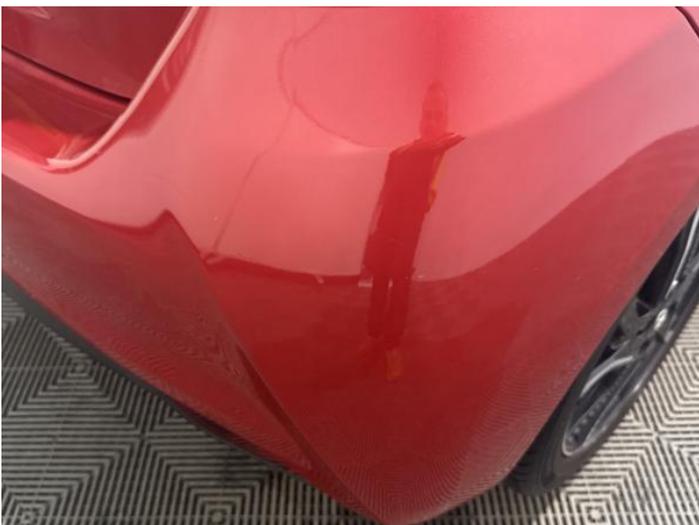
7: Bumper Rear
Scratched
25 to 100mm Thru Paint

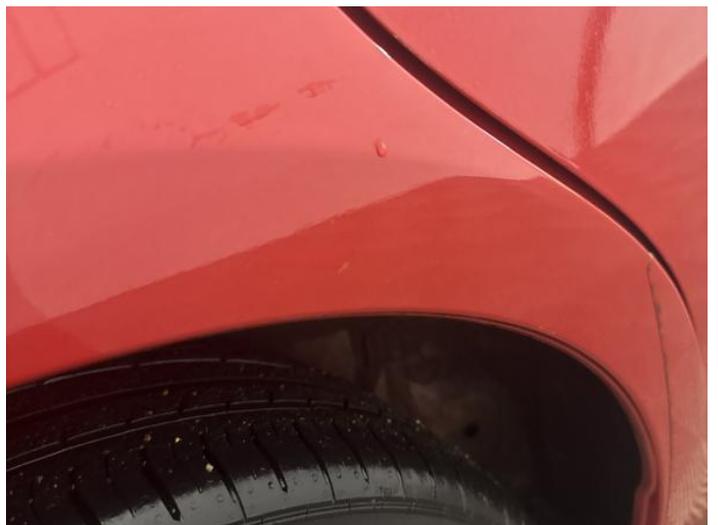
8: Qtr Panel osr
Chipped
1 To 5

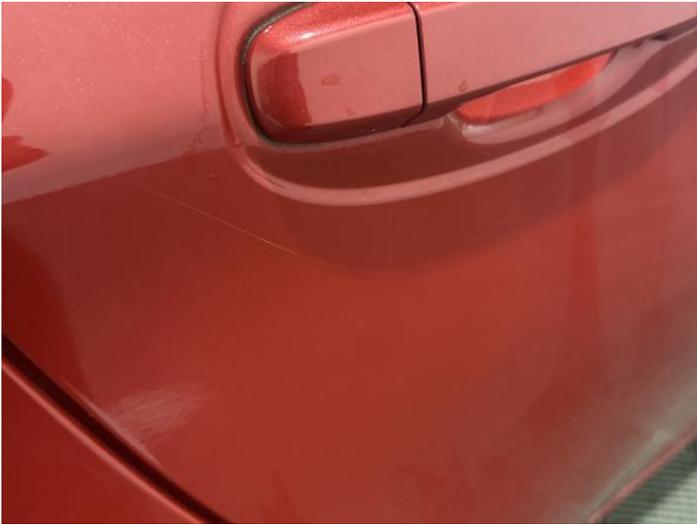
9: Door osr
 Scratched
 Over 25mm Thru Paint

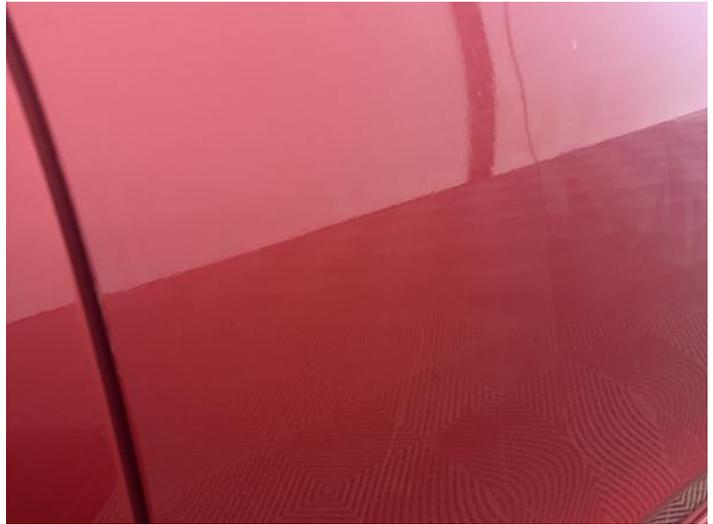
10: Door osf
 Scratched
 Over 25mm Thru Paint

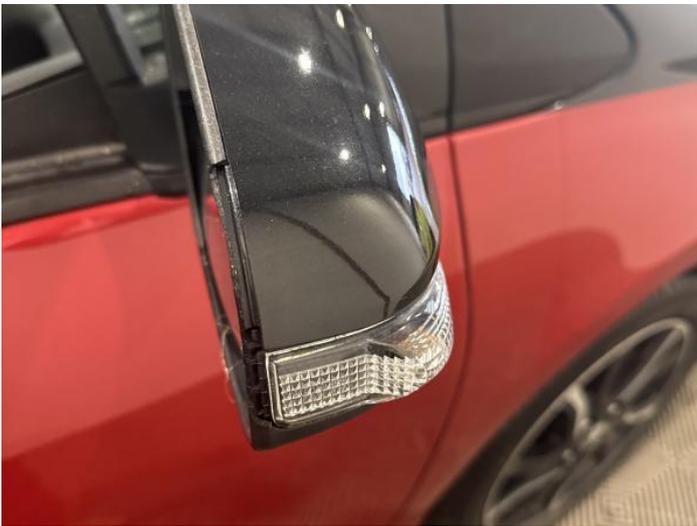
11: Door Mirror Assy osf
 Broken
 Replace

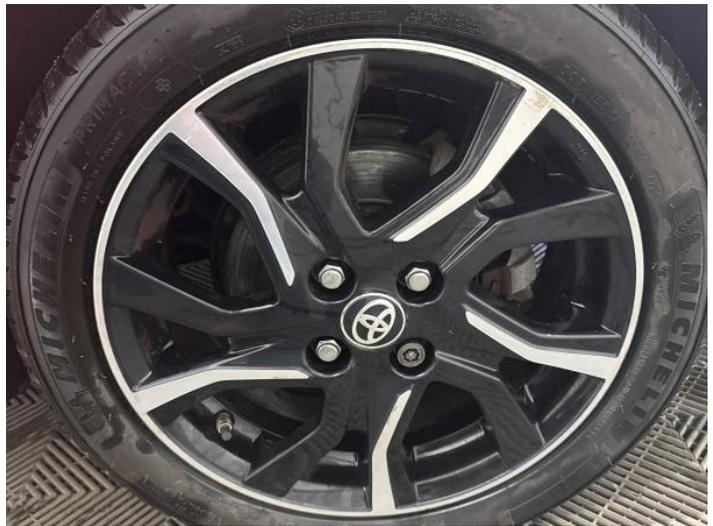
12: Wheel osf
 Scratched
 Over 50mm
