VEHICLE INSPECTION REPORT

DU66XVX

Vauxhall Corsa 1.4 ecoFLEX SRi 5dr

nama
GRADE
4

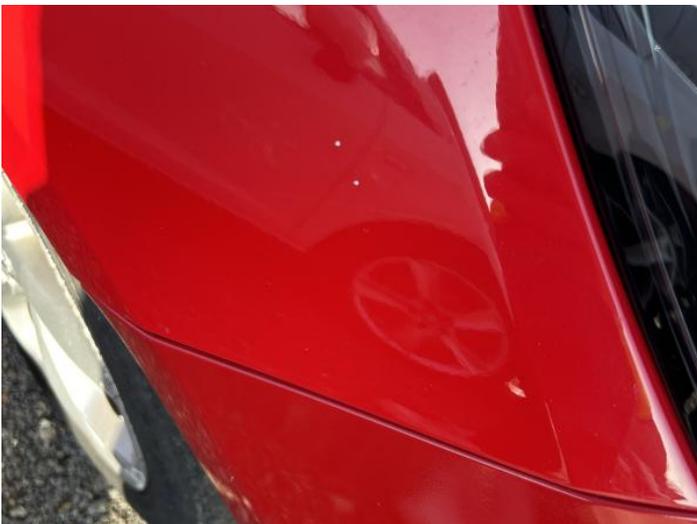
1: Wing ofsf
Chipped
1 To 5

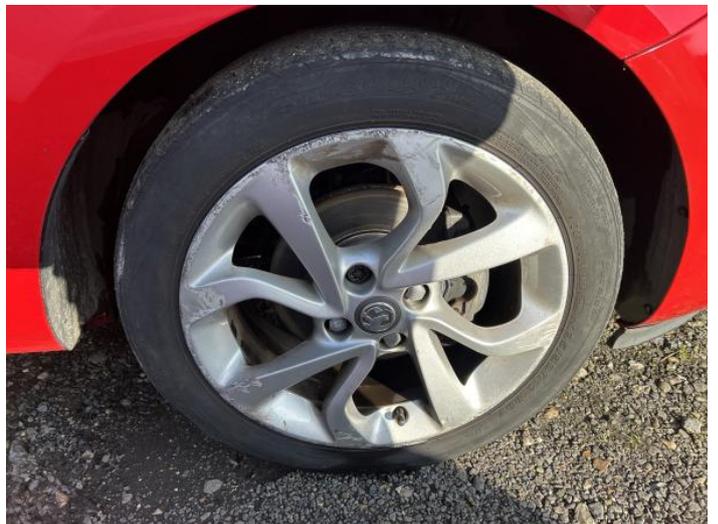
2: Wheel ofsf
Scratched
Over 50mm

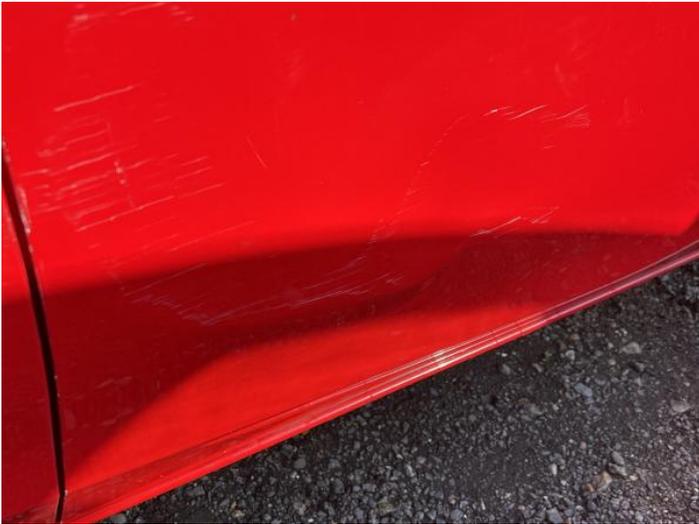
3: Door osf
Dented
With Paint Damage

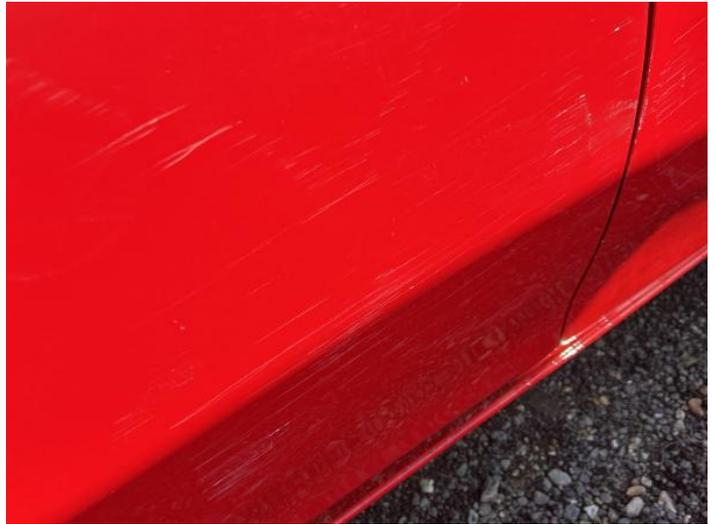
4: Door osr
Dented
With Paint Damage

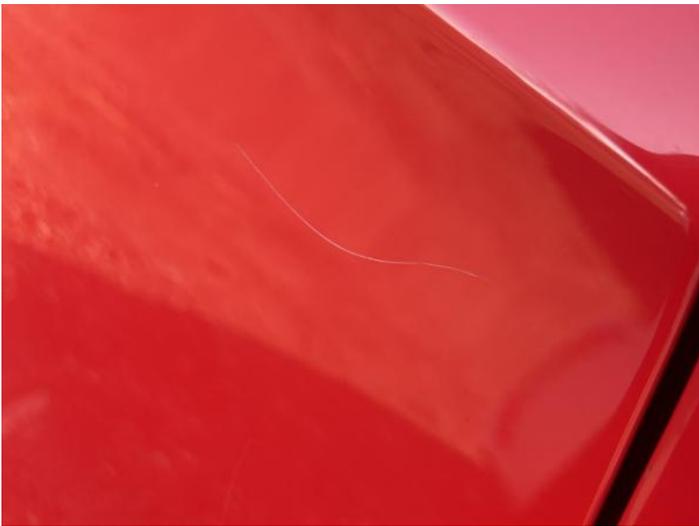
5: Qtr Panel osr
Scratched
Over 25mm Not Thru Paint

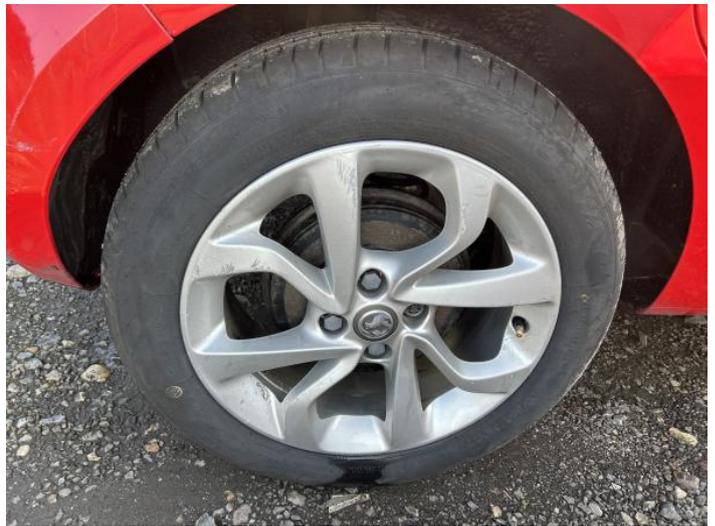
6: Wheel osr
Scratched
Over 50mm

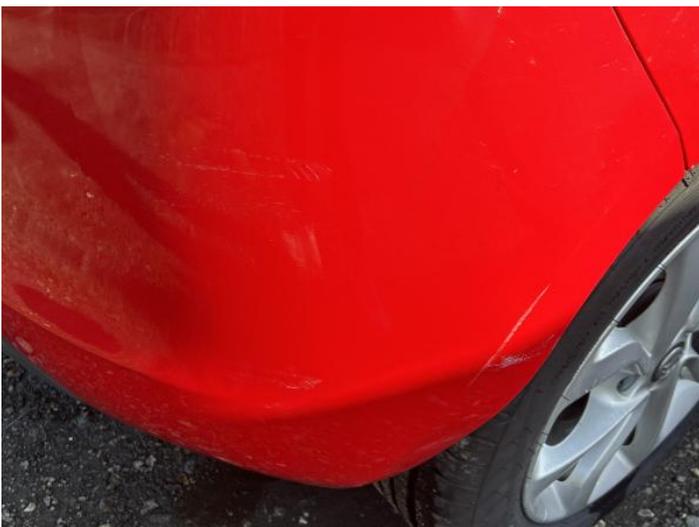
7: Bumper Rear
Scratched
Over 100mm Thru Paint

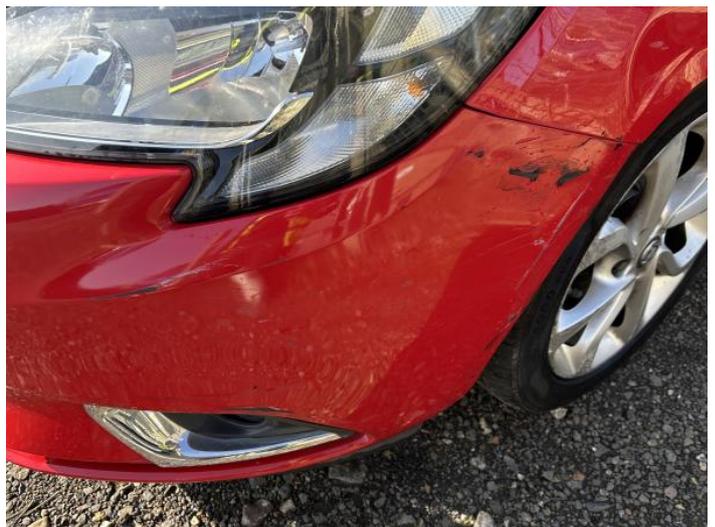
8: Bumper Front
Scratched
Over 100mm Thru Paint

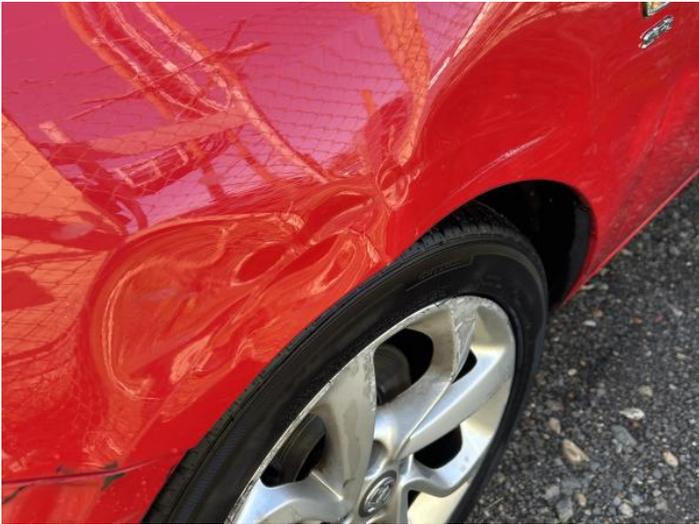
9: Wing nsf
Dented
With Paint Damage

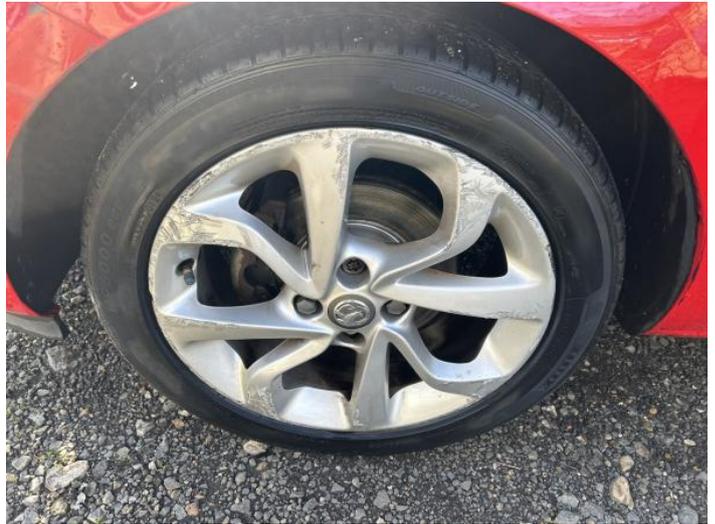
10: Wheel nsf
Scratched
Over 50mm

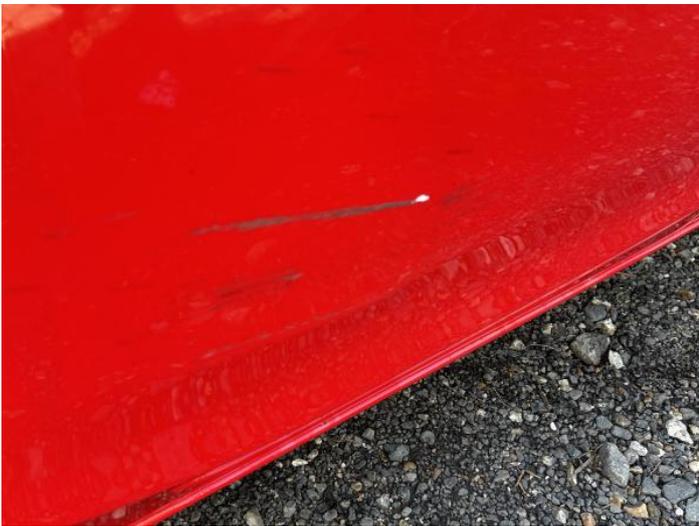
11: Door nsf
Dented
With Paint Damage

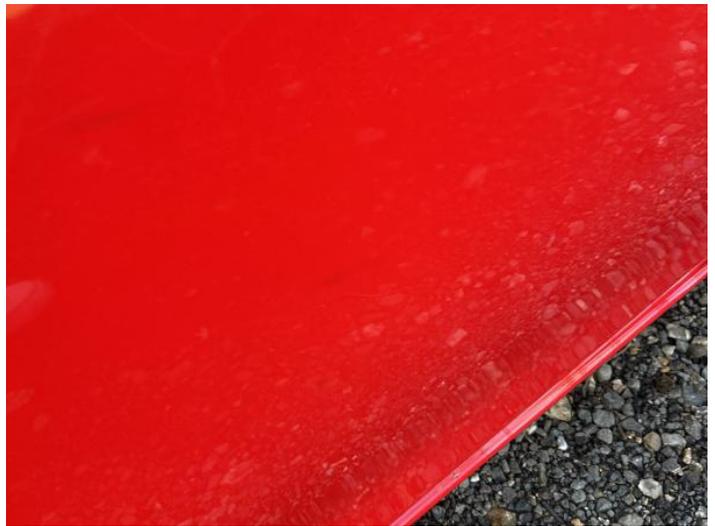
12: Door nsr
Scratched
Over 25mm Not Thru Paint

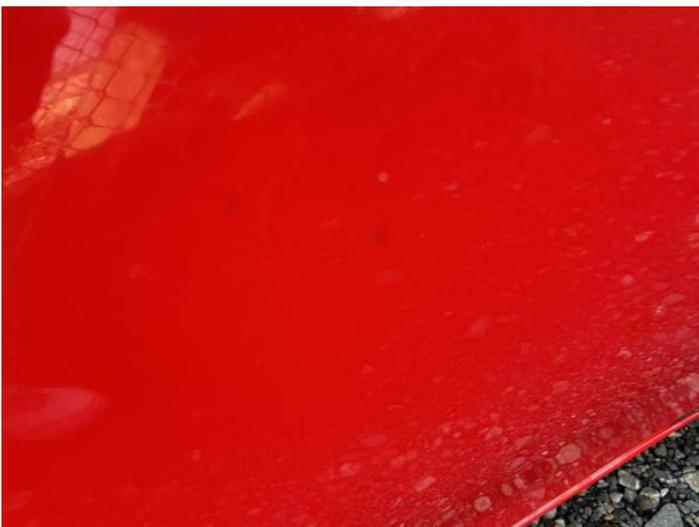
13: Door nsr
Chipped
1 To 5

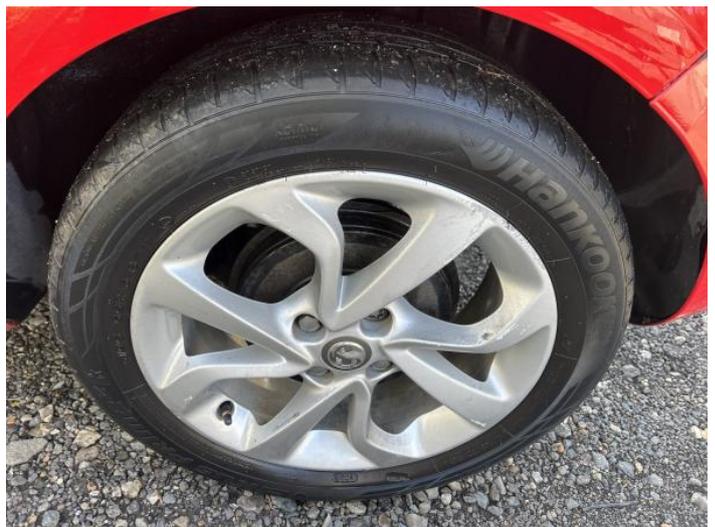
14: Wheel nsr
Scratched
Over 50mm

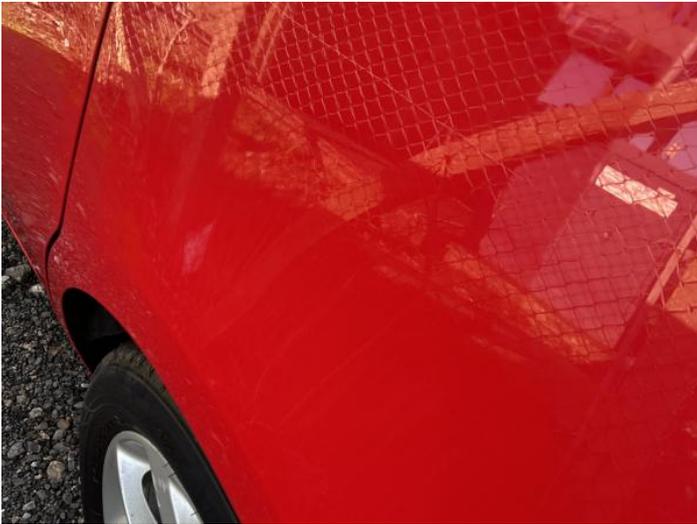
15: Qtr Panel nsr
 Scratched
 Over 25mm Not Thru Paint

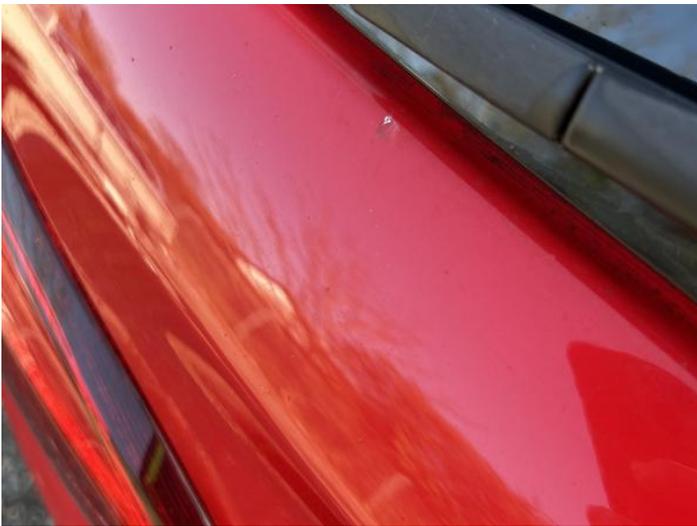
17: Tailgate
 Chipped
 1 To 5

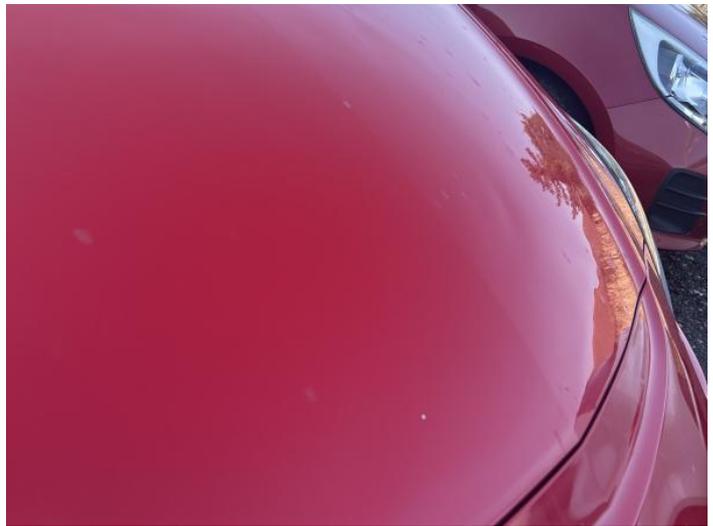
18: Bonnet
 Dented
 Over 30mm
