VEHICLE INSPECTION REPORT

EK60YTC

Audi A1 1.4 TFSI Sport 3dr S Tronic

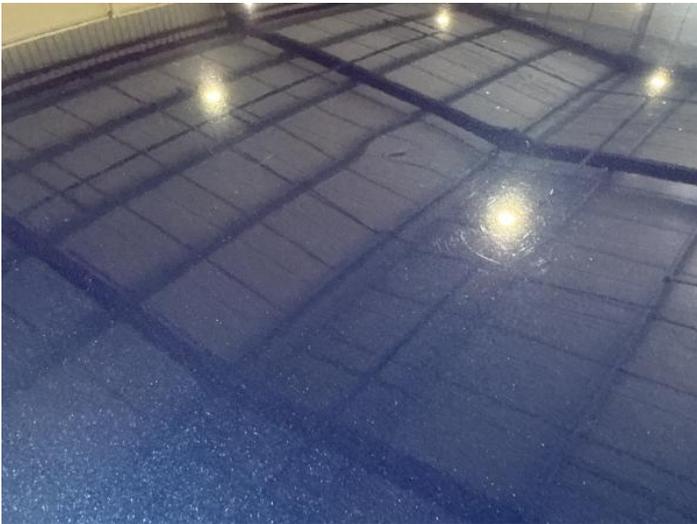
1: Roof
Dented
Between 10mm + 30mm

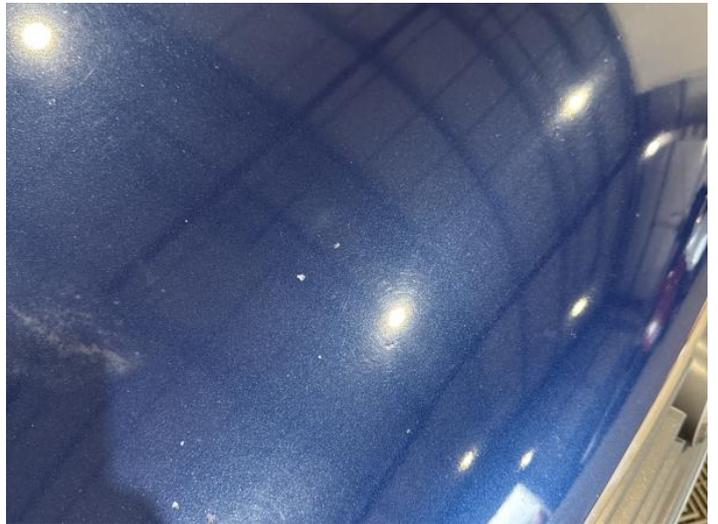
2: Bonnet
Poor Previous Repair
Paint Flake

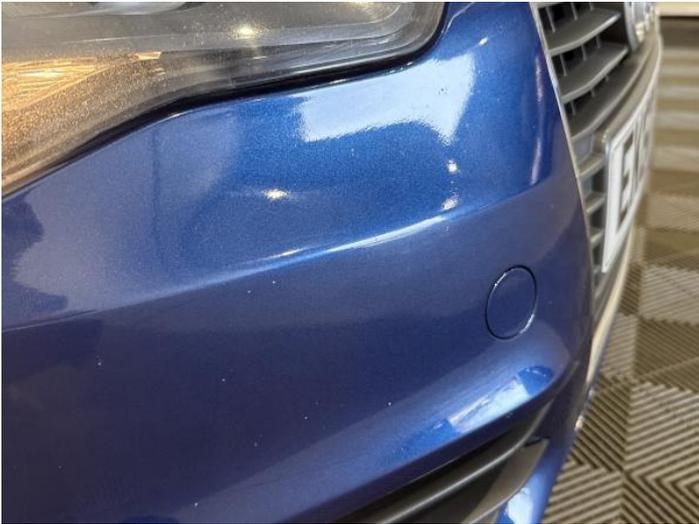
3: Bumper Front
Poor Previous Repair
Poor Paint

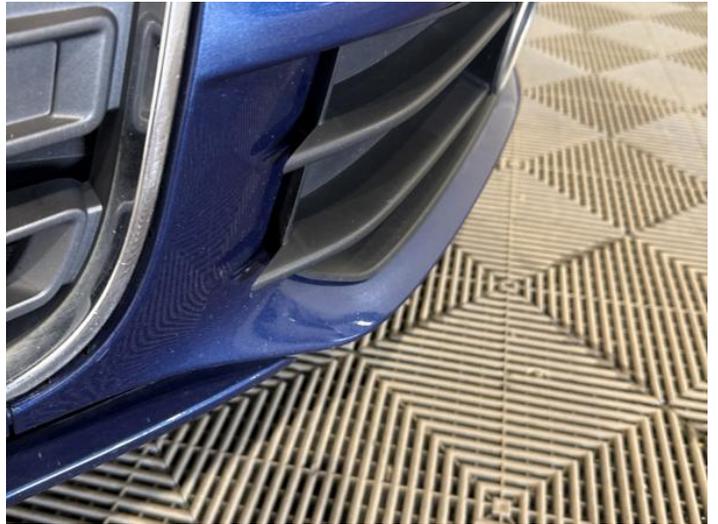
4: Fog Lamp Surround ns
Broken
Replace

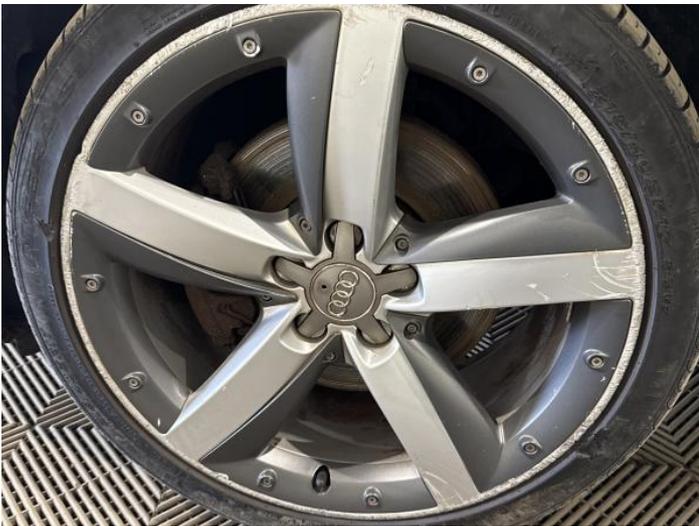
5: Wheel nsf
Scratched
Over 50mm

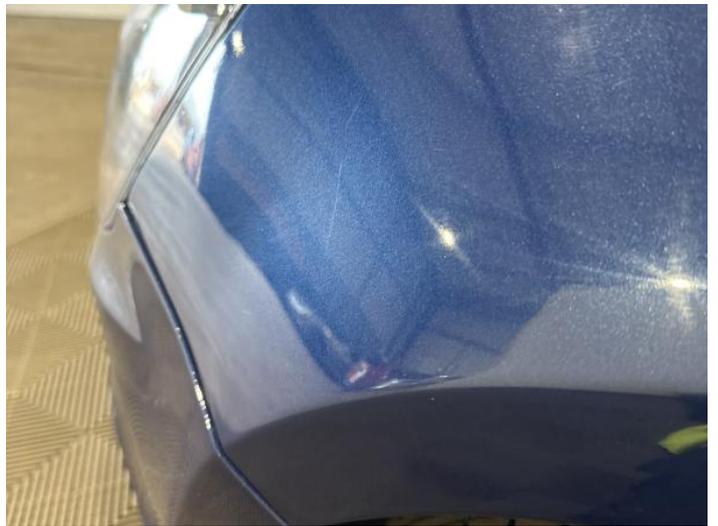
6: Wing nsf
Poor Previous Repair
Poor Paint

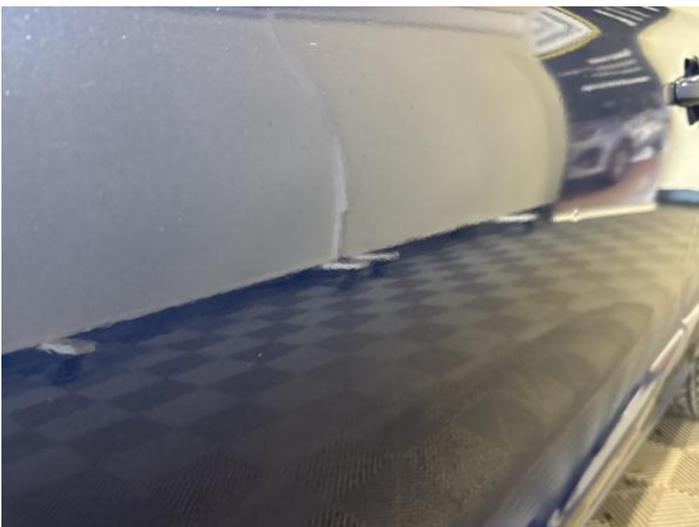
7: Door nsf
Poor Previous Repair
Rippled UpTo 30%

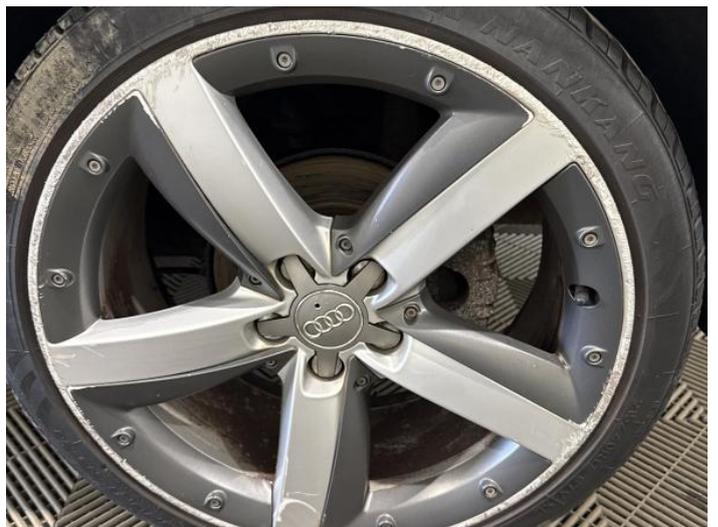
8: Wheel nsr
Scratched
Over 50mm

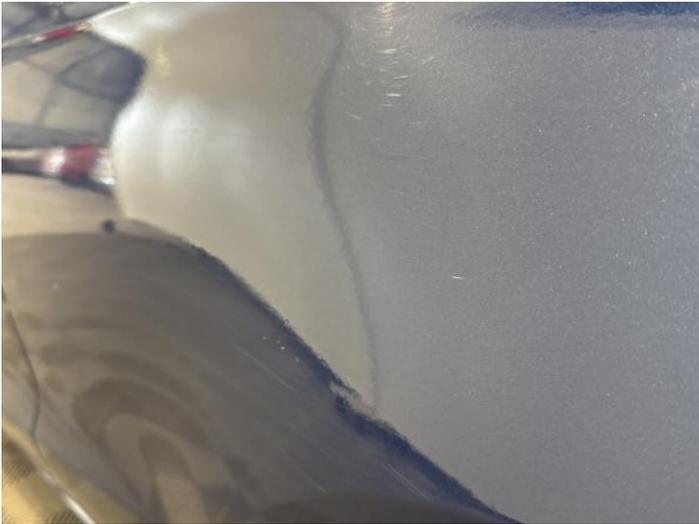
9: Qtr Panel nsr
Poor Previous Repair
Rippled UpTo 30%

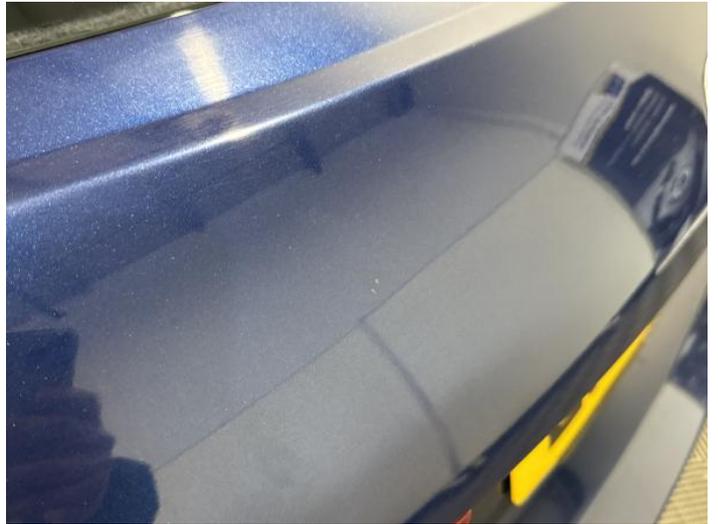
10: Tailgate
Chipped
1 To 5

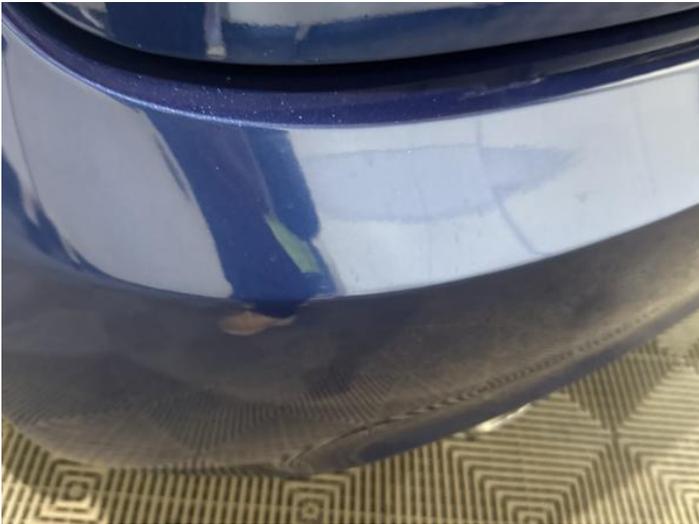
11: Bumper Rear
Scratched
25 to 100mm Thru Paint

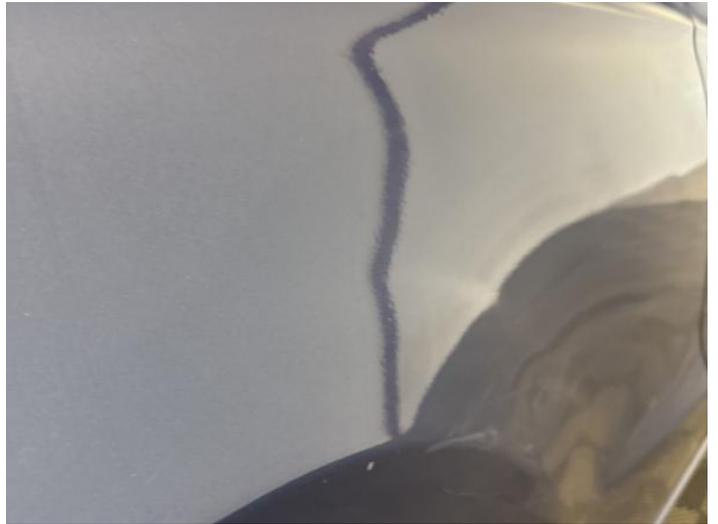
12: Qtr Panel osr
Poor Previous Repair
Rippled UpTo 30%

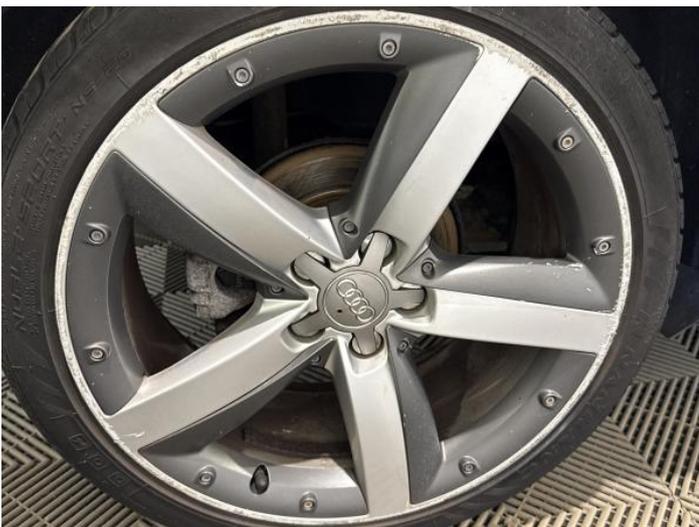
13: Wheel osr
Scratched
Over 50mm

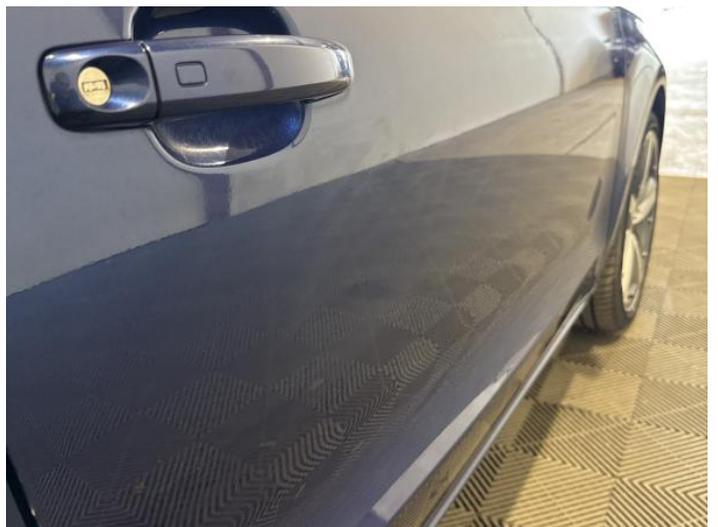
14: Door osf
Poor Previous Repair
Rippled UpTo 30%

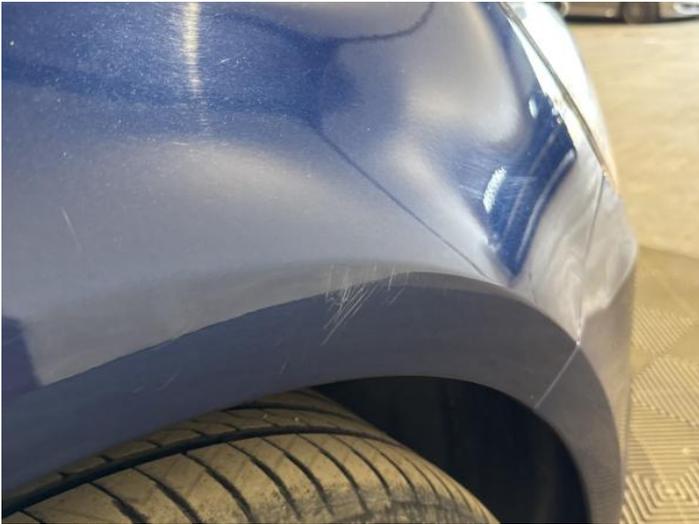
15: Wing osf
Scratched
Over 25mm Thru Paint

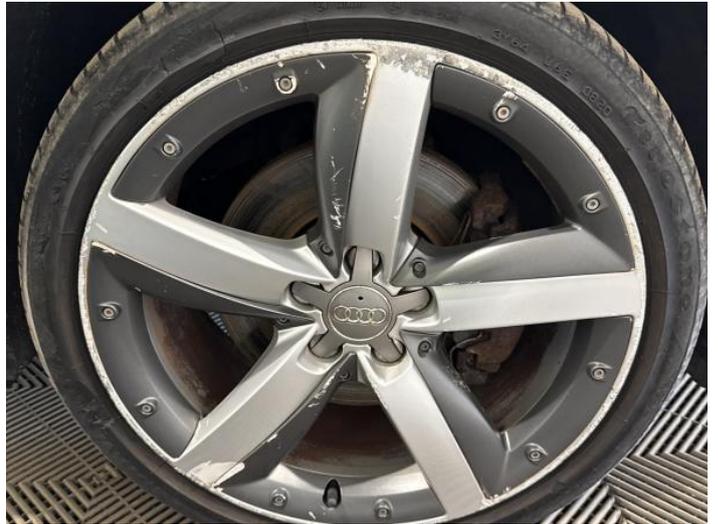
16: Wheel osf
Scratched
Over 50mm

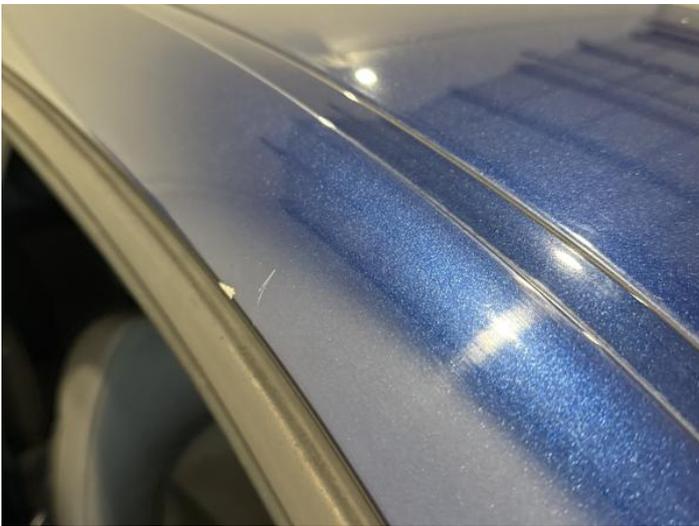
17: A Post os
Scratched
UpTo 25mm Thru Paint

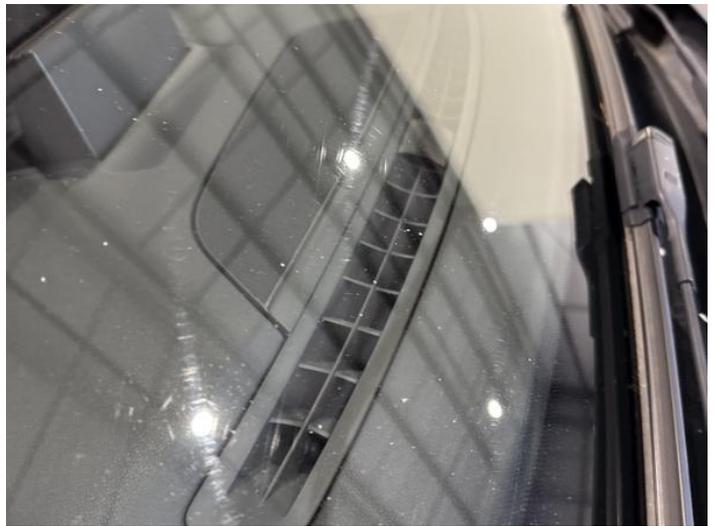
18: Screen Front
Chipped
UpTo 10mm

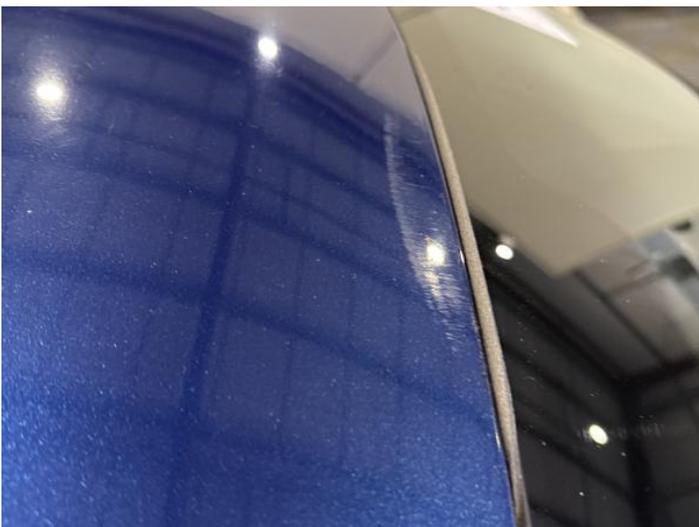
19: Roof
Scratched
Over 25mm Thru Paint

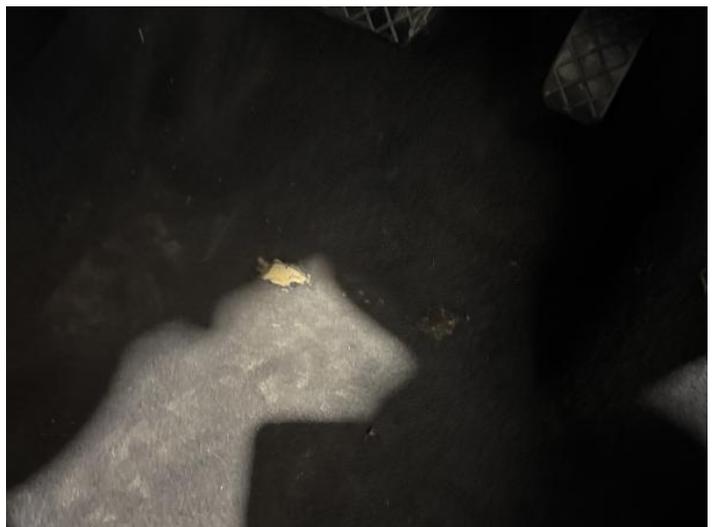
20: Carpets Front
Scuffed
Over 25mm

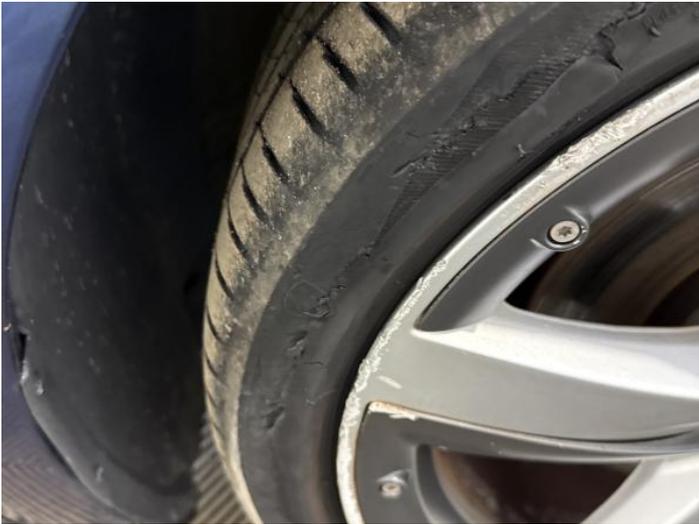
NSF	NEXEN	Damaged
NSR	NANKANG	5.0mm
OSF	FIRESTONE	Damaged
OSR	NANKANG	5.0mm

21: Tyre osf
 Damaged
 Replace

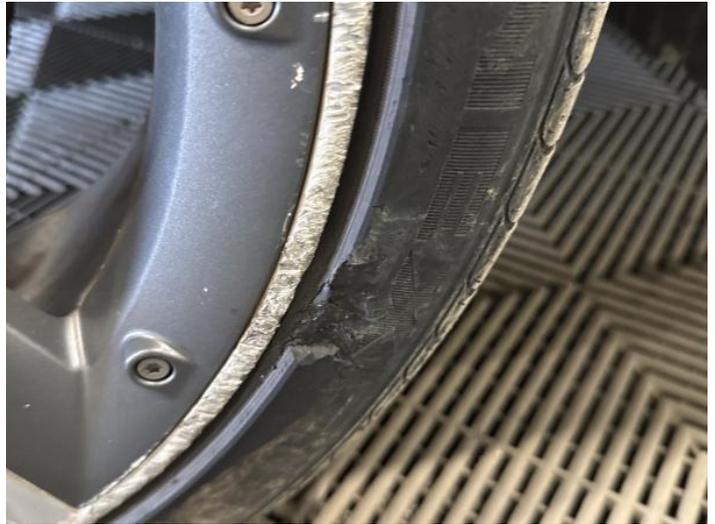
22: Tyre nsf
 Damaged
 Replace
