VEHICLE INSPECTION REPORT

FY21EJN

Nissan X-Trail 1.3 DiG-T 158 Tekna 5dr [7 Seat] DCT

nama
GRADE
4

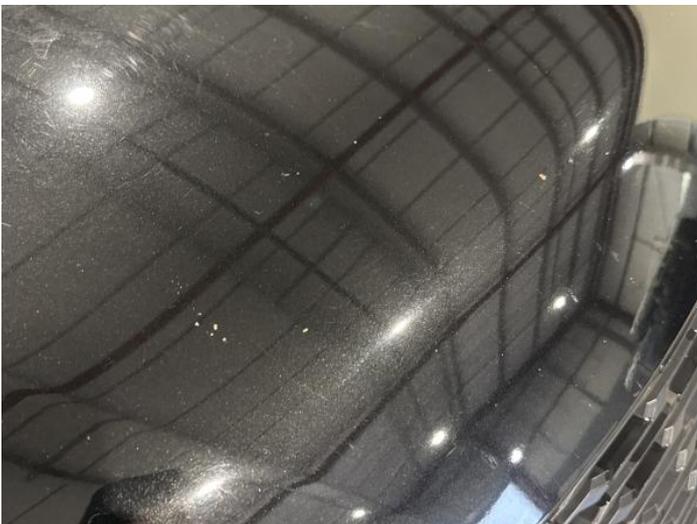
1: Bonnet
Chipped
Multiple Chips

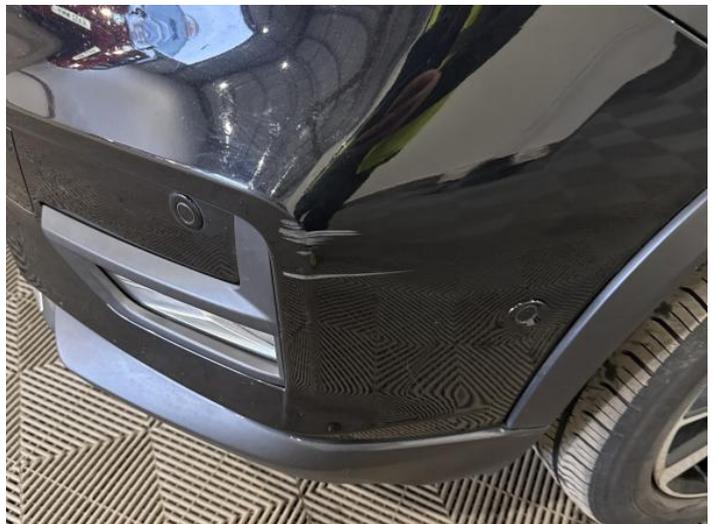
2: Bumper Front
Scratched
25 to 100mm Thru Paint

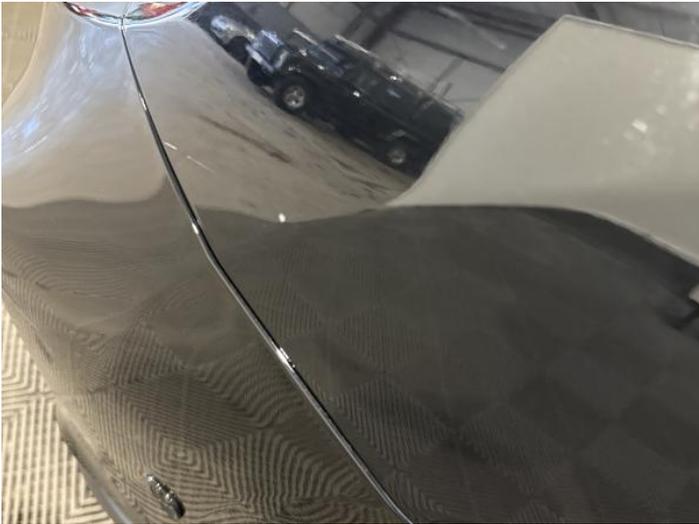
3: Wing nsf
Scratched
UpTo 25mm Thru Paint

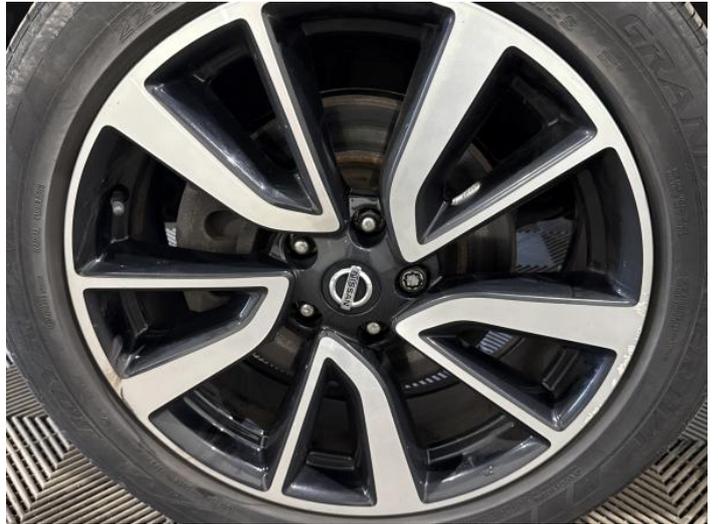
4: Wheel nsf
Scratched
Over 50mm

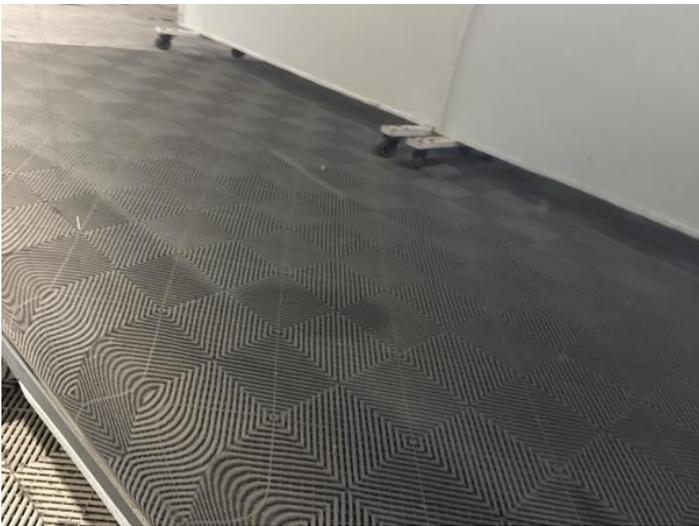
5: Door nsf
Scratched
Over 25mm Thru Paint

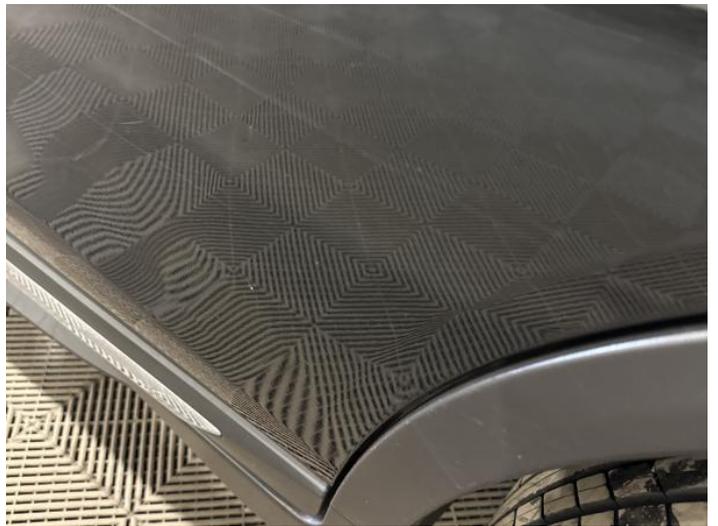
6: Door nsr
Scratched
Over 25mm Thru Paint

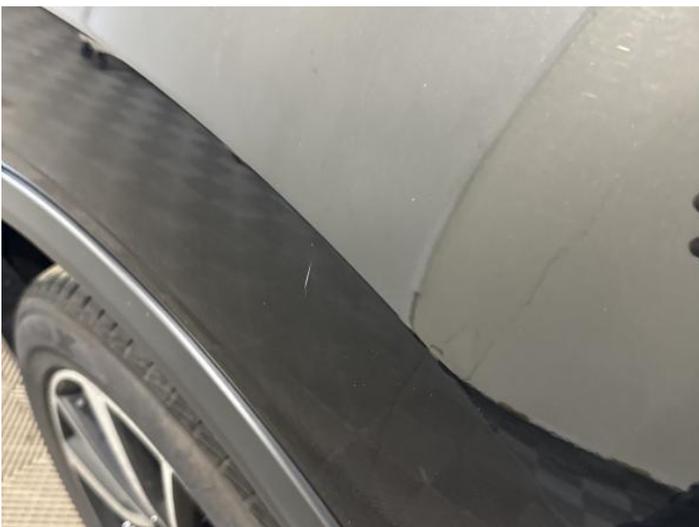
7: Qtr Panel nsr
Scratched
UpTo 25mm Thru Paint

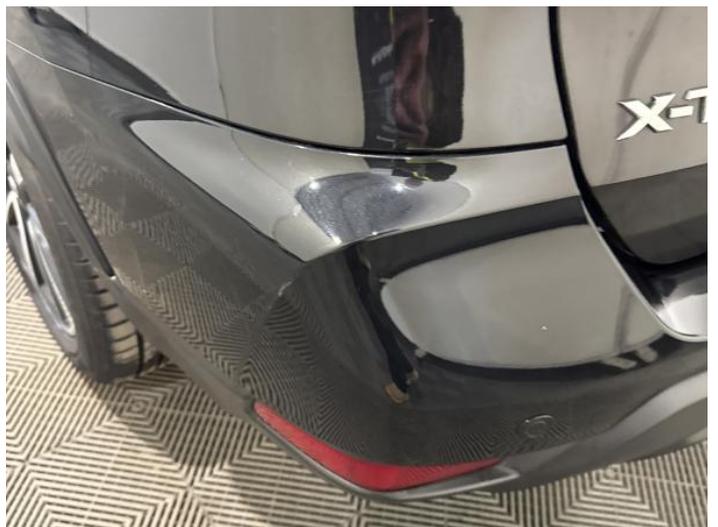
8: Bumper Rear
Scratched
25 to 100mm Thru Paint

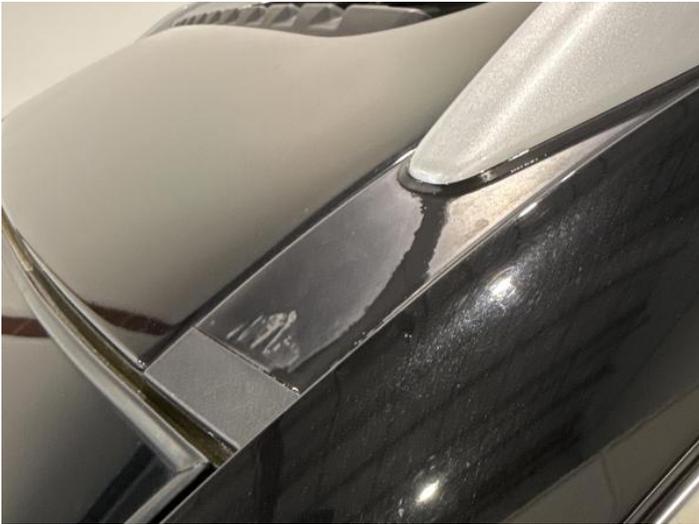
9: A Post ns
Chipped
1 To 5

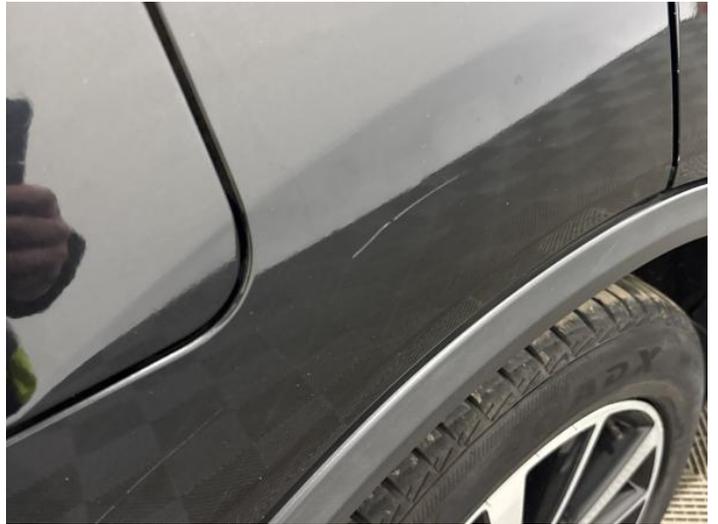
10: Qtr Panel osr
Scratched
Over 25mm Thru Paint

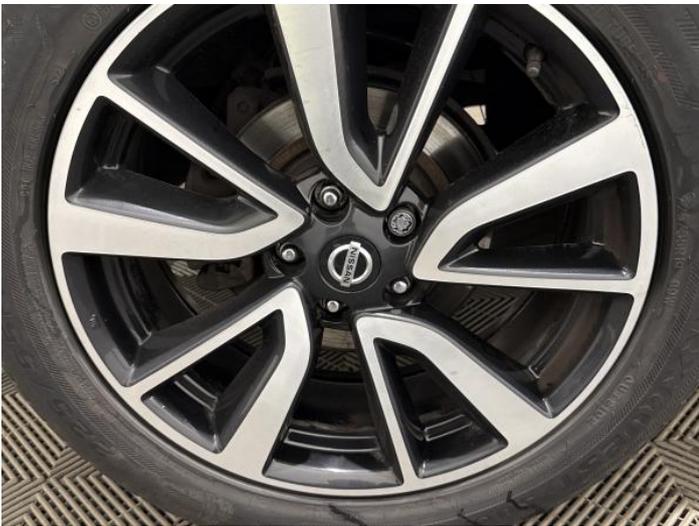
11: Wheel osr
Scratched
Up To 50mm

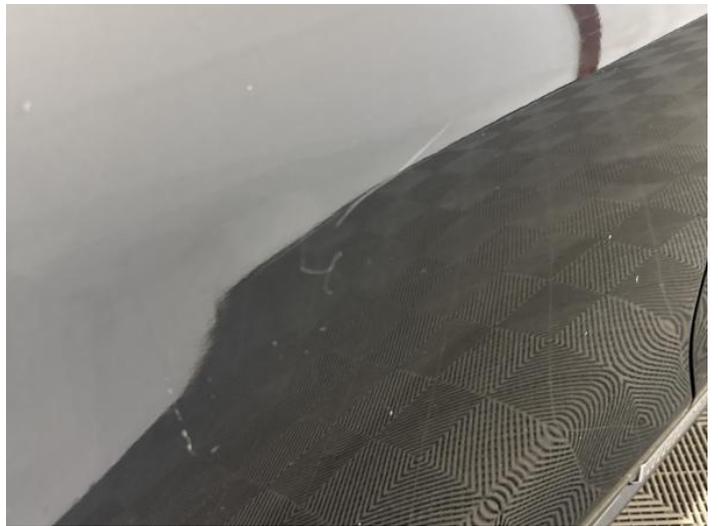
12: Door osr
Scratched
Over 25mm Thru Paint

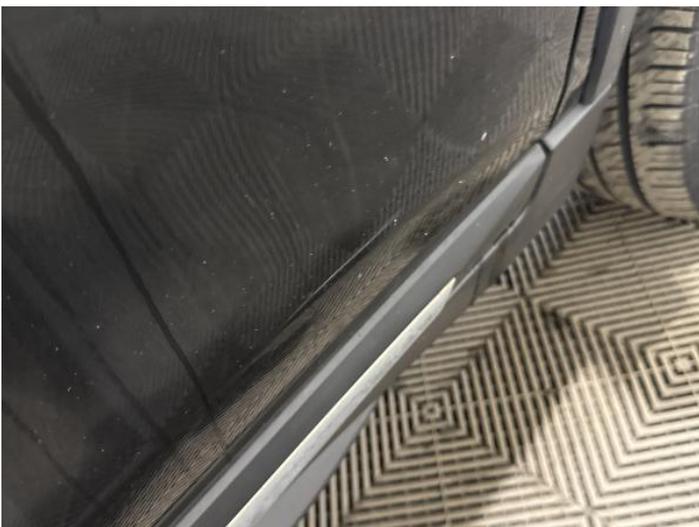
13: Door osf
Scratched
Over 25mm Thru Paint

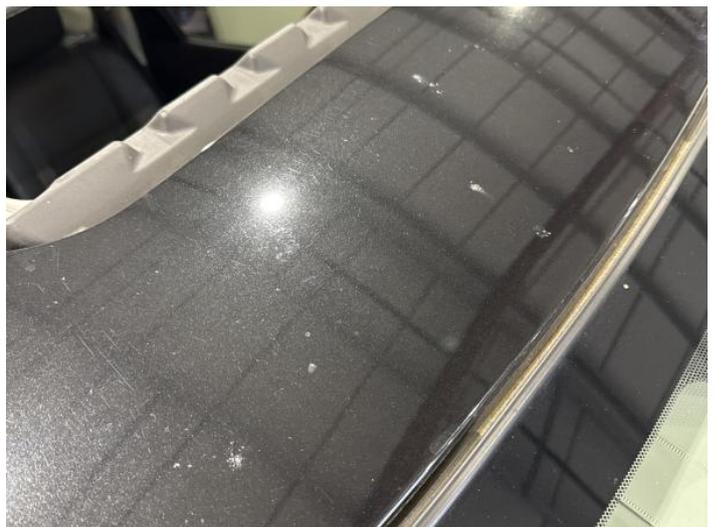
14: Roof
Chipped
1 To 5

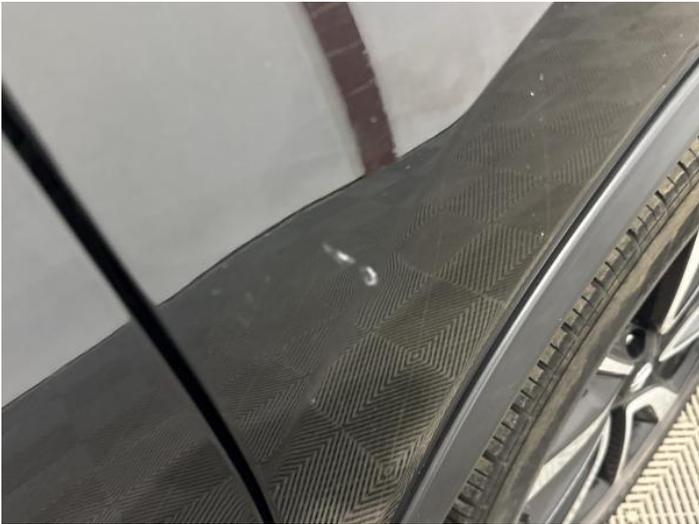
15: Wing osf
Dented
Between 10mm + 30mm

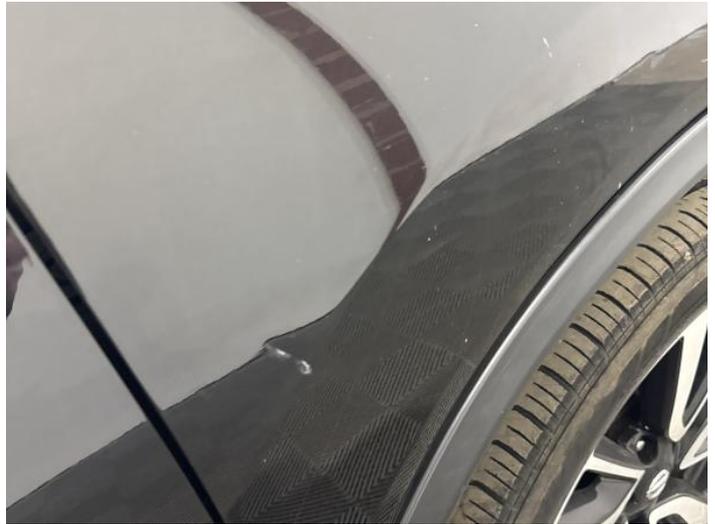
16: Wing osf
Scratched
Over 25mm Thru Paint

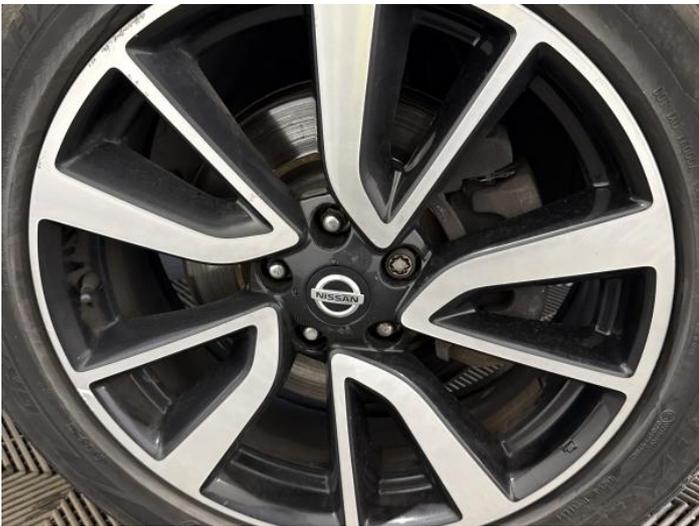
17: Wheel osf
Scratched
Over 50mm
