# VEHICLE INSPECTION REPORT

**GV70GVK**

## Dacia Sandero Stepway 1.0 TCe Bi-Fuel Comfort 5dr

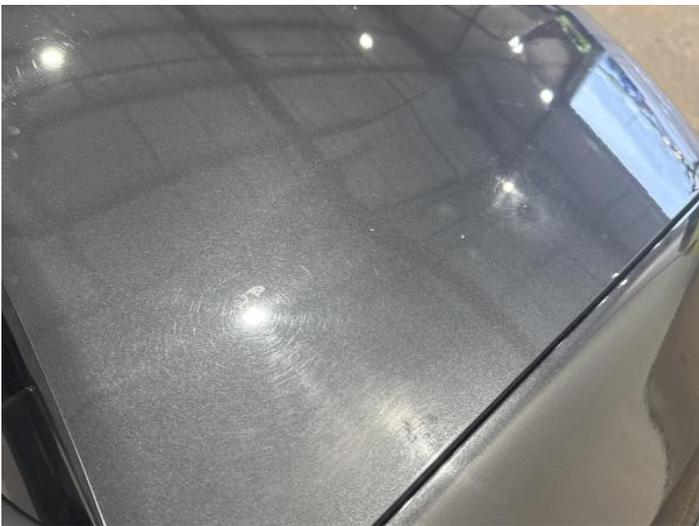
1: Bonnet  
Scratched  
Over 25mm Thru Paint

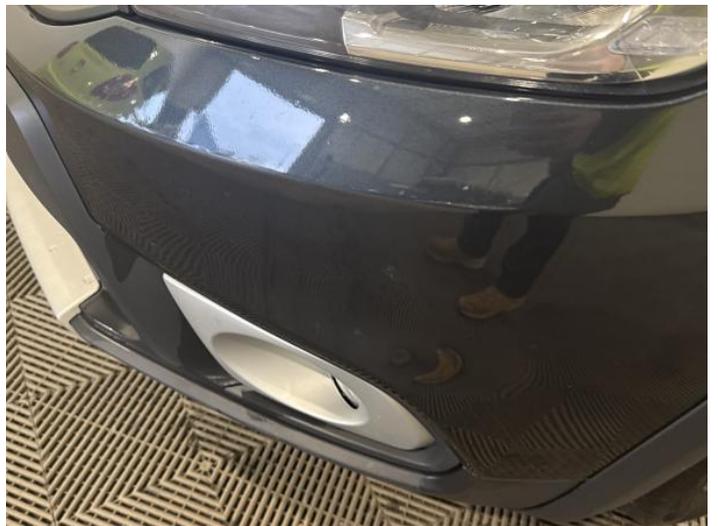
2: Bumper Front  
Scratched  
25 to 100mm Thru Paint

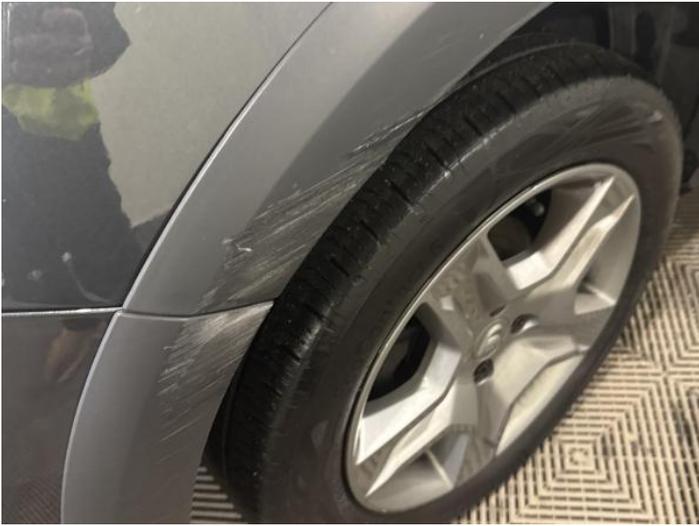
3: Wing Front Arch Extension ns  
Scuffed (Unpainted)  
Over 100mm

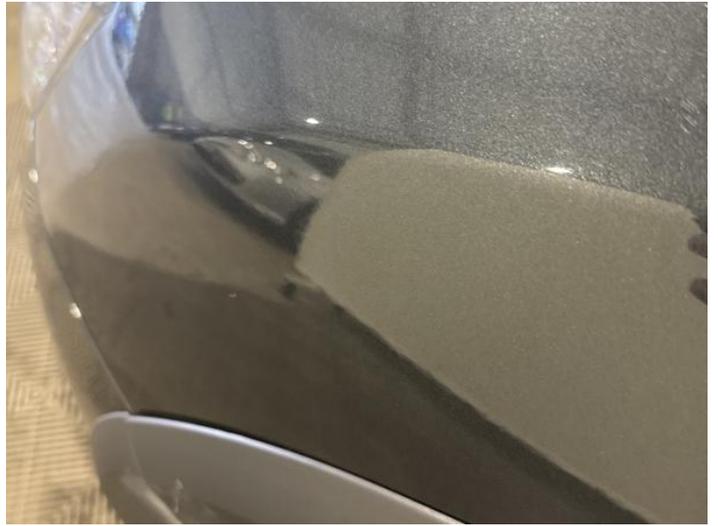
4: Wing nsf  
Chipped  
1 To 5

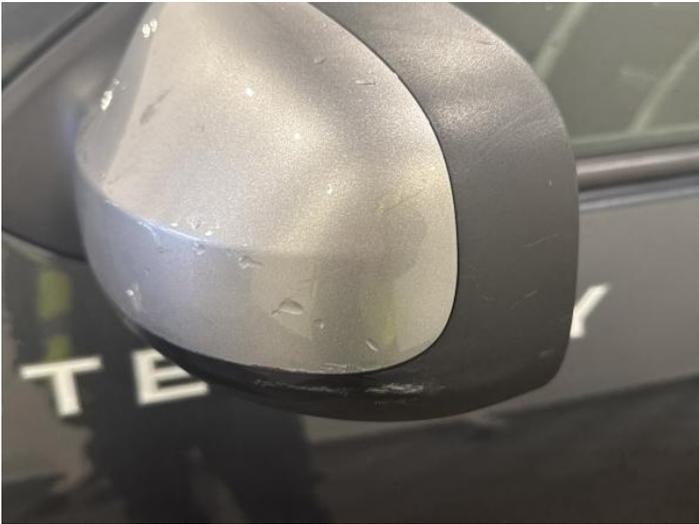
5: Door Mirror Assy nsf  
Scuffed (Unpainted)  
UpTo 100mm

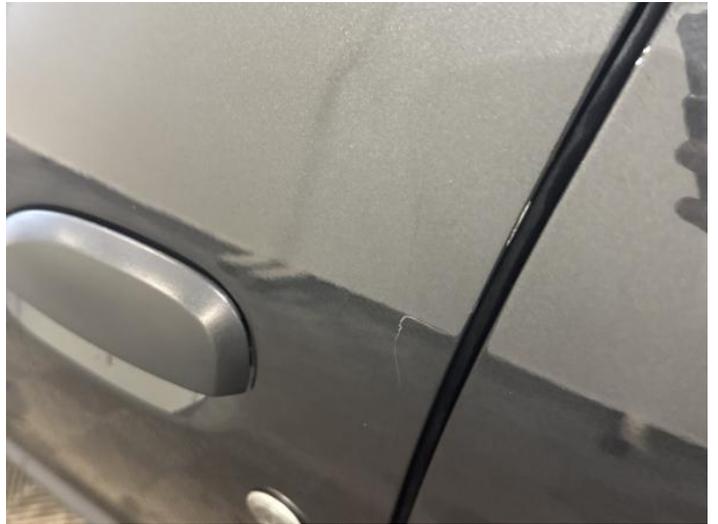
6: Door nsf  
Scratched  
Over 25mm Thru Paint

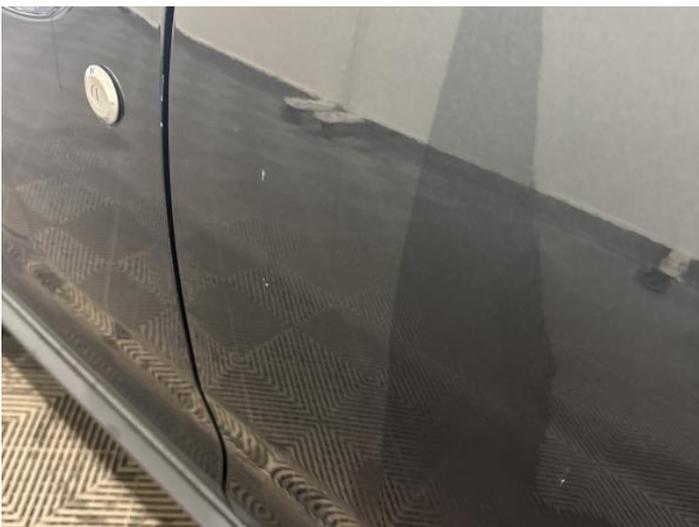
7: Door nsr  
Chipped  
1 To 5

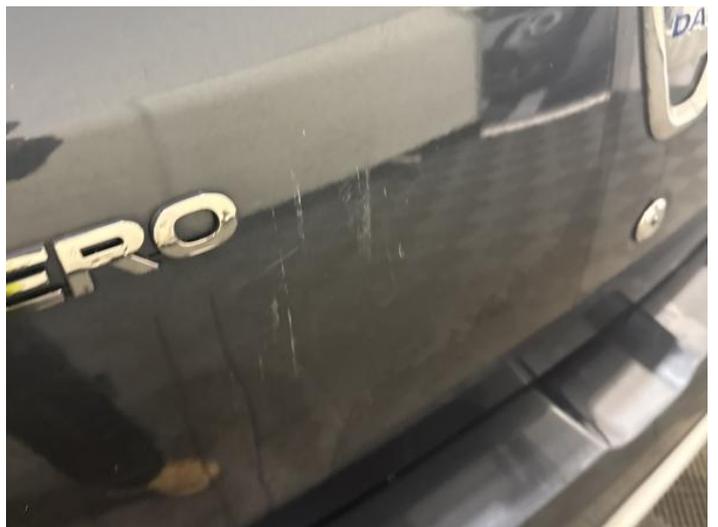
8: Tailgate  
Scratched  
Over 25mm Thru Paint

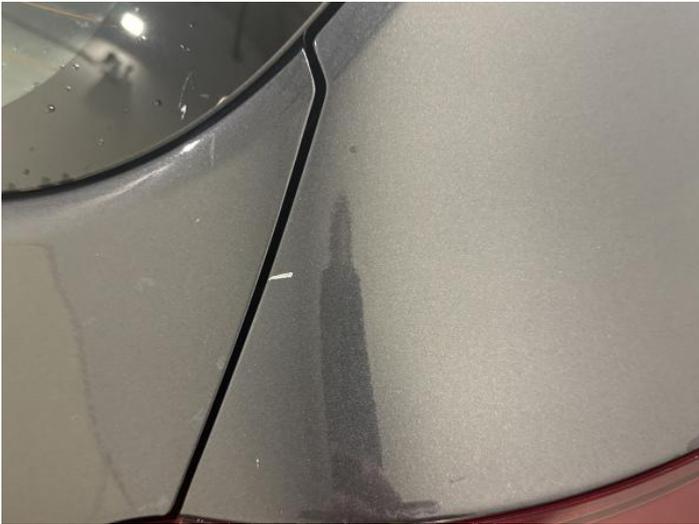
9: Qtr Panel osr  
Scratched  
UpTo 25mm Thru Paint

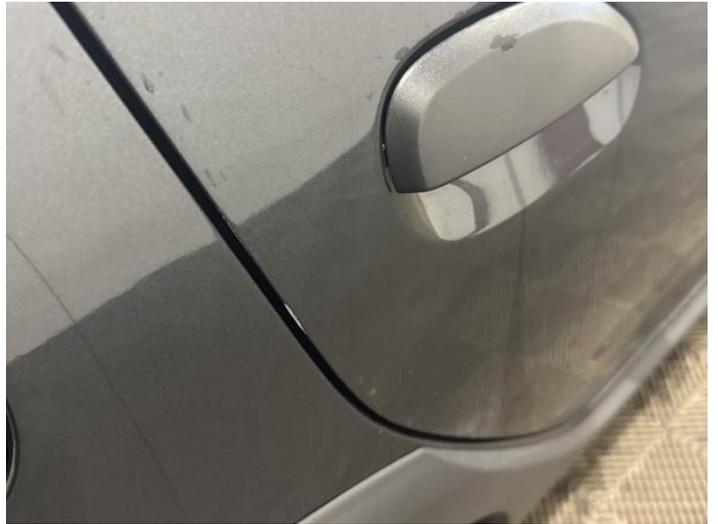
10: Door osr  
Chipped  
Edge Chip

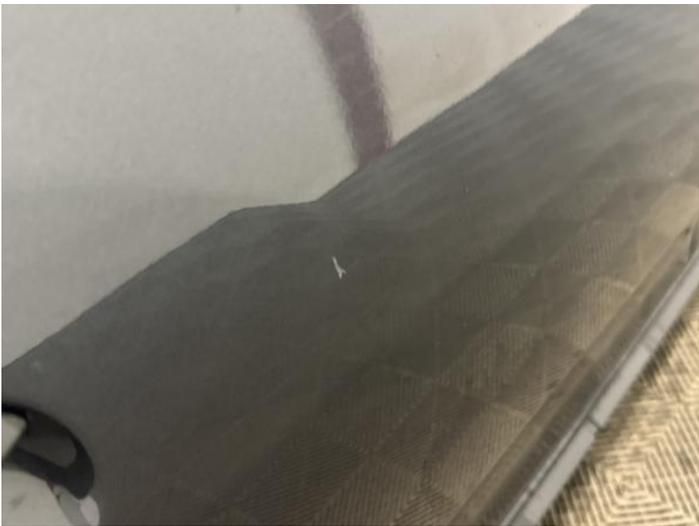
11: Door osr  
Scratched  
UpTo 25mm Thru Paint

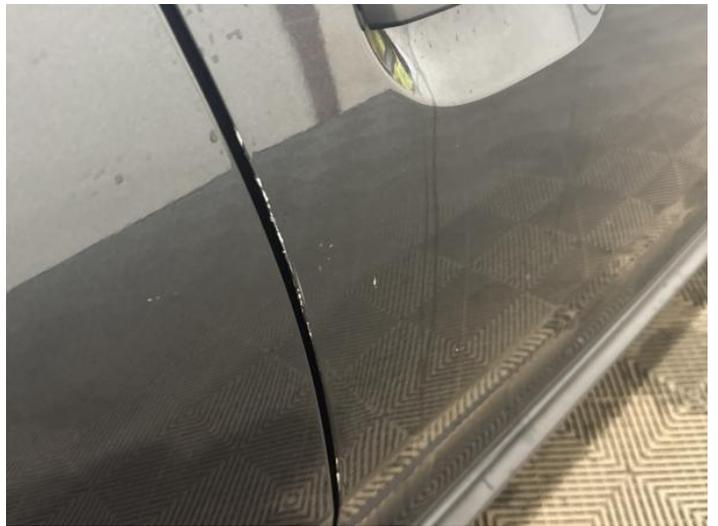
12: Door osf  
Chipped  
Edge Chip

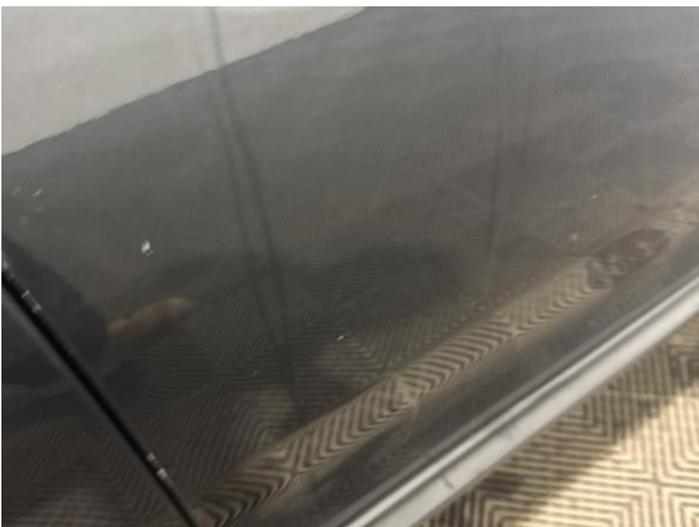
13: Door osf  
Chipped  
1 To 5

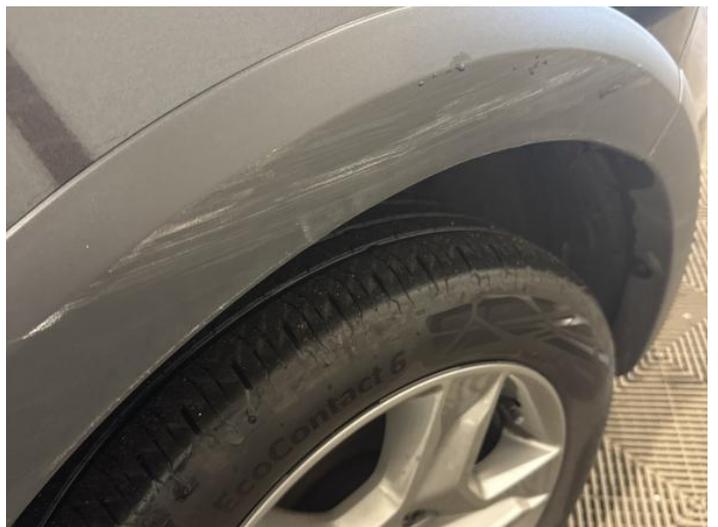
14: Wing Front Arch Extension os  
Scuffed (Unpainted)  
Over 100mm
