VEHICLE INSPECTION REPORT

GU67JXK

Vauxhall Mokka X 1.4T Active 5dr

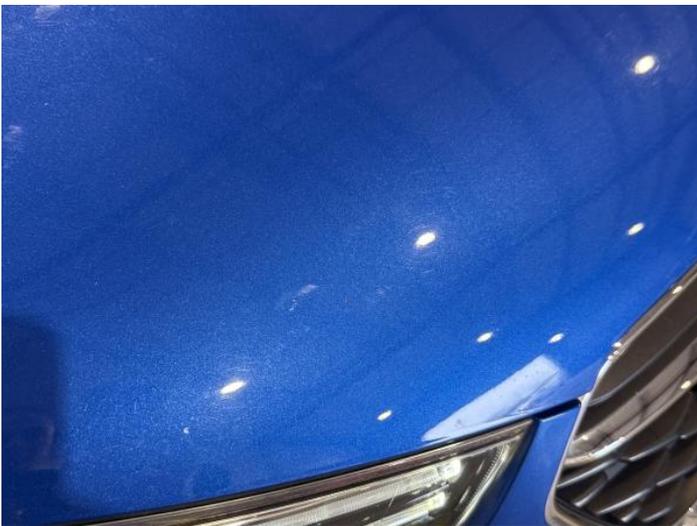
1: Bonnet
Chipped
1 To 5

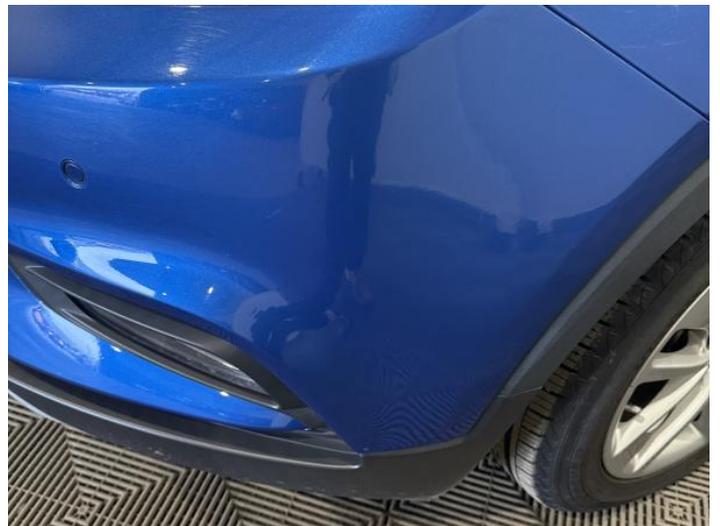
2: Bumper Front
Scratched
UpTo 25mm Thru Paint

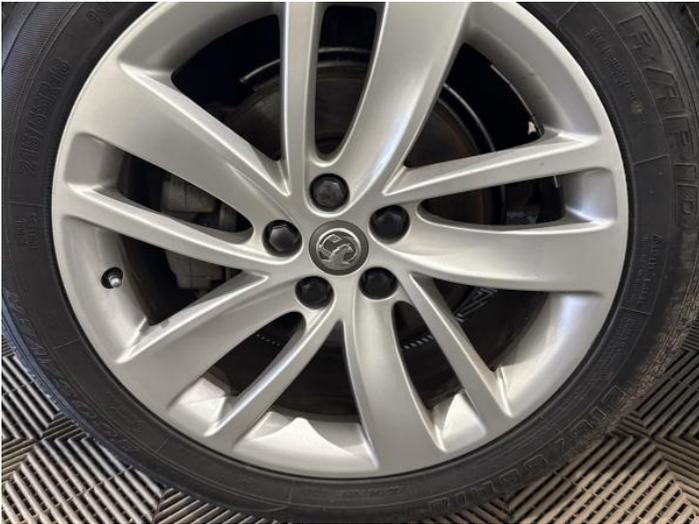
3: Wheel nsf
Scratched
Up To 50mm

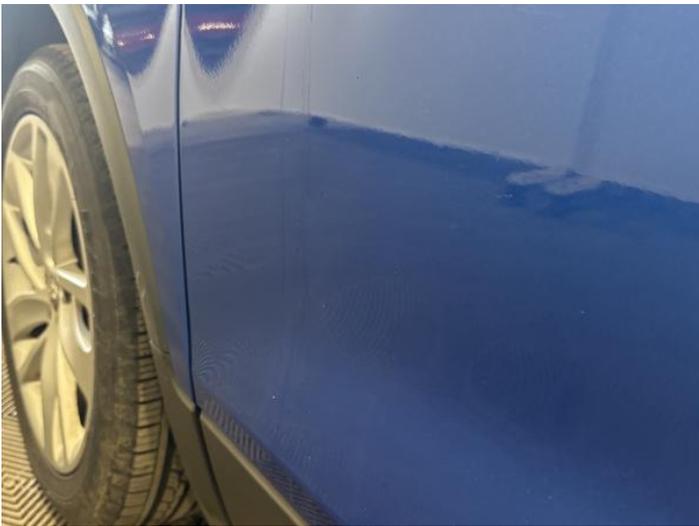
5: Door nsf
Dented
Between 10mm + 30mm

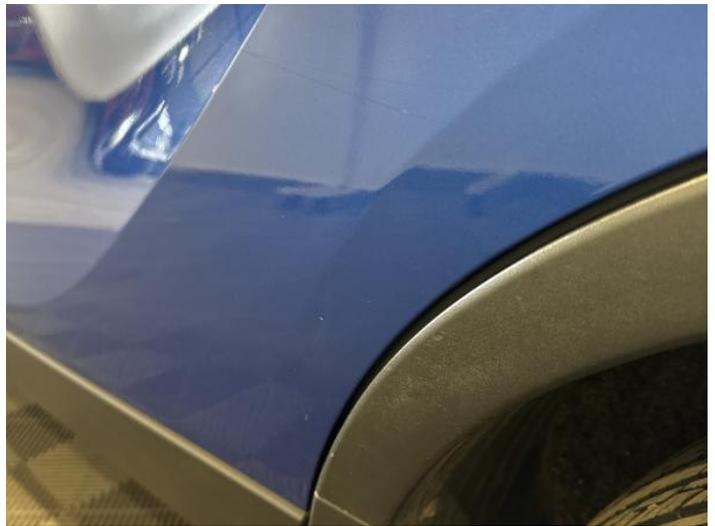
6: Door nsr
Chipped
1 To 5

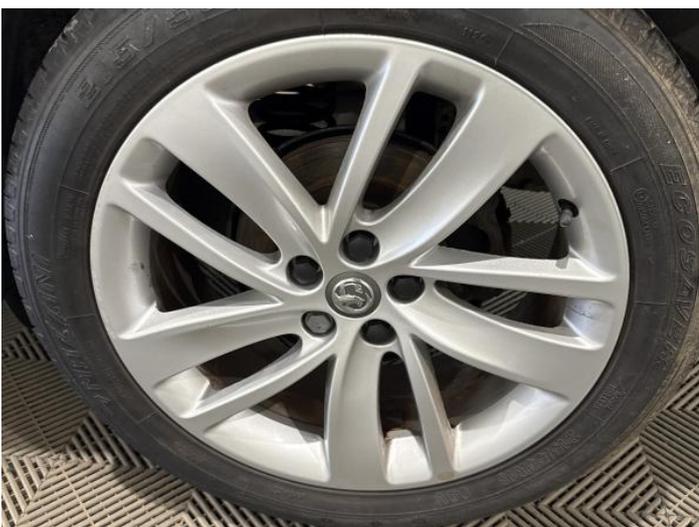
7: Wheel nsr
Scratched
Over 50mm

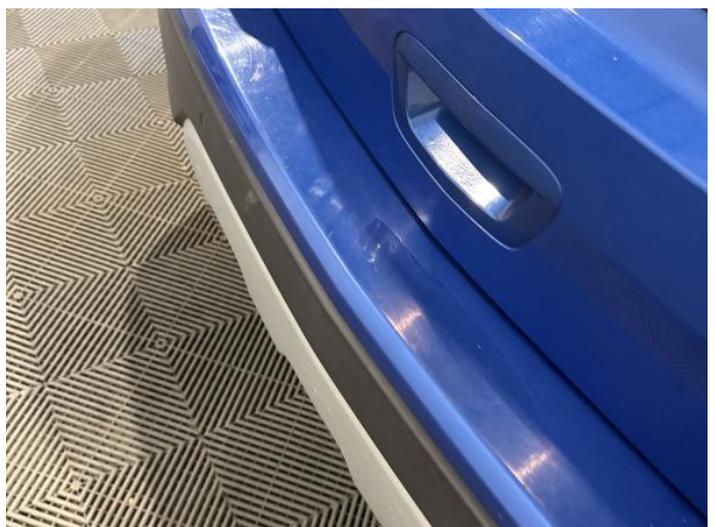
8: Bumper Rear
Scratched
25 to 100mm Thru Paint

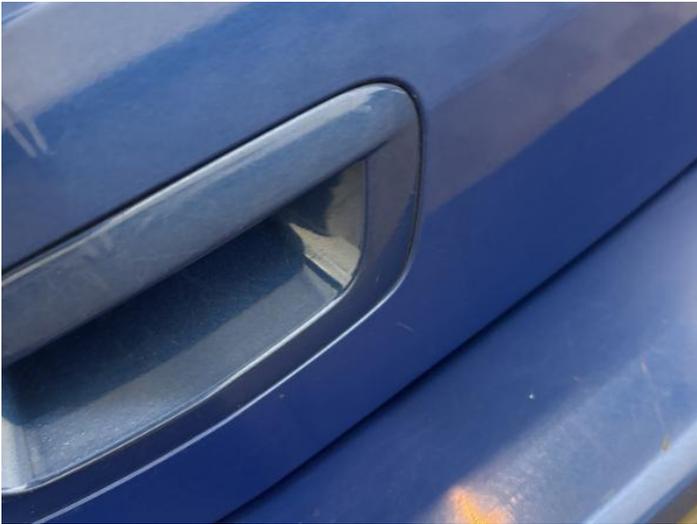
9: Tailgate
Scratched
UpTo 25mm Thru Paint

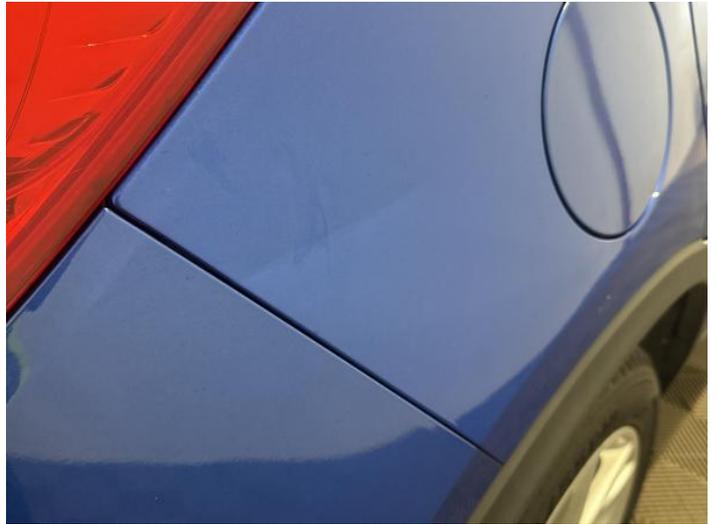
10: Qtr Panel osr
Dented
Over 30mm

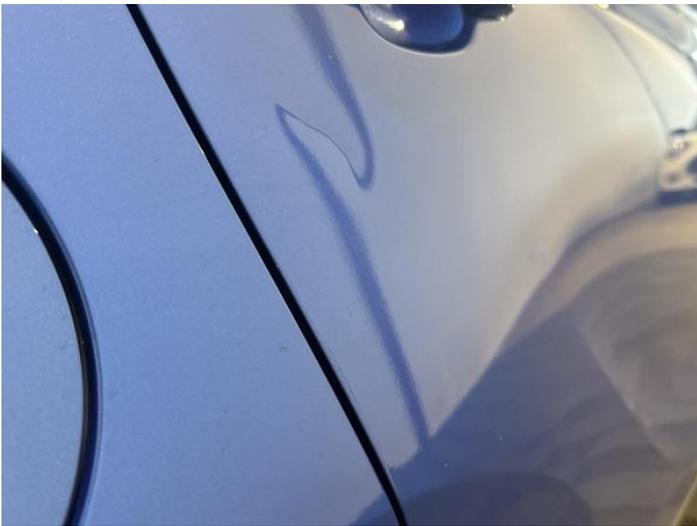
11: Door osr
Dented
Over 30mm

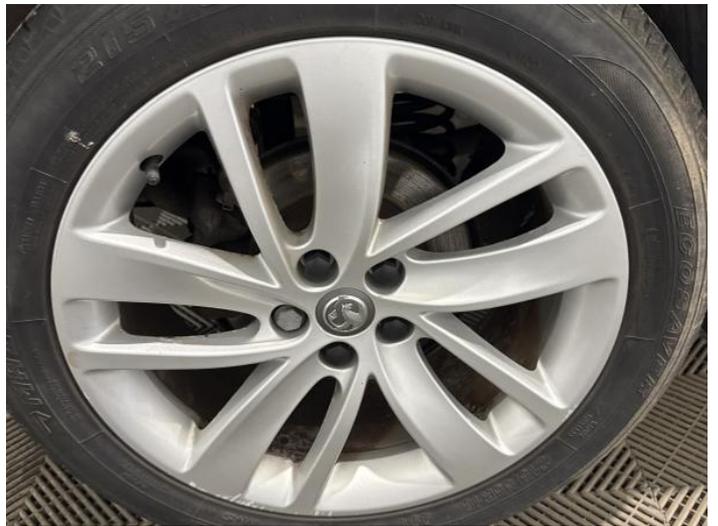
12: Wheel osr
Scratched
Over 50mm

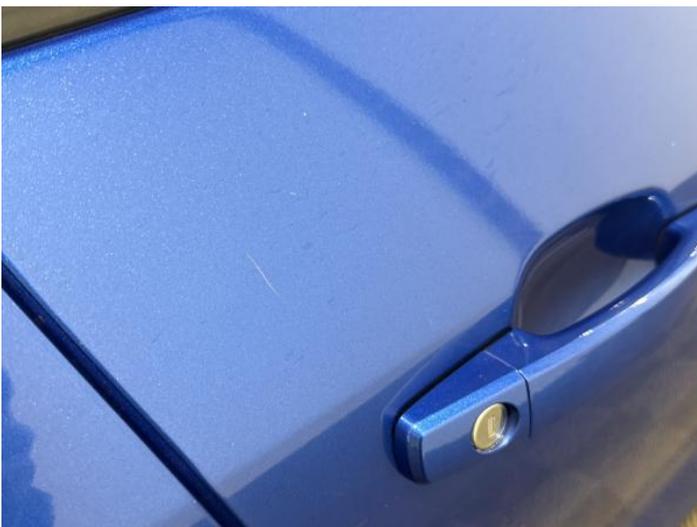
13: Door osf
Scratched
UpTo 25mm Thru Paint

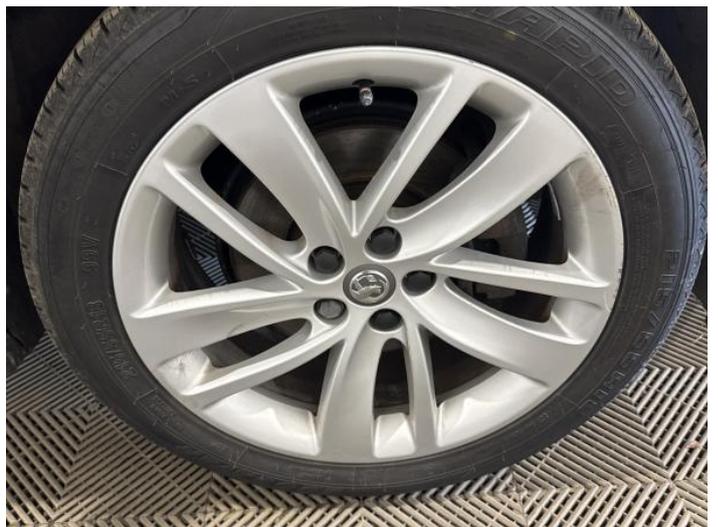
14: Wheel osf
Scratched
Over 50mm

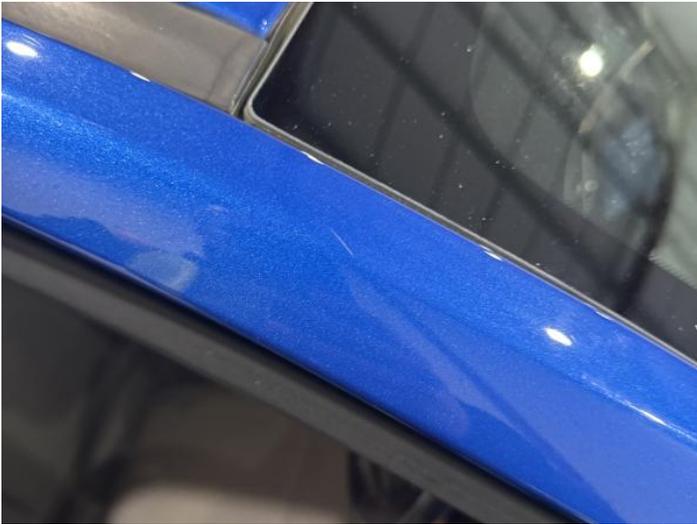
15: A Post os
 Scratched
 UpTo 25mm Thru Paint
