VEHICLE INSPECTION REPORT

PE16AVG

Volkswagen Golf 1.4 TSI 150 GT Edition 5dr

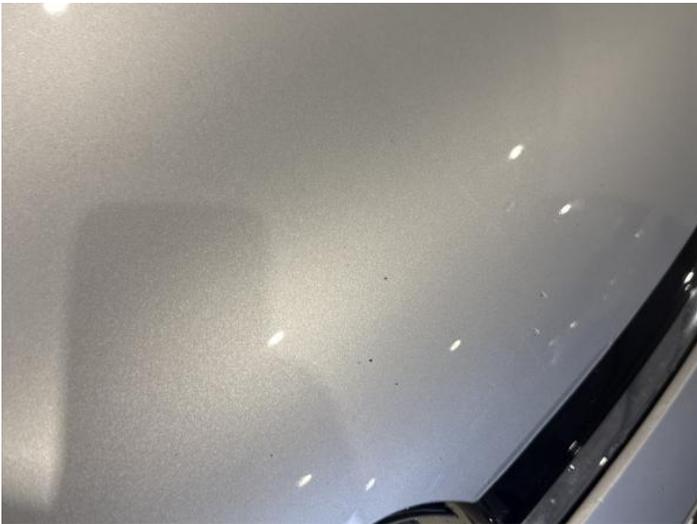
1: Bonnet
Chipped
Multiple Chips

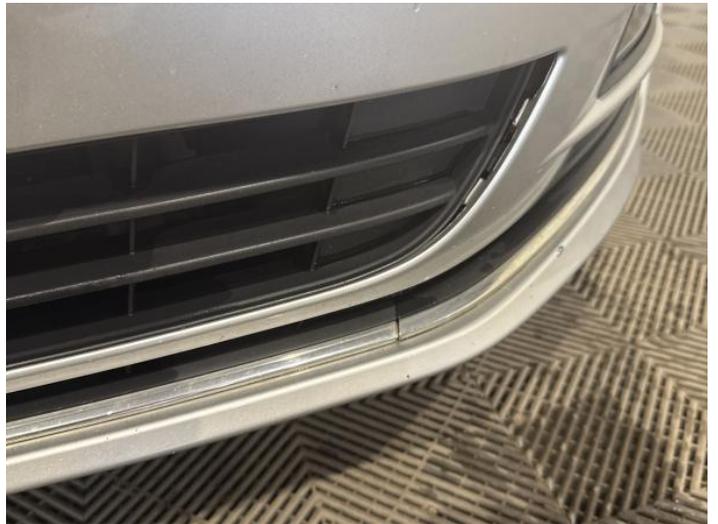
2: Bumper Front Grill
Broken
Replace

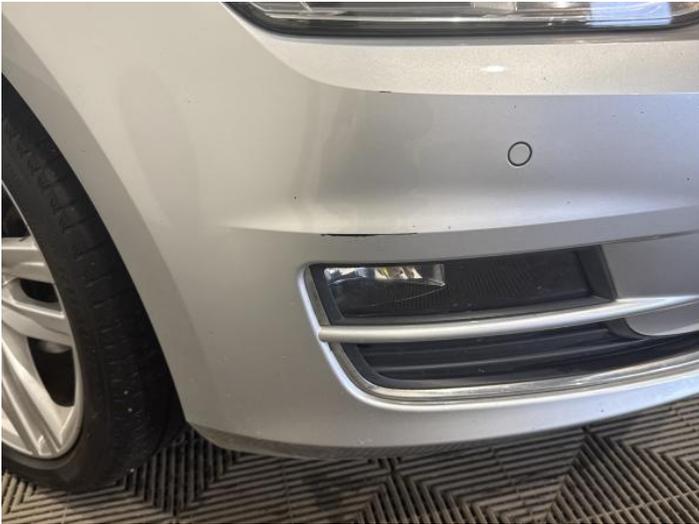
3: Bumper Front
Scratched
25 to 100mm Thru Paint

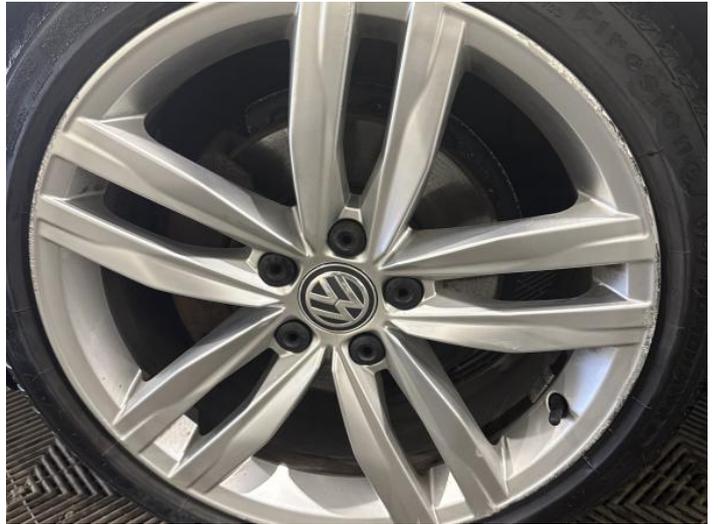
4: Wheel nsf
Scratched
Over 50mm

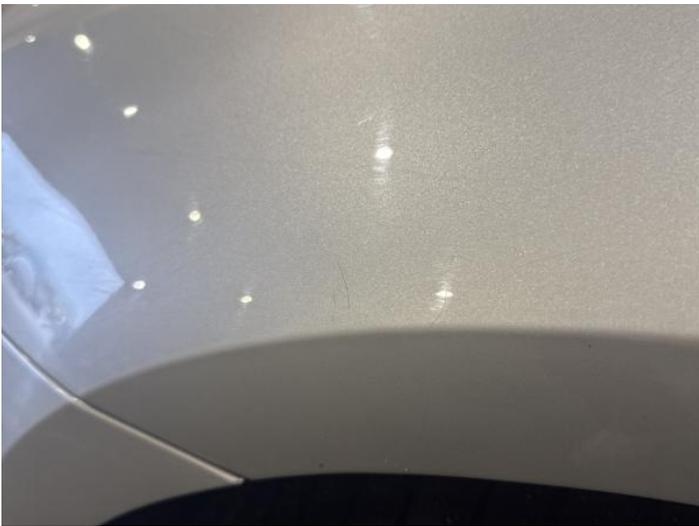
5: Wing nsf
Scratched
UpTo 25mm Thru Paint

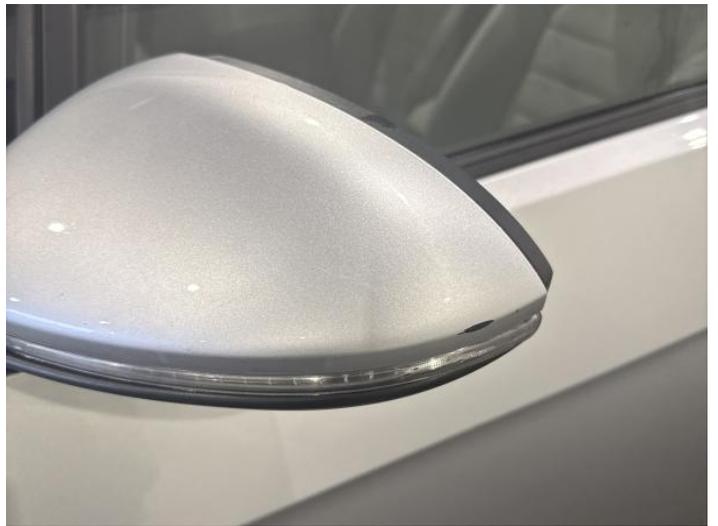
6: Door Mirror Assy nsf
Scratched (Painted)
Over 25mm Thru Paint

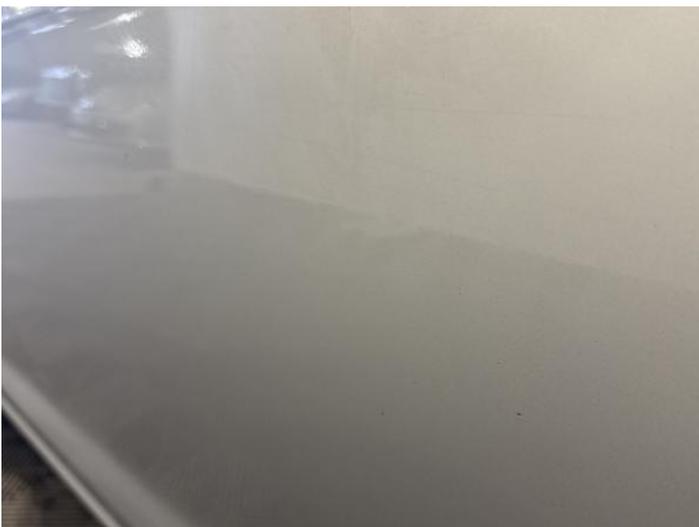
7: Door nsf
Chipped
1 To 5

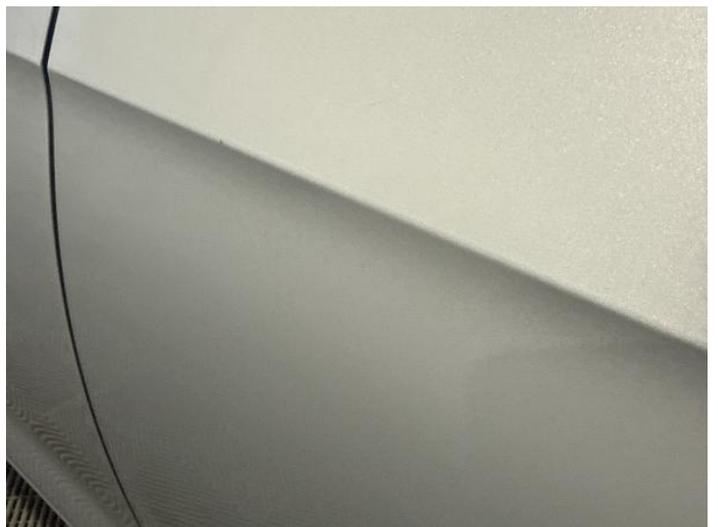
8: Door nsr
Chipped
1 To 5

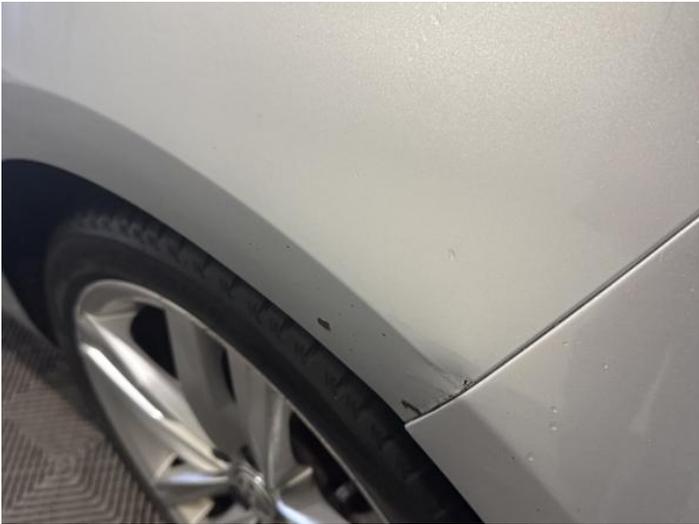
9: Qtr Panel nsr
Dented
With Paint Damage

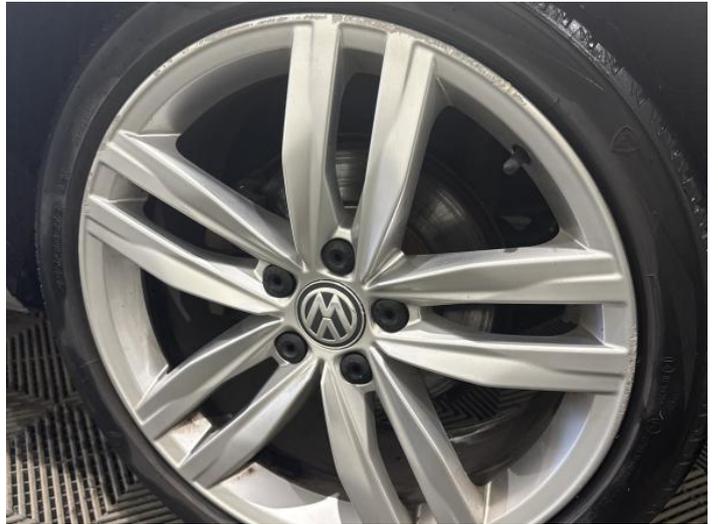
10: Wheel nsr
Scratched
Over 50mm

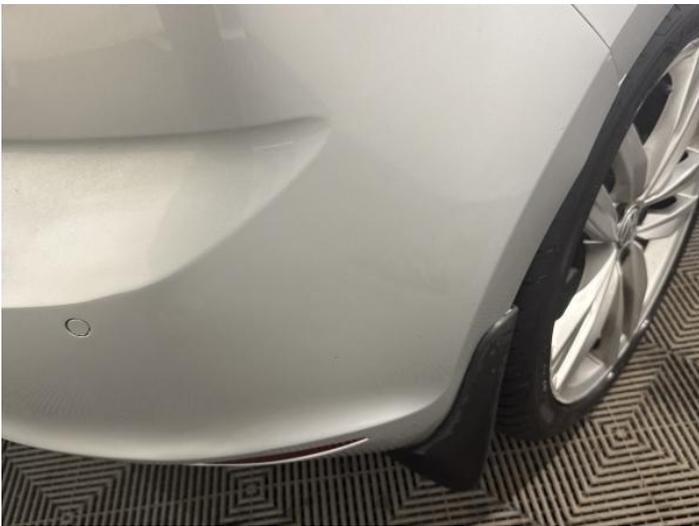
11: Bumper Rear
Scratched
25 to 100mm Thru Paint

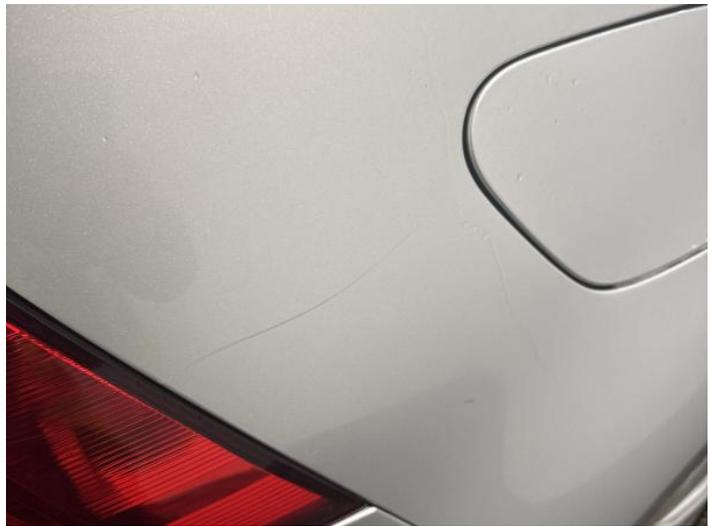
12: Qtr Panel osr
Scratched
Over 25mm Thru Paint

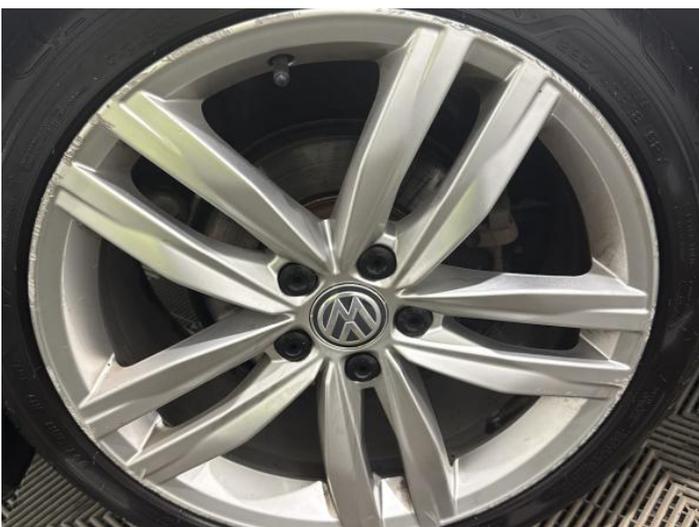
13: Wheel osr
Scratched
Over 50mm

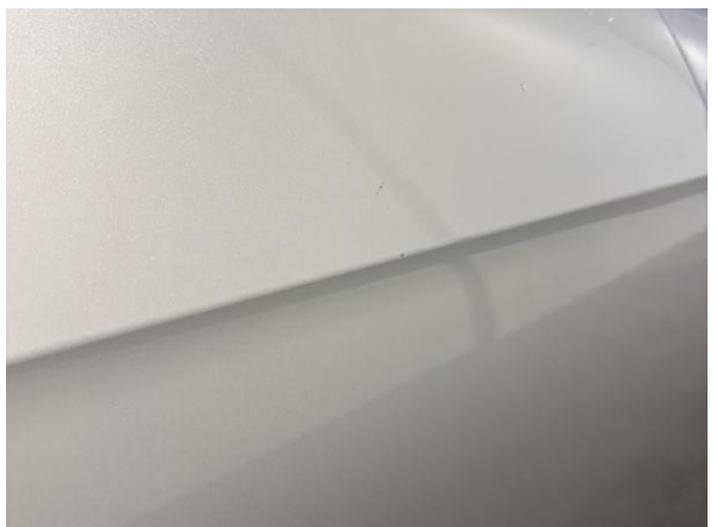
14: Door osr
Chipped
1 To 5

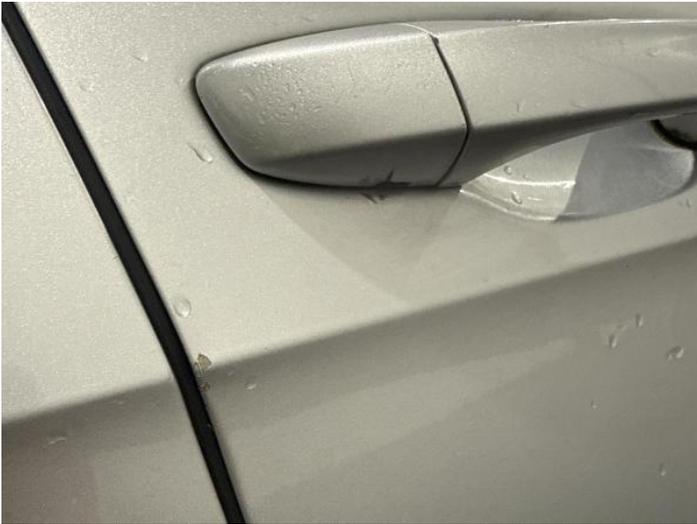
15: Door osf
Chipped
1 To 5

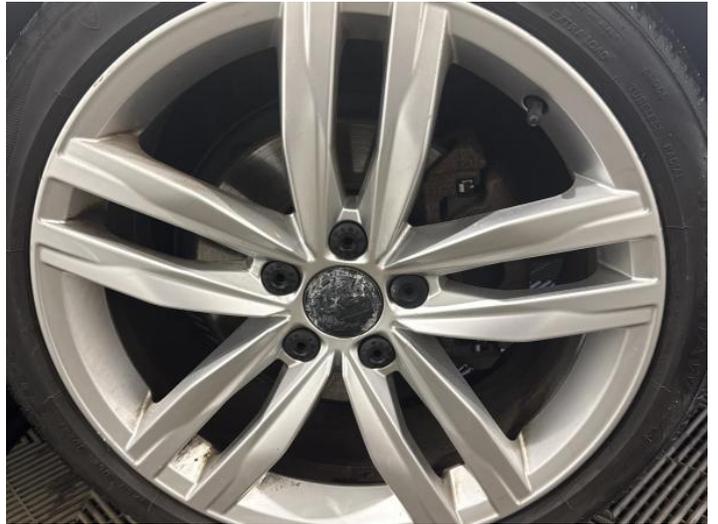
16: Wheel osf
Scratched
Up To 50mm

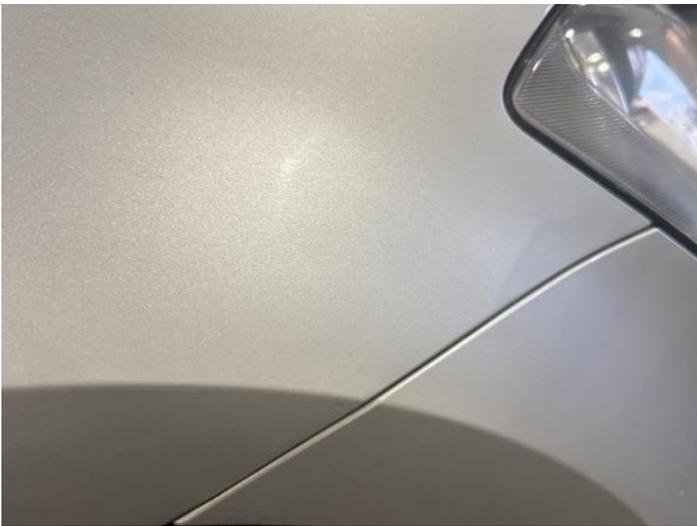
17: Wing osf
Chipped
1 To 5

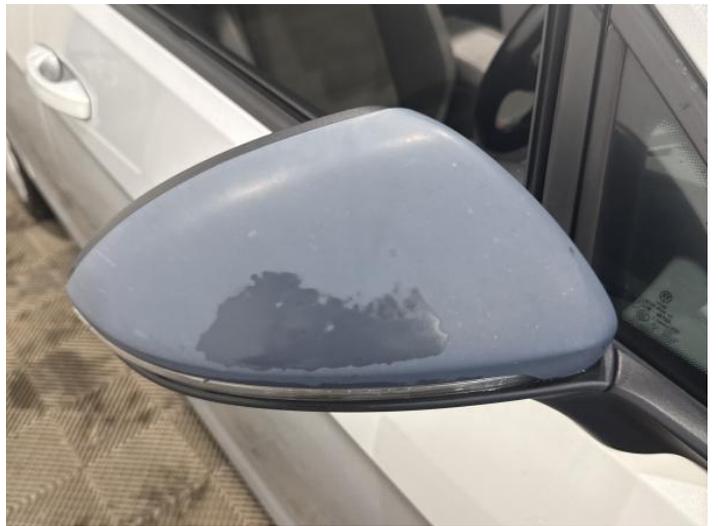
18: Door Mirror Assy osf
Scratched (Painted)
Over 25mm Thru Paint

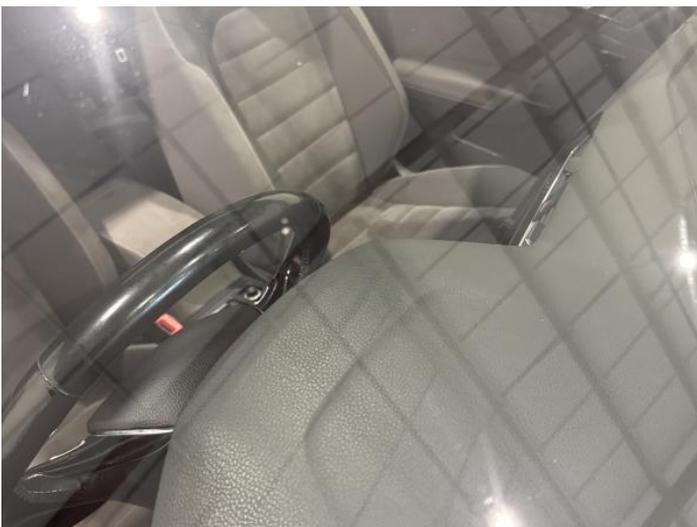
19: Screen Front
Chipped
UpTo 10mm
