VEHICLE INSPECTION REPORT

LG15SKK

Skoda Yeti Outdoor 2.0 TDI CR [170] Elegance 4x4 5dr DSG

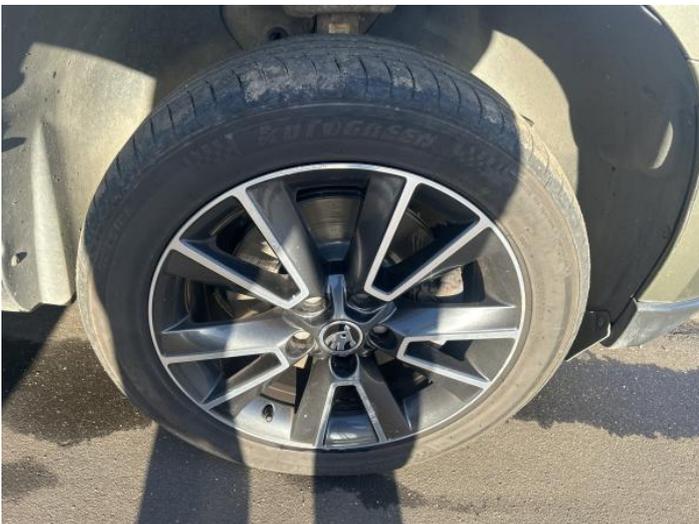
1: Wheel osf
Scratched
Over 50mm

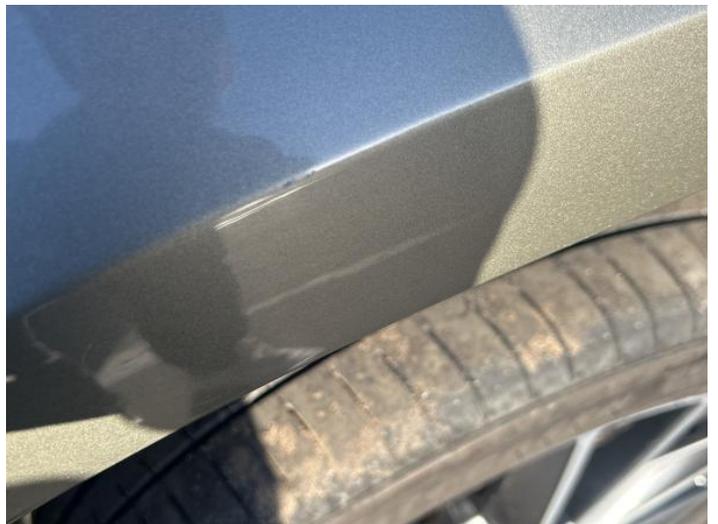
2: Wing osf
Chipped
1 To 5

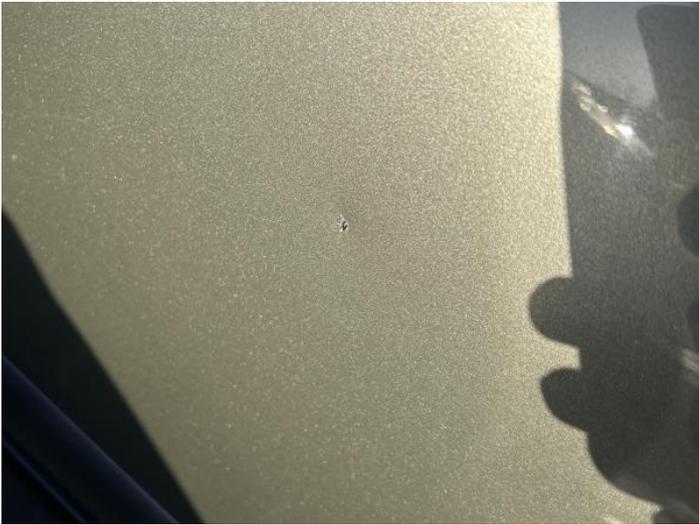
3: Door osf
Chipped
1 To 5

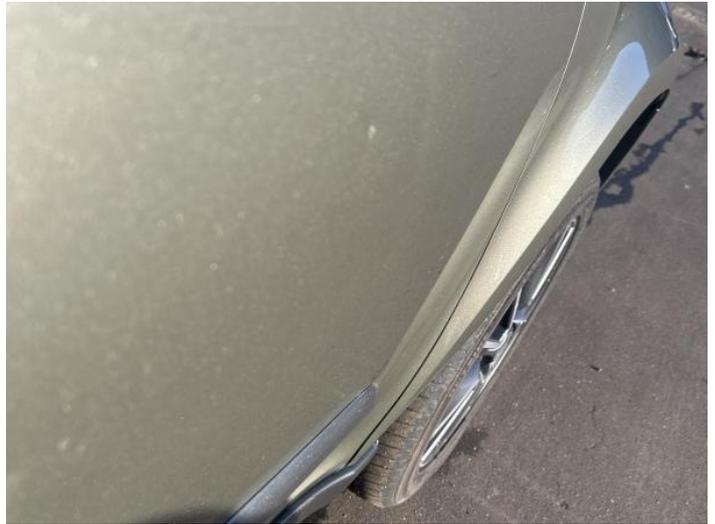
4: Door osf
Dented
2 Or Less UpTo 10mm

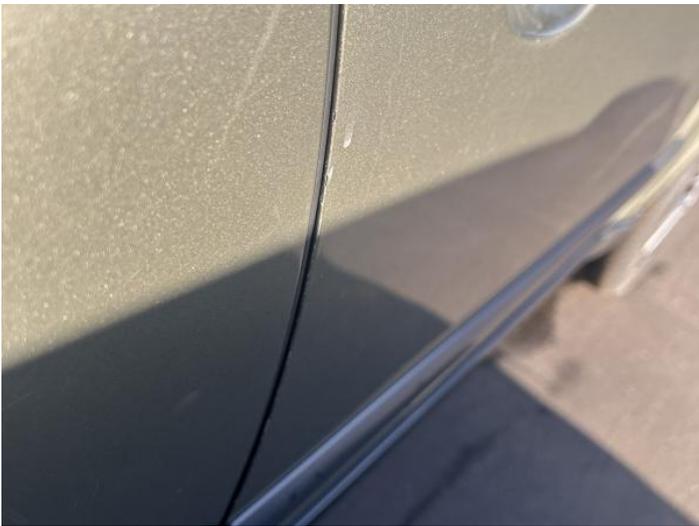
5: Door osf
Chipped
Edge Chip

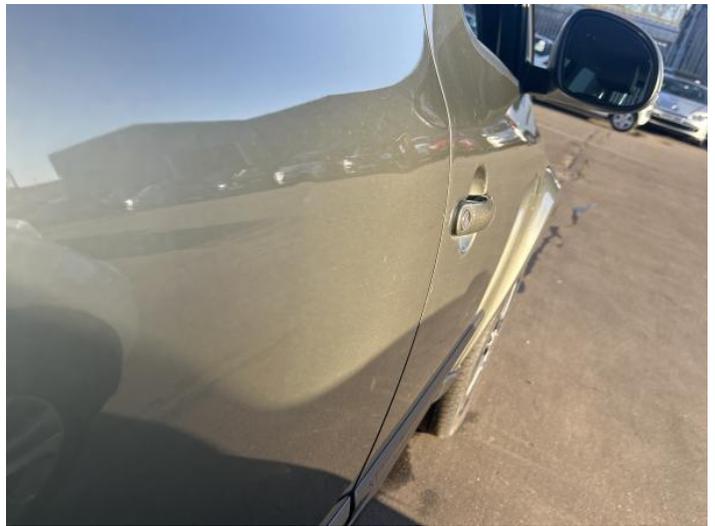
6: Door osr
Dented
Over 2 UpTo 10mm

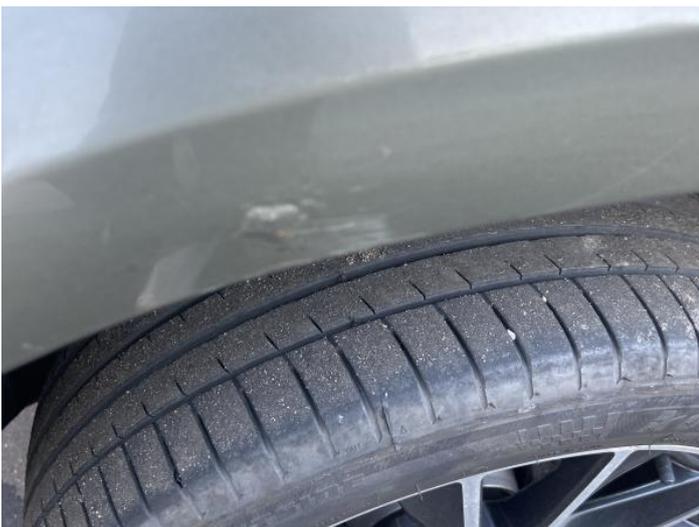
7: Qtr Panel osr
Rusted
Over 5mm

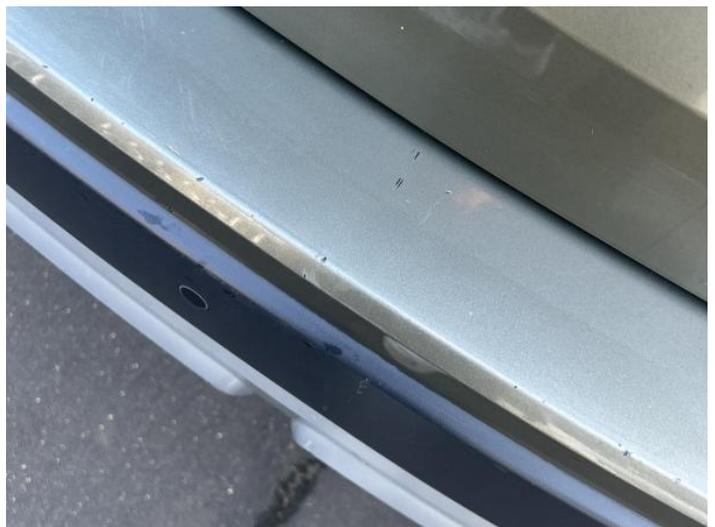
8: Bumper Rear
Chipped
Multiple Chips

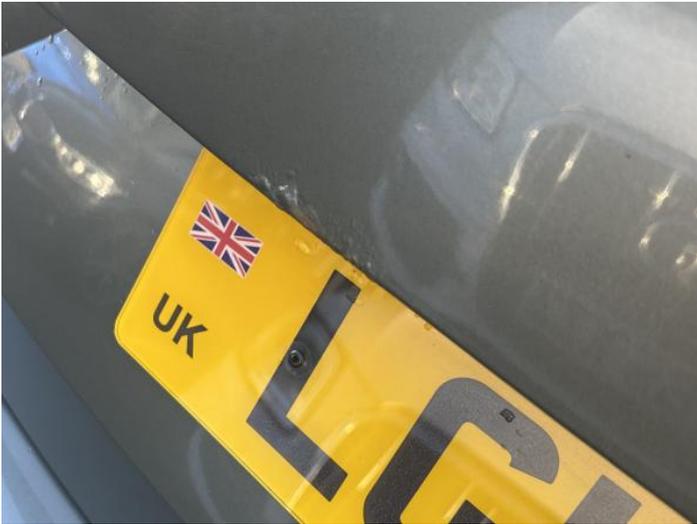
9: Tailgate
Rusted
Over 5mm

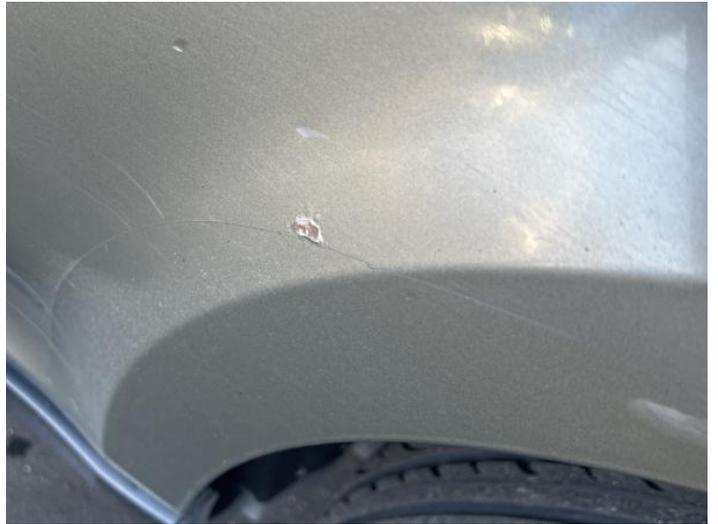
10: Door nsr
Chipped
1 To 5

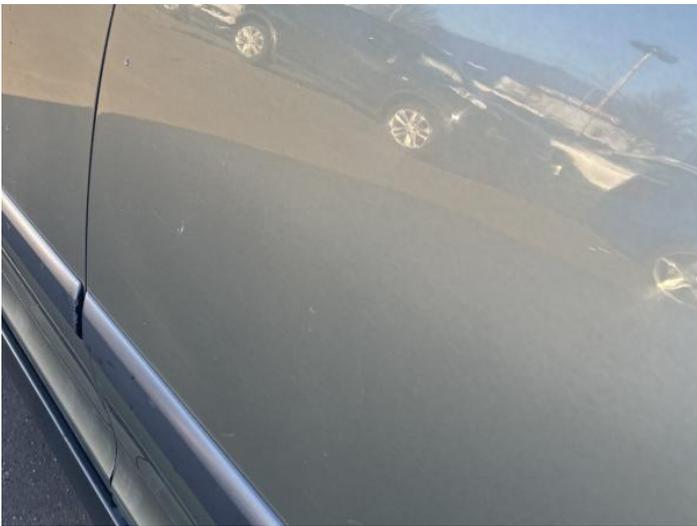
11: Door nsr
Scratched
Over 25mm Not Thru Paint

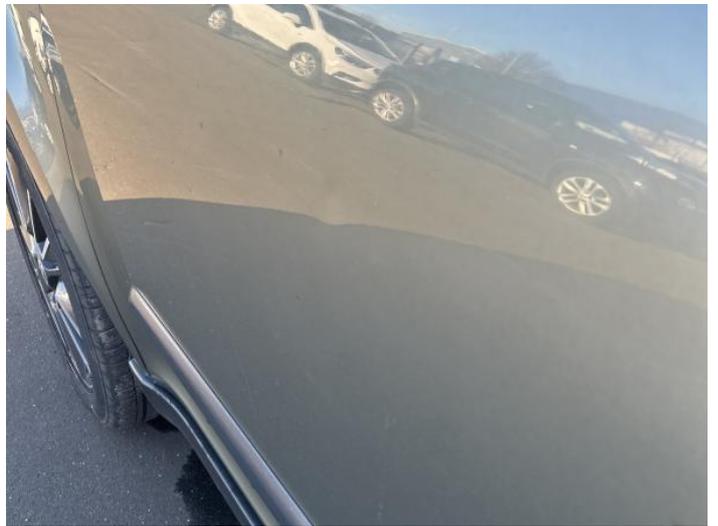
12: Door nsf
Dented
Between 10mm + 30mm

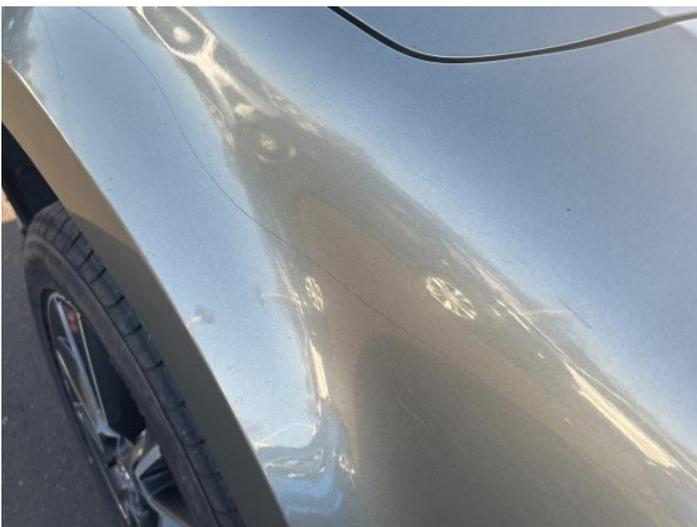
13: Wing nsf
Scratched
Over 25mm Thru Paint

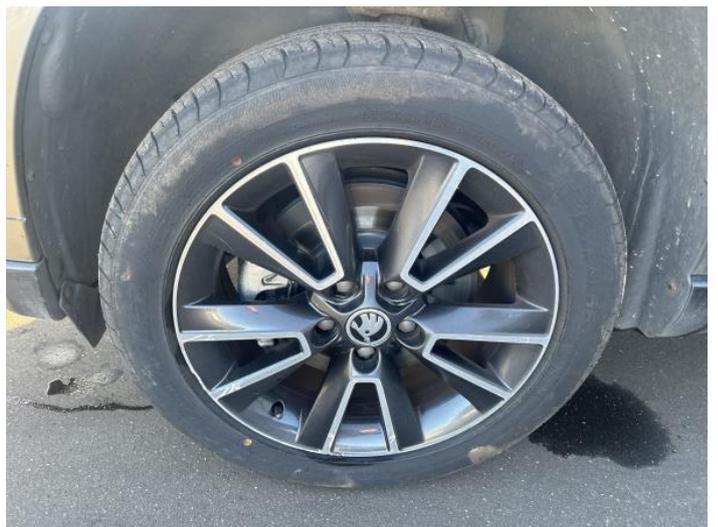
14: Wheel nsf
Scratched
Over 50mm

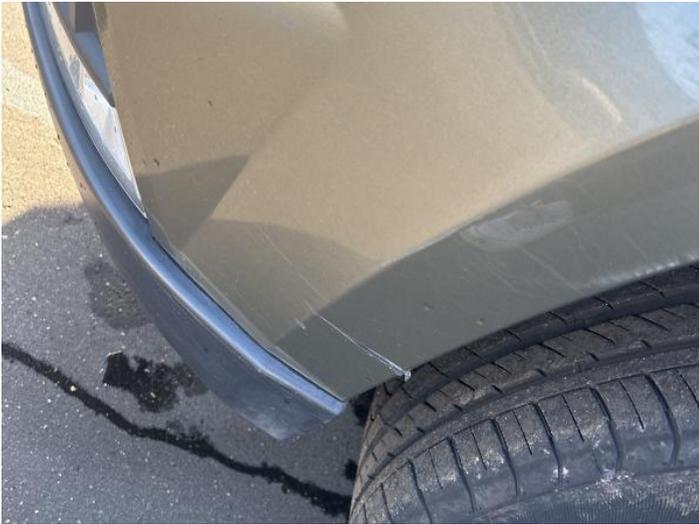
15: Bumper Front
 Scratched
 Over 100mm Thru Paint

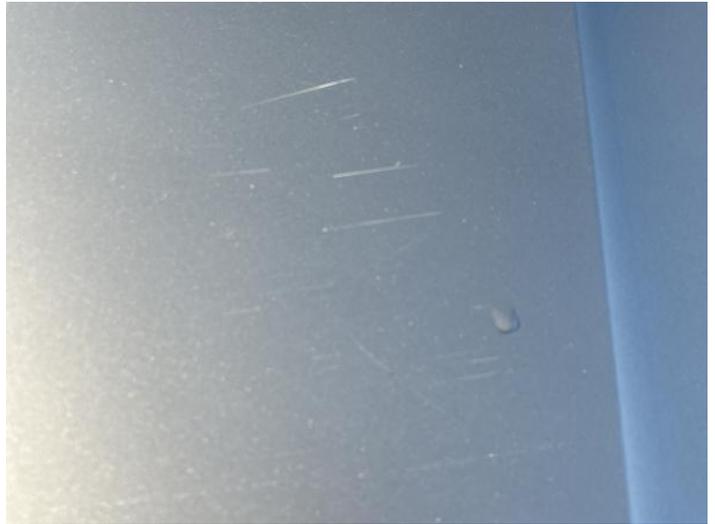
16: Bonnet
 Scratched
 Over 25mm Thru Paint

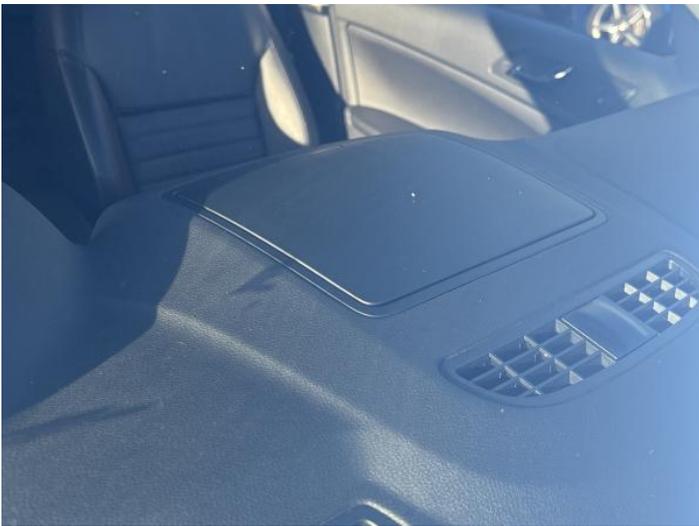
17: Screen Front
 Chipped
 UpTo 10mm
