VEHICLE INSPECTION REPORT

WJ20HUO

Nissan Juke 1.0 DiG-T Tekna+ 5dr

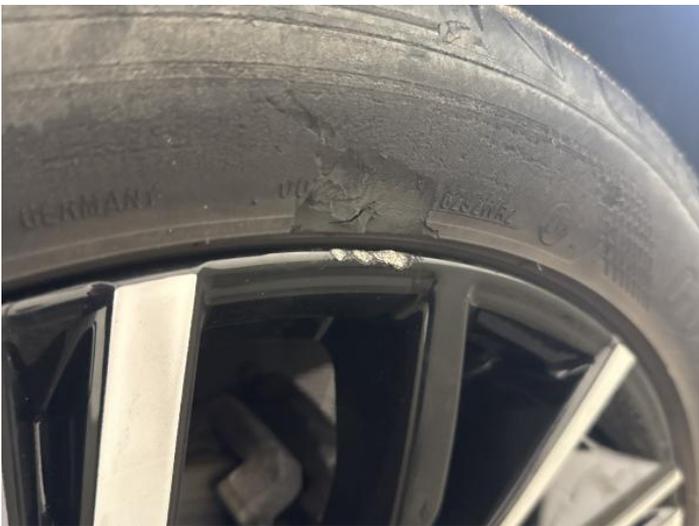
1: Tyre of
Damaged
Replace

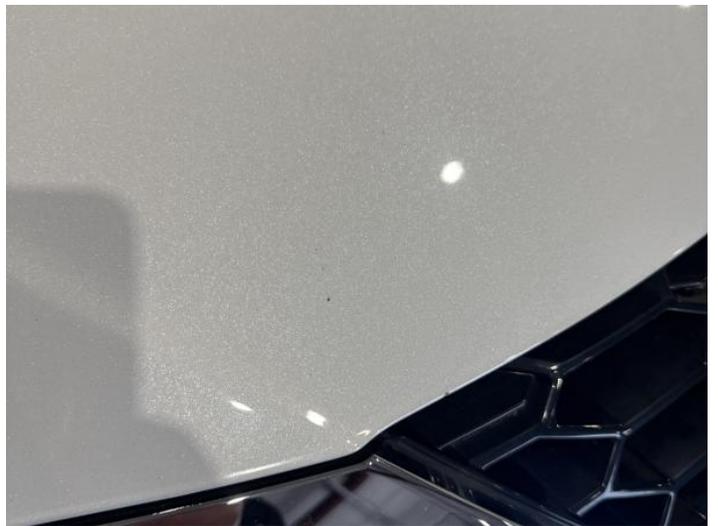
2: Bonnet
Chipped
1 To 5

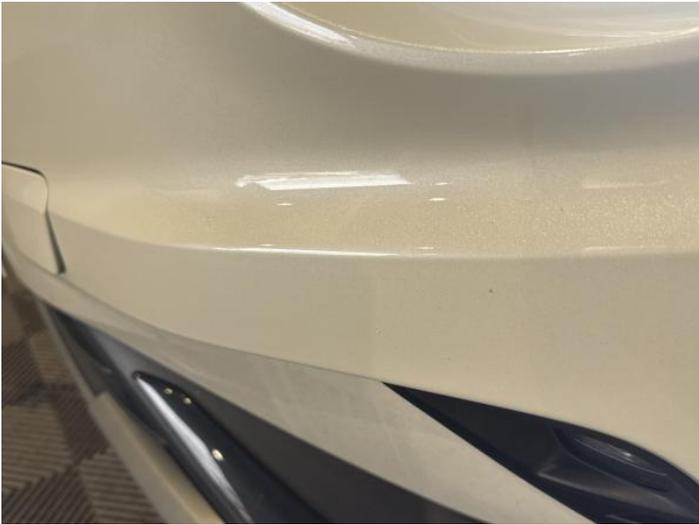
3: Bumper Front
Chipped
1 To 5

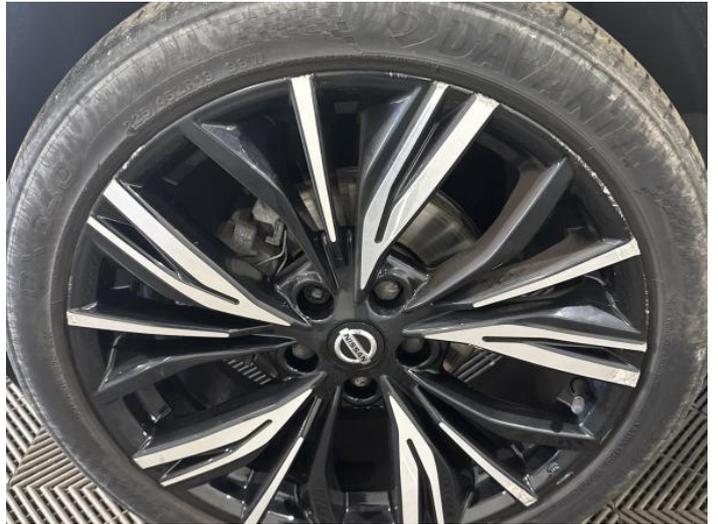
4: Wheel nsf
Scratched
Over 50mm

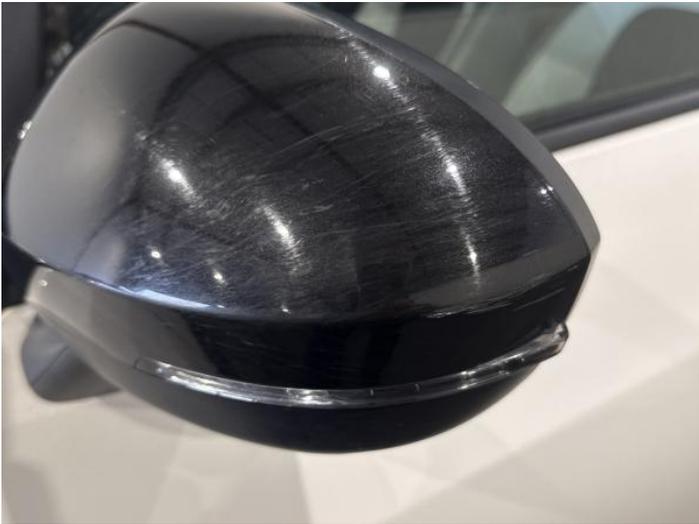
5: Door Mirror Assy nsf
Scratched (Painted)
Over 25mm Thru Paint

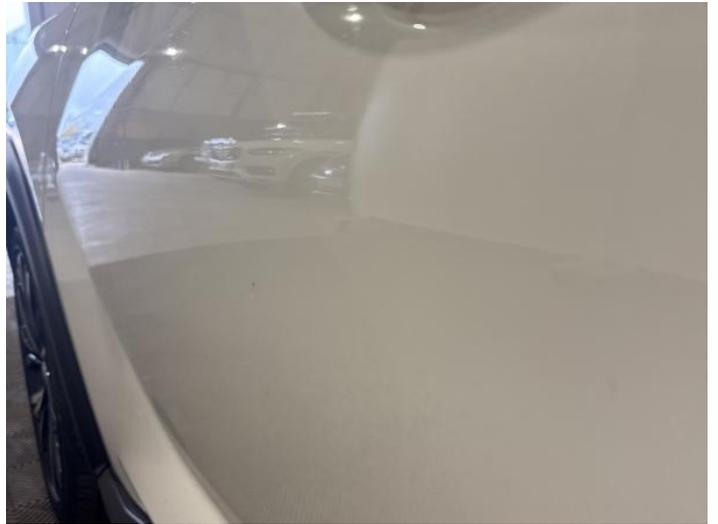
6: Door nsf
Dented
Over 30mm

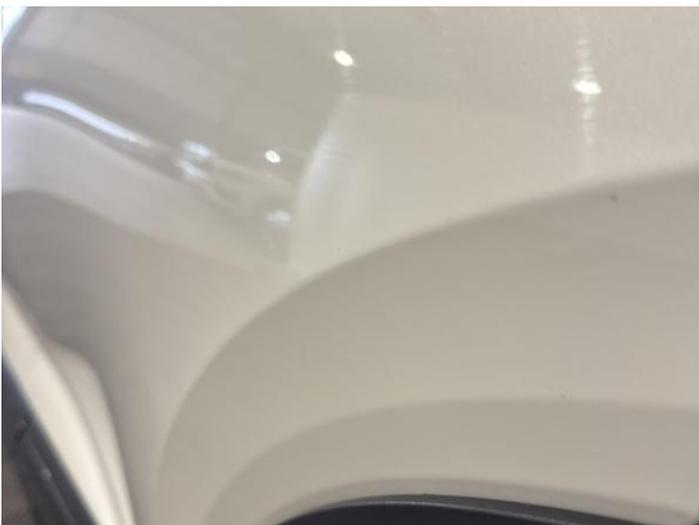
7: Door nsr
Dented
Between 10mm + 30mm

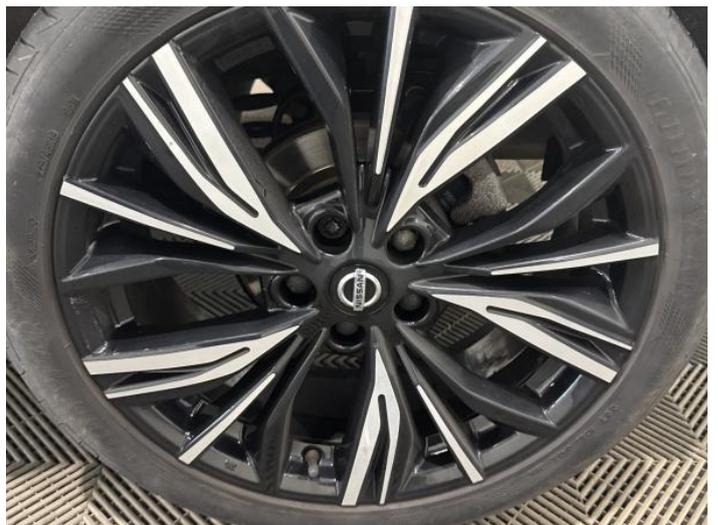
8: Wheel nsr
Scratched
Up To 50mm

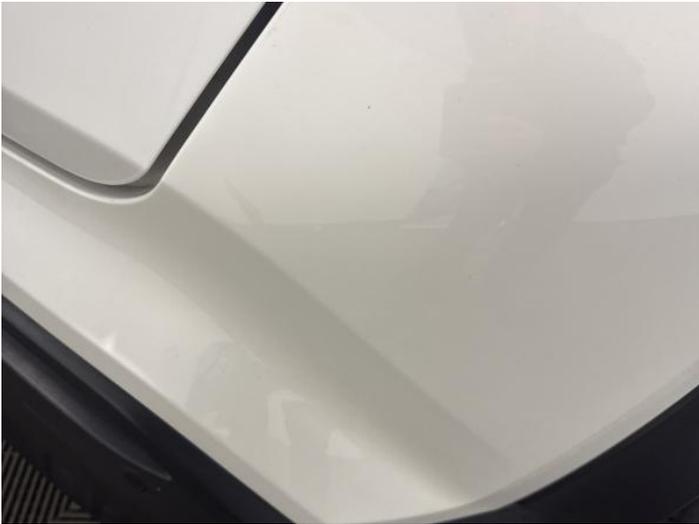
9: Bumper Rear
Scratched
Up To 25mm Thru Paint

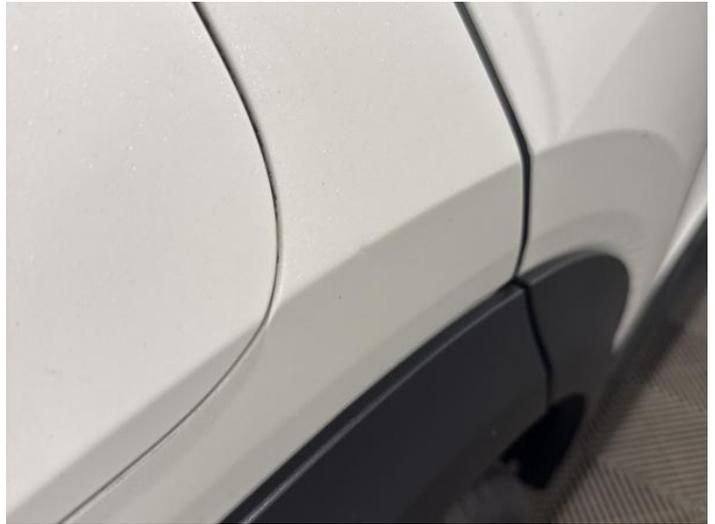
10: Qtr Panel nsr
Dented
2 Or Less Up To 10mm

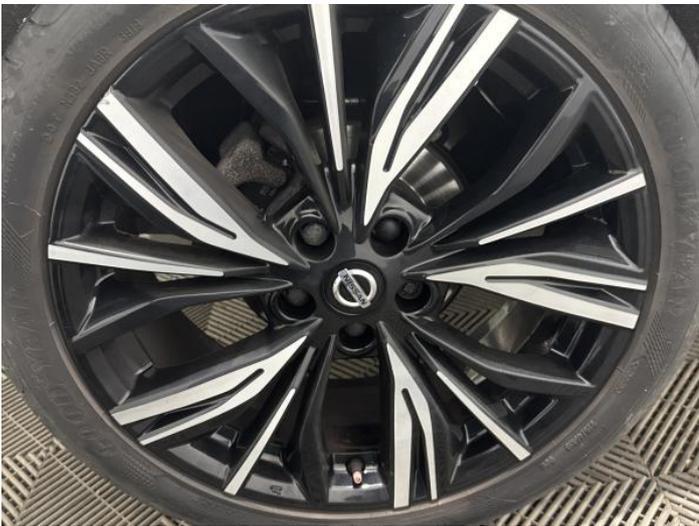
11: Wheel osr
Scratched
Up To 50mm

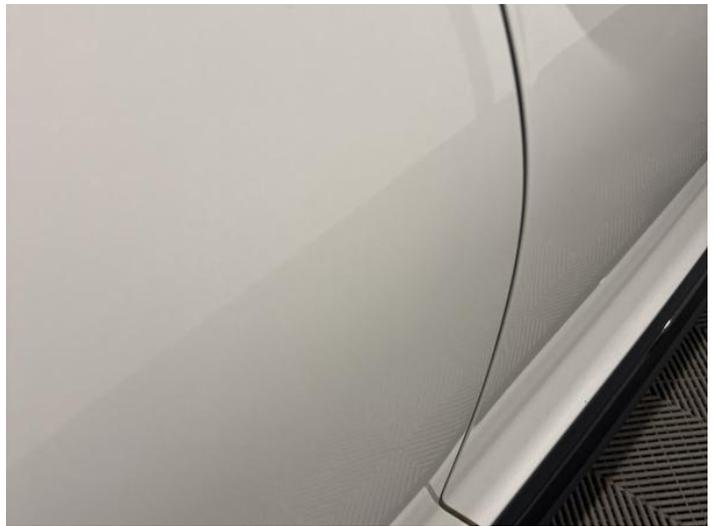
12: Door osr
Dented
Between 10mm + 30mm

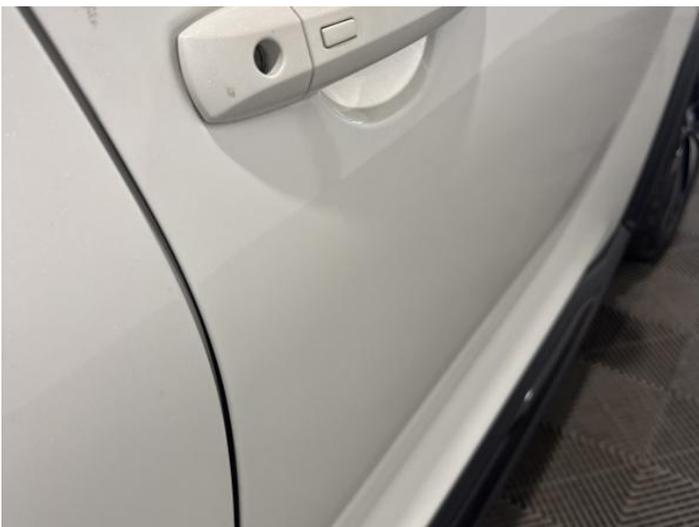
13: Door osf
Dented
Over 30mm

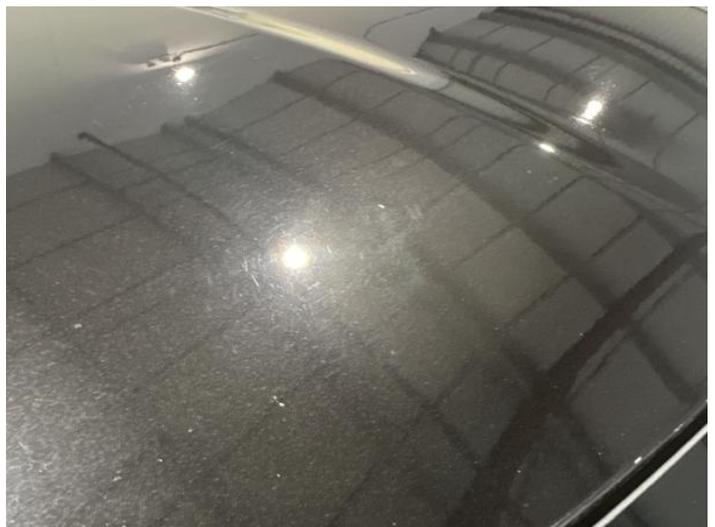
14: Roof
Dented
Over 30mm

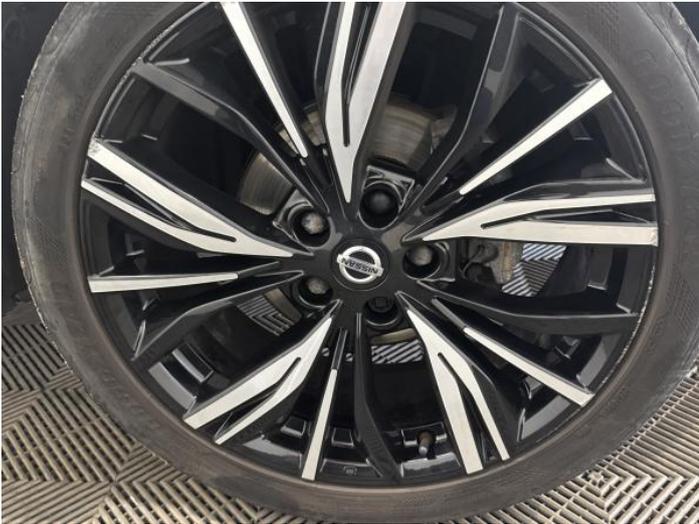
15: Wheel osf
Scratched
Over 50mm

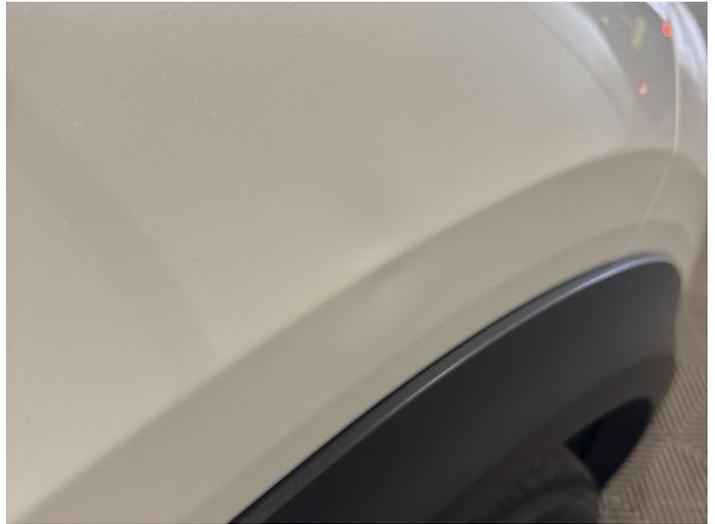
16: Wing osf
Dented
Over 30mm
