VEHICLE INSPECTION REPORT

LG62RVK

Jaguar XF 2.2d [163] Luxury 4dr Auto

nama
GRADE
4

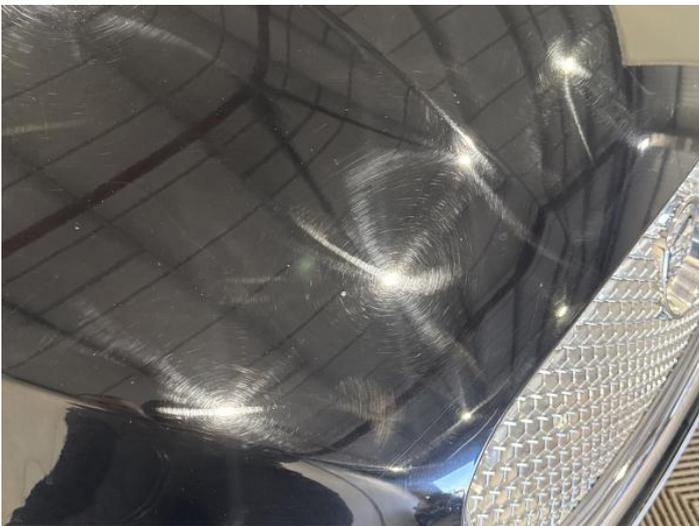
1: Bonnet
Chipped
Multiple Chips

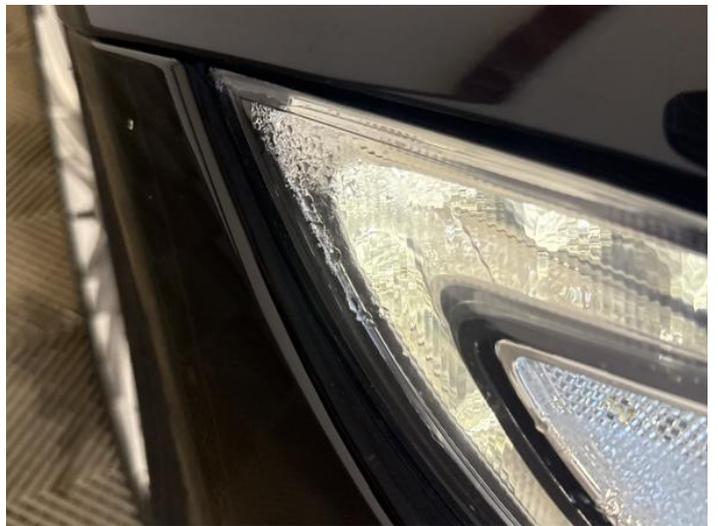
2: Bumper Front
Chipped
1 To 5

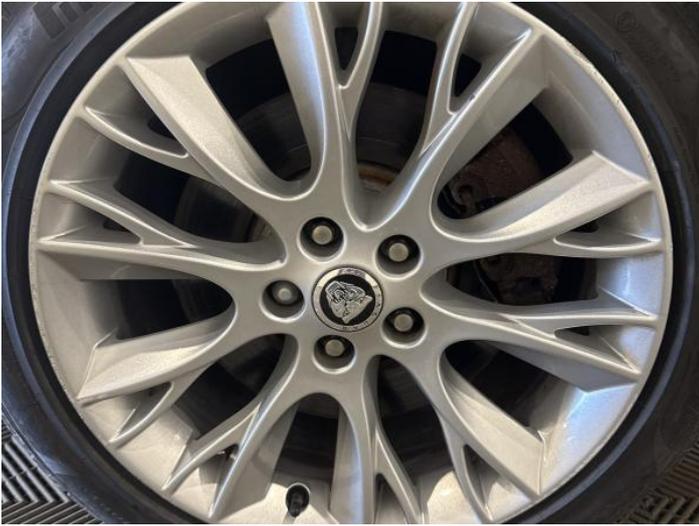
3: Wheel nsf
Scratched
Over 50mm

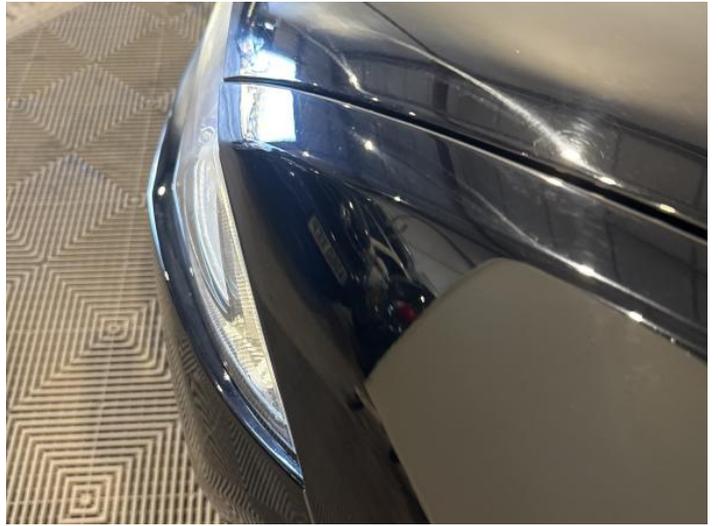
4: Wing nsf
Chipped
1 To 5

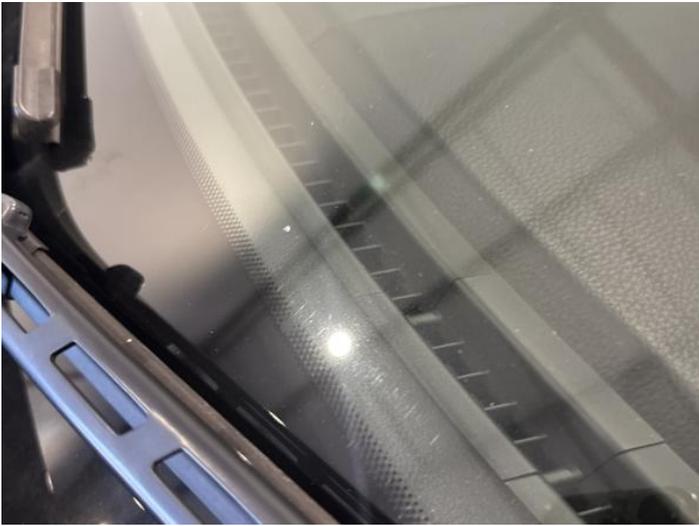
5: Screen Front
Chipped
Up To 10mm

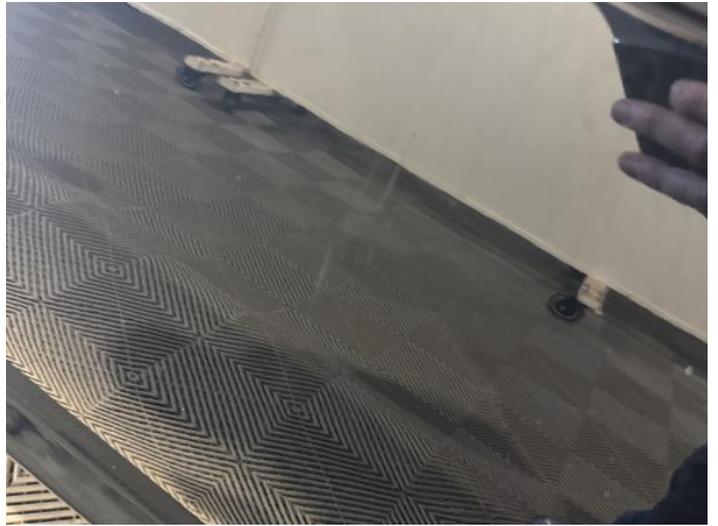
6: Door nsf
Scratched
Over 25mm Thru Paint

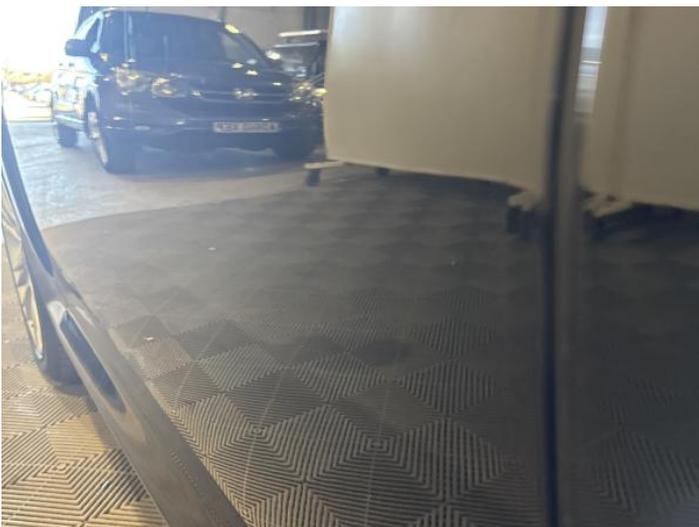
7: Door nsf
Dented
Over 30mm

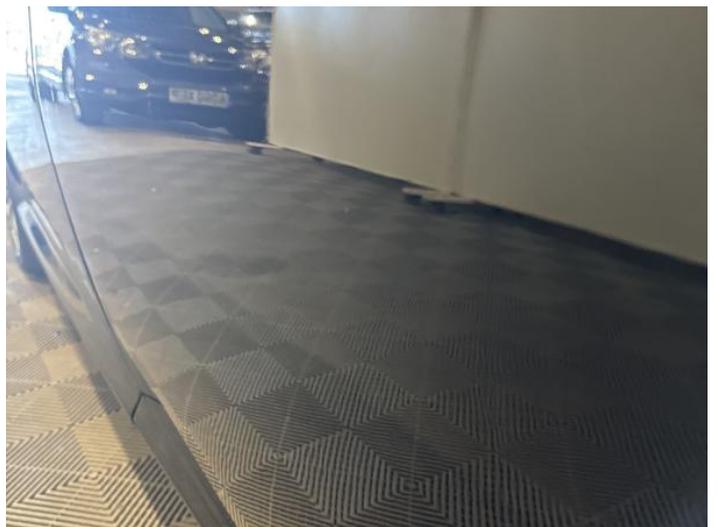
8: Door nsr
Dented
Between 10mm + 30mm

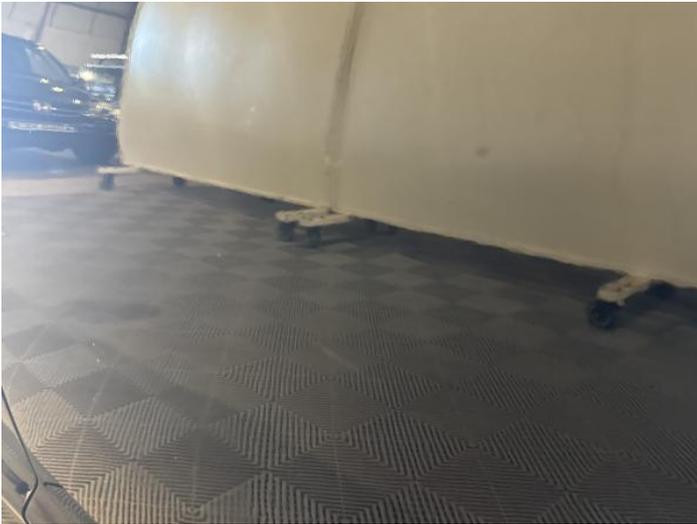
9: Door nsr
Scratched
UpTo 25mm Thru Paint

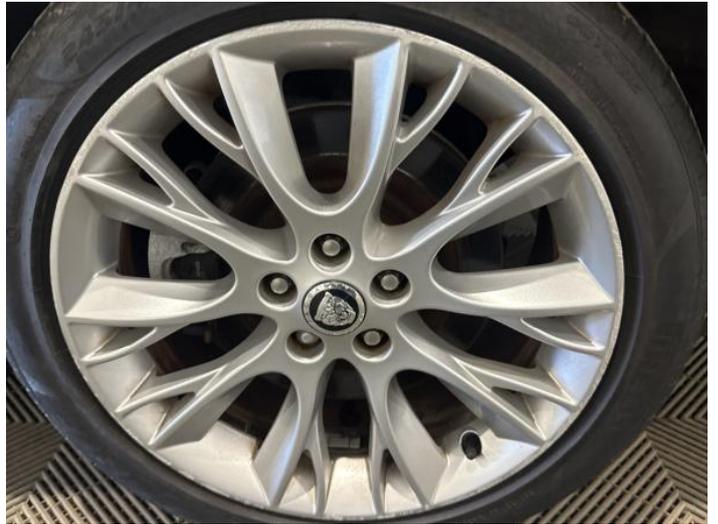
10: Wheel nsr
Scratched
Over 50mm

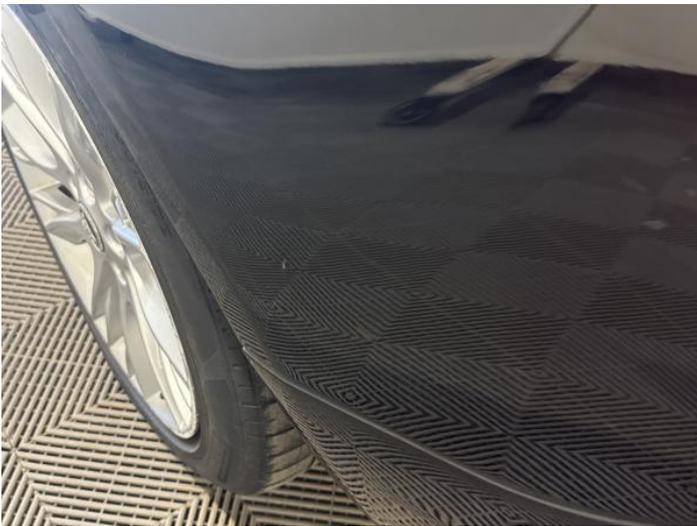
11: Qtr Panel nsr
Chipped
1 To 5

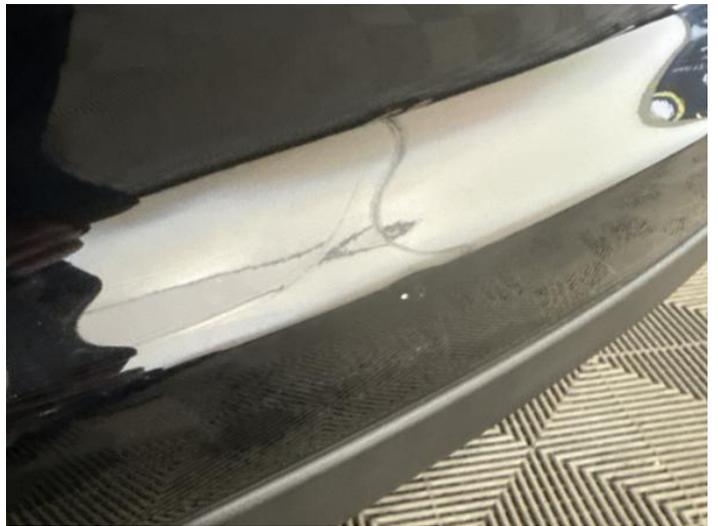
12: Bumper Rear
Dented
With Paint Damage

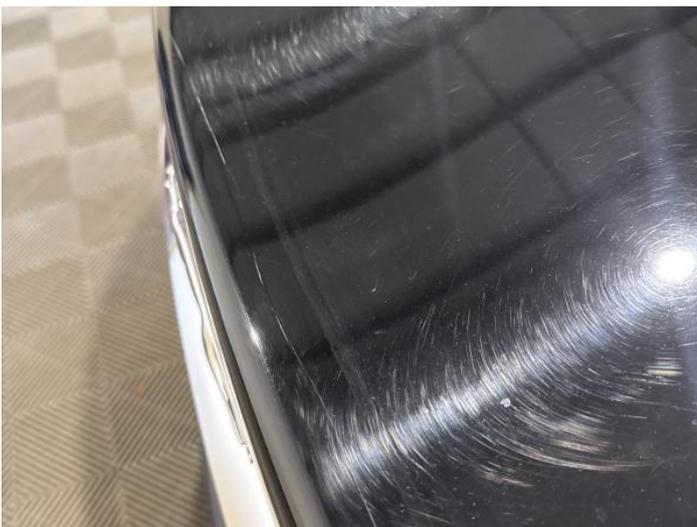
13: Boot Lid
Scratched
Over 25mm Thru Paint

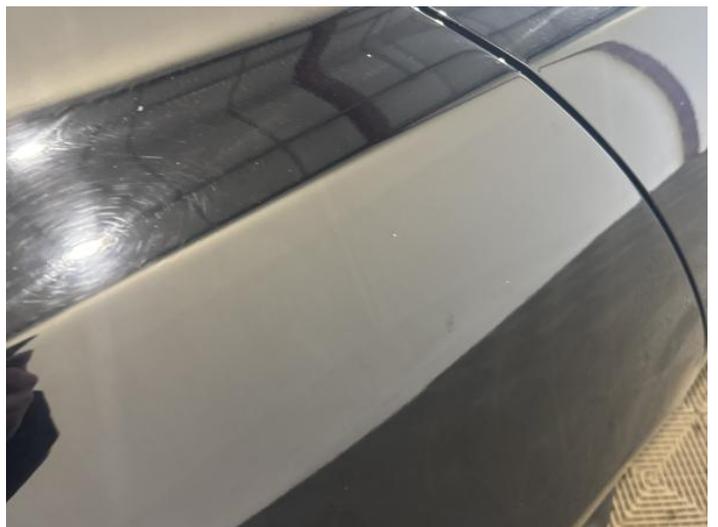
14: Qtr Panel osr
Chipped
1 To 5

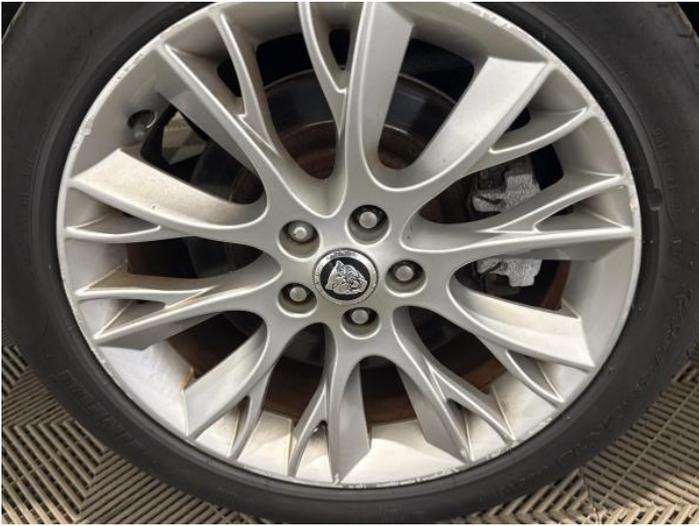
15: Wheel osr
Scratched
Over 50mm

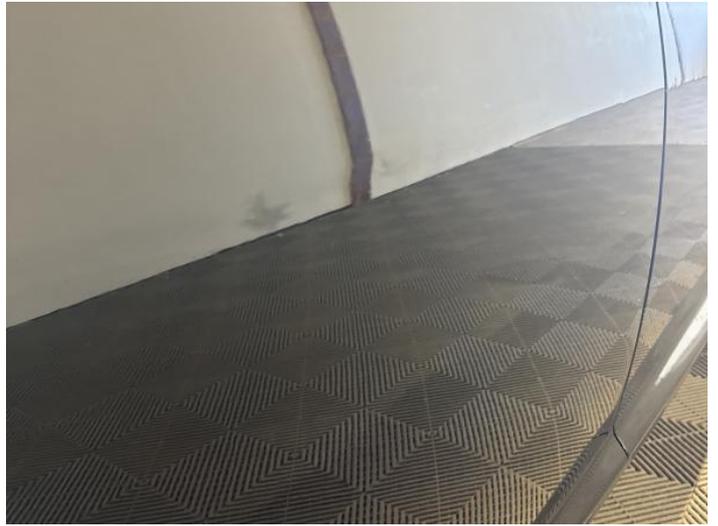
16: Door osr
Scratched
Over 25mm Thru Paint

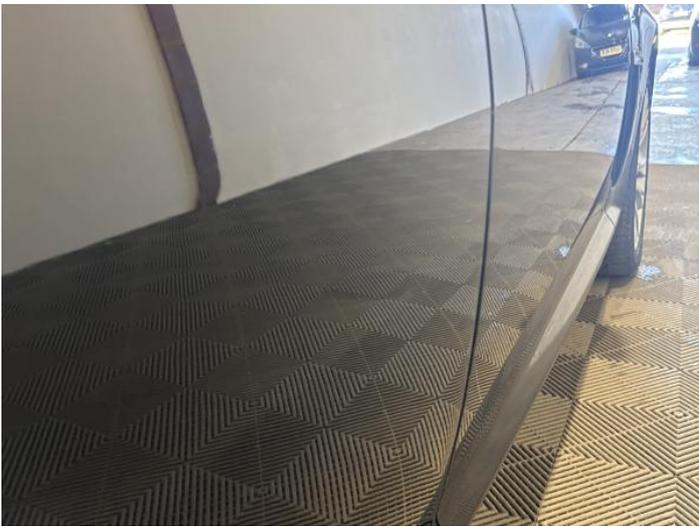
17: Door osr
Dented
Between 10mm + 30mm

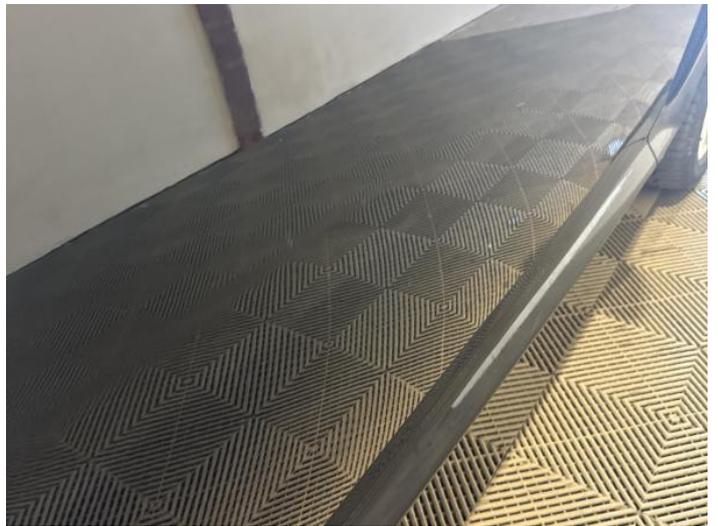
18: Door osf
Dented
Over 30mm

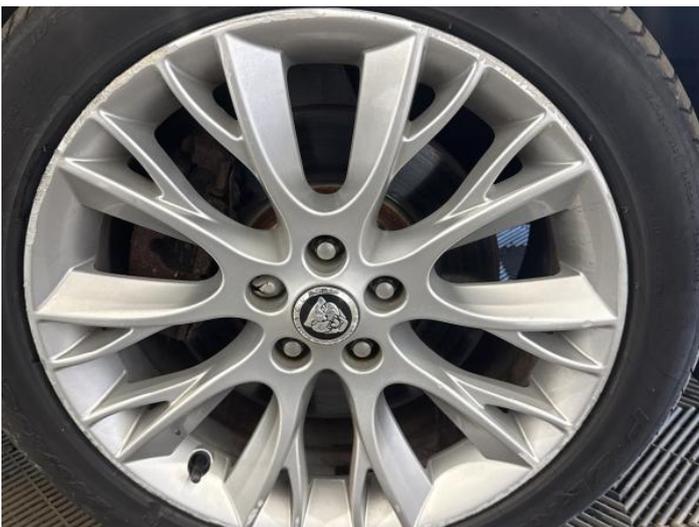
19: Wheel osf
Scratched
Over 50mm

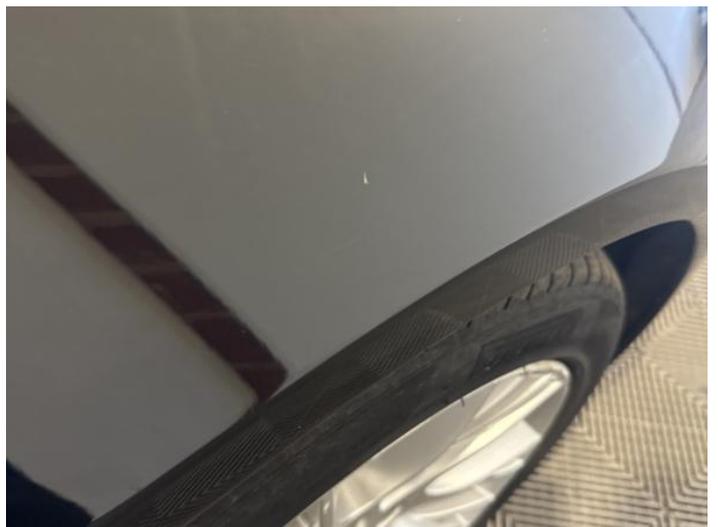
20: Wing osf
Scratched
Over 25mm Thru Paint
