VEHICLE INSPECTION REPORT

Toyota Yaris 1.33 VVT-i Icon+ 5dr

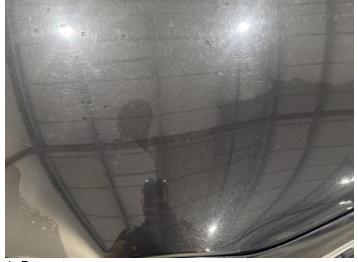
1: Bonnet Chipped 1 To 5

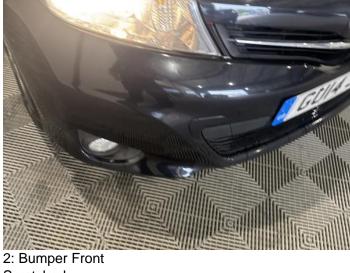
2: Bumper Front Scratched 25 to 100mm Thru Paint

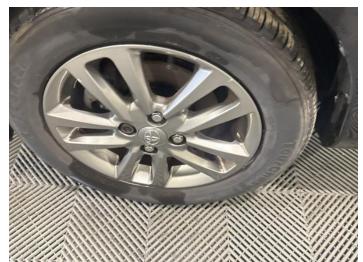
3: Wheel nsf Scratched Up To 50mm

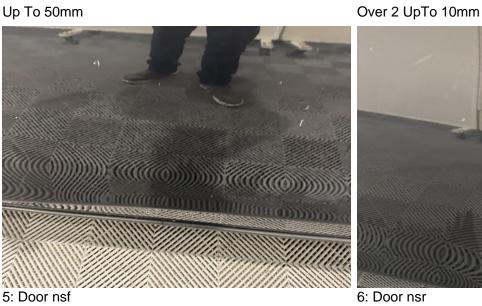
5: Door nsf Chipped Multiple Chips

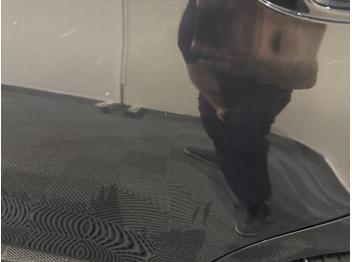
6: Door nsr Chipped 1 To 5

Dented

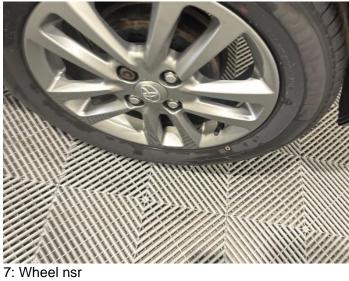
7: Wheel nsr Scratched Up To 50mm

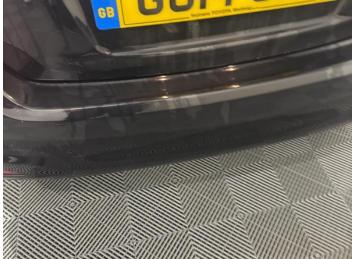
8: Bumper Rear Chipped Multiple Chips

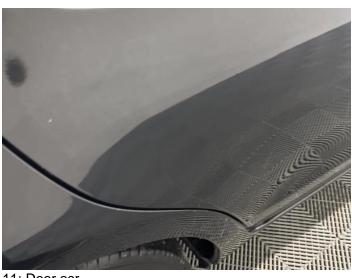
11: Door osr Dented Over 2 UpTo 10mm

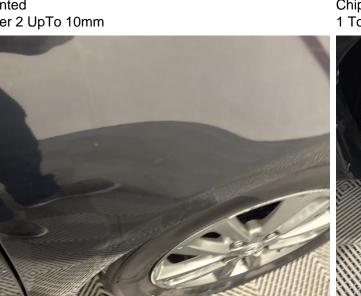
13: Wing osf Chipped 1 To 5

1 To 5
