VEHICLE INSPECTION REPORT

GY22MLJ

Peugeot 2008 1.2 PureTech Allure Premium 5dr

nama
GRADE
4

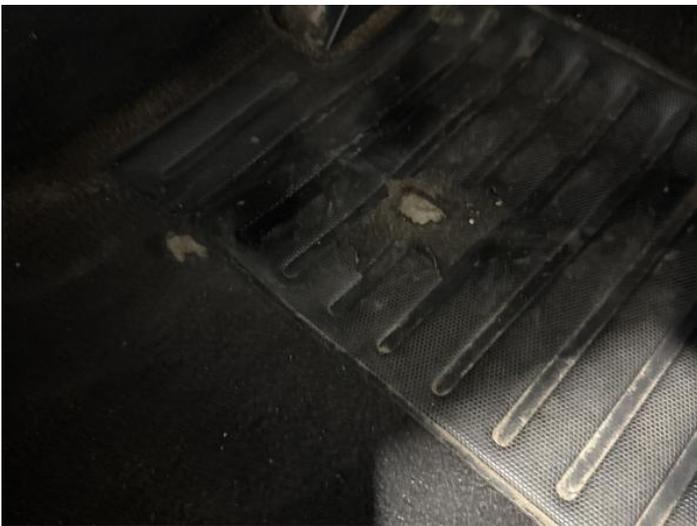
1: Carpets Front
Scuffed
Over 25mm

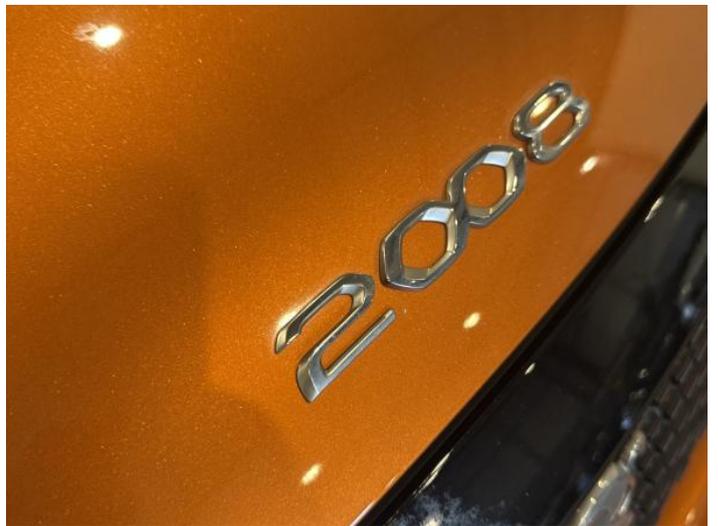
2: Bonnet
Chipped
1 To 5

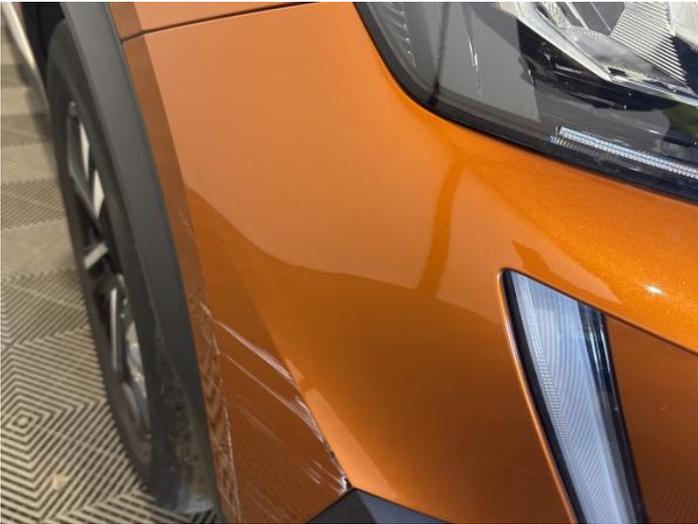
3: Bumper Front
Scratched
25 to 100mm Thru Paint

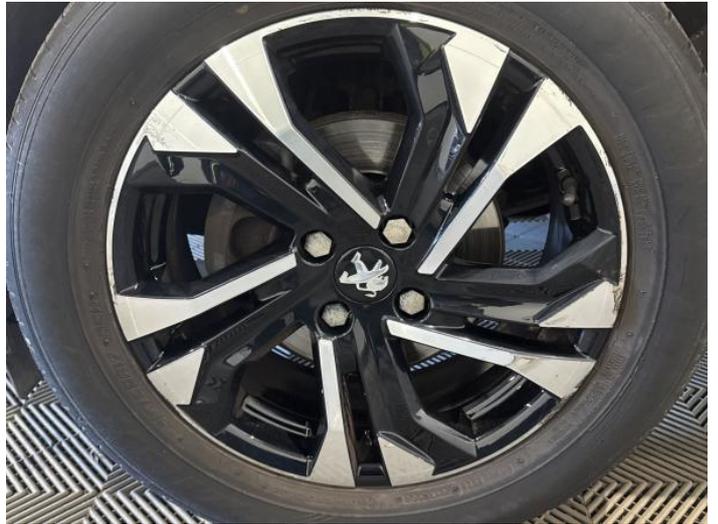
4: Wheel nsf
Scratched
Over 50mm

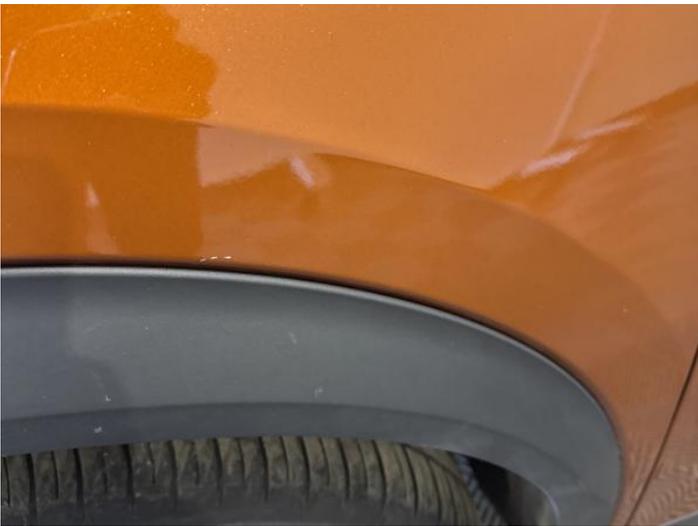
5: Wing nsf
Chipped
1 To 5

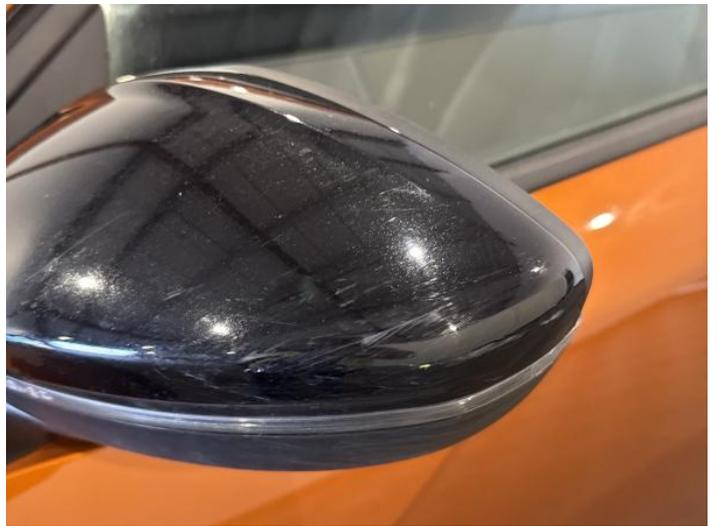
6: Door Mirror Assy nsf
Scratched (Painted)
UpTo 25mm Thru Paint

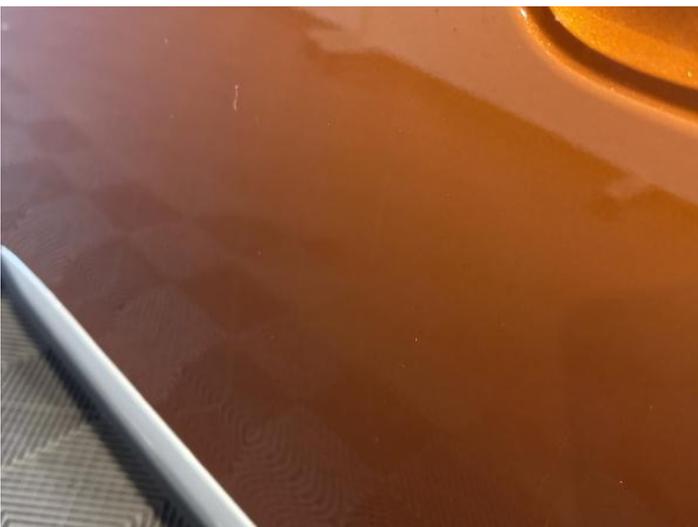
7: Door nsf
Chipped
Multiple Chips

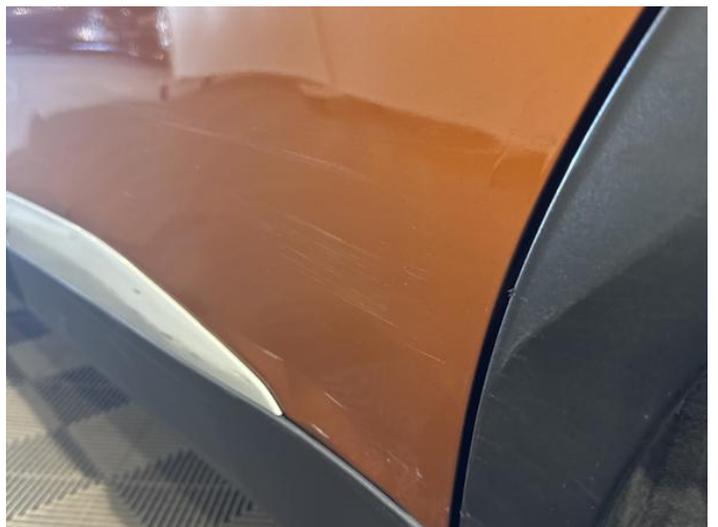
8: Door nsr
Dented
With Paint Damage

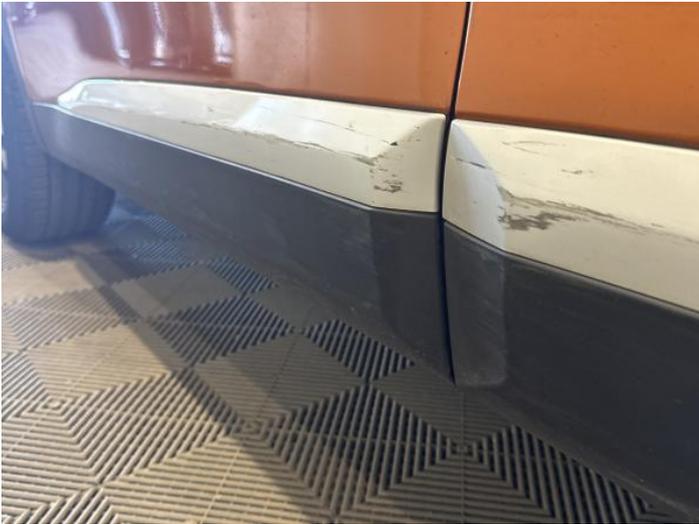
9: Door Moulding nsf
Scratched (Painted)
Over 25mm Thru Paint

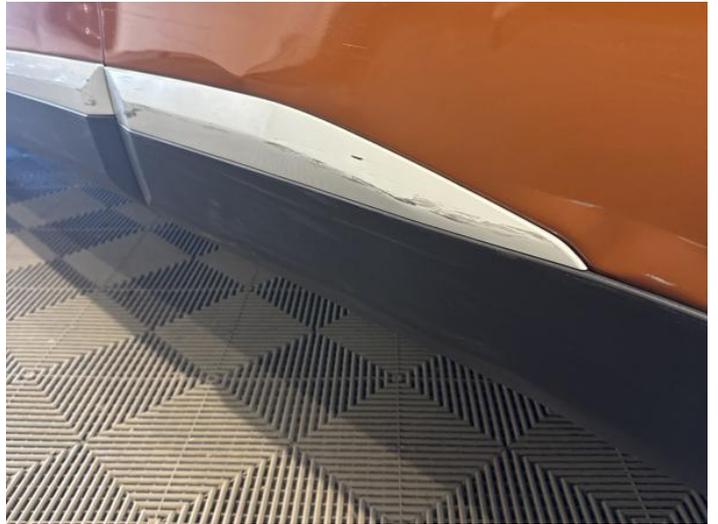
10: Door Moulding nsr
Scratched (Painted)
Over 25mm Thru Paint

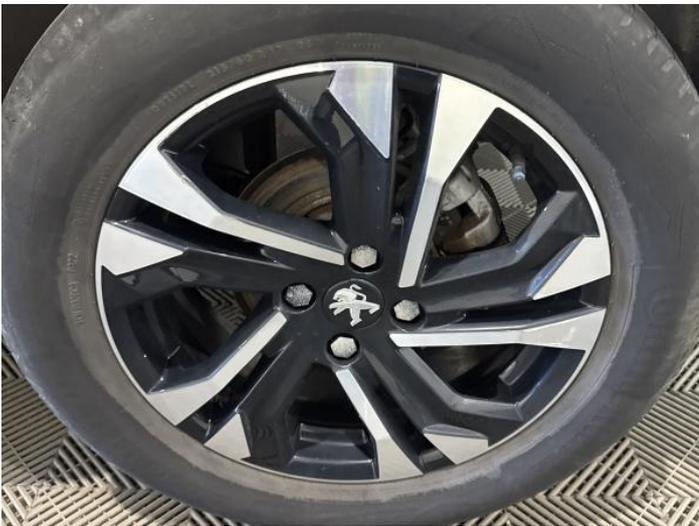
11: Wheel nsr
Scratched
Over 50mm

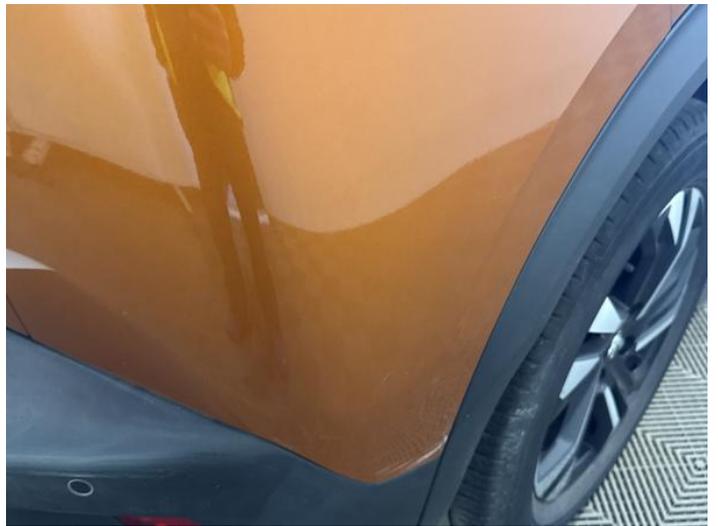
12: Bumper Rear
Scratched
25 to 100mm Thru Paint

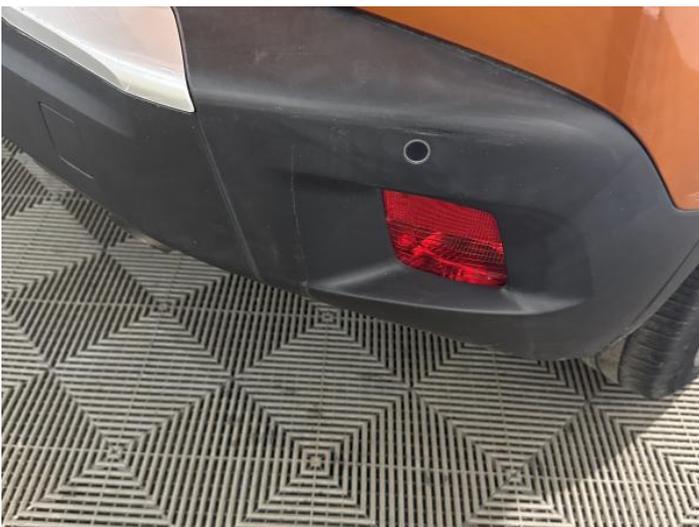
13: Bumper Rear Moulding
Scuffed (Unpainted)
Over 100mm

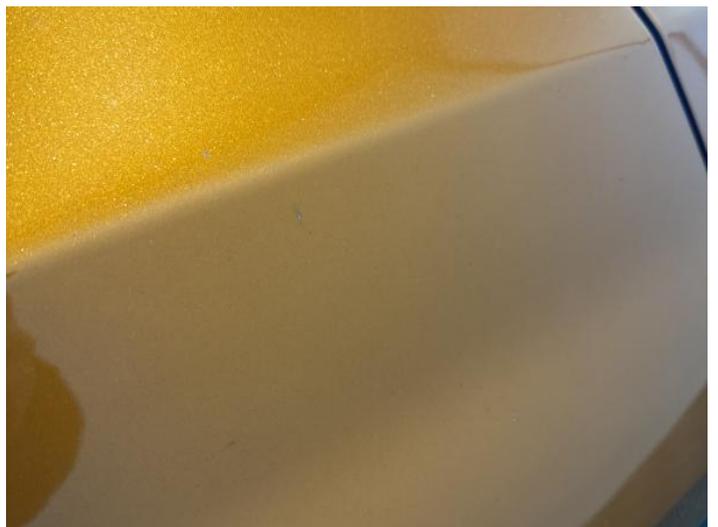
14: Qtr Panel osr
Chipped
1 To 5

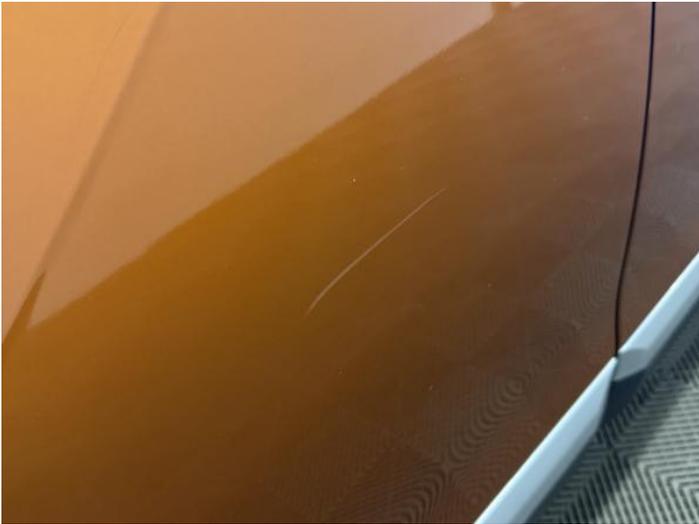
15: Door osr
Scratched
Over 25mm Thru Paint

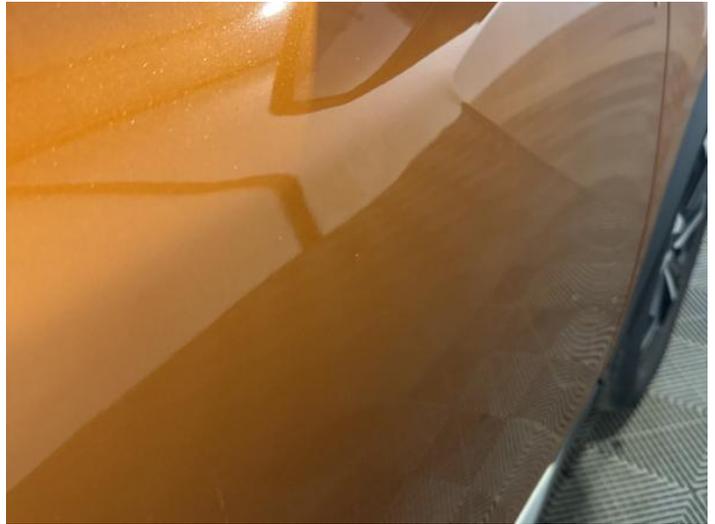
16: Door osf
Dented
Over 30mm

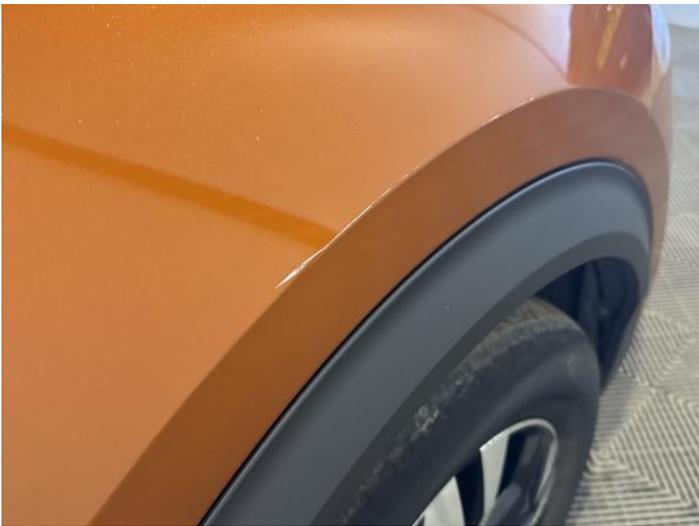
17: Wing osf
Scratched
Over 25mm Thru Paint

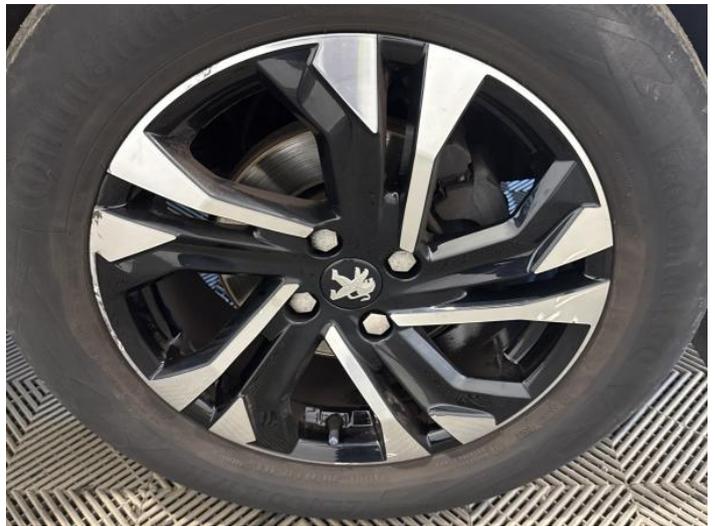
18: Wheel osf
Scratched
Over 50mm

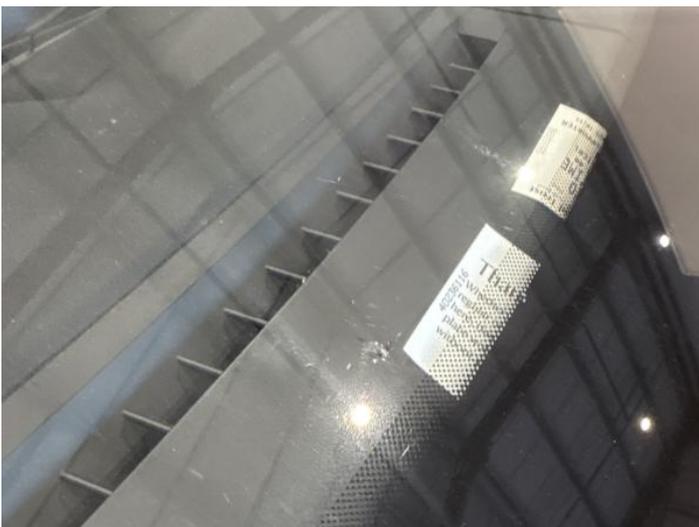
19: Screen Front
Cracked
Replace

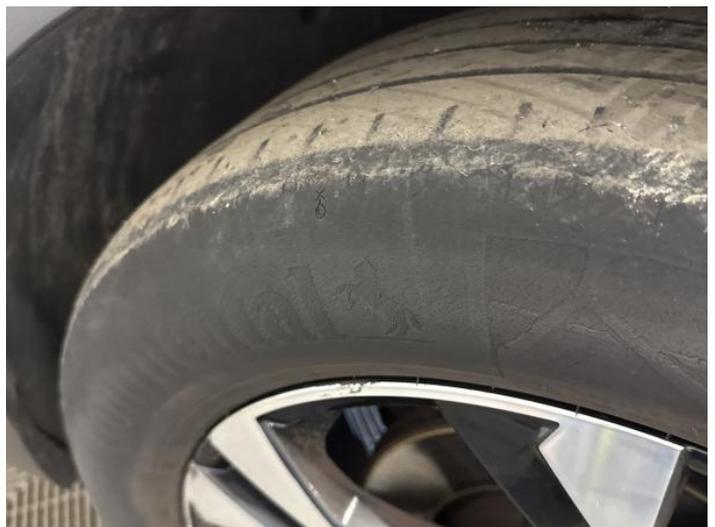
NSF	FALKEN	4.0mm
NSR	CONTINENTAL	Worn
OSF	CONTINENTAL	Damaged
OSR	FALKEN	4.0mm
Spare

20: Tyre osf
Damaged
Replace
