VEHICLE INSPECTION REPORT

EG15OSM

Nissan X-Trail 1.6 dCi N-Tec 5dr

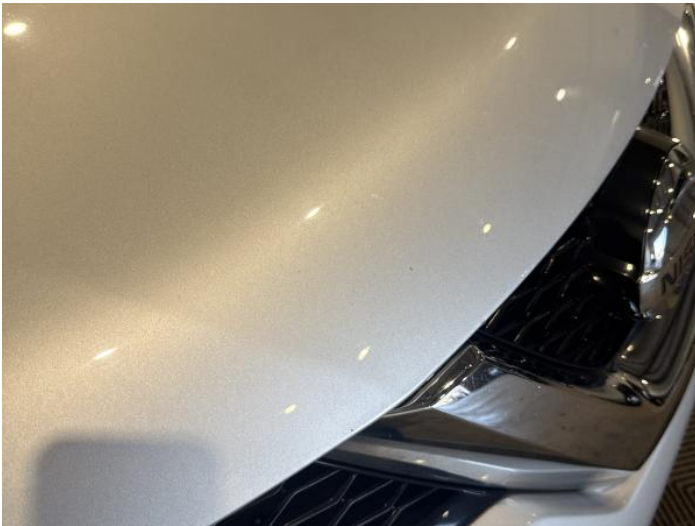
1: Bonnet
Chipped
1 To 5

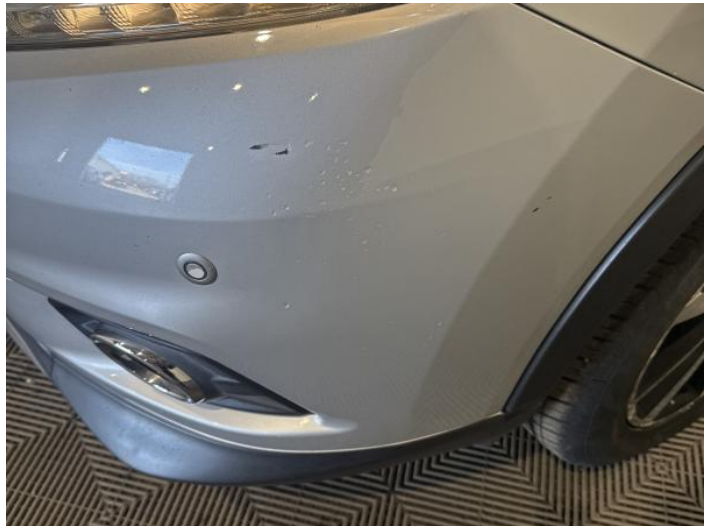
2: Bumper Front
Poor Previous Repair
Poor Colour

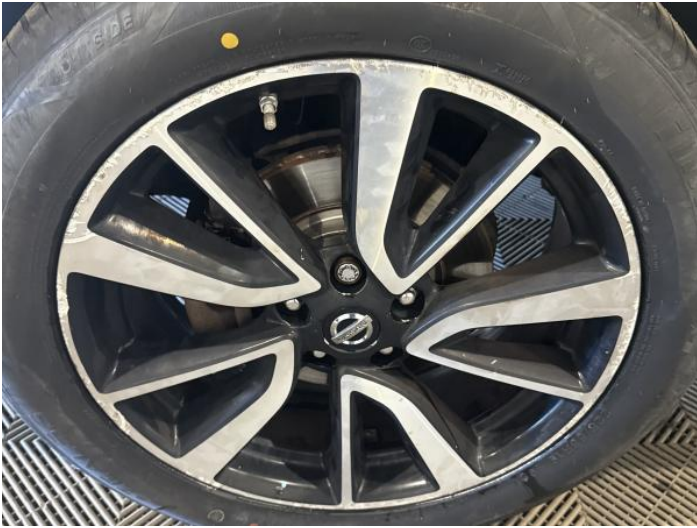
3: Wheel nsf
Scratched
Over 50mm

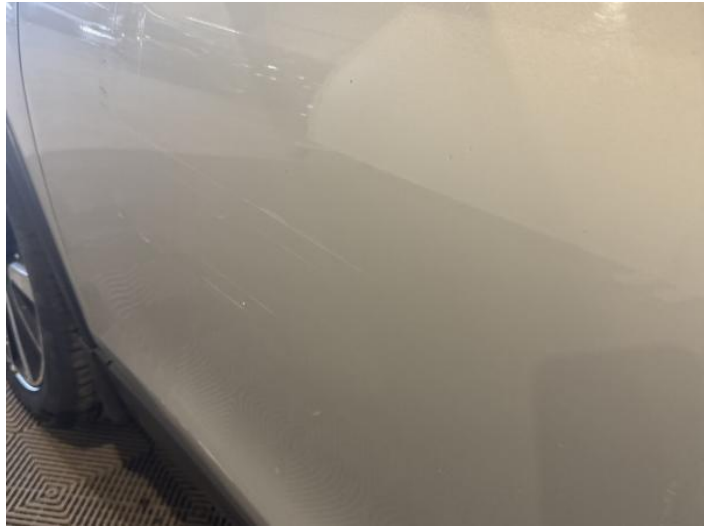
4: Door nsf
Scratched
Over 25mm Thru Paint

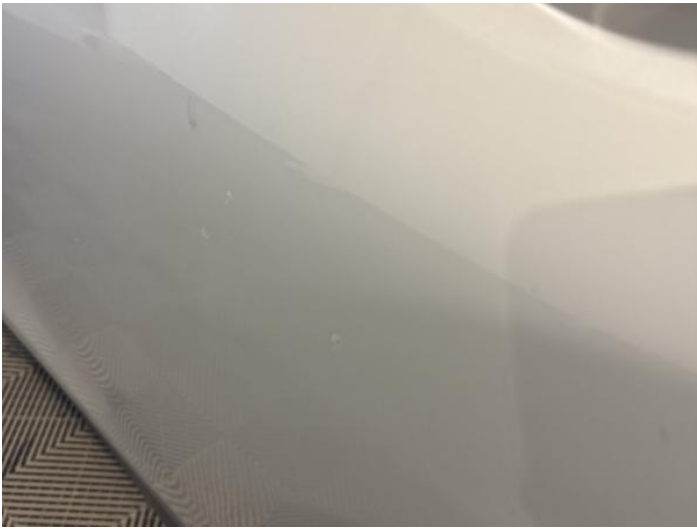
5: Door nsr
Chipped
Over 5mm

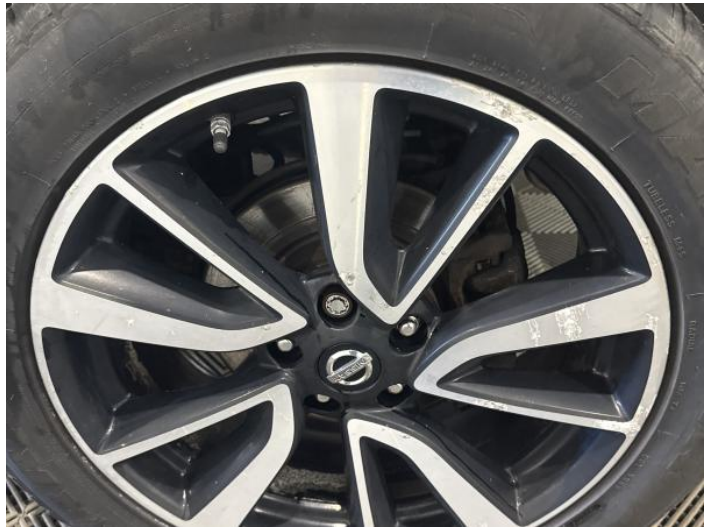
6: Wheel nsr
Scratched
Over 50mm

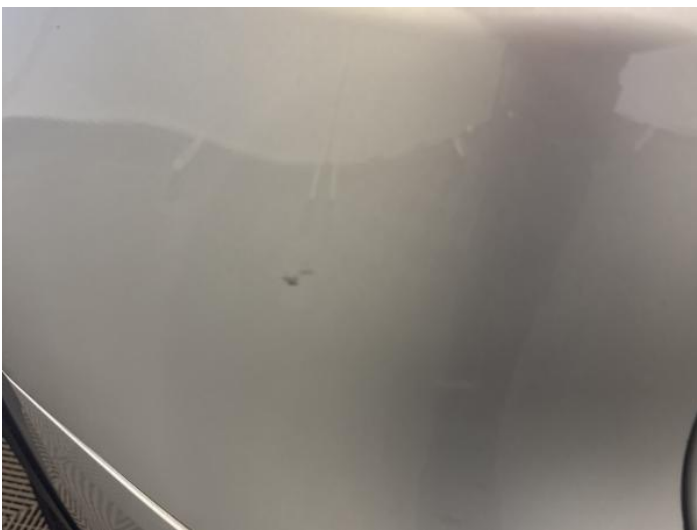
7: Bumper Rear
Scratched
Up To 25mm Thru Paint

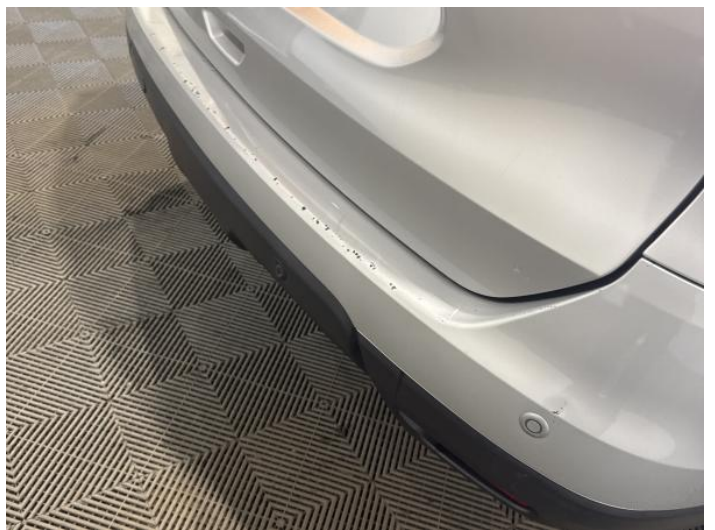
8: Bumper Rear
Scratched
Over 100mm Thru Paint

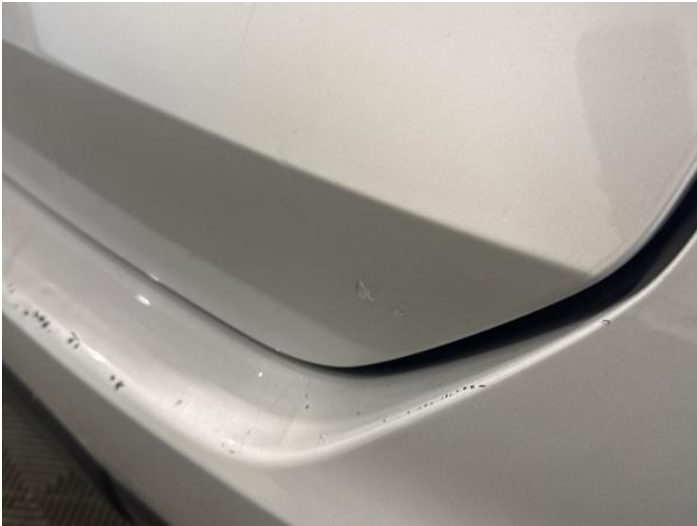
9: Tailgate
Dented
With Paint Damage

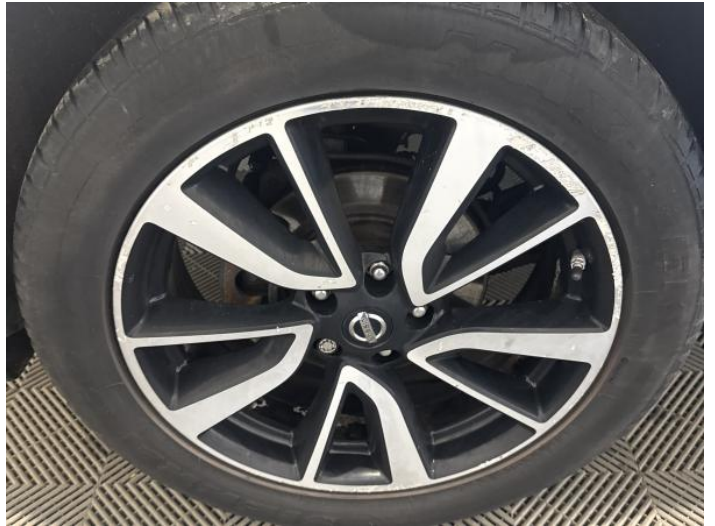
10: Wheel osf
Scratched
Over 50mm

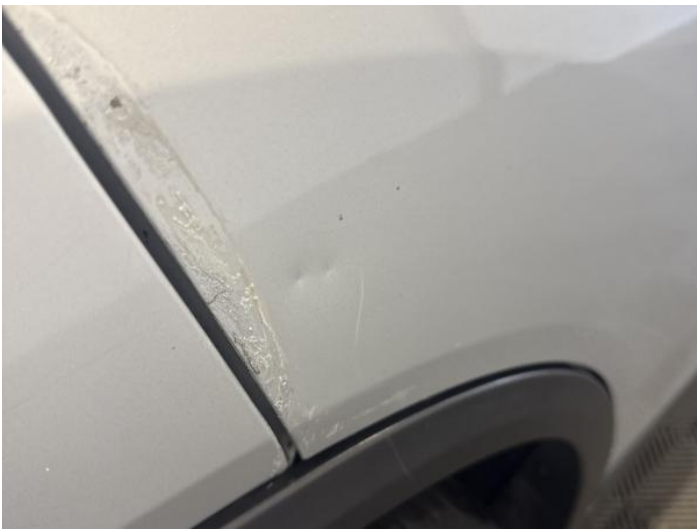
11: Door osf
Dented
With Paint Damage

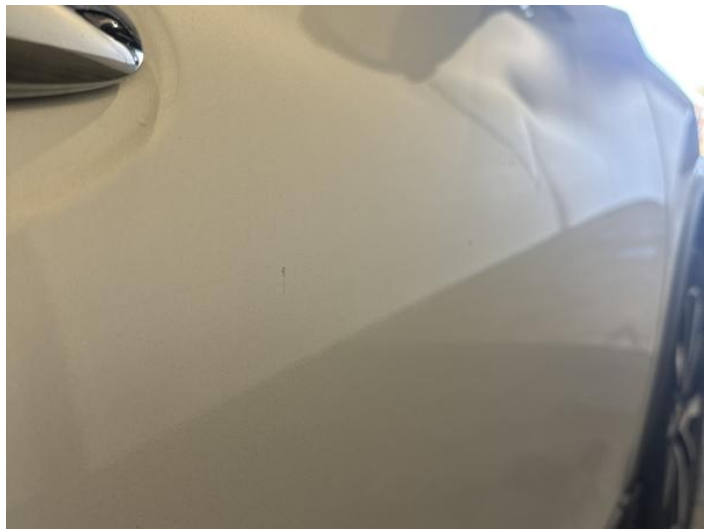
12: Door osf
Dented
Over 30mm

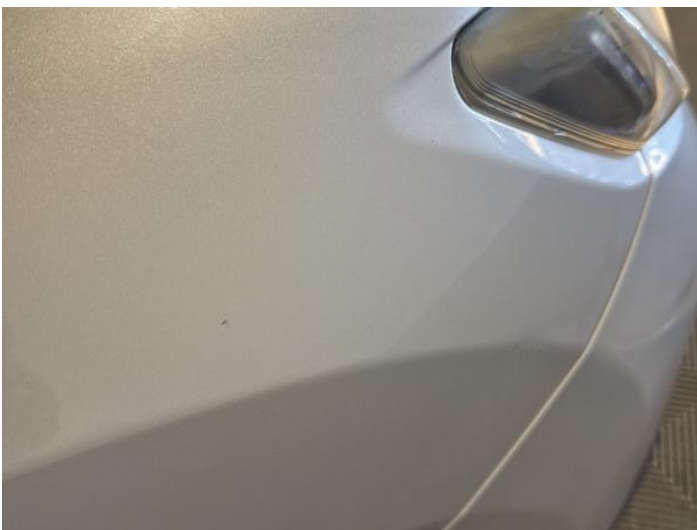
13: Wing osf
Chipped
1 To 5

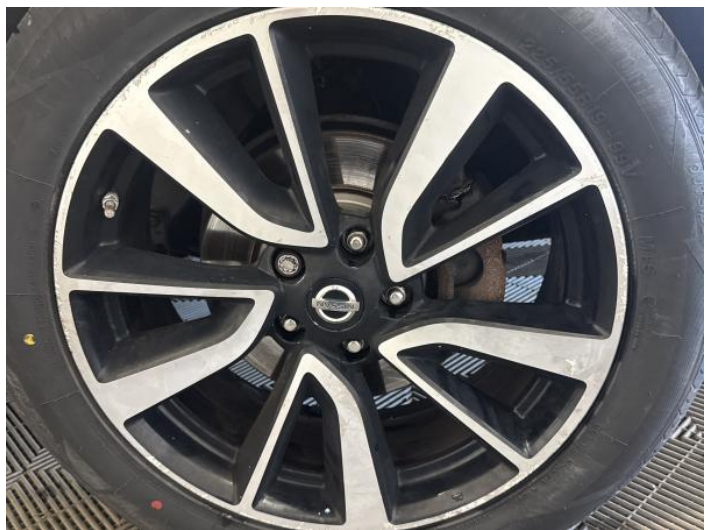
14: Wheel osf
Scratched
Over 50mm

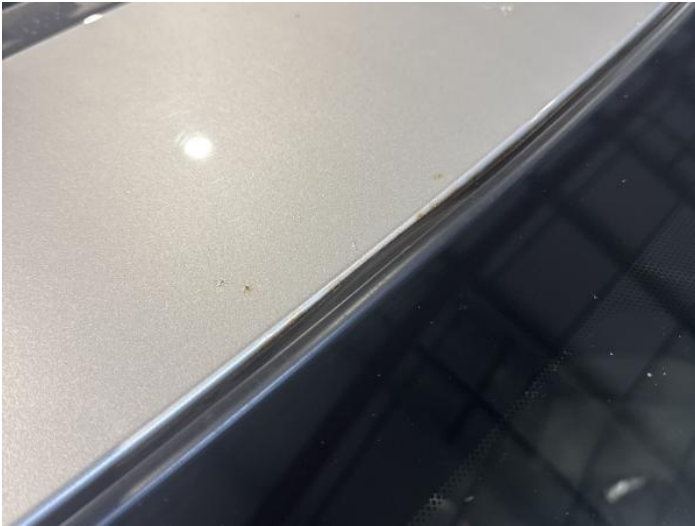
15: Roof
Rusted
Over 5mm
