VEHICLE INSPECTION REPORT

FY10SVU

Volkswagen Touran 1.9 TDI Match 5dr

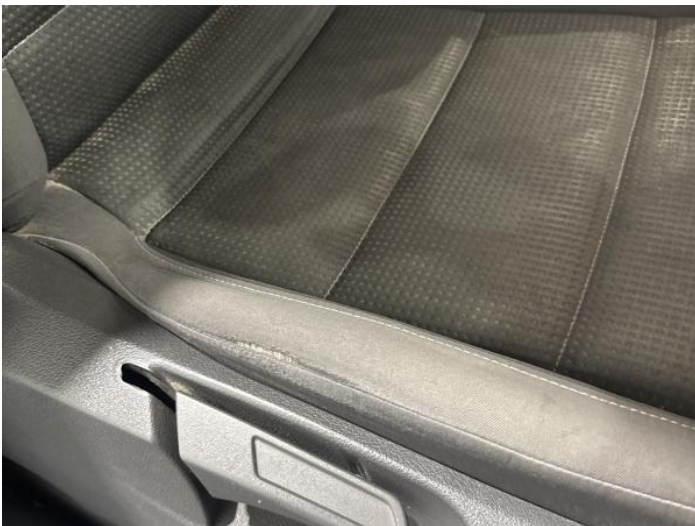
1: Seat Back Cover osf
Scuffed
Over 25mm

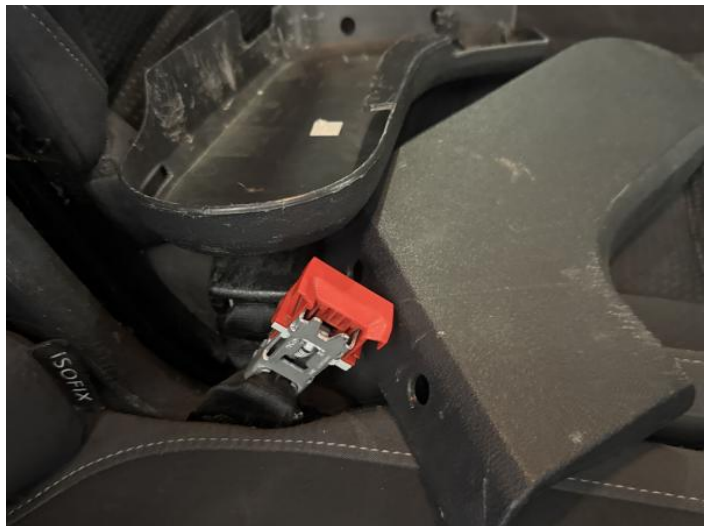
2: Seat Belt osr
Broken
Replace

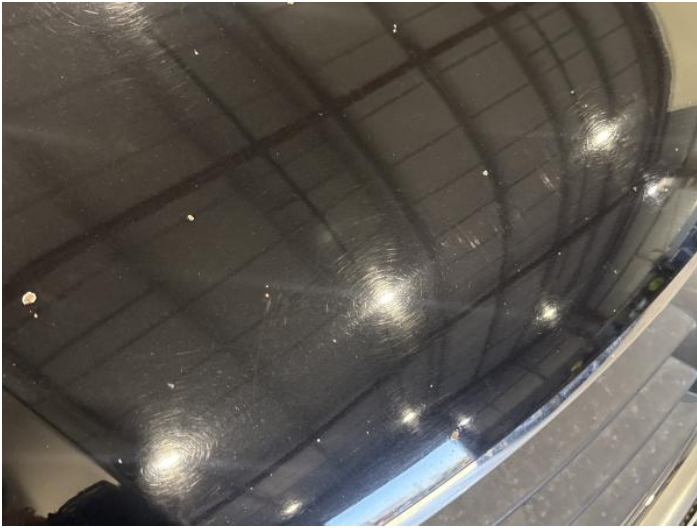
3: Bonnet
Chipped
Multiple Chips

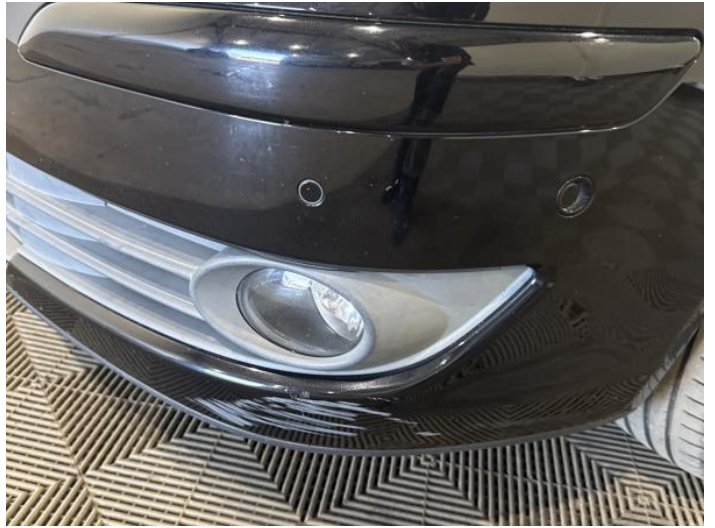
4: Bumper Front
Scratched
Over 100mm Thru Paint

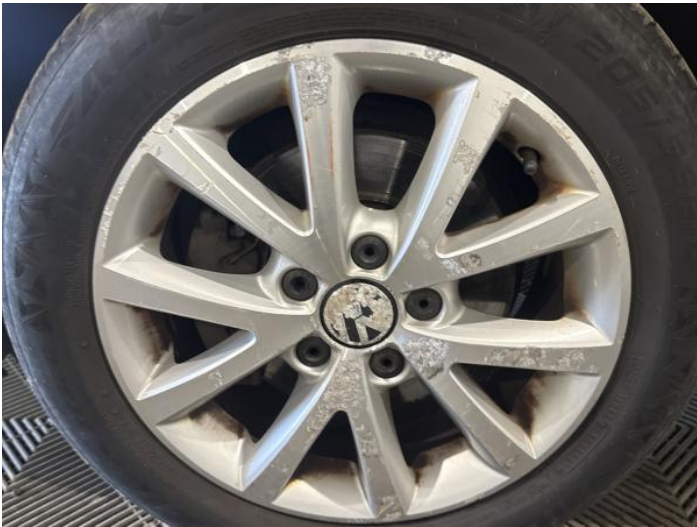
5: Wheel nsf
Scratched
Over 50mm

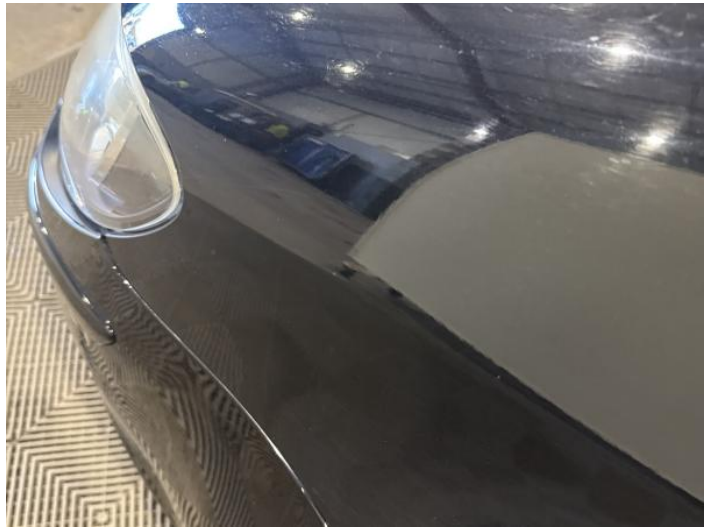
6: Wing nsf
Chipped
1 To 5

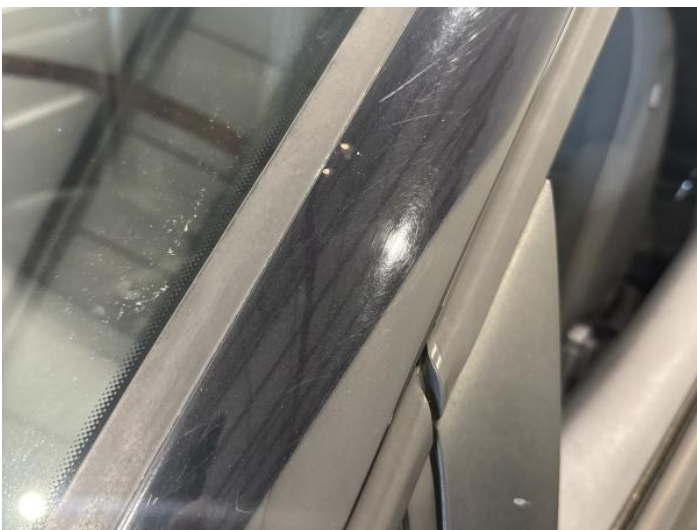
7: A Post ns
Chipped
1 To 5

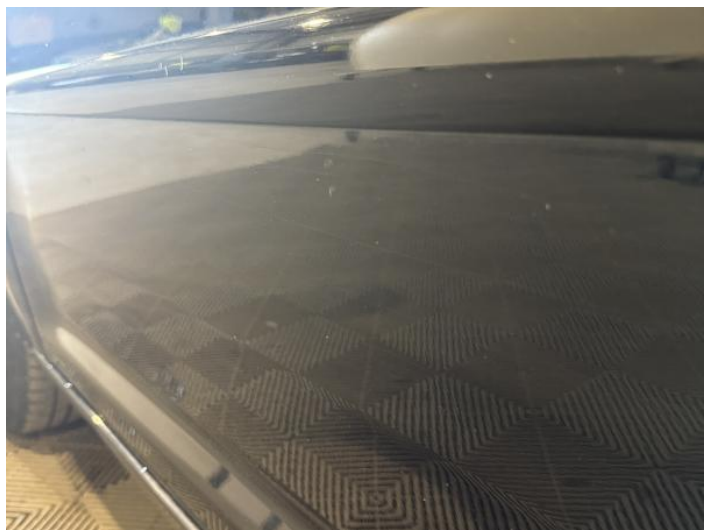
8: Door nsf
Dented
Between 10mm + 30mm

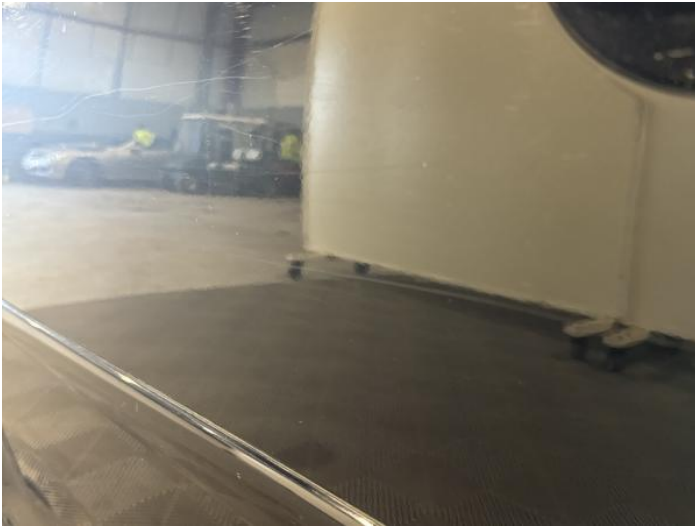
9: Door nsf
Scratched
Over 25mm Thru Paint

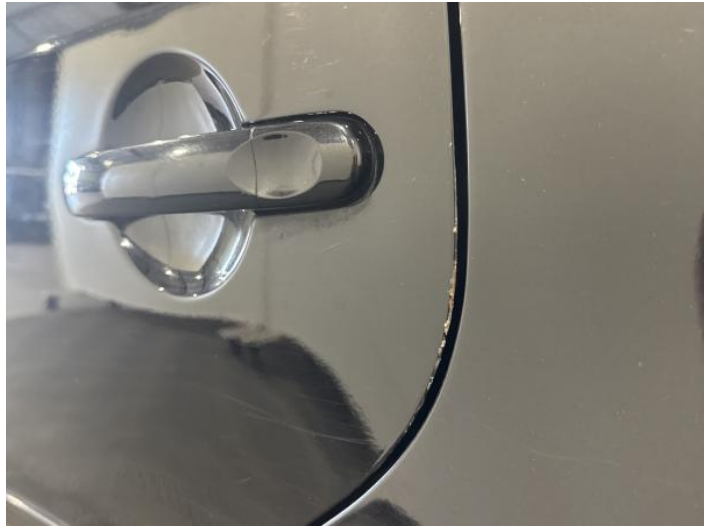
10: Door nsr
Scratched
Rusted

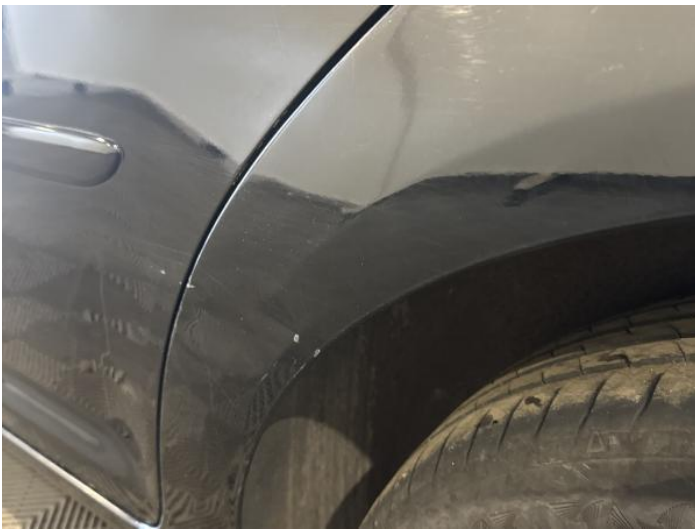
11: Qtr Panel nsr
Dented
With Paint Damage

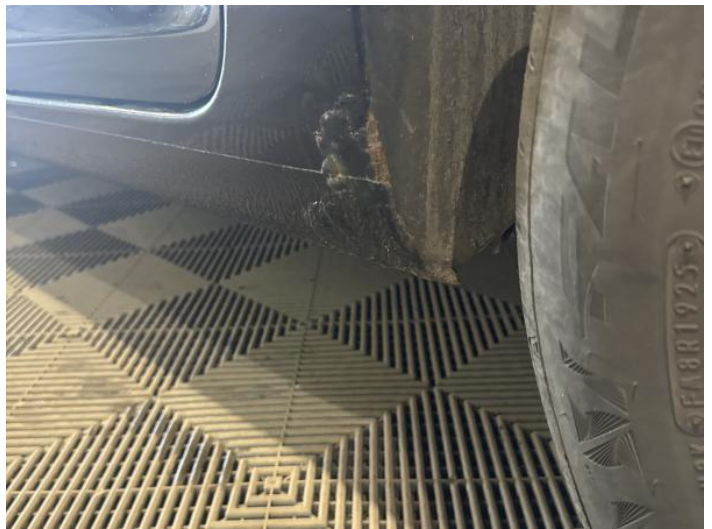
12: Sill ns
Rusted
Over 5mm

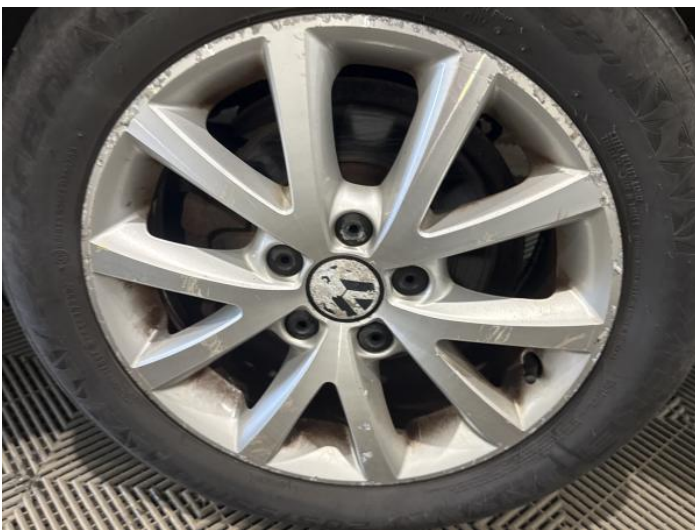
13: Wheel nsr
Scratched
Over 50mm

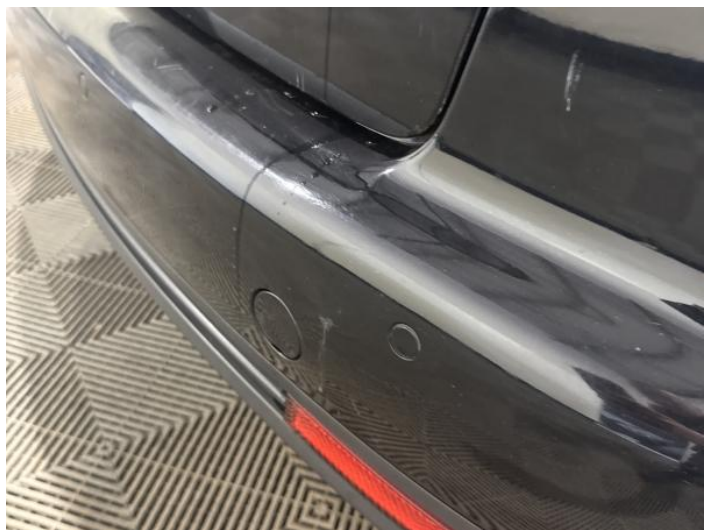
14: Bumper Rear
Dented
With Paint Damage

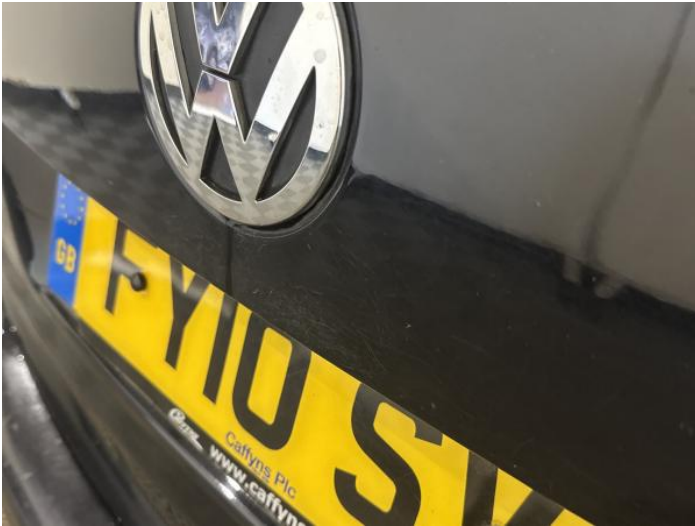
15: Tailgate
Dented
Between 10mm + 30mm

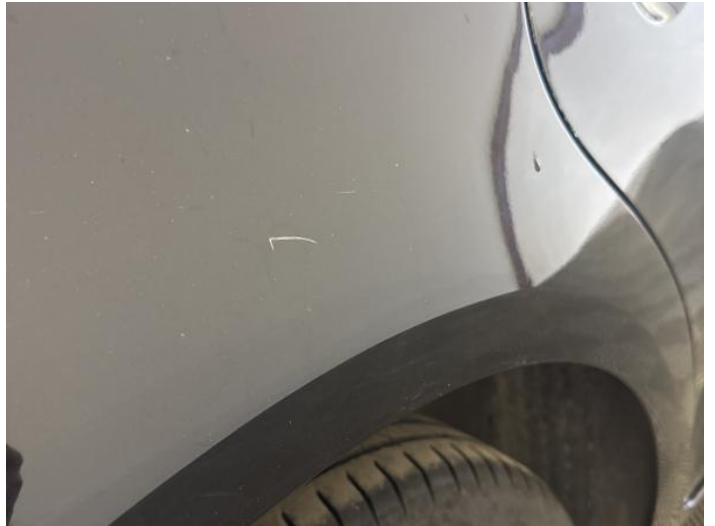
16: Qtr Panel osr
Scratched
Over 25mm Thru Paint

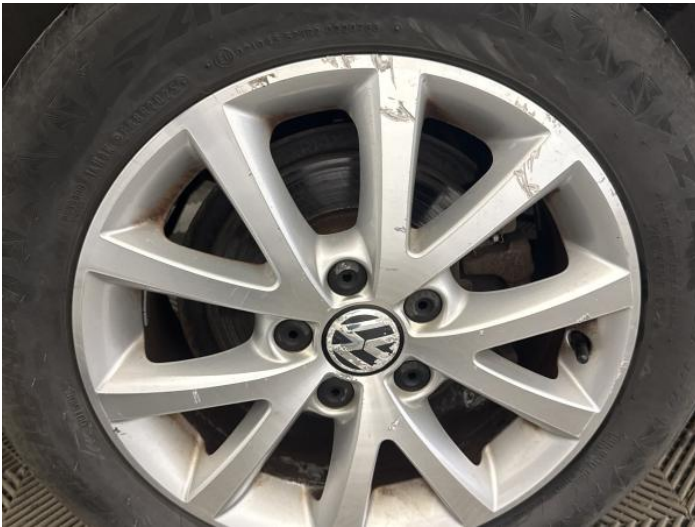
17: Wheel osr
Scratched
Over 50mm

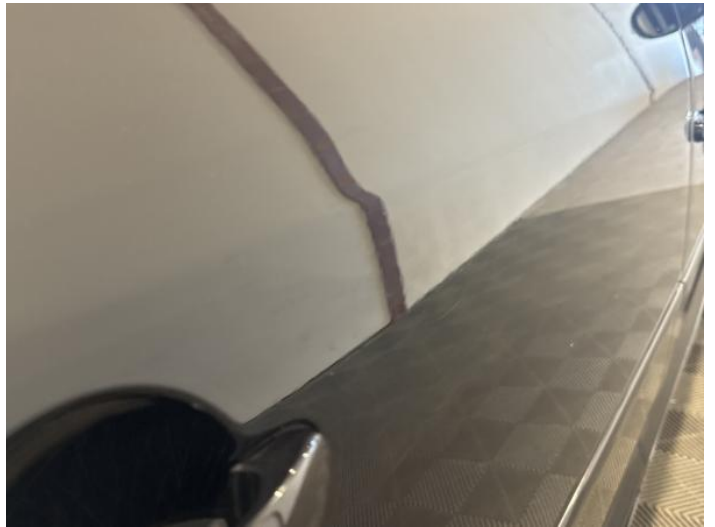
18: Door osr
Dented
Between 10mm + 30mm

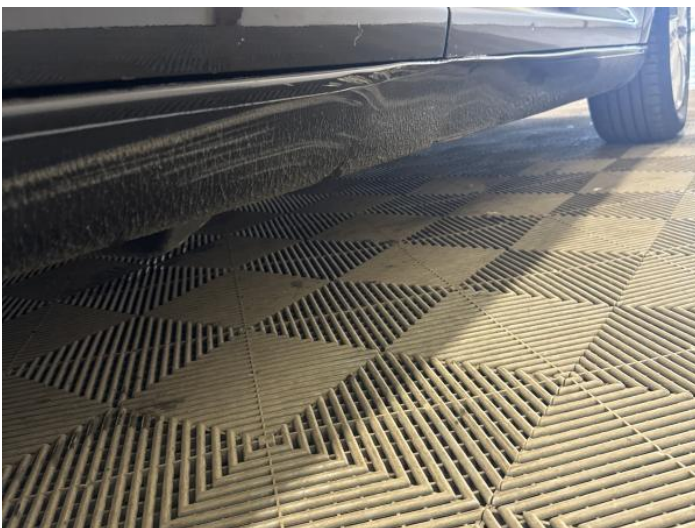
19: Sill os
Dented
With Paint Damage

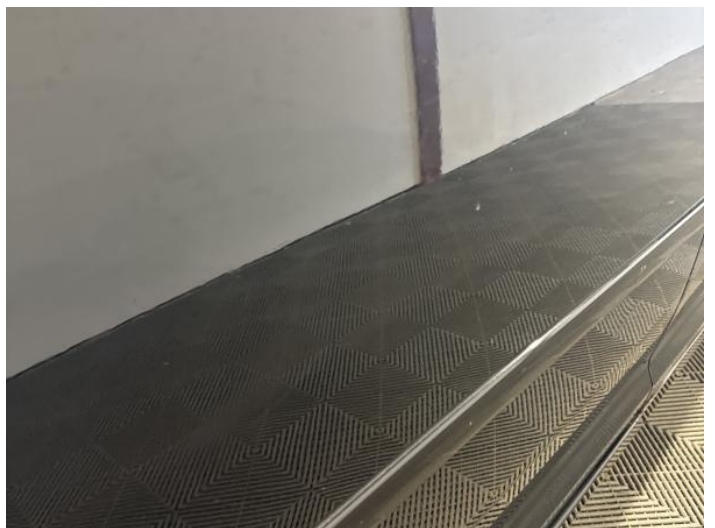
20: Door osr
Scratched
Over 25mm Thru Paint

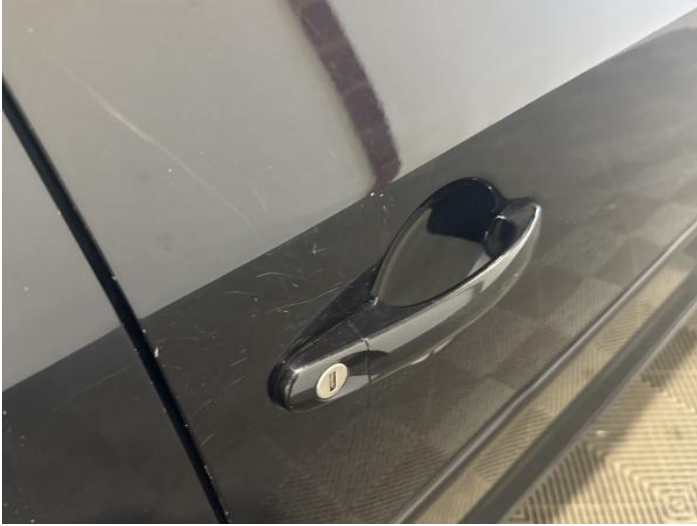
21: Door osf
Scratched
Over 25mm Thru Paint

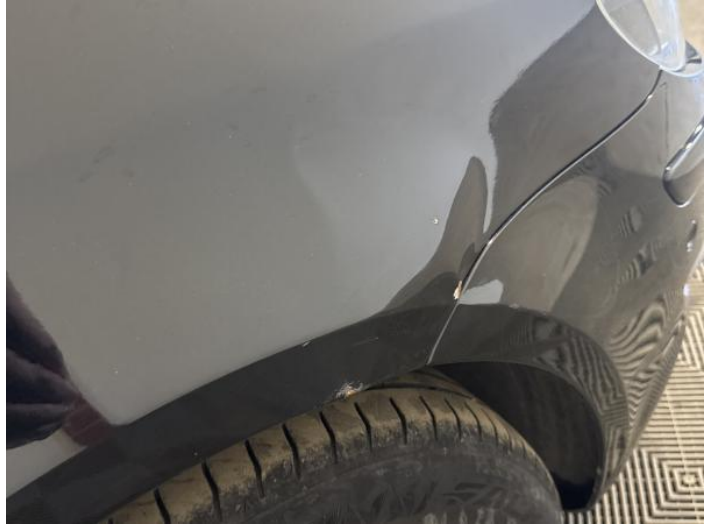
22: Wing osf
Dented
With Paint Damage

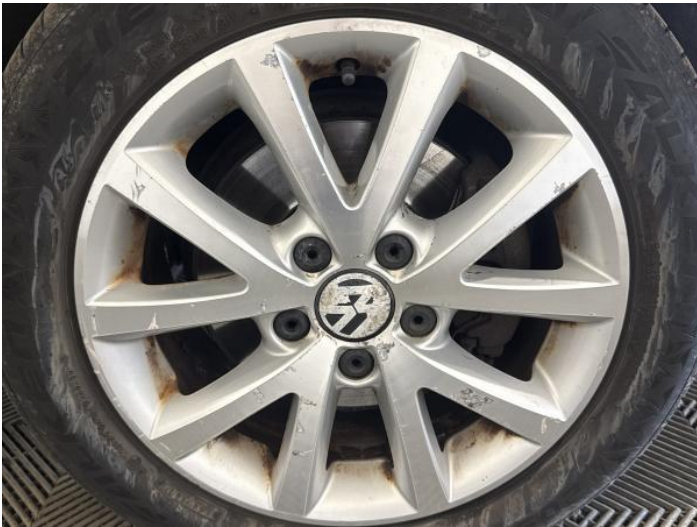
23: Wheel osf
Scratched
Over 50mm

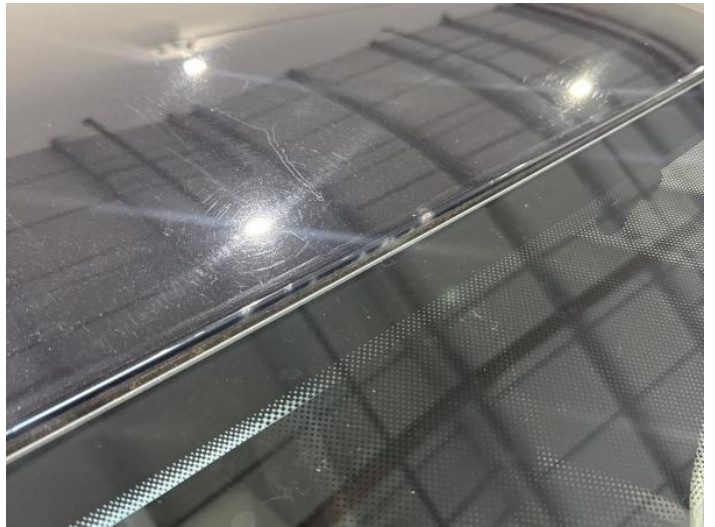
24: Roof
Chipped
Edge Chip

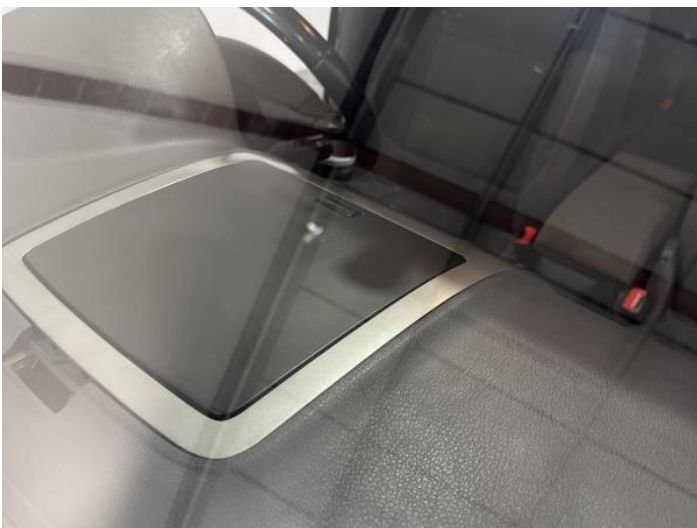
25: Screen Front
Chipped
UpTo 10mm
