VEHICLE INSPECTION REPORT

VK58BUP

nama
GRADE
4

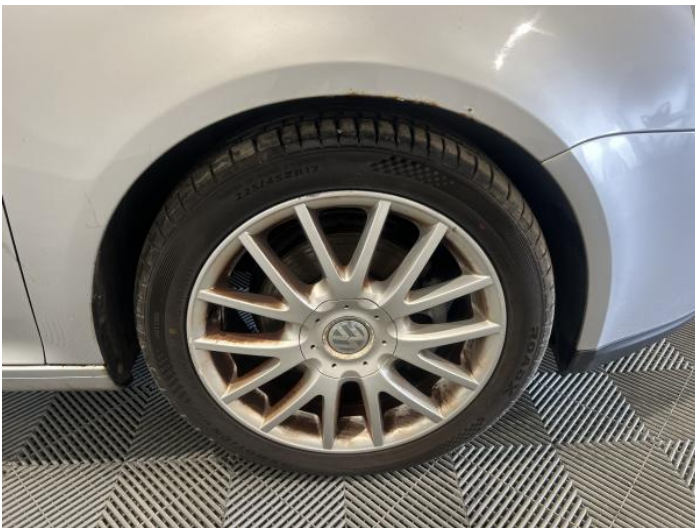
1: Wheel osf
Scratched
Over 50mm

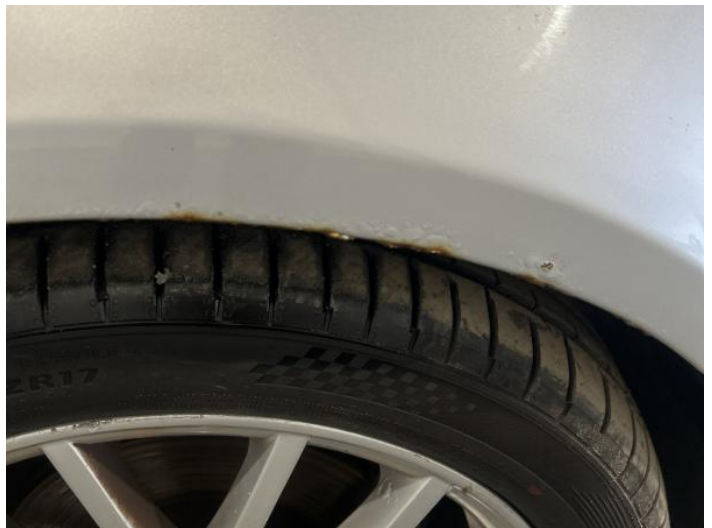
2: Wing osf
Rusted
Over 5mm

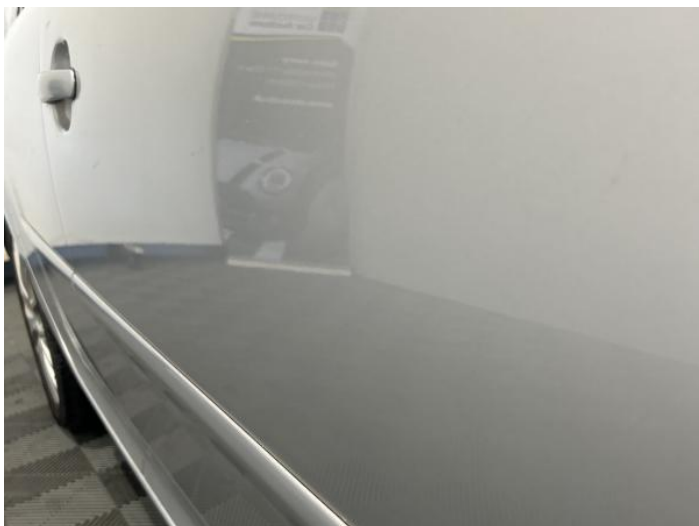
3: Door osf
Dented
2 Or Less UpTo 10mm

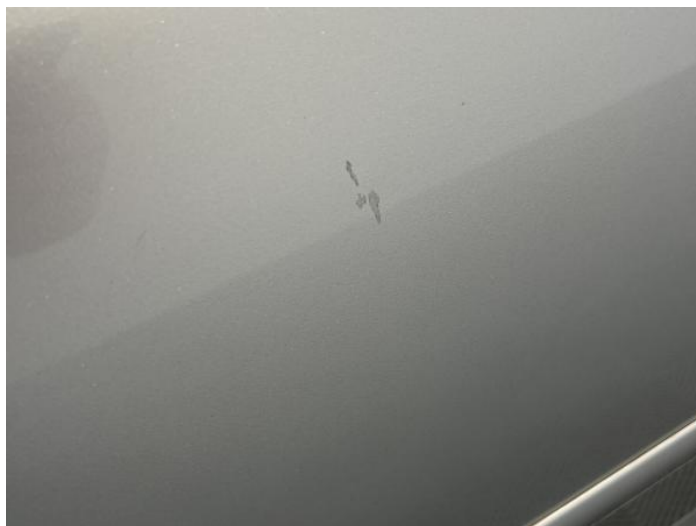
4: Door osr
Chipped
1 To 5

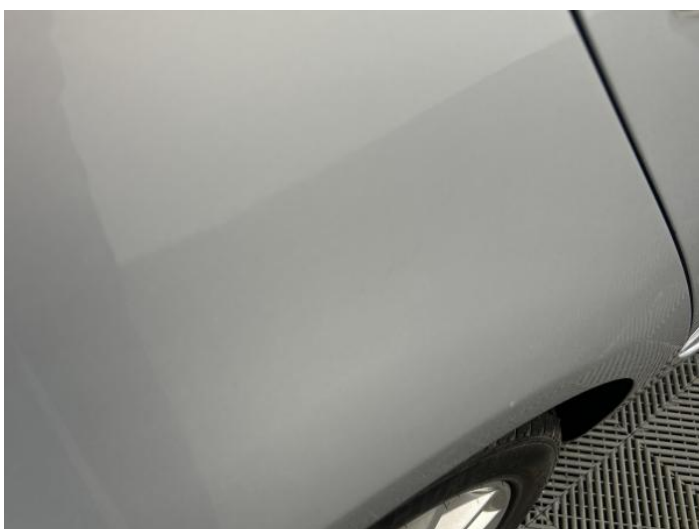
5: Qtr Panel osr
Poor Previous Repair
Poor Paint

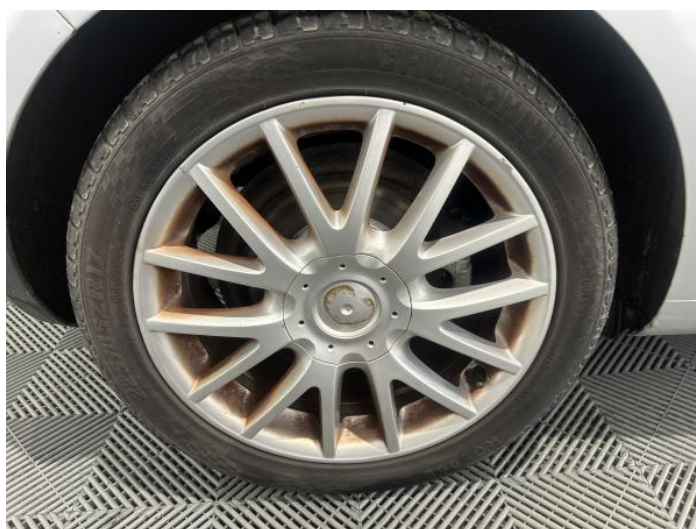
6: Wheel osr
Scratched
Up To 50mm

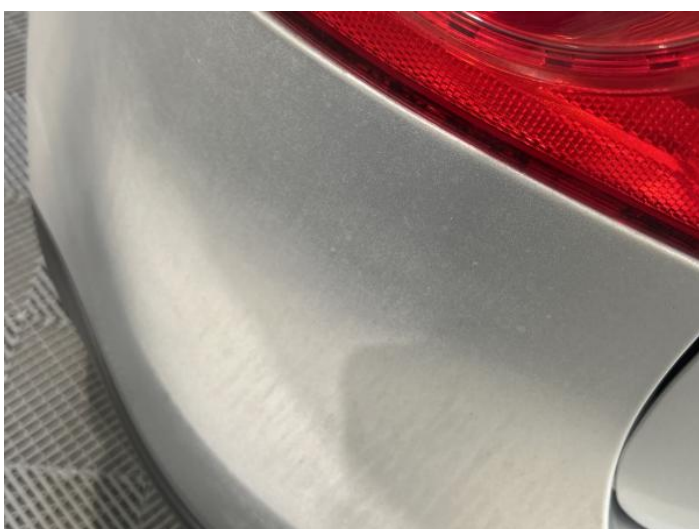
7: Bumper Rear
Poor Previous Repair
Poor Paint

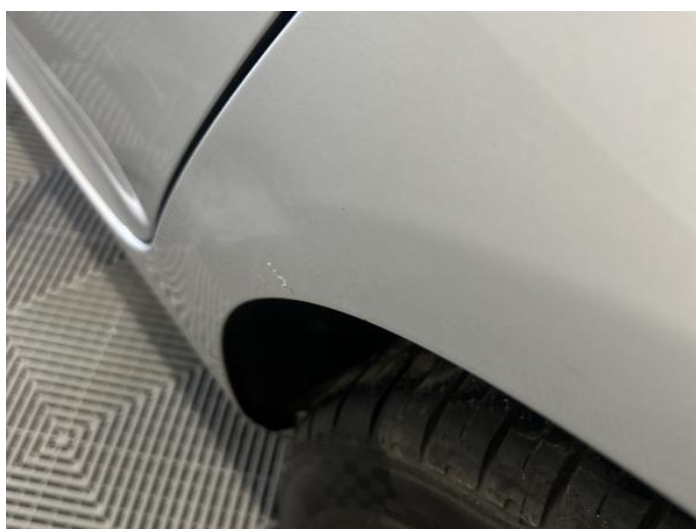
8: Qtr Panel nsr
Dented
Over 30mm

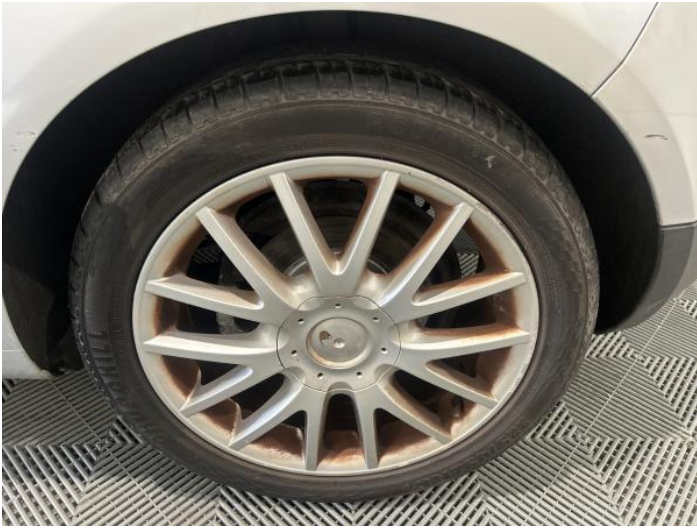
9: Wheel nsr
Scratched
Over 50mm

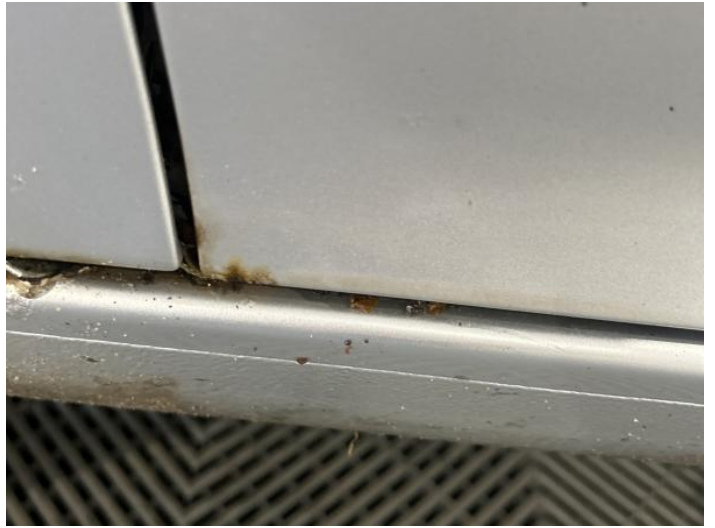
10: Door nsf
Rusted
UpTo 5mm

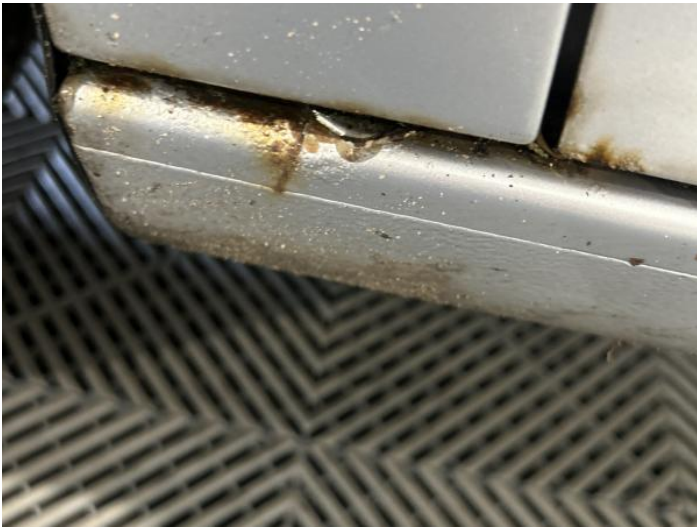
11: Sill ns
Rusted
UpTo 5mm

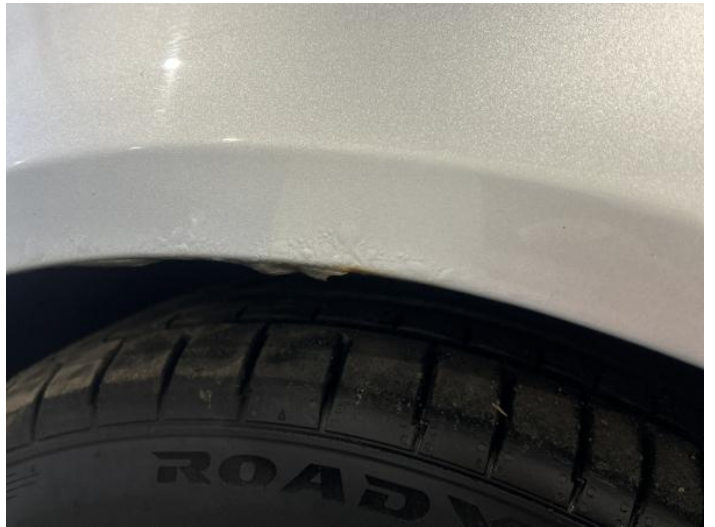
12: Wing nsf
Rusted
Over 5mm

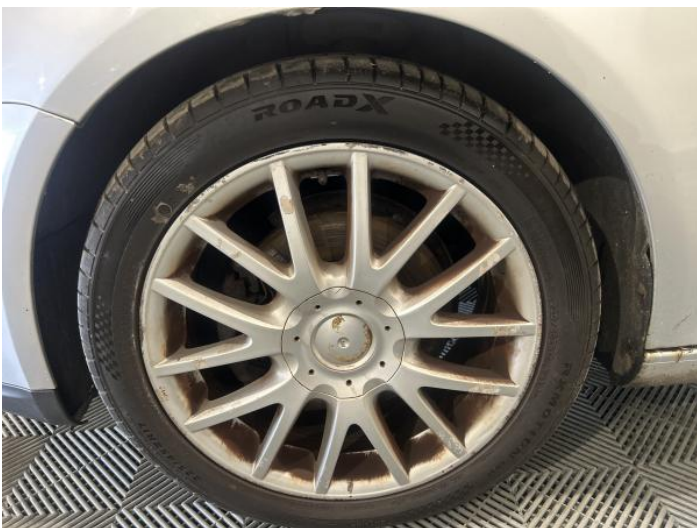
13: Wheel nsf
Scratched
Over 50mm

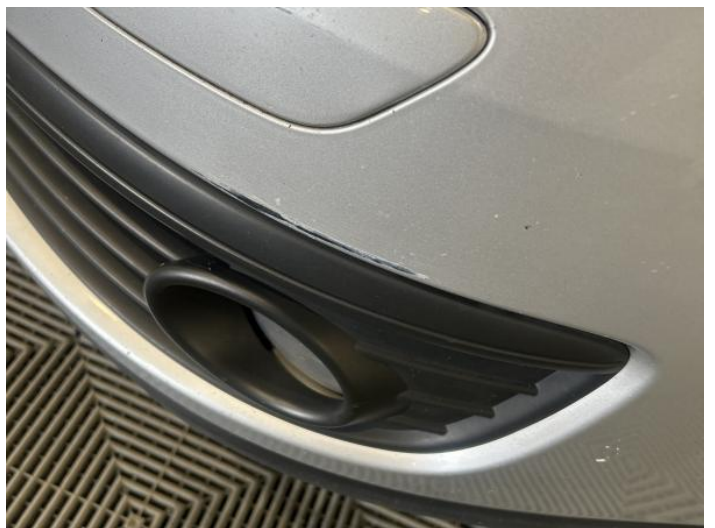
14: Bumper Front
Scratched
25 to 100mm Thru Paint

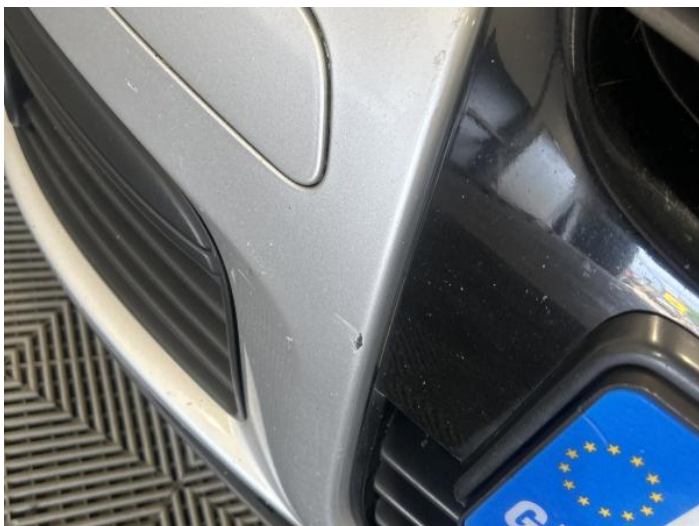
15: Bumper Front
Chipped
Multiple Chips

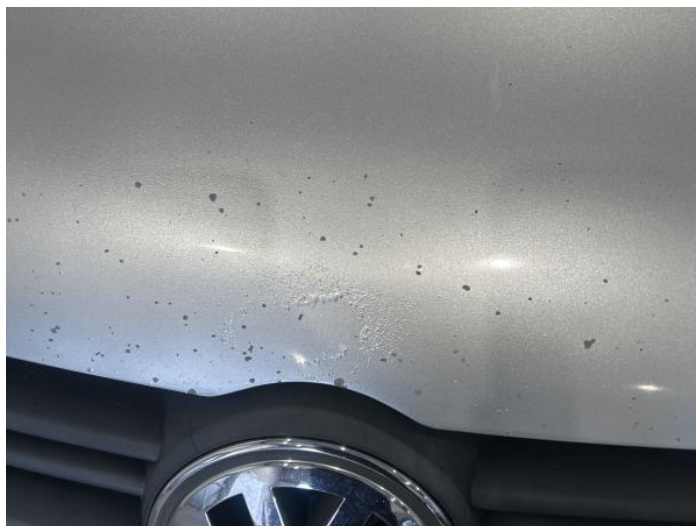
16: Bonnet
Poor Previous Repair
Poor Paint

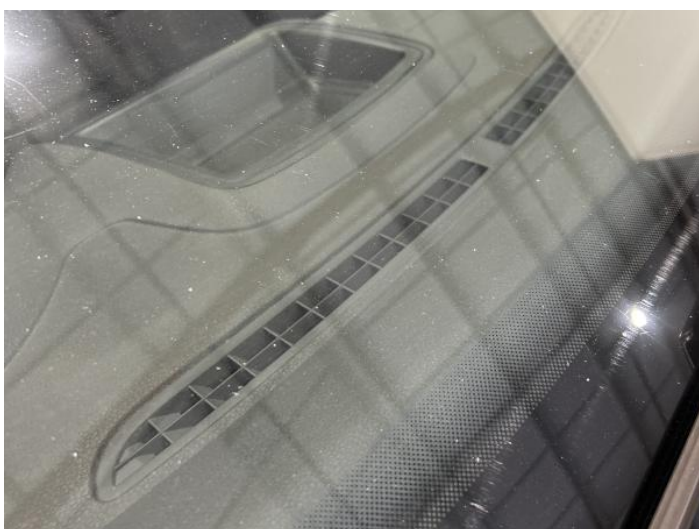
17: Screen Front
Chipped
UpTo 10mm

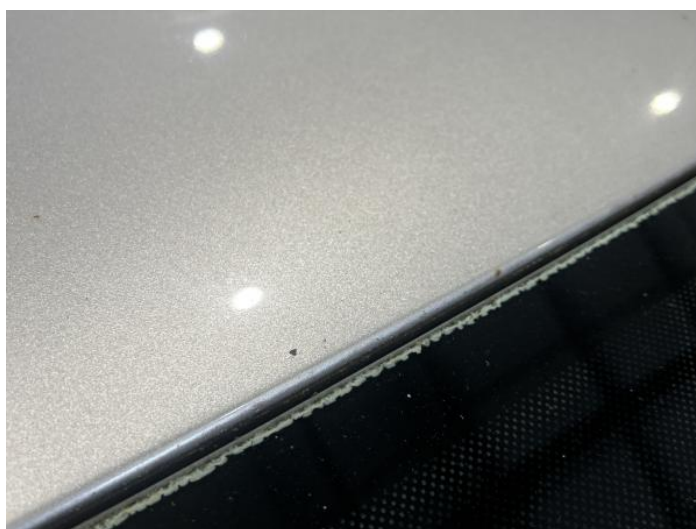
18: Roof
Chipped
1 To 5
