# VEHICLE INSPECTION REPORT

**SP63SGZ**

## Ford C-Max 1.0 EcoBoost 125 Zetec 5dr

nama  
GRADE  
**4**

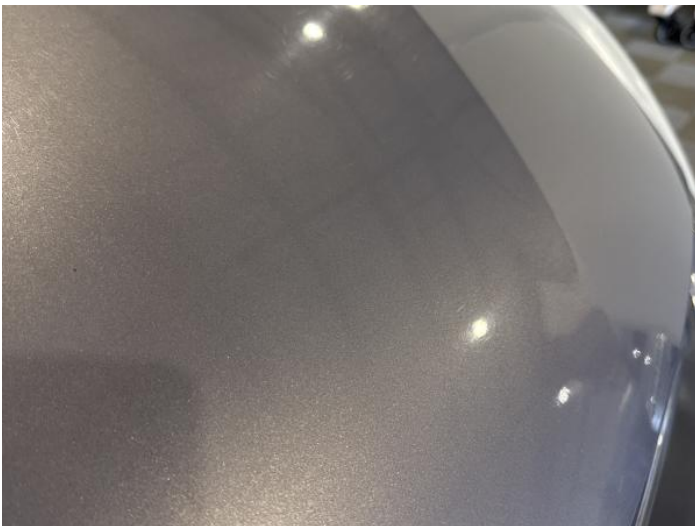
1: Bonnet  
Dented  
Between 10mm + 30mm

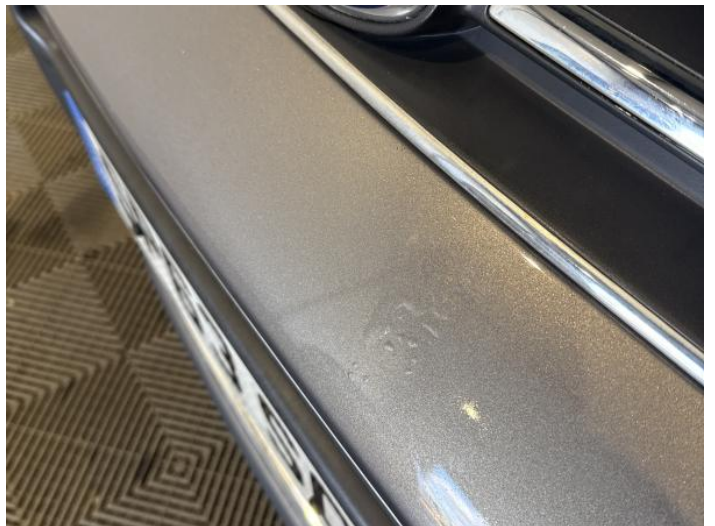
2: Bumper Front  
Poor Previous Repair  
Poor Paint

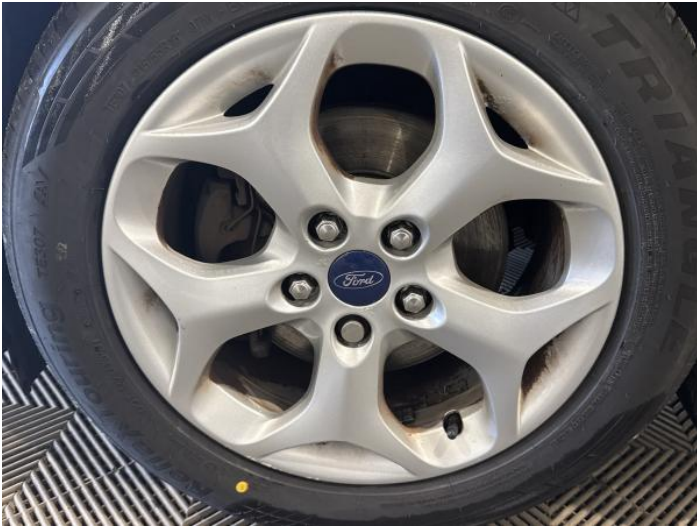
3: Wheel nsf  
Scratched  
Over 50mm

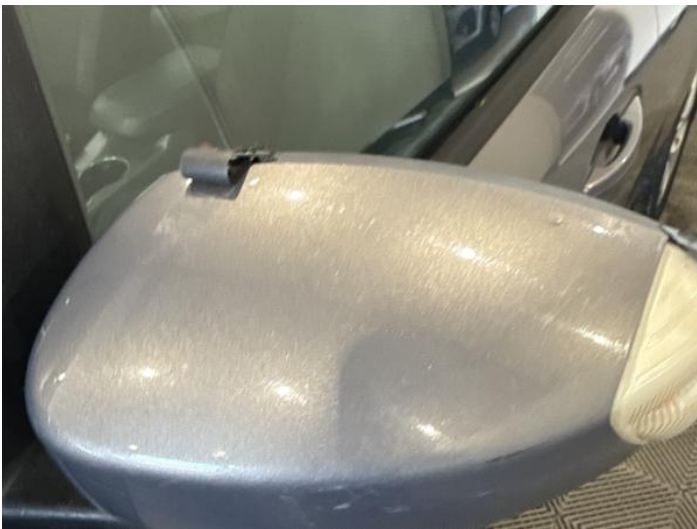
5: Door Mirror Assy nsf  
Scratched (Painted)  
UpTo 25mm Thru Paint

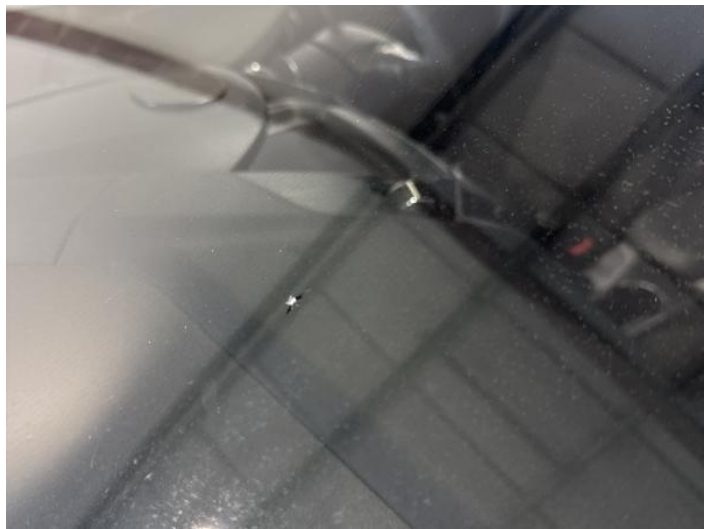
6: Screen Front  
Chipped  
Over 10mm

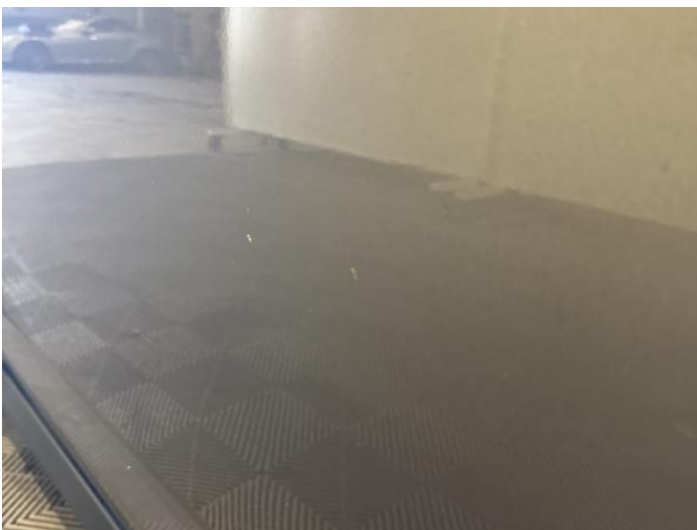
7: Door nsf  
Chipped  
1 To 5

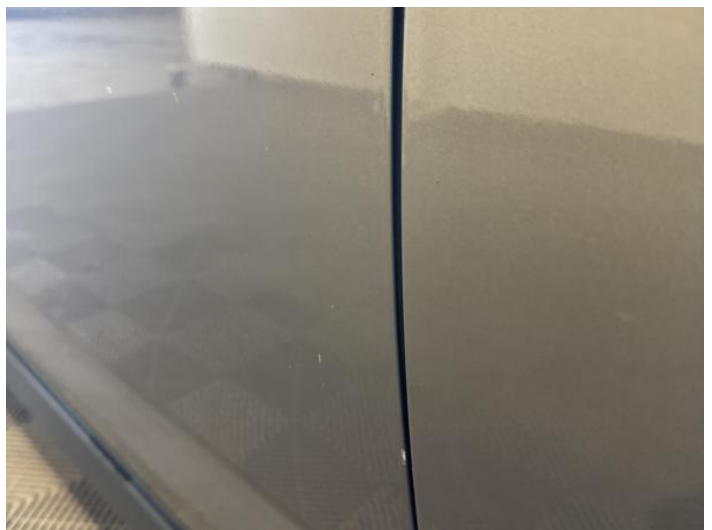
8: Door nsf  
Chipped  
Edge Chip

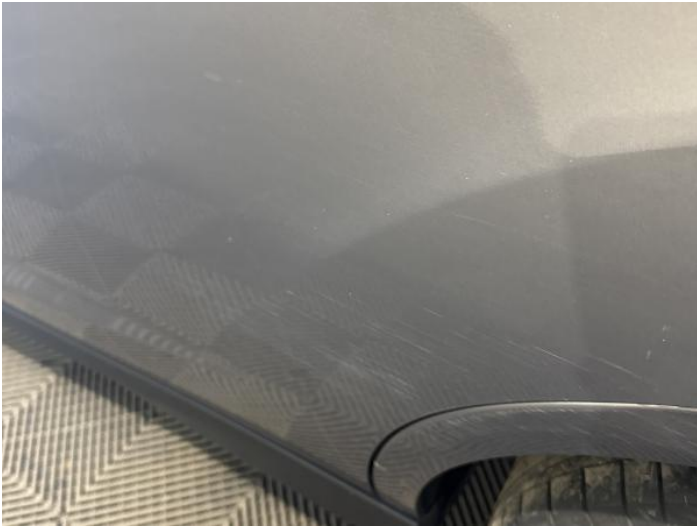
9: Door nsr  
Scratched  
Over 25mm Thru Paint

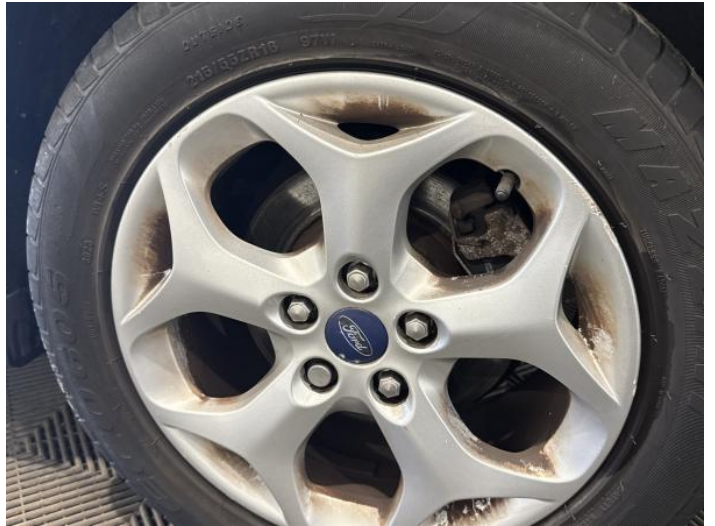
10: Wheel nsr  
Scratched  
Over 50mm

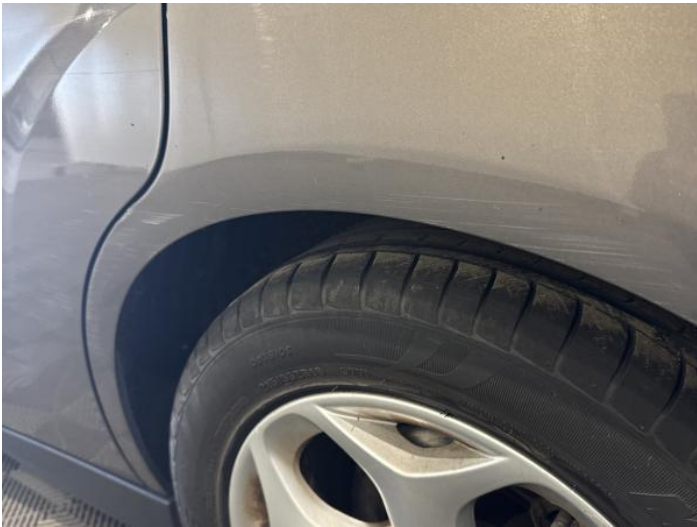
11: Qtr Panel nsr  
Dented  
With Paint Damage

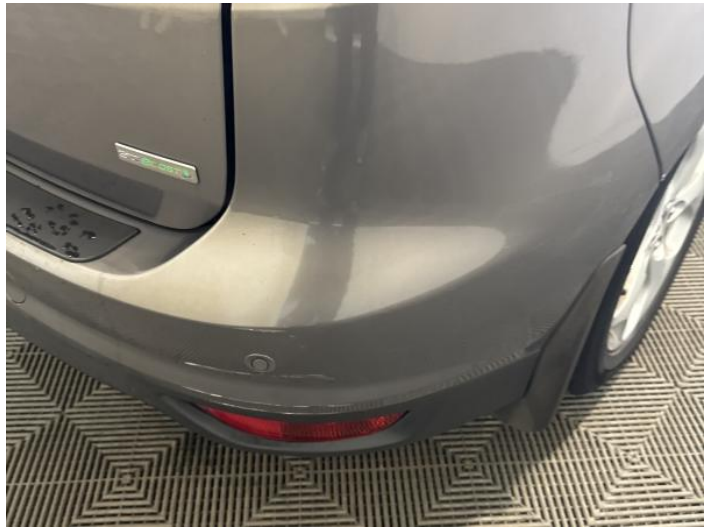
12: Bumper Rear  
Scratched  
Over 100mm Thru Paint

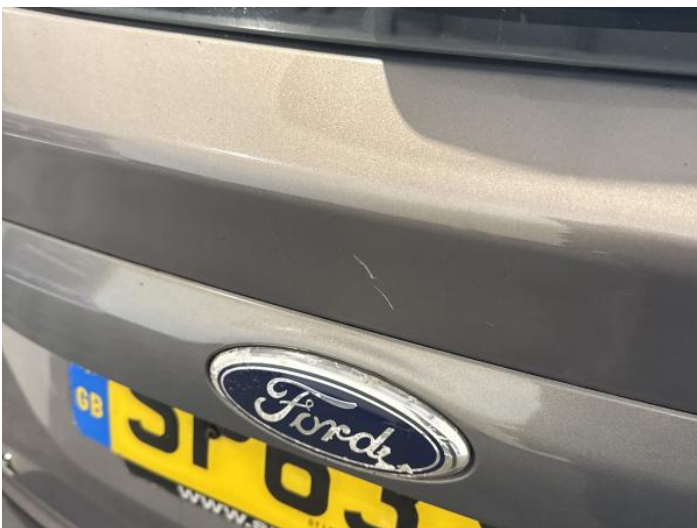
13: Tailgate  
Scratched  
Over 25mm Thru Paint

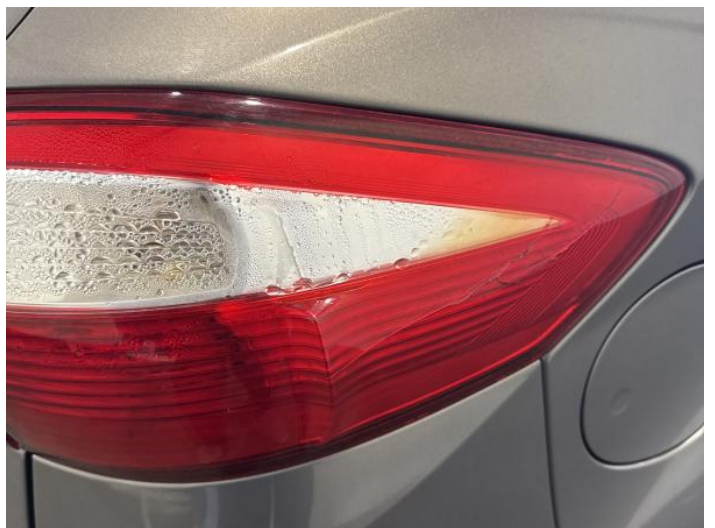
14: Lamp osr  
Broken  
Replace

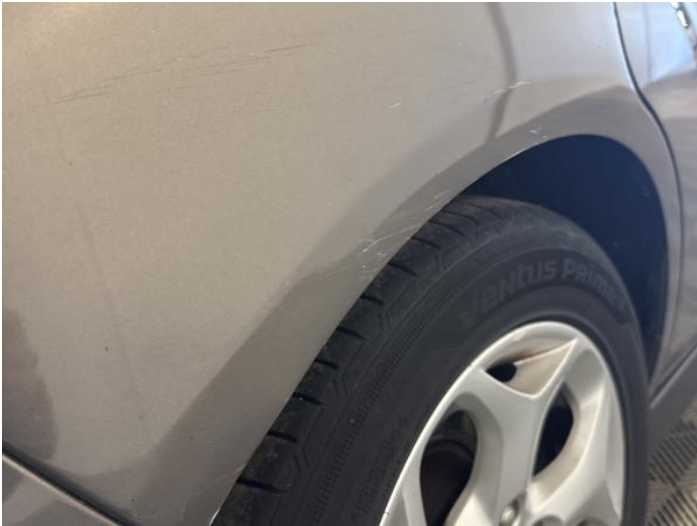
15: Qtr Panel osr  
Dented  
With Paint Damage

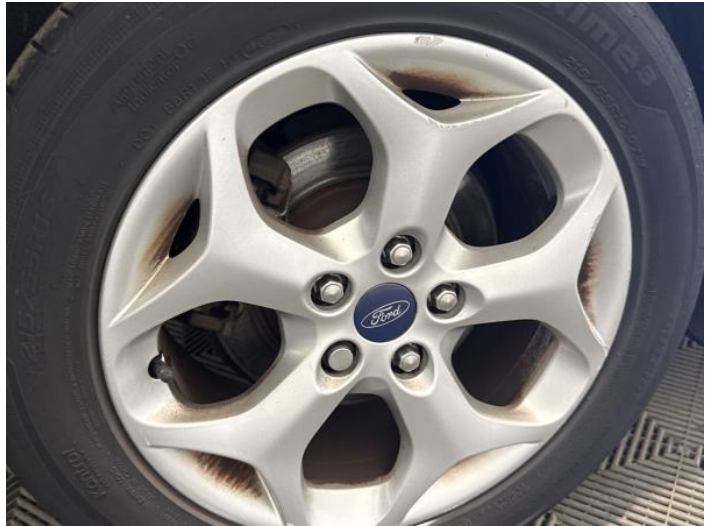
16: Wheel osr  
Scratched  
Over 50mm

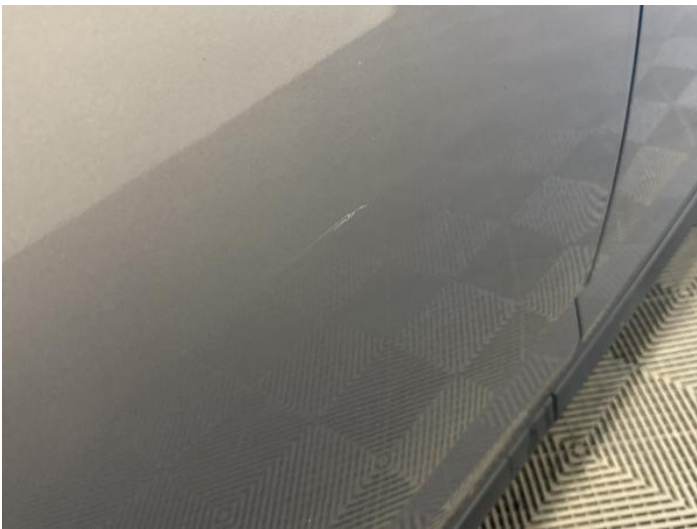
17: Door osr  
Scratched  
Over 25mm Thru Paint

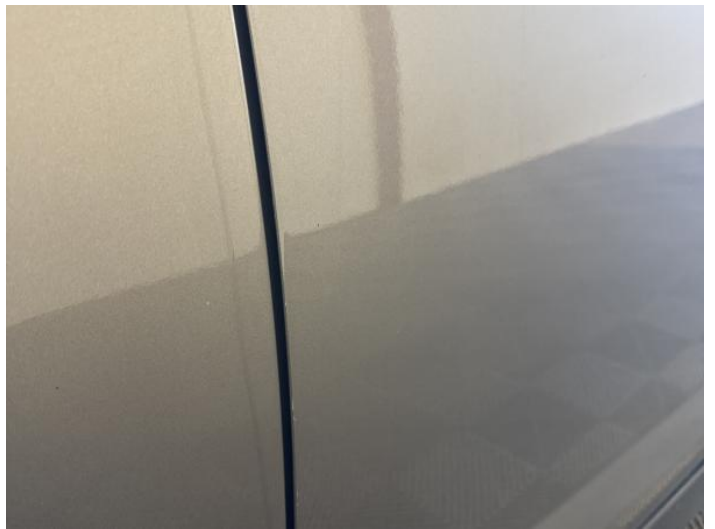
18: Door osf  
Chipped  
Edge Chip

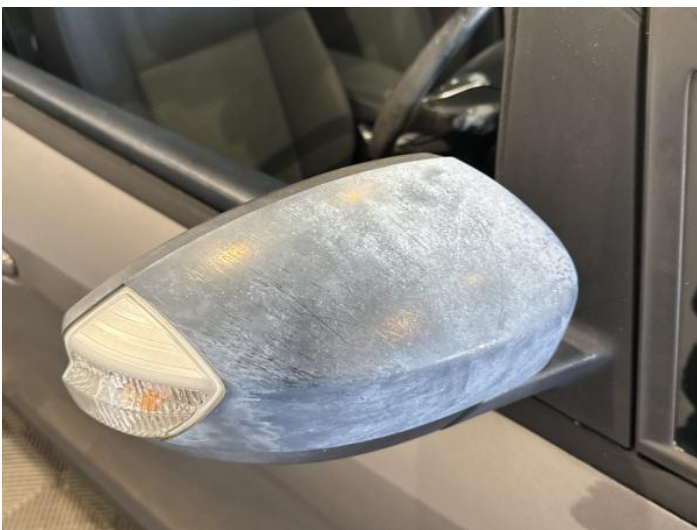
19: Door Mirror Assy osf  
Scratched (Painted)  
Over 25mm Thru Paint

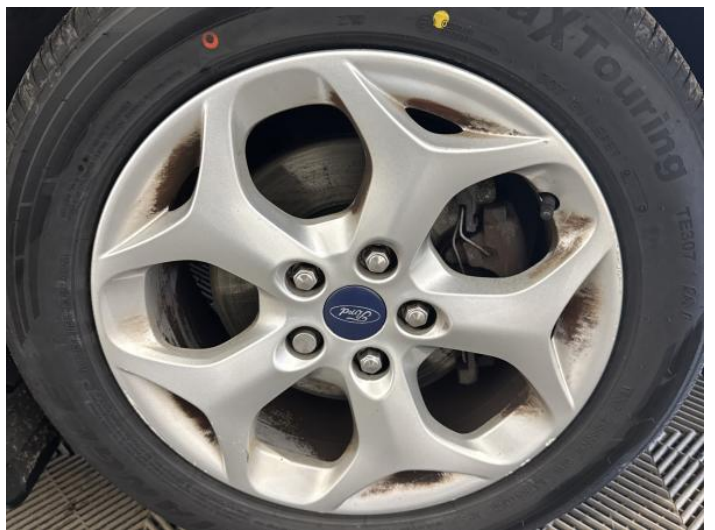
20: Wheel osf  
Scratched  
Over 50mm

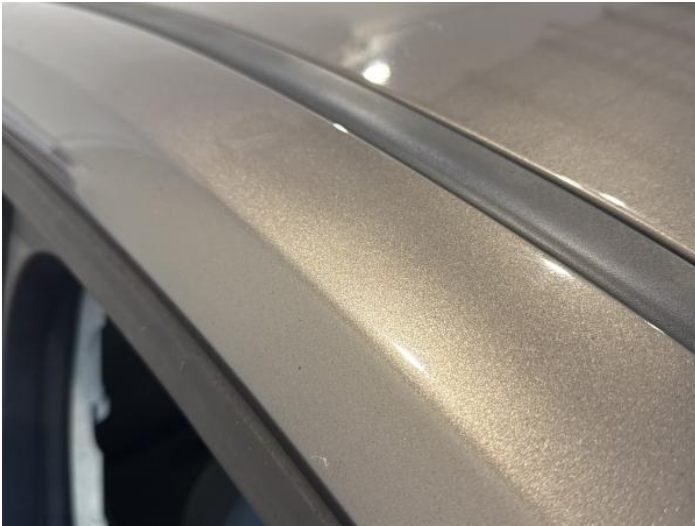
21: A Post os  
Dented  
Over 30mm
