VEHICLE INSPECTION REPORT

YK58MUY

Vauxhall Astra 1.6i 16V Club [115] 5dr

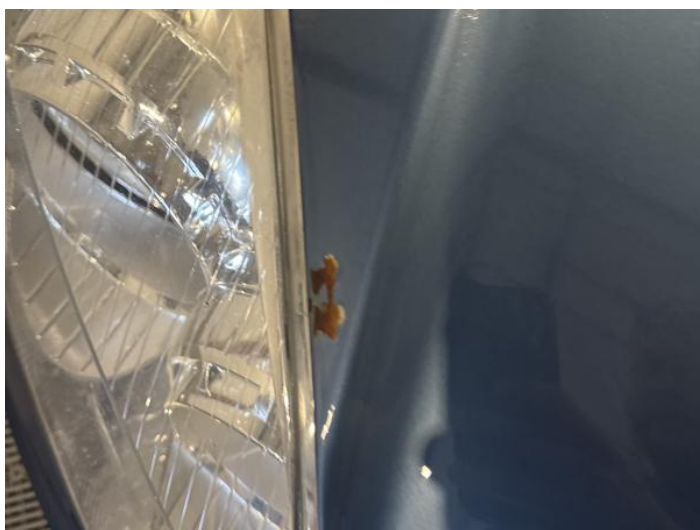
1: Bonnet
Rusted
Over 5mm

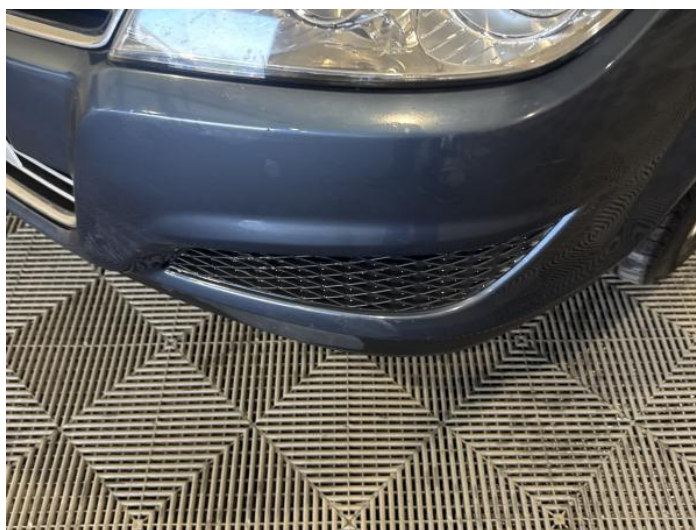
2: Bumper Front
Scratched
Over 100mm Thru Paint

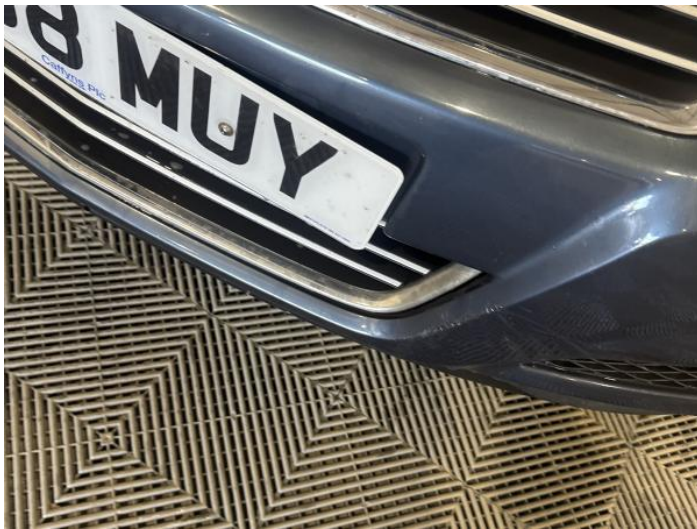
3: Bumper Front Grill
Broken
Replace

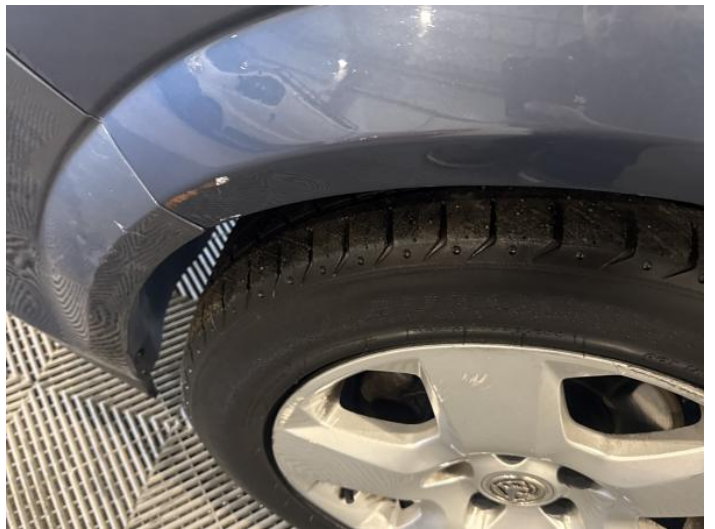
4: Wing nsf
Scratched
Over 25mm Thru Paint

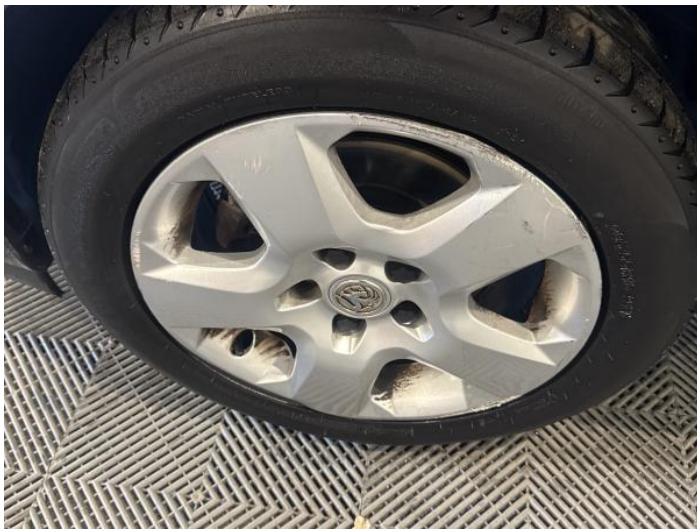
5: Wheel nsf
Scratched
Over 50mm

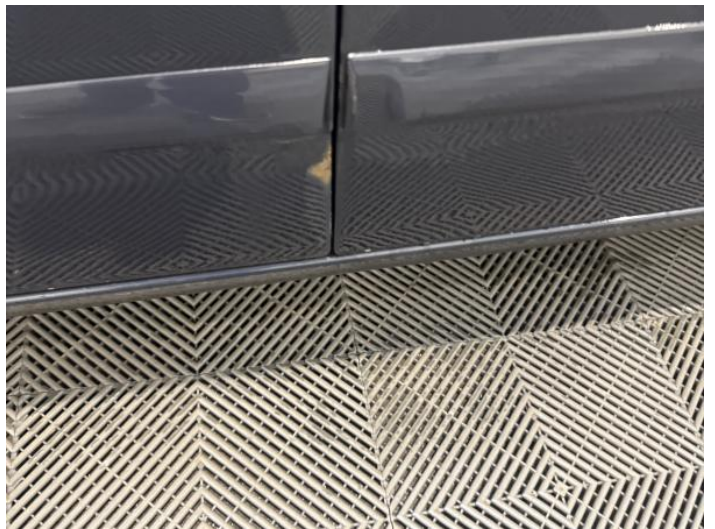
6: Door nsf
Rusted
Over 5mm

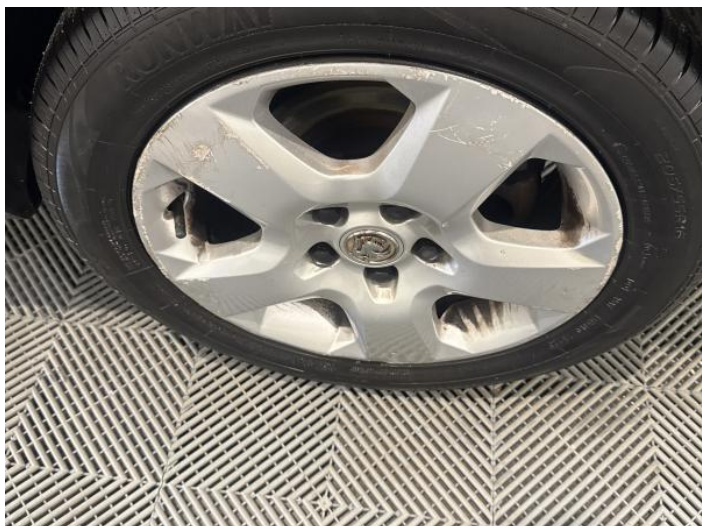
9: Wheel nsr
Scratched
Over 50mm

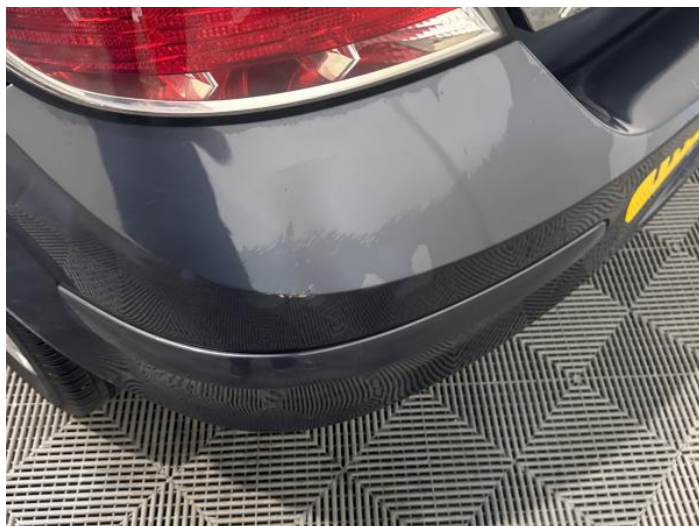
10: Bumper Rear
Scratched
Over 100mm Thru Paint

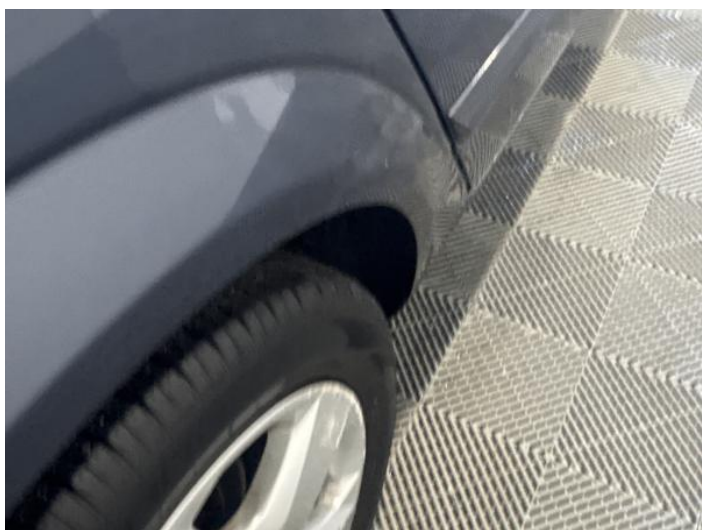
13: Qtr Panel osr
Dented
With Paint Damage

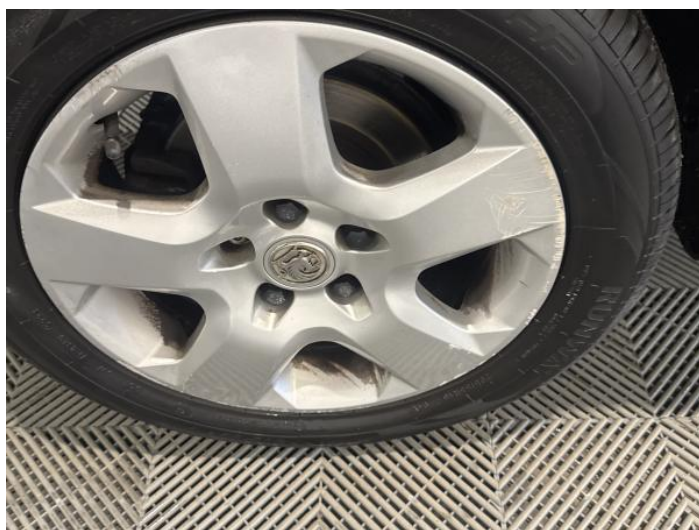
14: Wheel osr
Scratched
Over 50mm

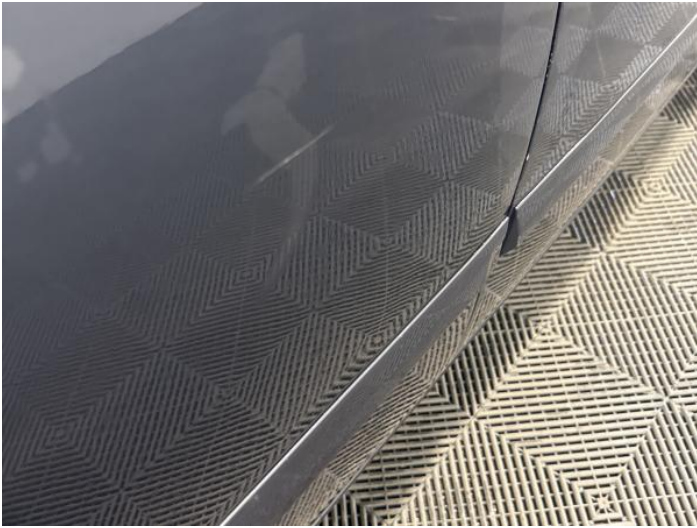
15: Door osr
Scratched
Over 25mm Thru Paint

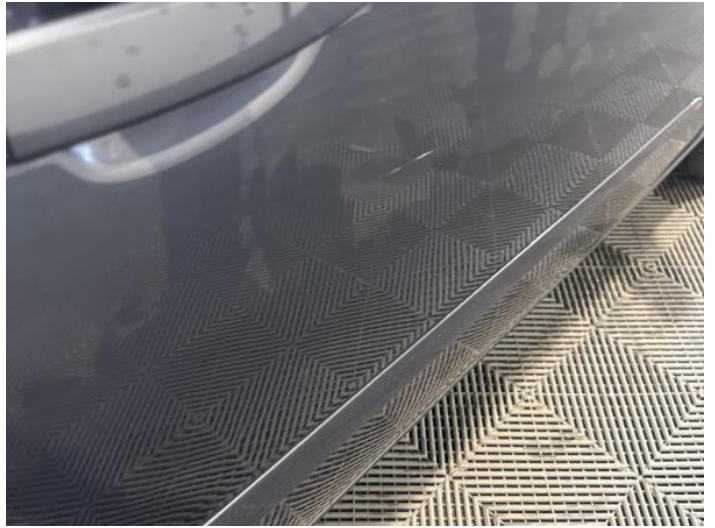
16: Door osf
Scratched
Over 25mm Thru Paint

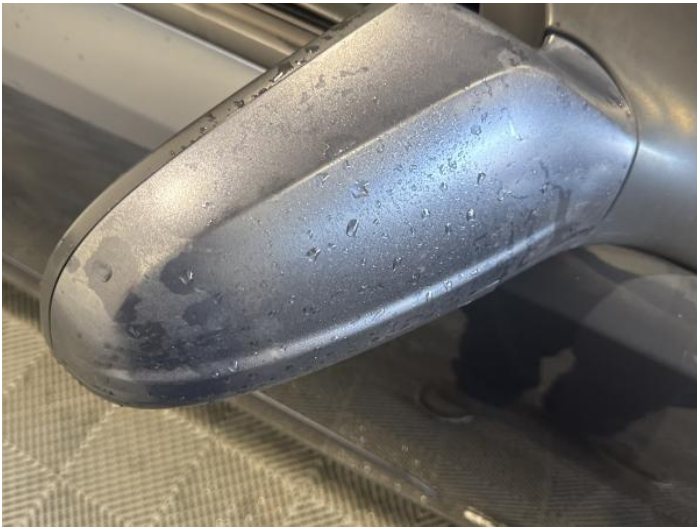
17: Door Mirror Assy osf
Scratched (Painted)
Over 25mm Thru Paint

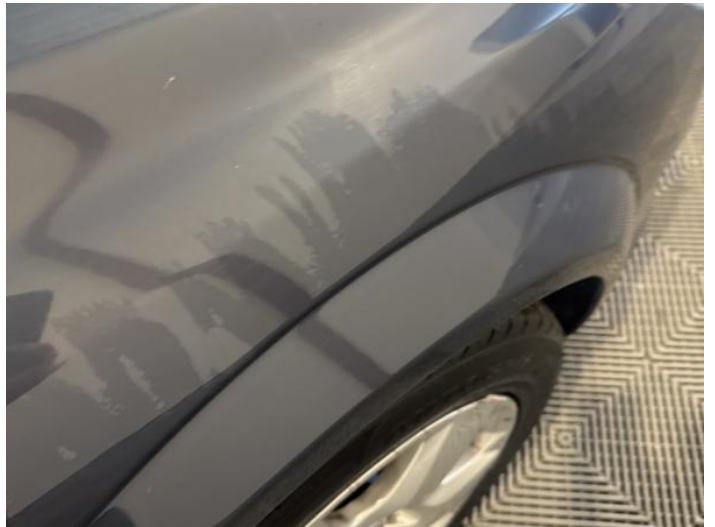
18: Wing osf
Chipped
1 To 5

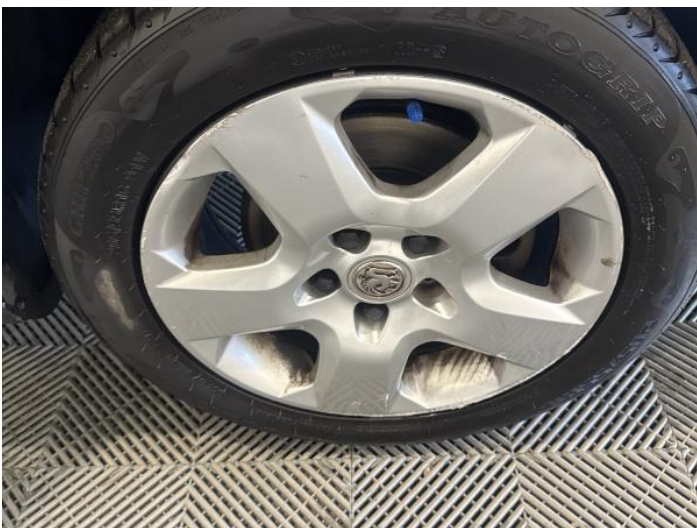
19: Wheel osf
Scratched
Over 50mm
