VEHICLE INSPECTION REPORT

LM13BHJ

Kia Picanto 1.0 1 5dr

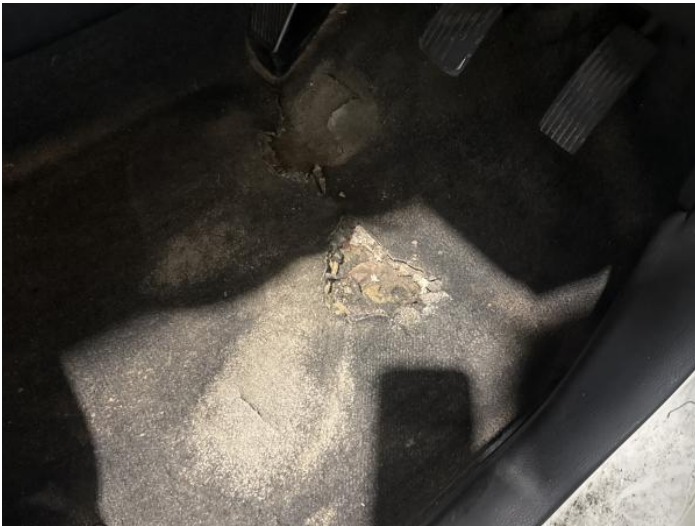
1: Carpets Front
Holed
Over 3mm

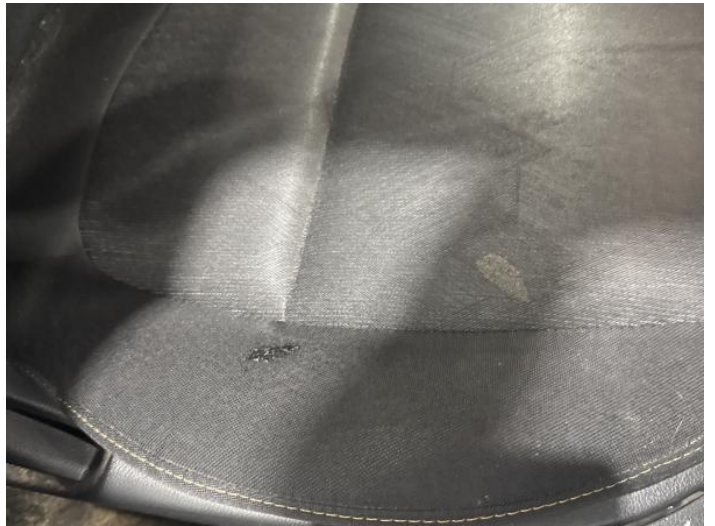
2: Seat Base Cover osf
Scuffed
Over 25mm

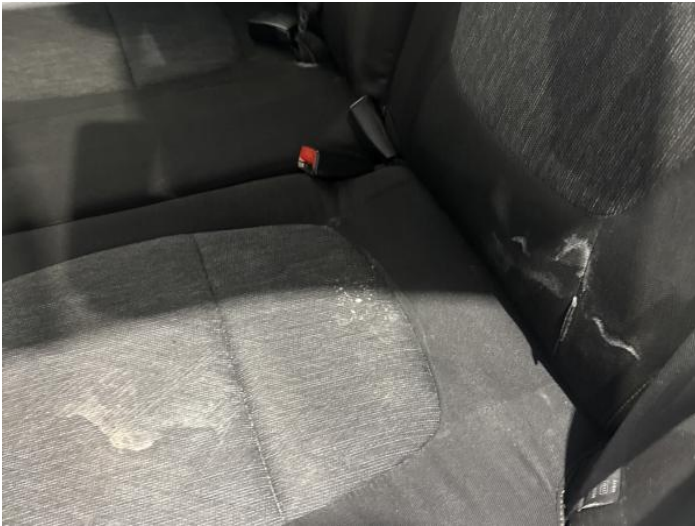
3: Seat Base Cover nsr
Soiled
Light

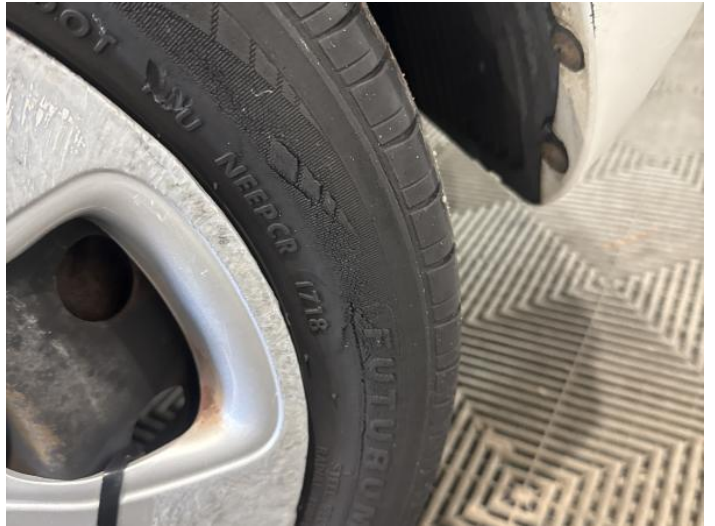
4: Tyre nsr
Damaged
Replace

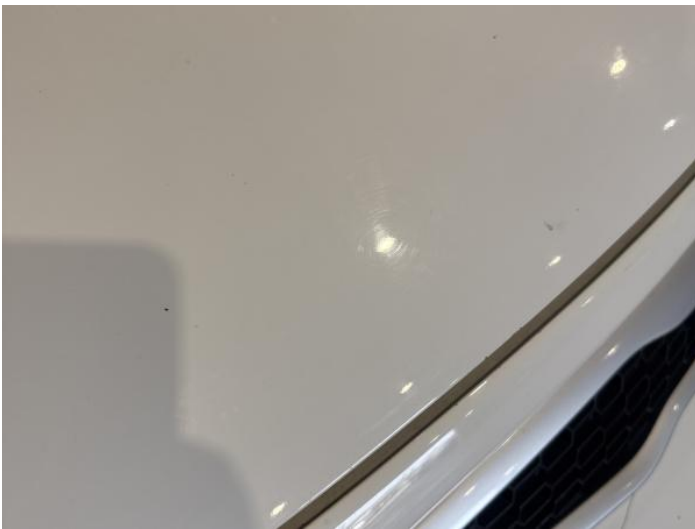
5: Bonnet
Chipped
1 To 5

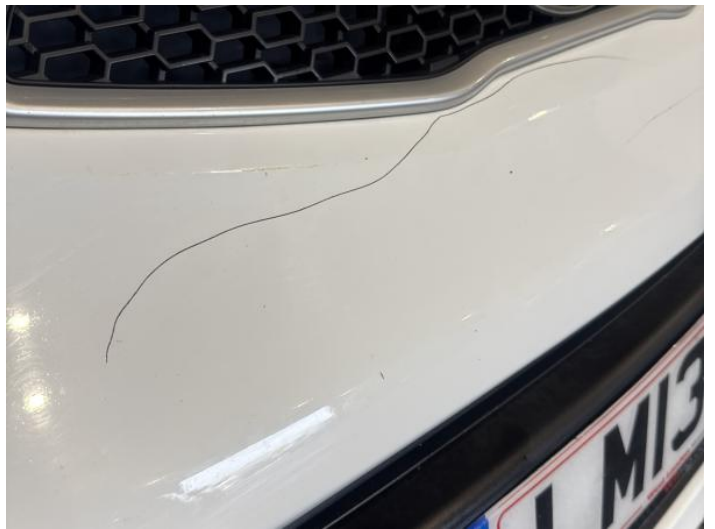
6: Bumper Front
Dented
With Paint Damage

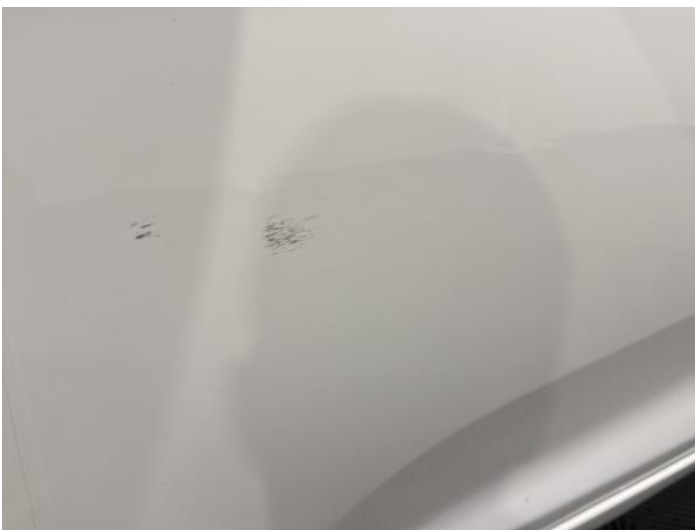
7: Door nsf
Scratched
Over 25mm Thru Paint

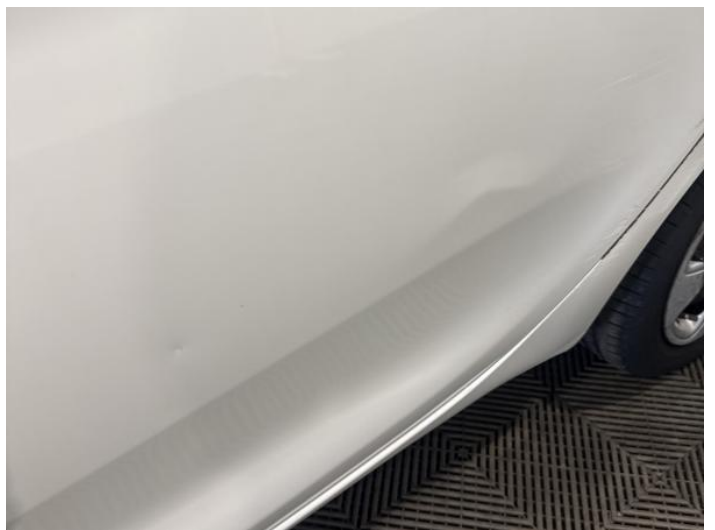
8: Door nsr
Dented
With Paint Damage

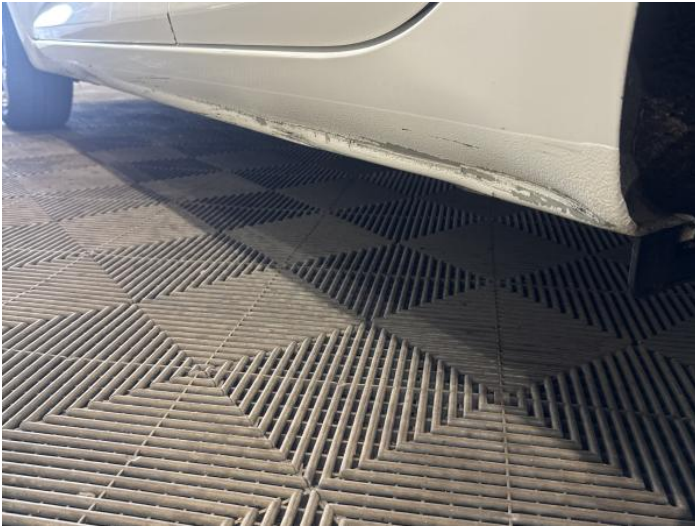
9: Sill ns
Dented
With Paint Damage

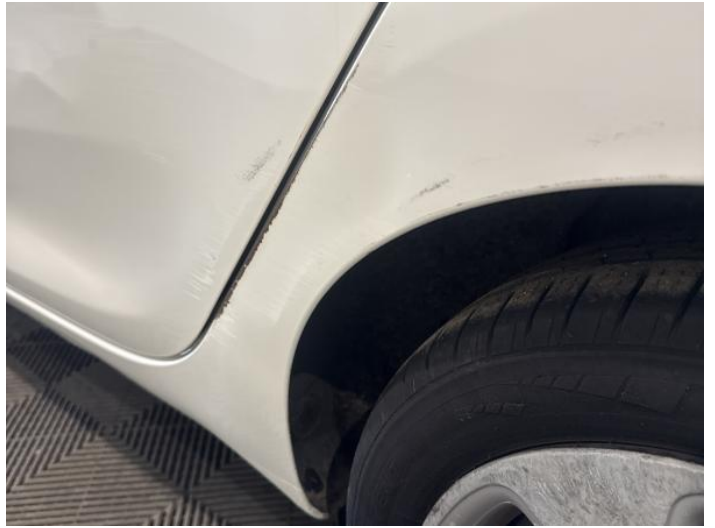
10: Qtr Panel nsr
Dented
With Paint Damage

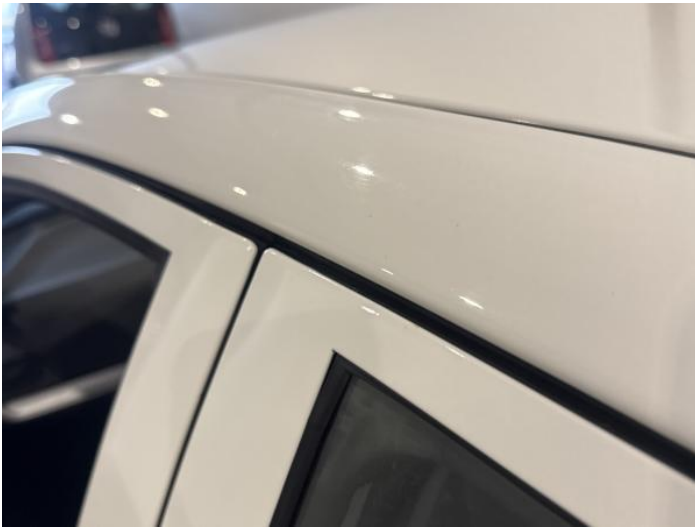
11: B Post ns
Dented
Between 10mm + 30mm

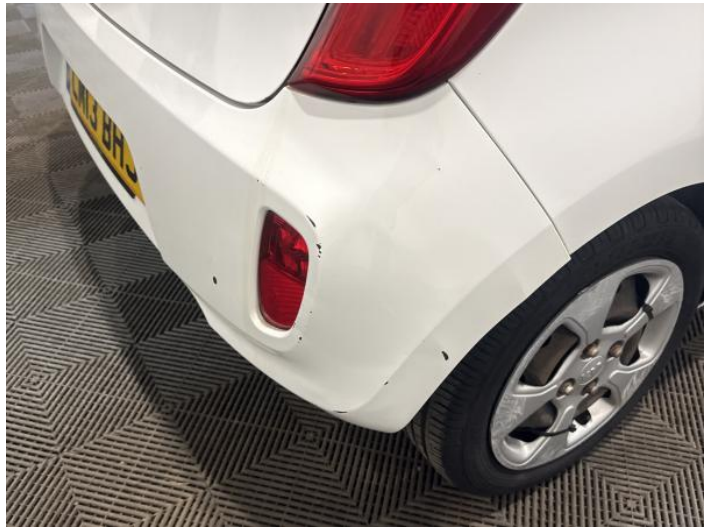
12: Bumper Rear
Scratched
Over 100mm Thru Paint

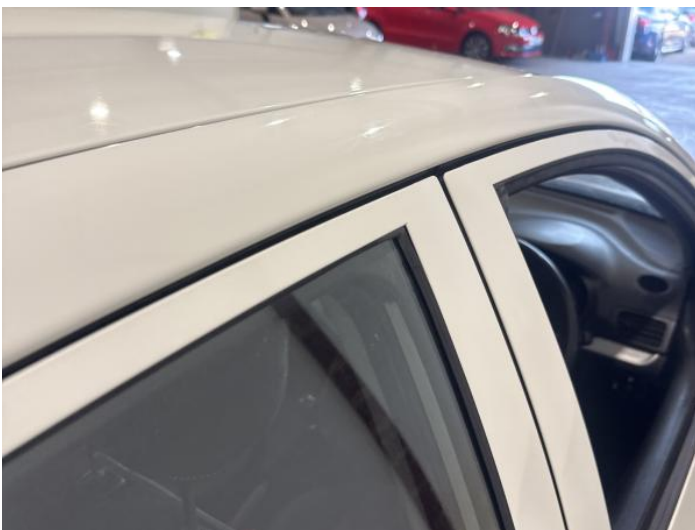
13: B Post os
Dented
Between 10mm + 30mm

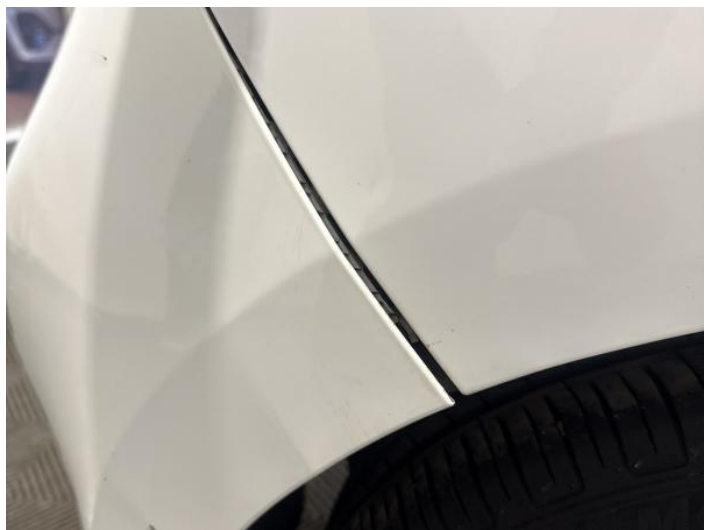
14: Bumper Rear
Insecure
Action Required

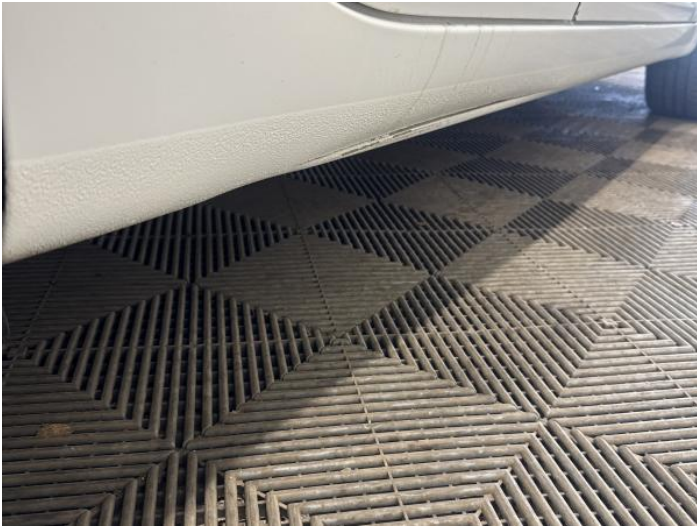
15: Sill os
Dented
With Paint Damage

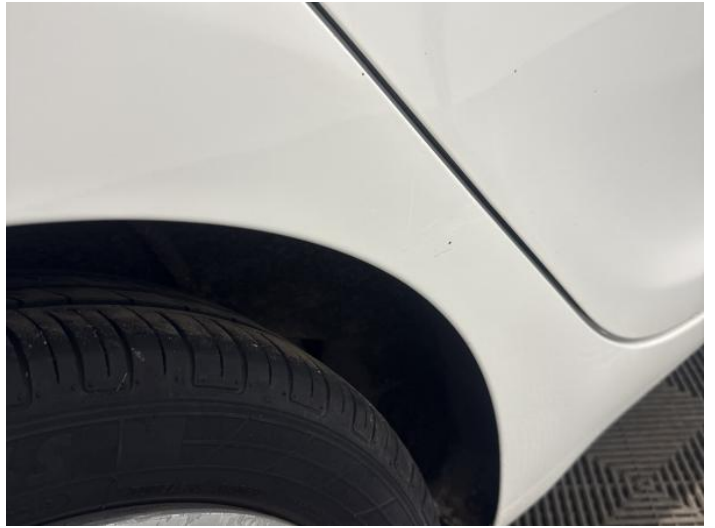
16: Qtr Panel osr
Scratched
Over 25mm Thru Paint

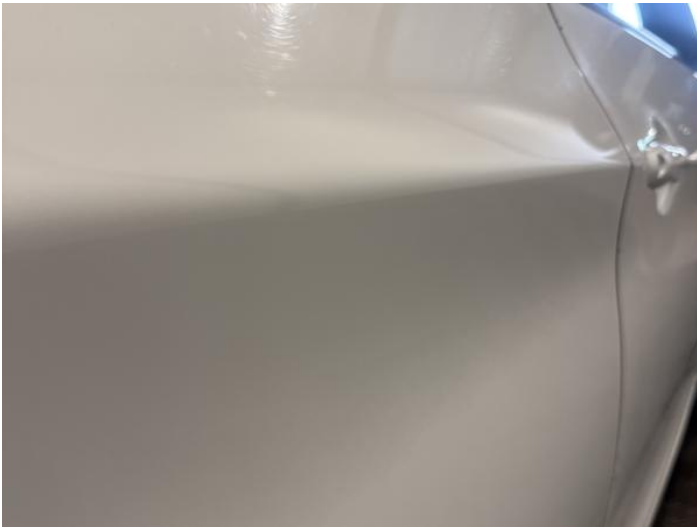
17: Door osr
Dented
Between 10mm + 30mm

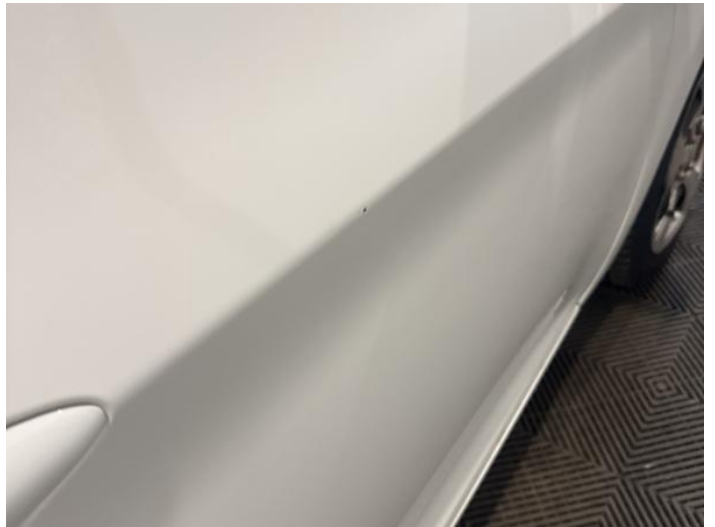
18: Door osf
Dented
Between 10mm + 30mm

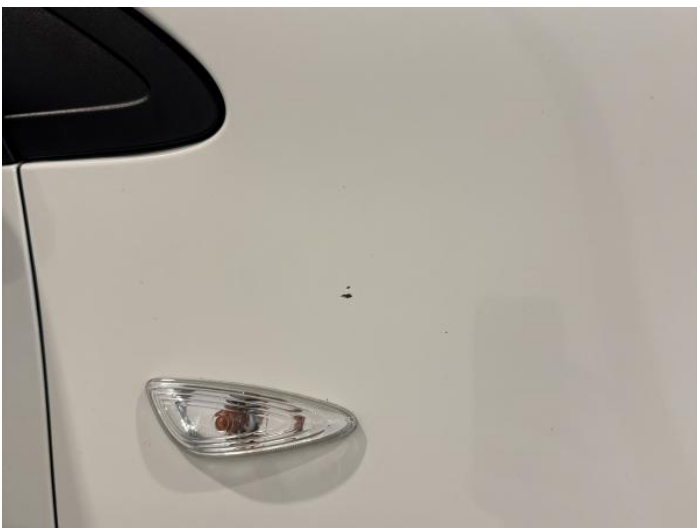
19: Wing osf
Chipped
1 To 5
