# VEHICLE INSPECTION REPORT

**DU69OLR**

## Vauxhall Astra 1.6 CDTi 16V ecoTEC Tech Line Nav 5dr

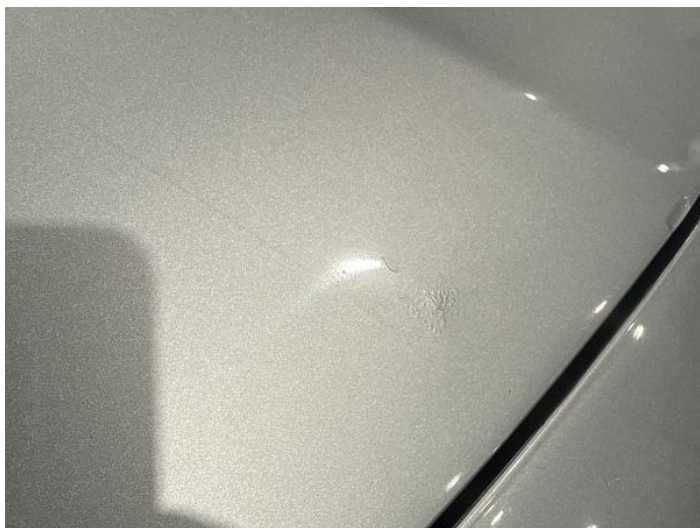
1: Bonnet  
Poor Previous Repair  
Rippled Up To 30%

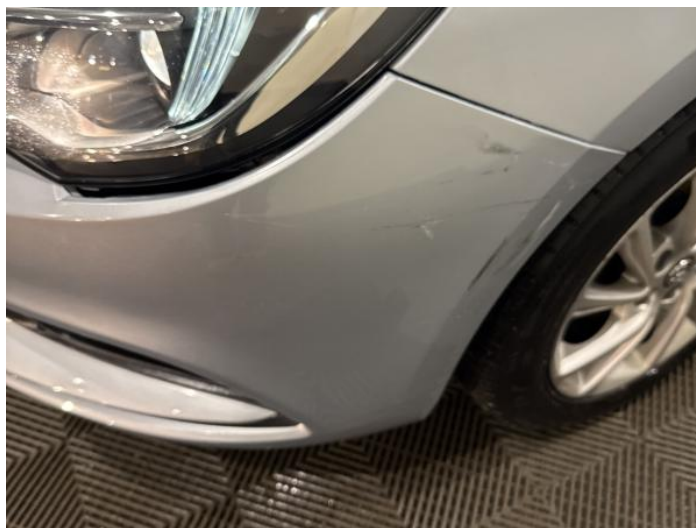
2: Bumper Front  
Scratched  
25 to 100mm Thru Paint

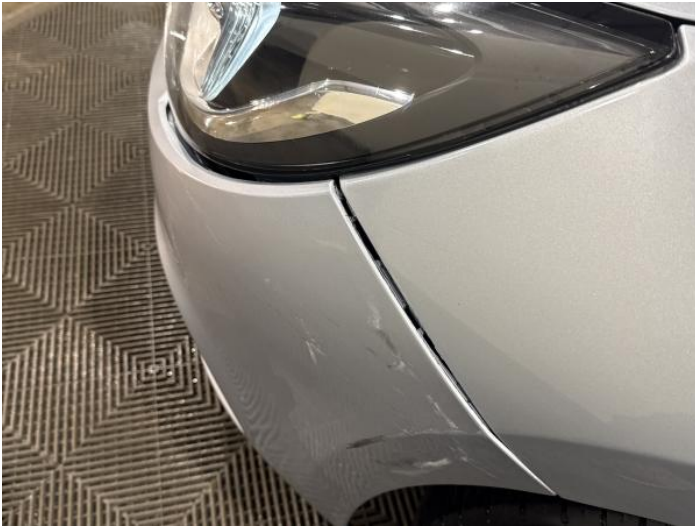
3: Bumper Front  
Insecure  
Action Required

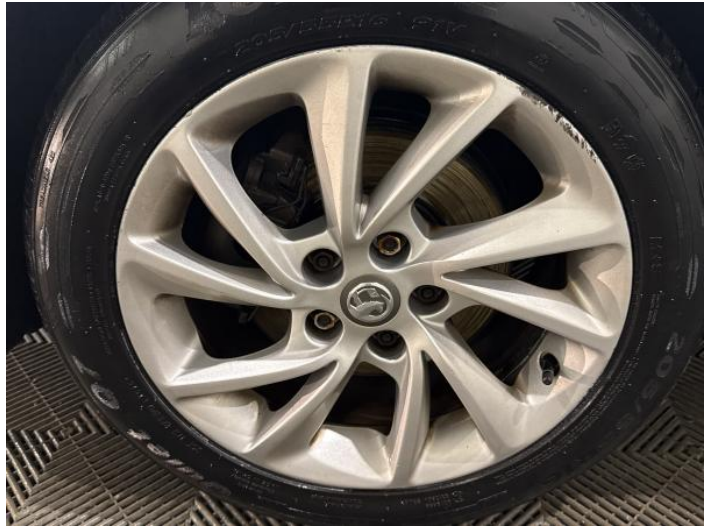
4: Wheel nsf  
Scratched  
Over 50mm

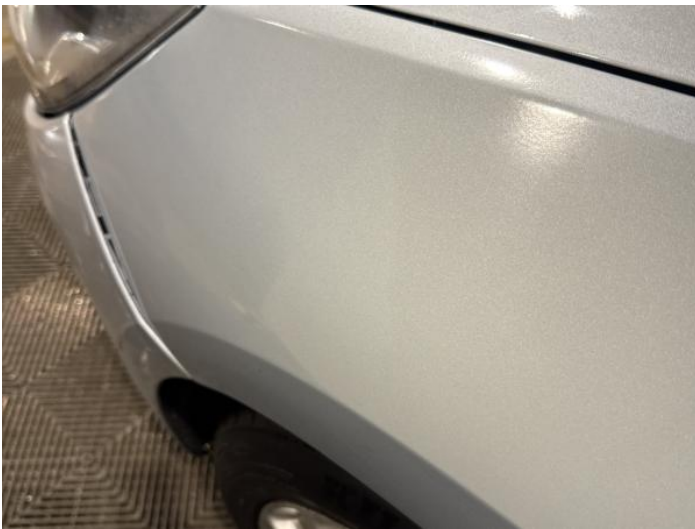
5: Wing nsf  
Poor Previous Repair  
Poor Paint

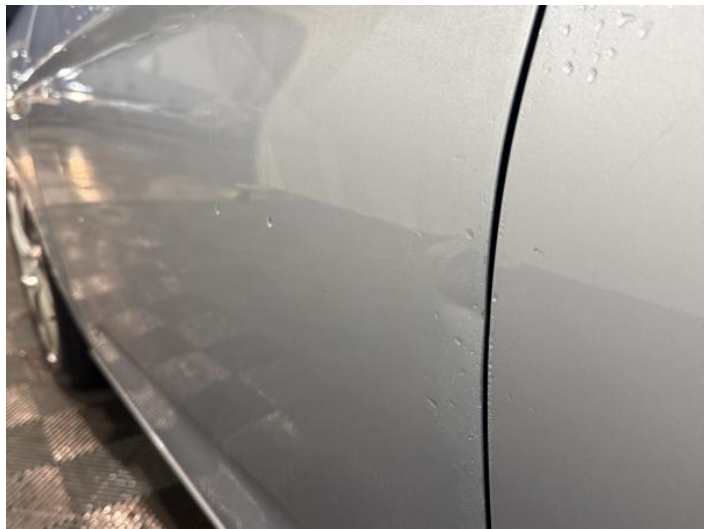
6: Door nsf  
Poor Previous Repair  
Rippled UpTo 30%

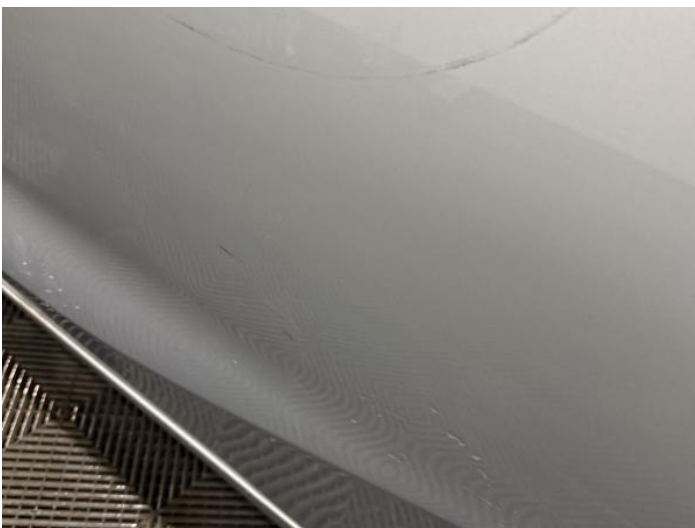
7: Door nsr  
Poor Previous Repair  
Rippled UpTo 30%

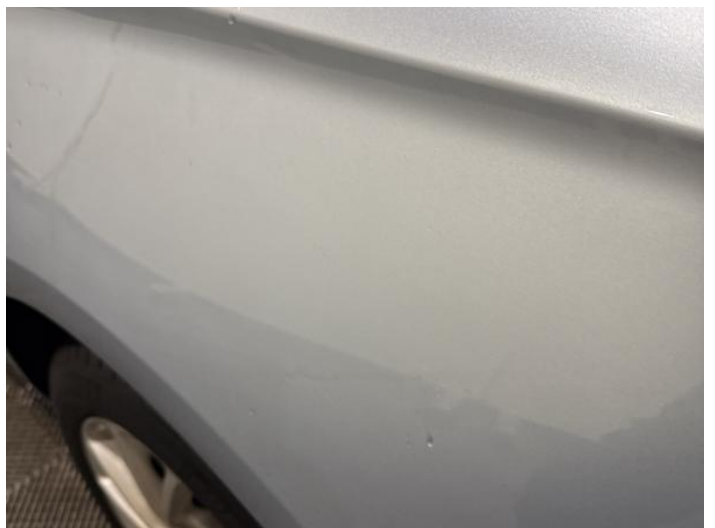
8: Qtr Panel nsr  
Scratched  
Over 25mm Thru Paint

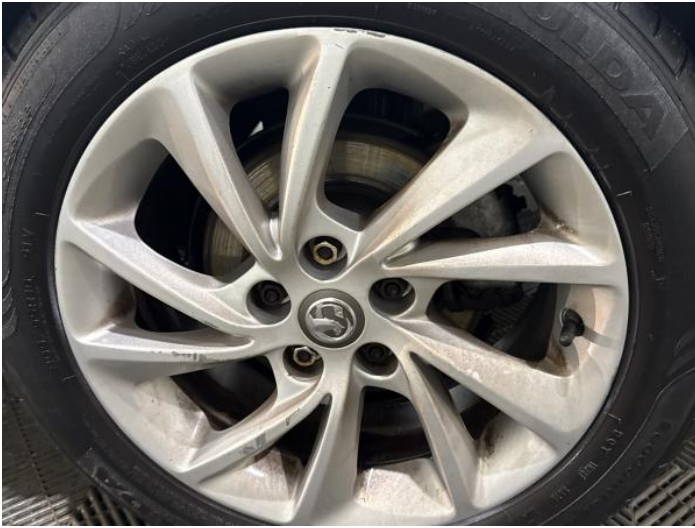
9: Wheel nsr  
Scratched  
Over 50mm

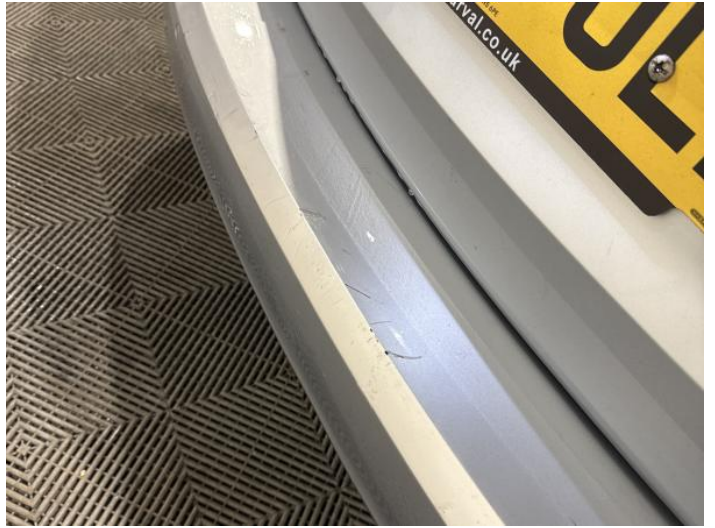
10: Bumper Rear  
Scratched  
25 to 100mm Thru Paint

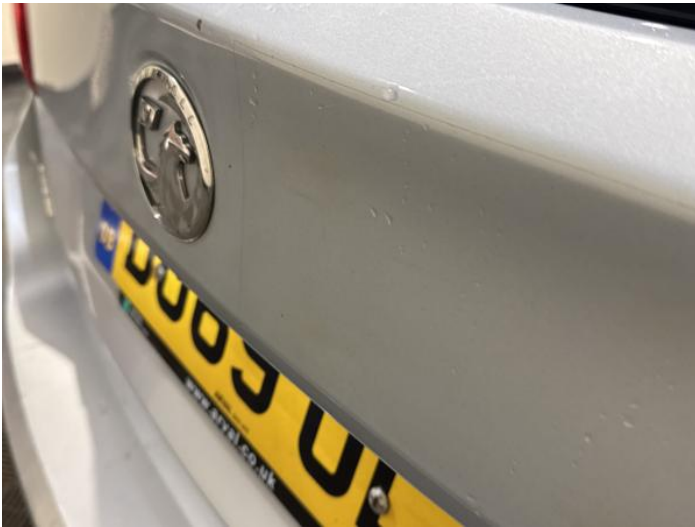
11: Tailgate  
Poor Previous Repair  
Rippled UpTo 30%

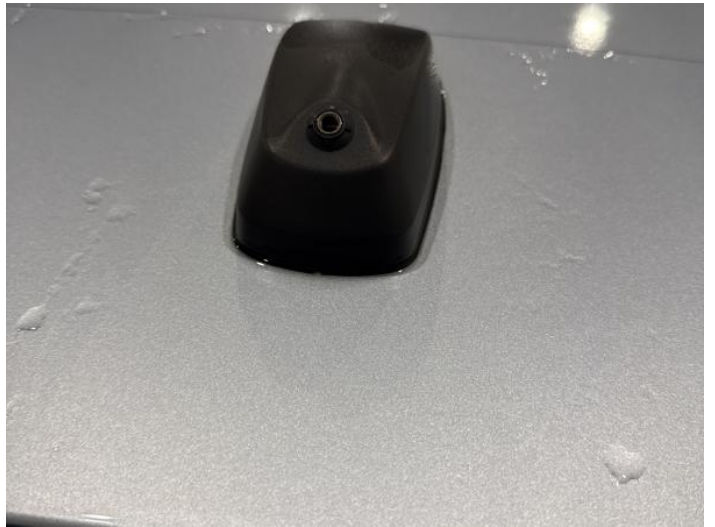
12: Aerial  
Missing  
Replace

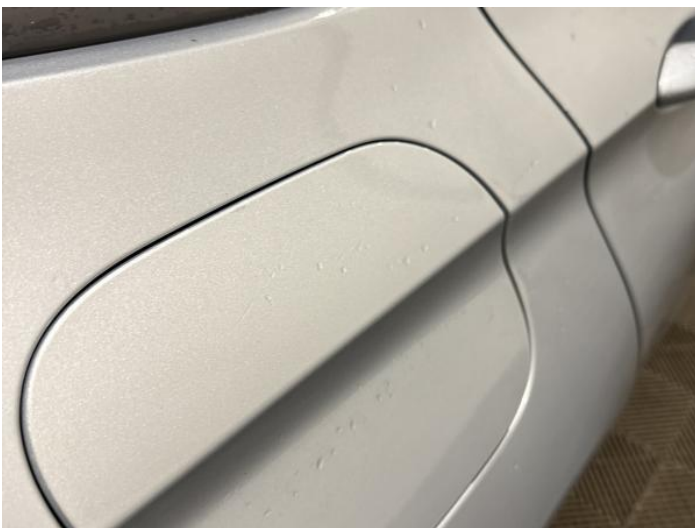
13: Qtr Panel osr  
Scratched  
Over 25mm Thru Paint

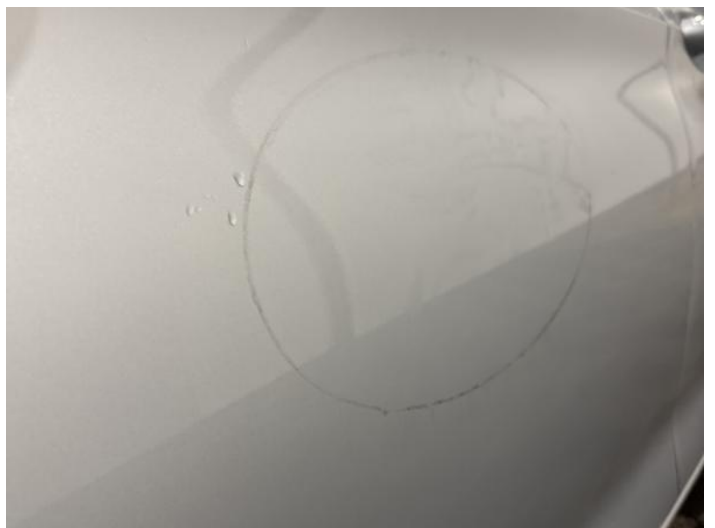
14: Door osr  
Scratched  
Over 25mm Not Thru Paint

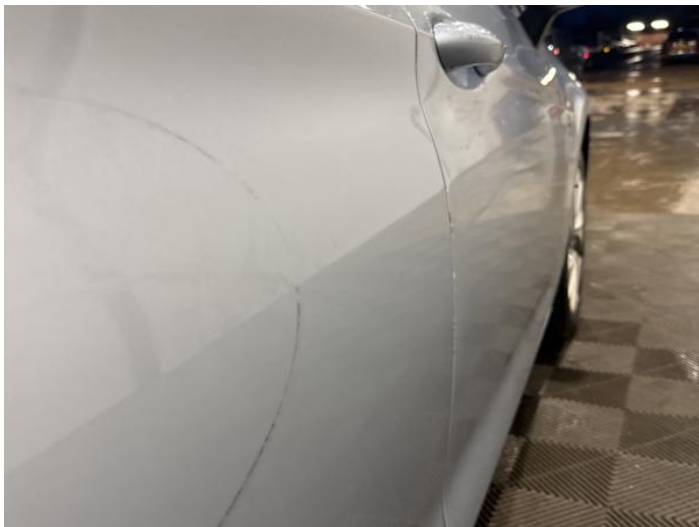
15: Door osr  
Dented  
Over 2 UpTo 10mm

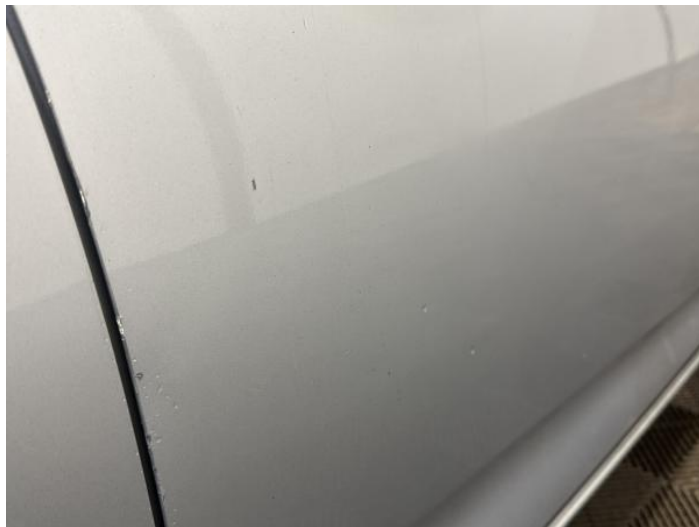
16: Door osf  
Scratched  
Over 25mm Thru Paint

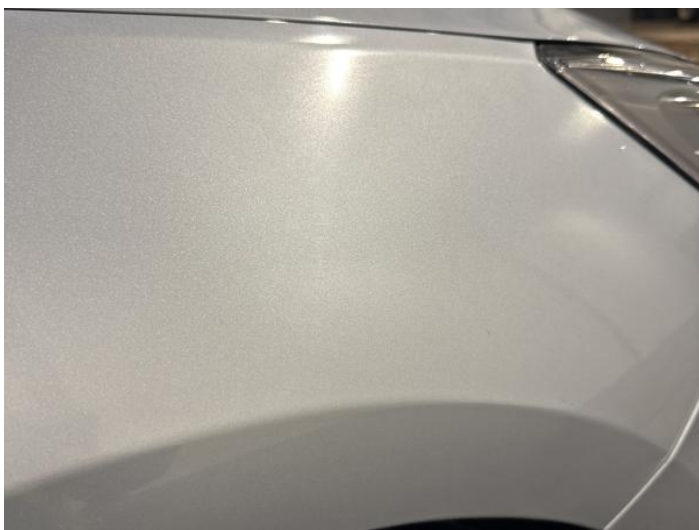
17: Wing osf  
Poor Previous Repair  
Poor Paint

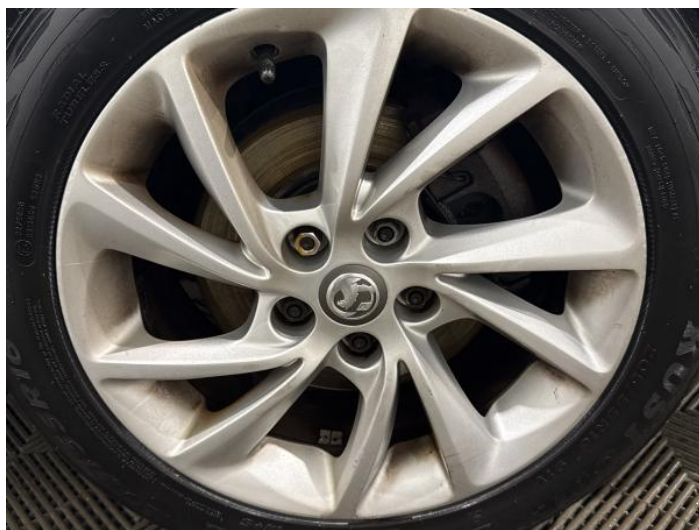
18: Wheel osf  
Scratched  
Up To 50mm

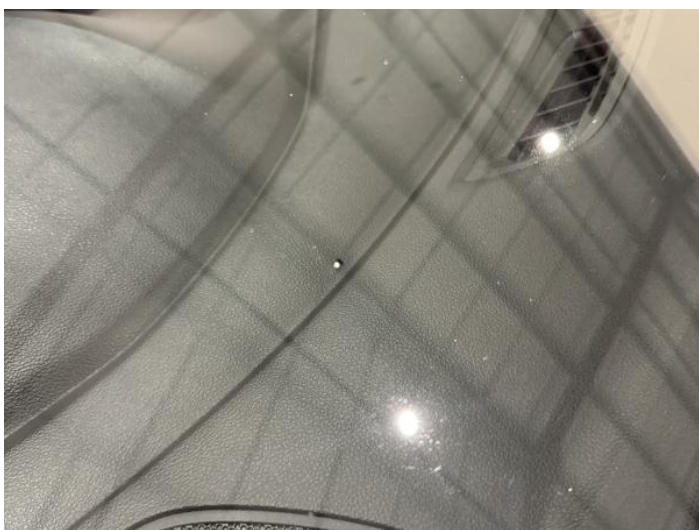
19: Screen Front  
Chipped  
UpTo 10mm

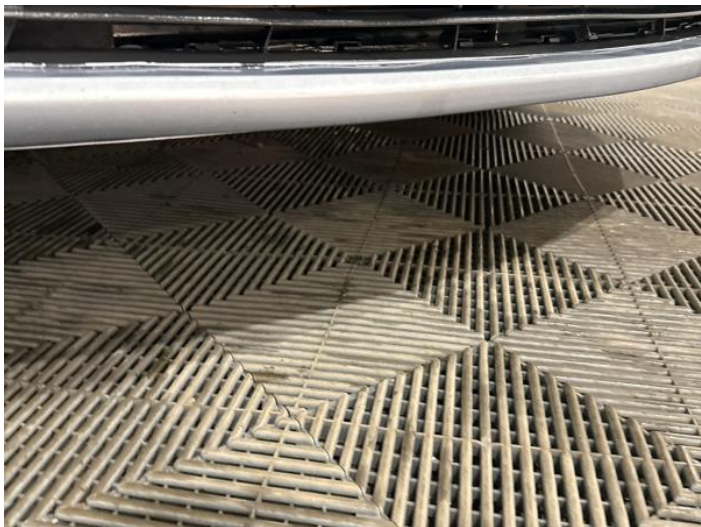
21: Bumper Front Moulding  
Missing  
Replace
