VEHICLE INSPECTION REPORT

DH60SEP

Renault Laguna 1.5 dCi eco2 Dynamique TomTom 5dr

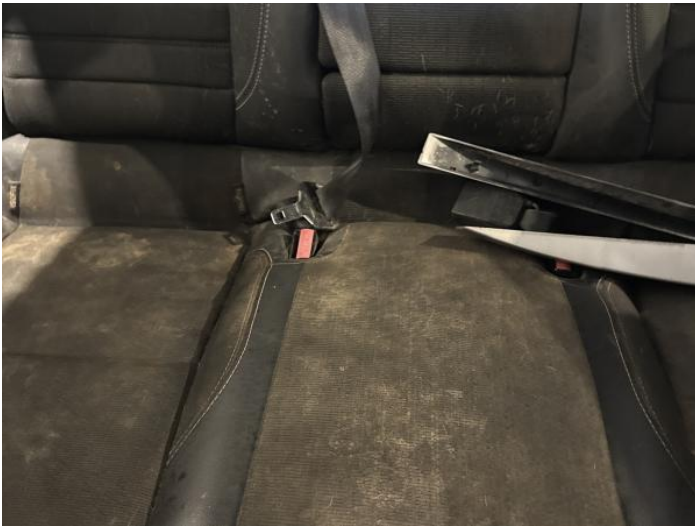
1: Seat Base Cover osr
Soiled
Light

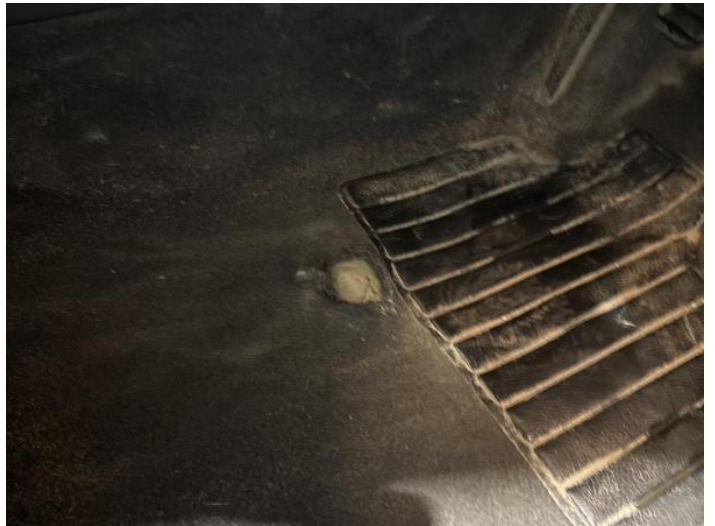
2: Carpets Front
Holed
Over 3mm

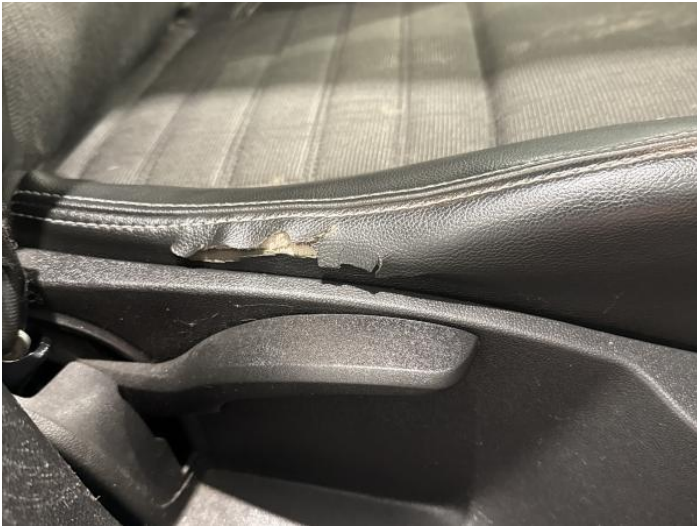
3: Seat Base Cover osf
Scuffed
Over 25mm

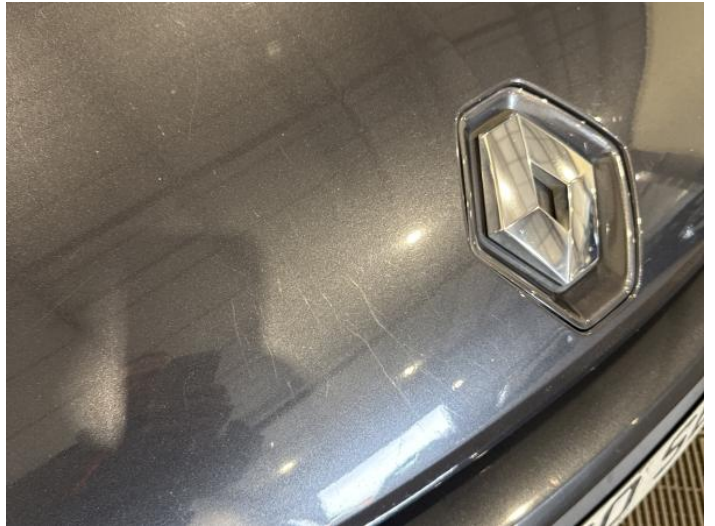
4: Bonnet
Scratched
Over 25mm Thru Paint

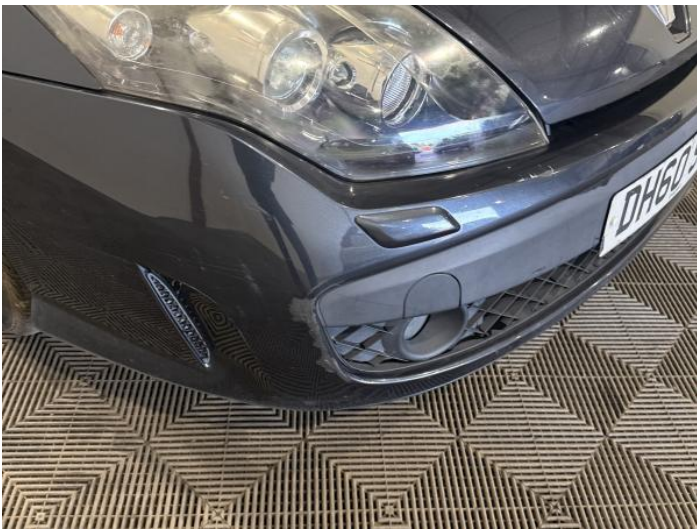
5: Bumper Front
Scratched
Over 100mm Thru Paint

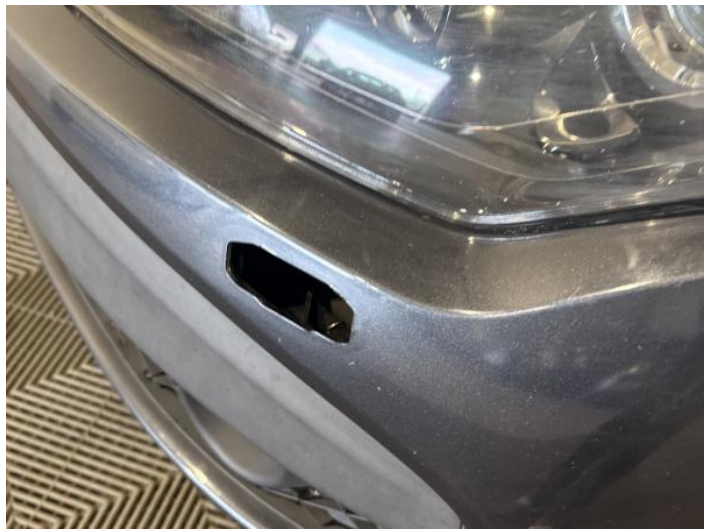
6: Bumper Front Moulding
Missing
Replace

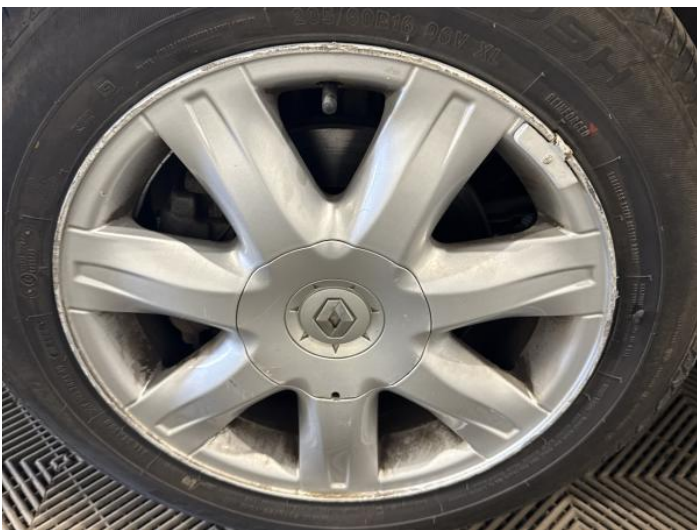
7: Wheel nsf
Scratched
Over 50mm

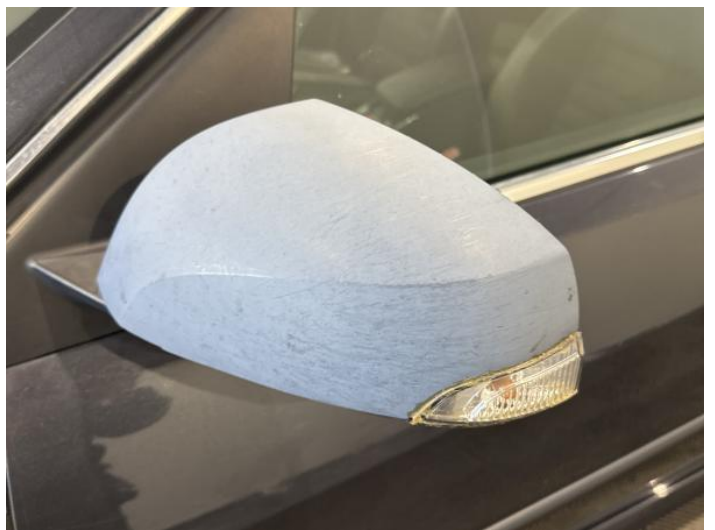
8: Door Mirror Assy nsf
Scratched (Painted)
Over 25mm Thru Paint

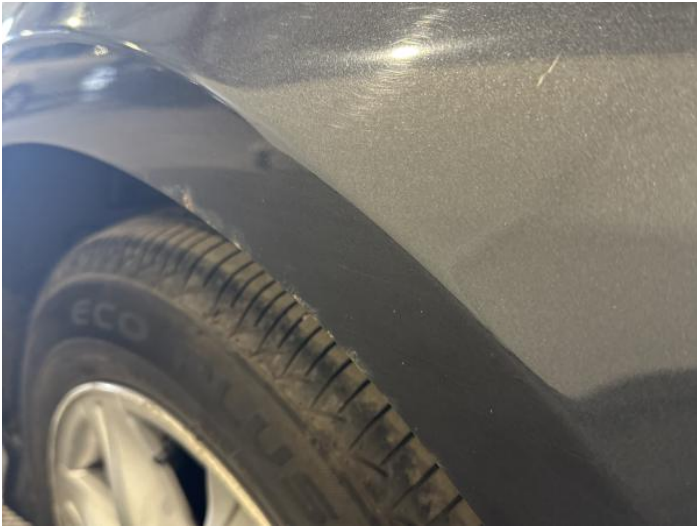
9: Wing nsf
Rusted
Over 5mm

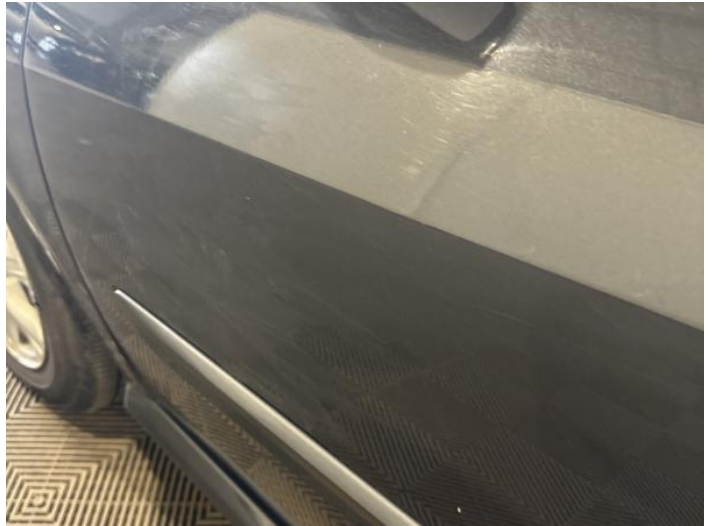
10: Door nsf
Scratched
Over 25mm Thru Paint

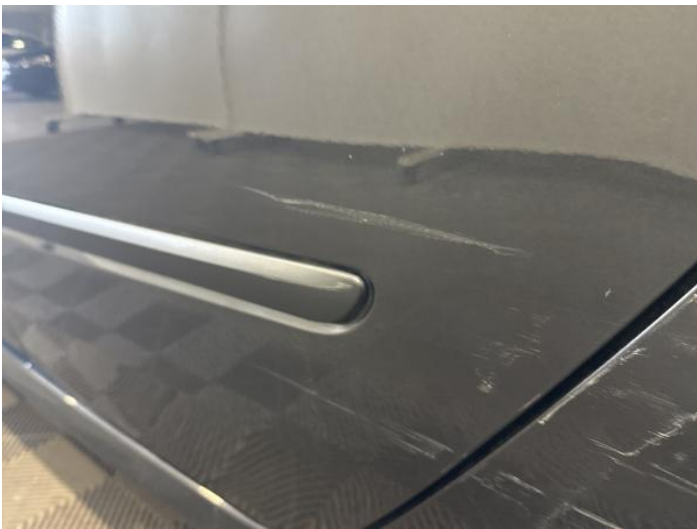
11: Door nsr
Scratched
Over 25mm Thru Paint

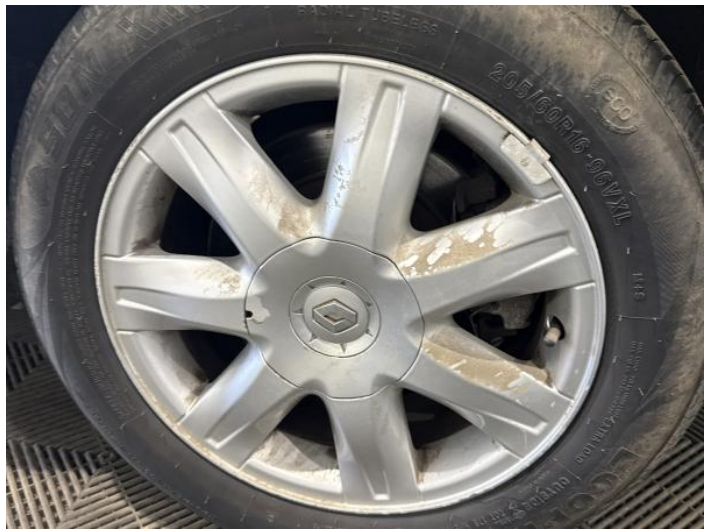
12: Wheel nsr
Scratched
Over 50mm

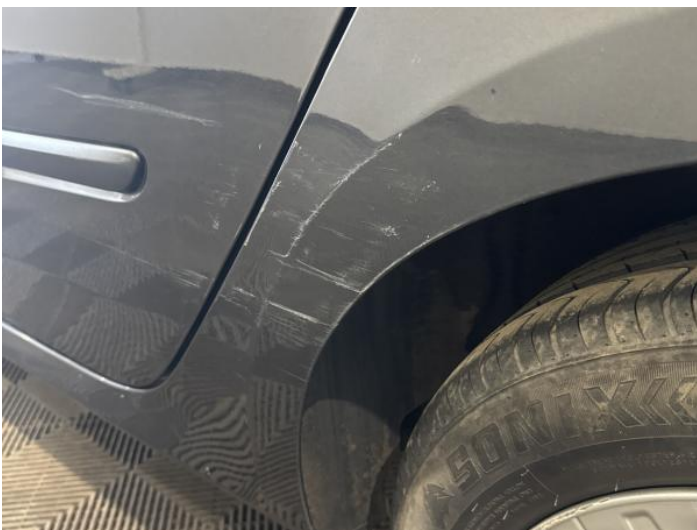
13: Qtr Panel nsr
Dented
With Paint Damage

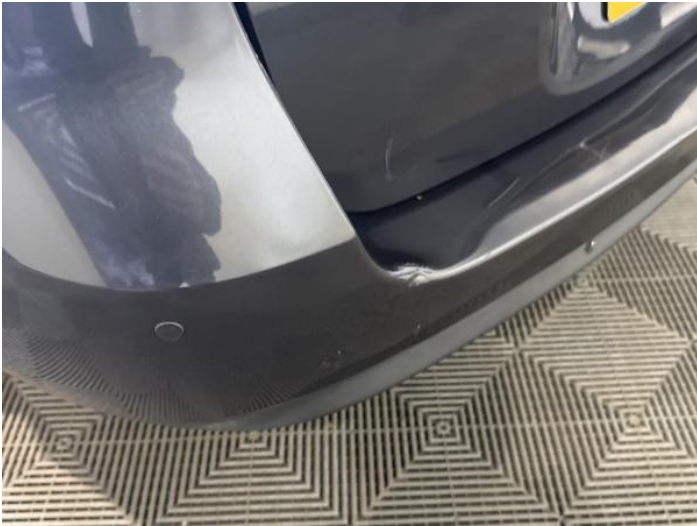
15: Bumper Rear
Dented
With Paint Damage

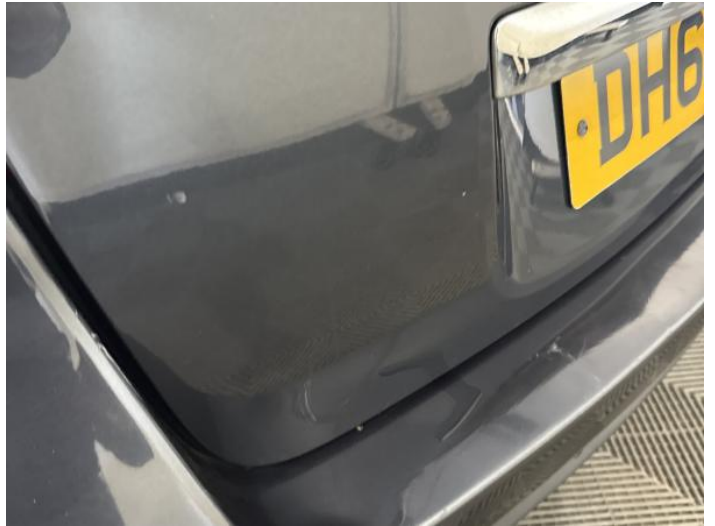
16: Tailgate
Scratched
Over 25mm Thru Paint

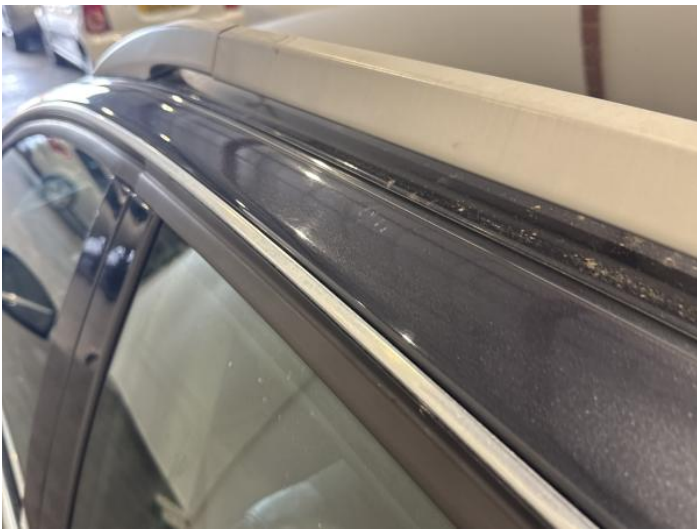
17: B Post ns
Dented
Between 10mm + 30mm

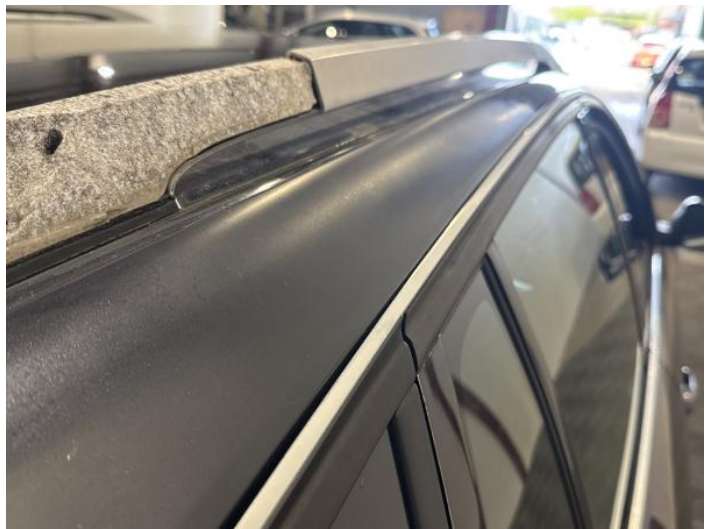
18: B Post os
Dented
With Paint Damage

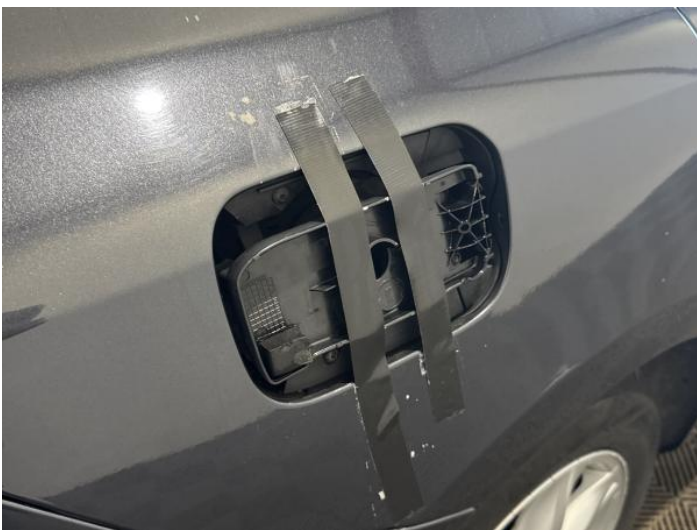
19: Fuel Flap
Missing
Replace

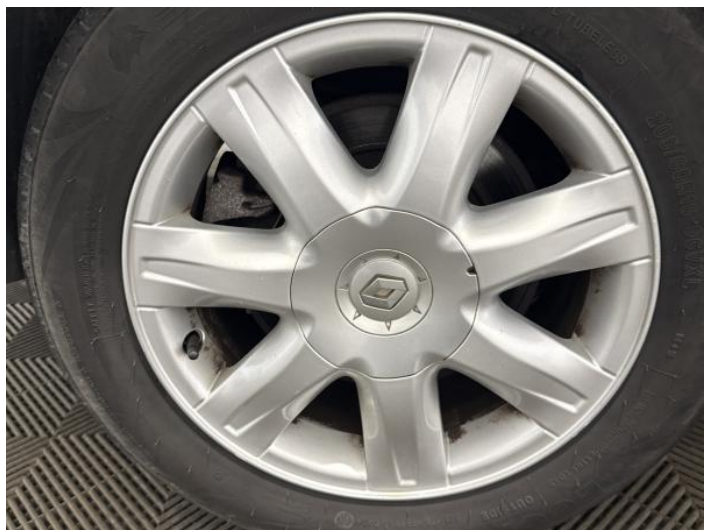
20: Wheel osr
Scratched
Over 50mm

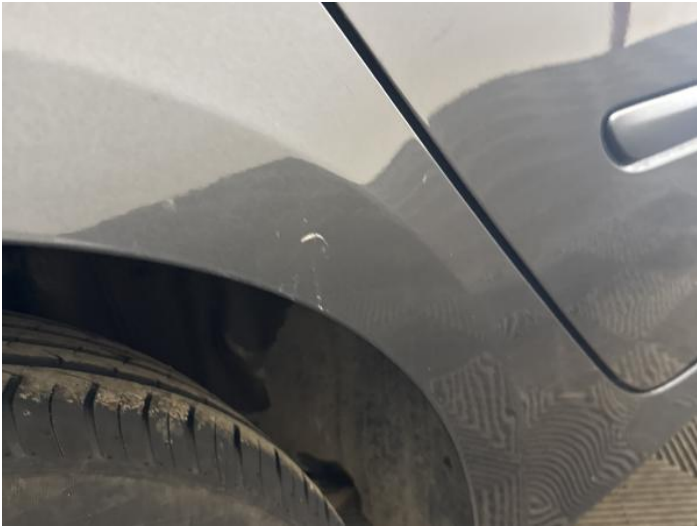
21: Qtr Panel osf
Scratched
Over 25mm Thru Paint

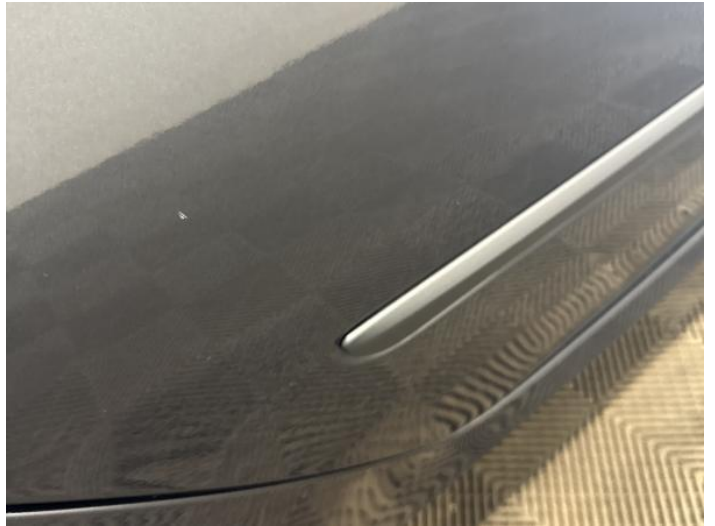
22: Door osf
Chipped
1 To 5

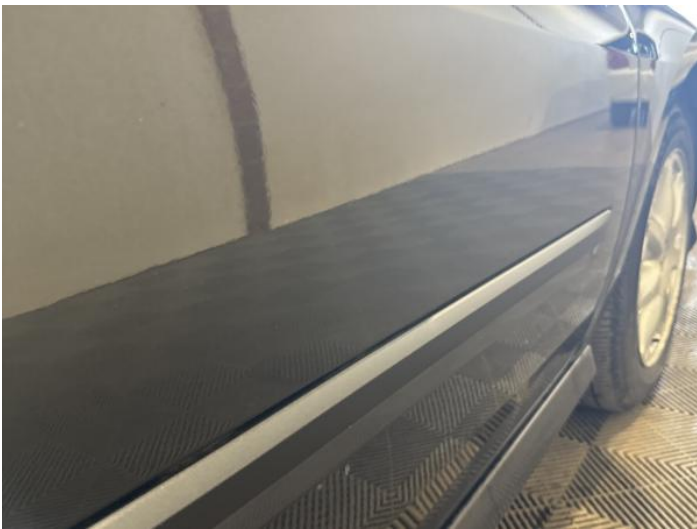
23: Door osf
Dented
Between 10mm + 30mm

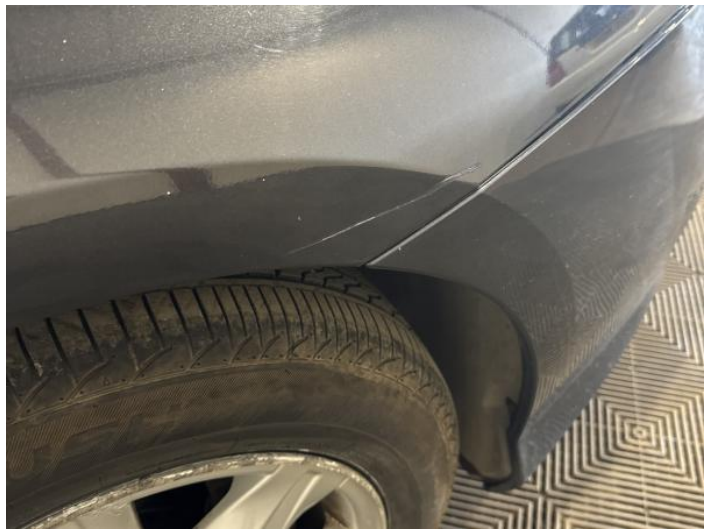
24: Wing osf
Scratched
Over 25mm Thru Paint

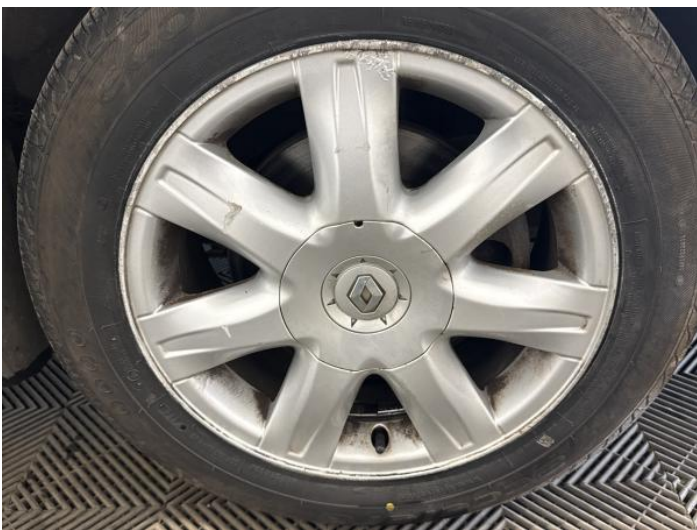
25: Wheel osf
Scratched
Over 50mm

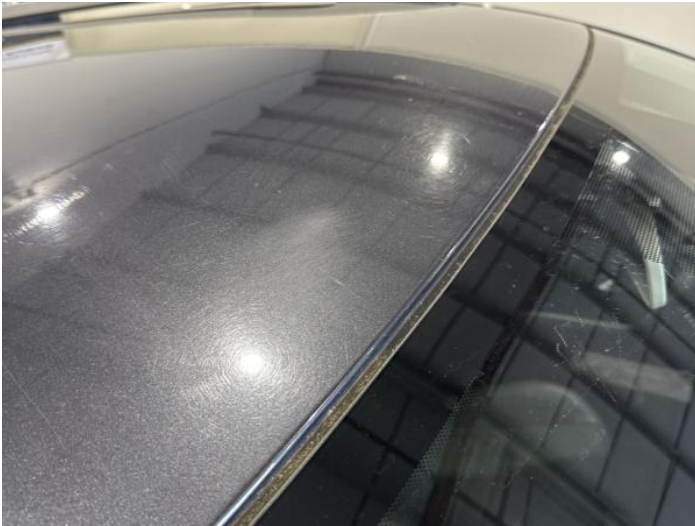
27: Roof
 Scratched
 Over 25mm Thru Paint
