VEHICLE INSPECTION REPORT

FX61DHC

Lexus RX 450h 3.5 SE-L 5dr CVT Auto

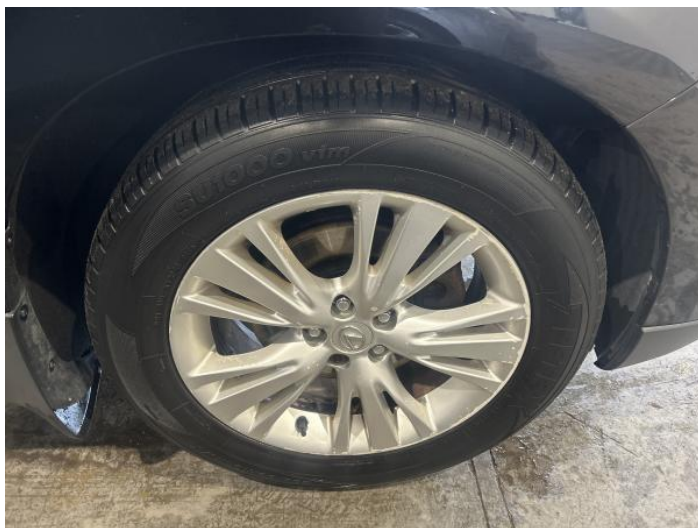
1: Wheel osf
Scratched
Over 50mm

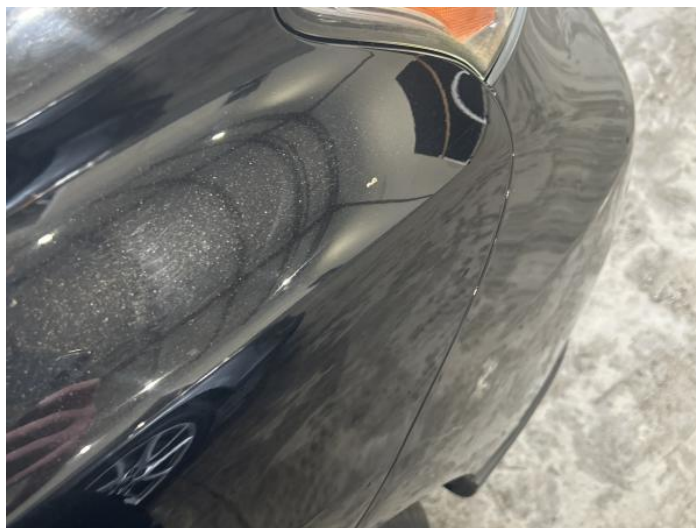
2: Wing osf
Chipped
1 To 5

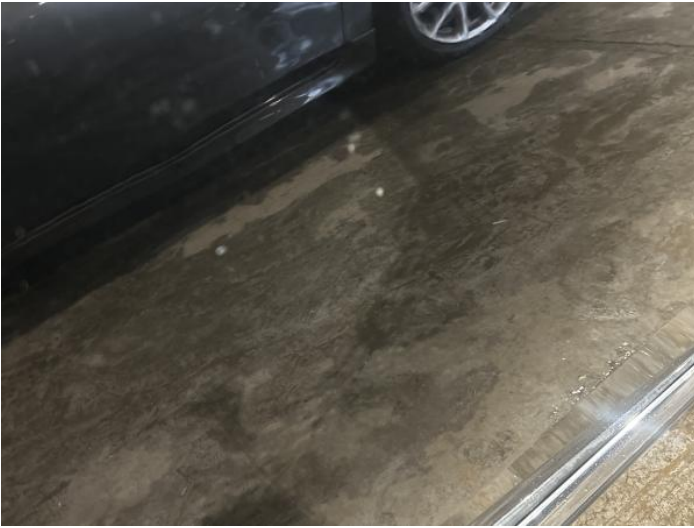
3: Door osf
Chipped
1 To 5

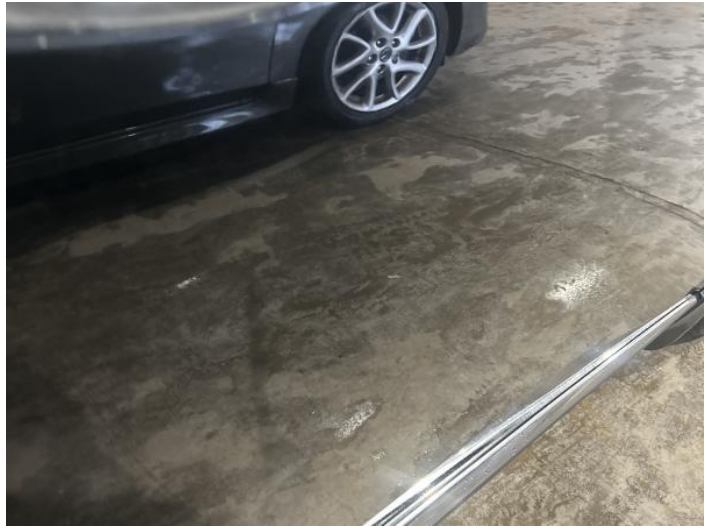
4: Door osf
Scratched
Over 25mm Not Thru Paint

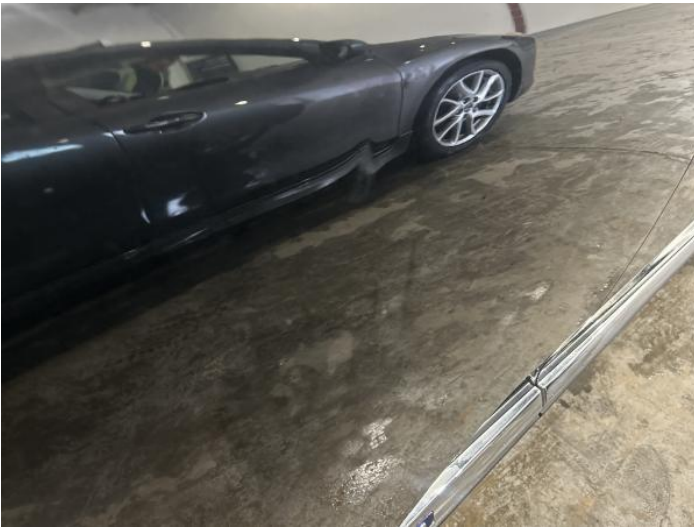
5: Door osr
Dented
Between 10mm + 30mm

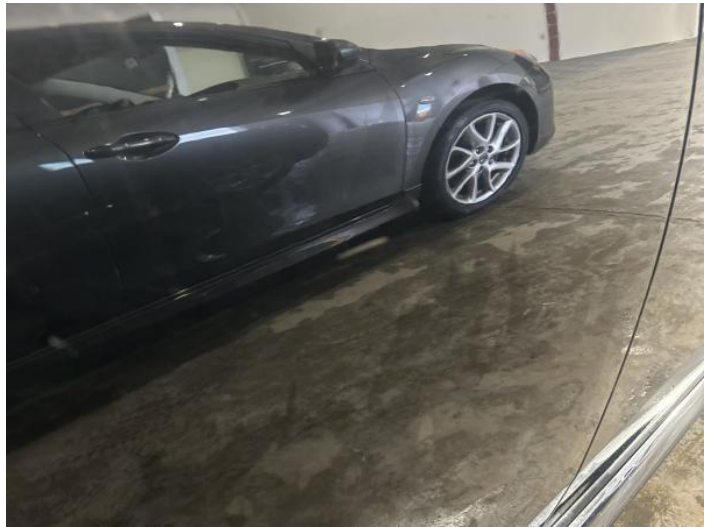
6: Door osr
Scratched
Over 25mm Not Thru Paint

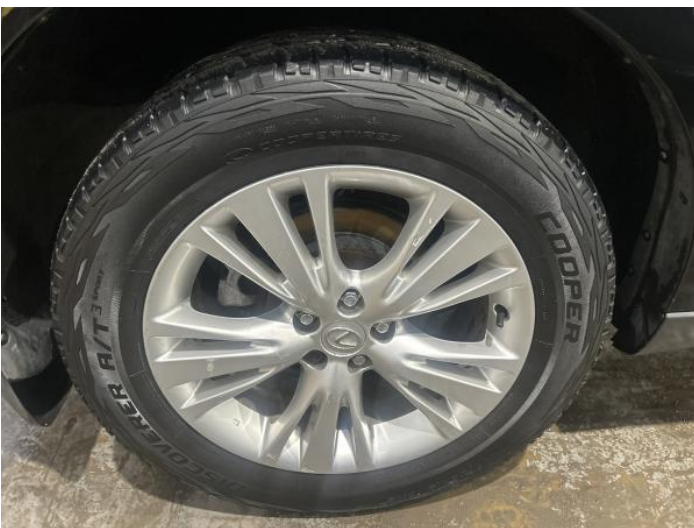
7: Wheel osr
Scratched
Over 50mm

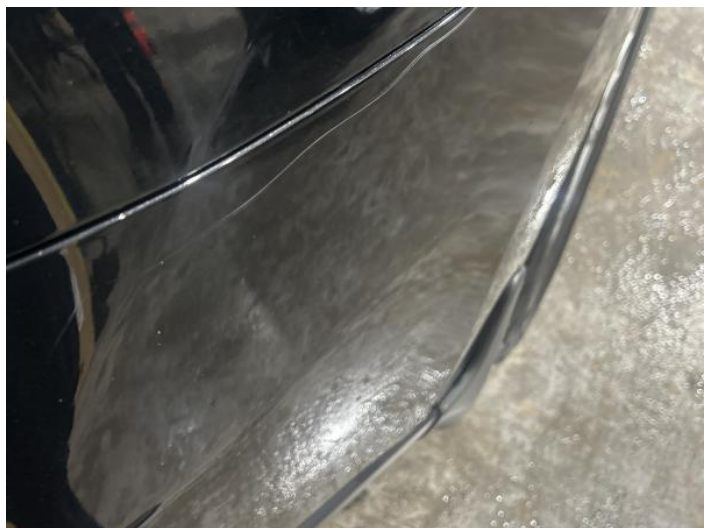
8: Bumper Rear
Scratched
Over 25mm Not Thru Paint

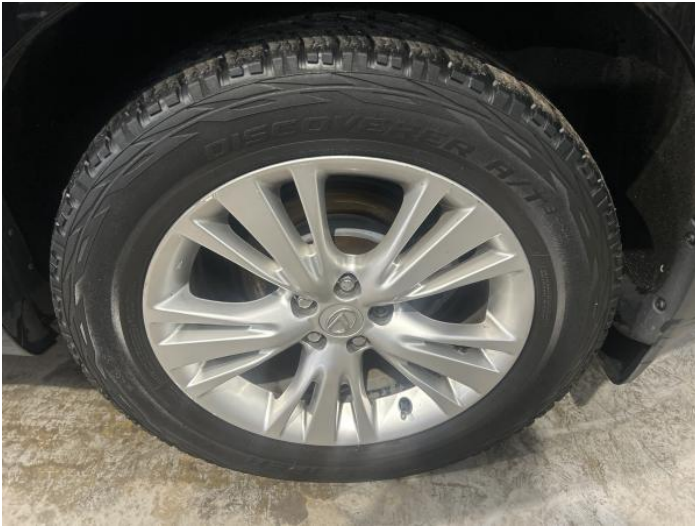
9: Wheel nsr
Scratched
Up To 50mm

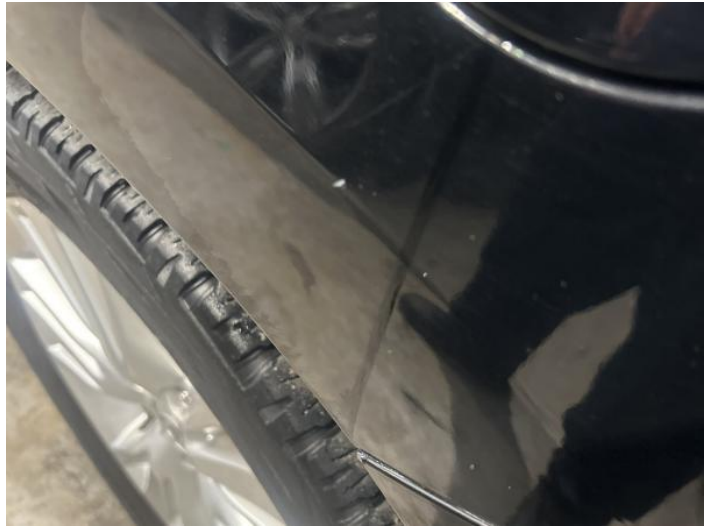
10: Qtr Panel nsr
Chipped
1 To 5

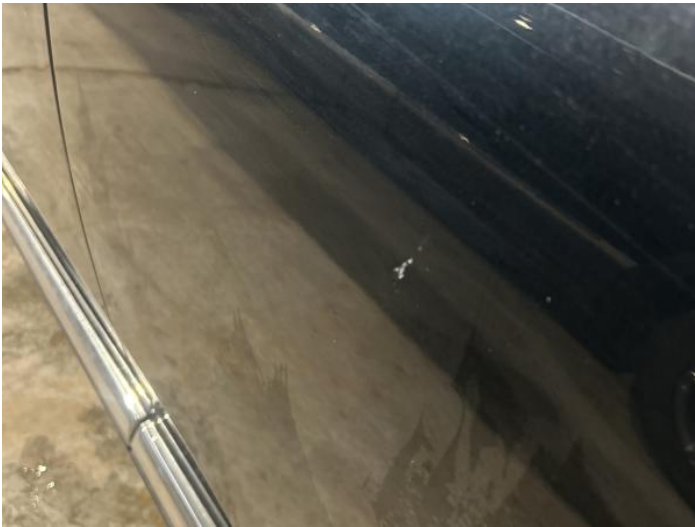
11: Door nsr
Chipped
1 To 5

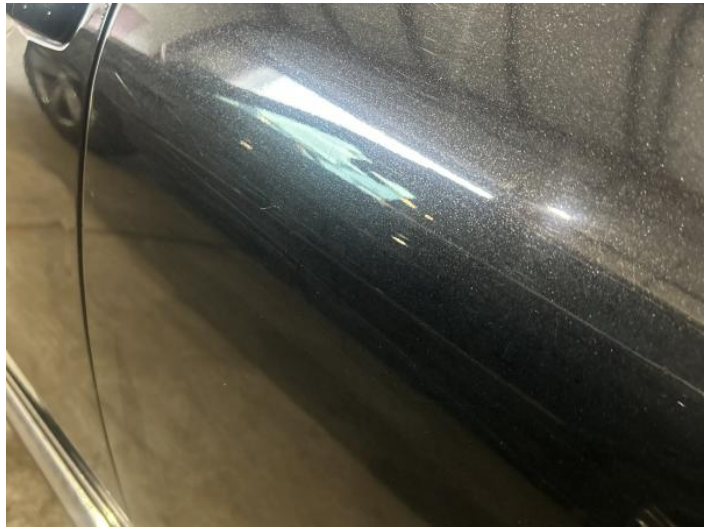
12: Door nsr
Scratched
Over 25mm Not Thru Paint

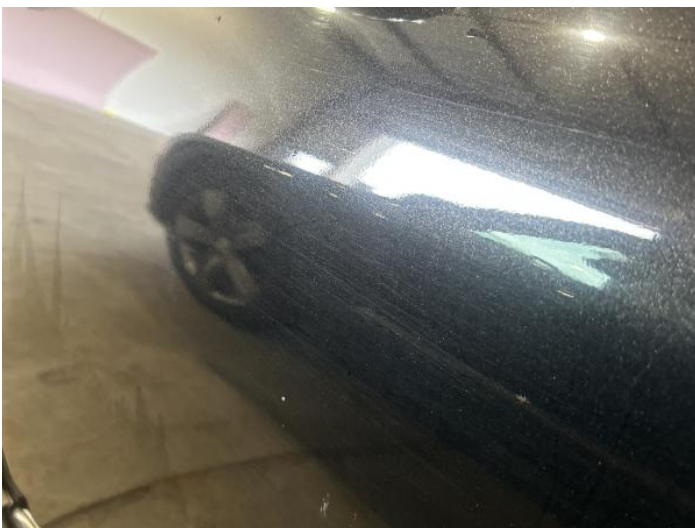
13: Door nsf
Poor Previous Repair
Poor Paint

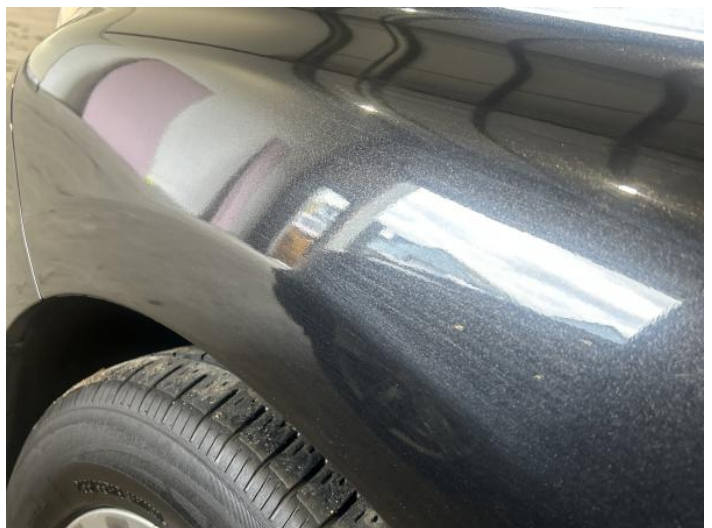
14: Wing nsf
Poor Previous Repair
Poor Paint

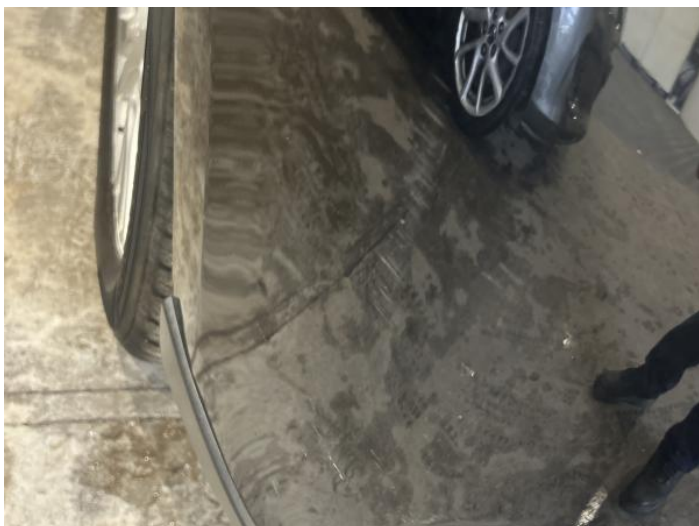
15: Bumper Front
Scratched
25 to 100mm Thru Paint

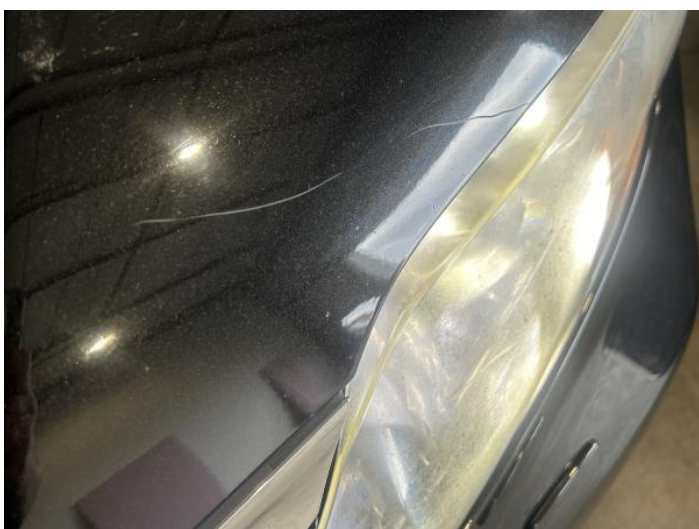
17: Bonnet
Scratched
Over 25mm Thru Paint

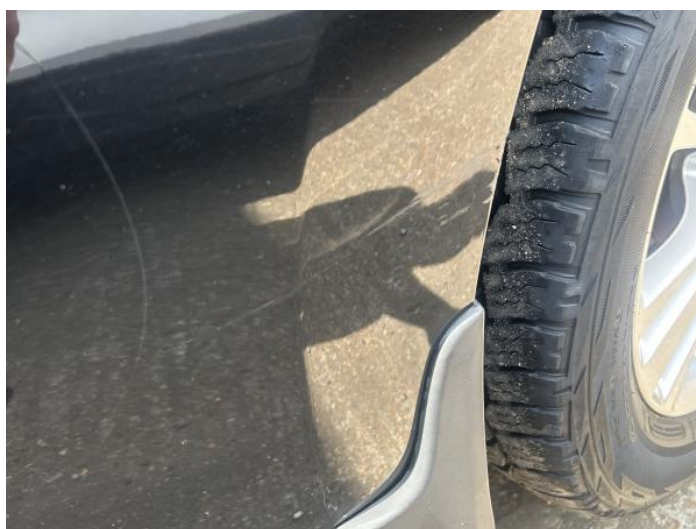
18: Bumper Rear
Scratched
25 to 100mm Thru Paint
