# VEHICLE INSPECTION REPORT

**MA10CWK**

## Ford KA 1.2 Zetec 3dr

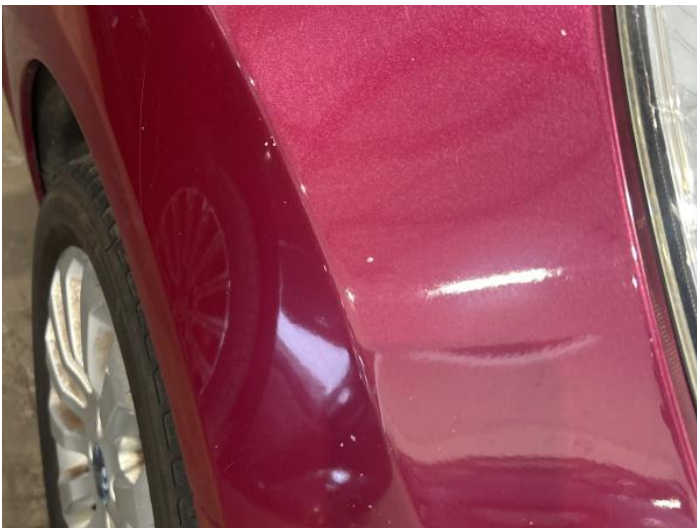
1: Wing osf  
Chipped  
Multiple Chips

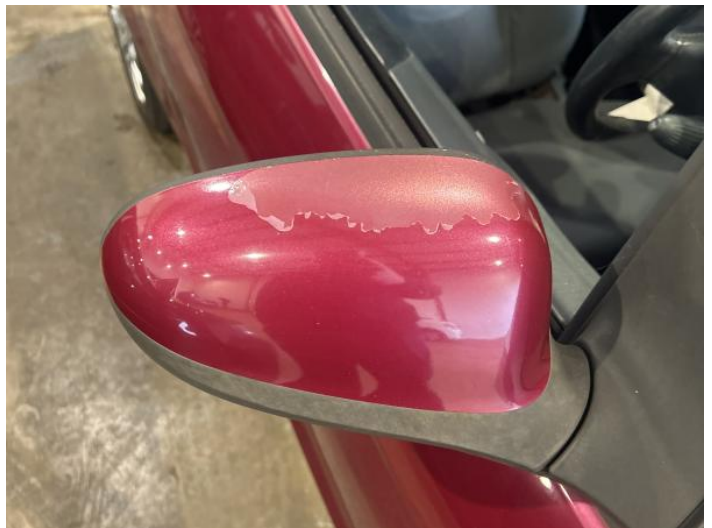
2: Door Mirror Assy osf  
Scratched (Painted)  
Over 25mm Thru Paint

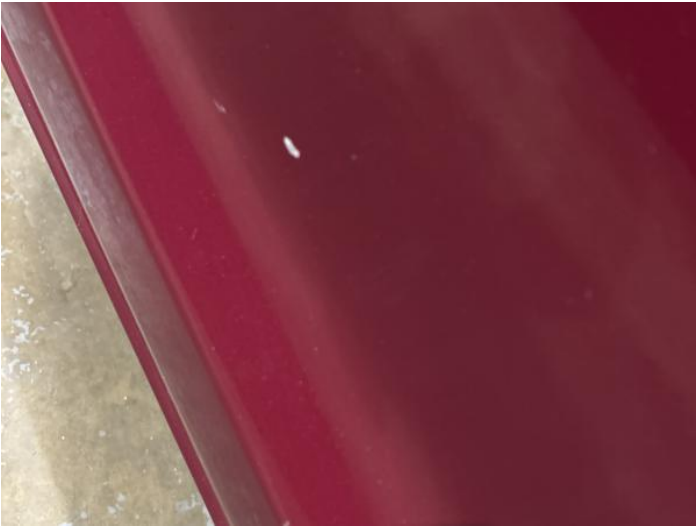
3: Door osf  
Chipped  
1 To 5

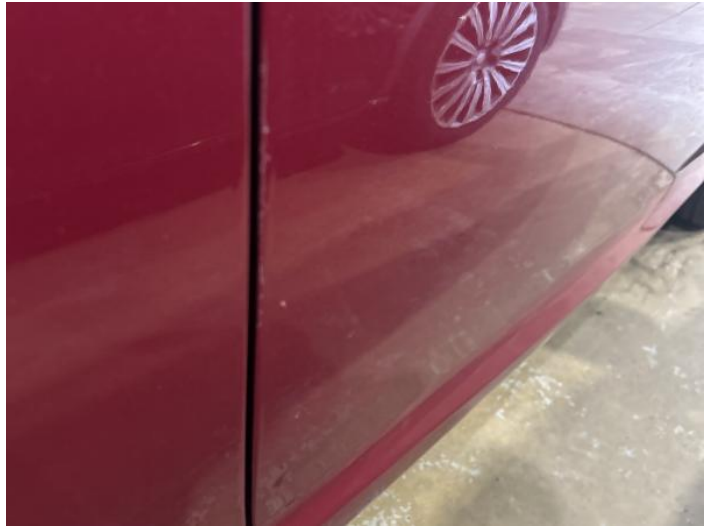
4: Door osf  
Chipped  
Edge Chip

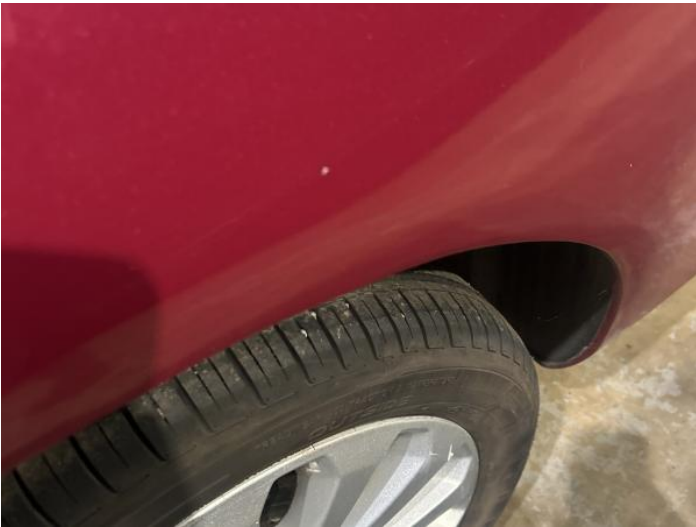
5: Qtr Panel osr  
Chipped  
1 To 5

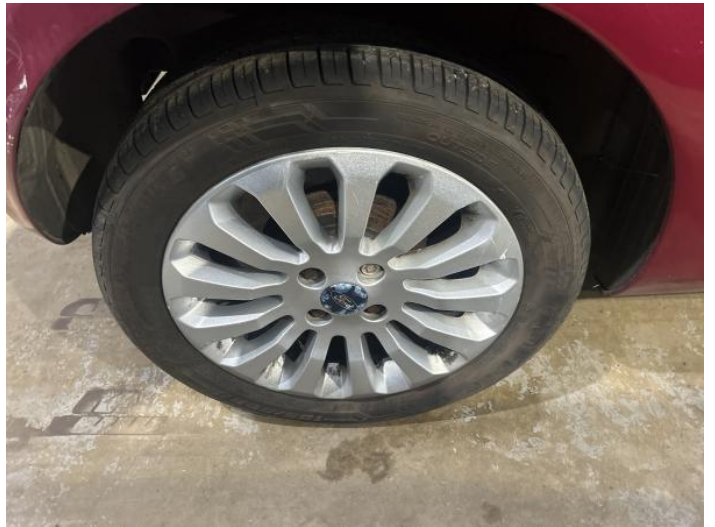
6: Wheel osr  
Scratched  
Up To 50mm

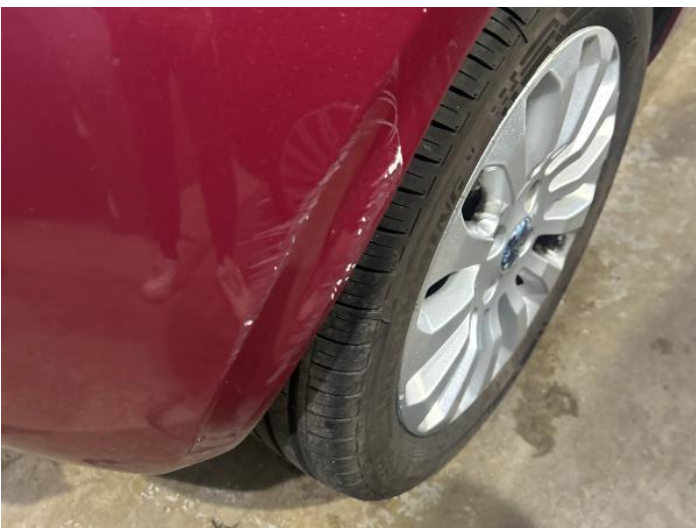
7: Bumper Rear  
Scratched  
Over 100mm Thru Paint

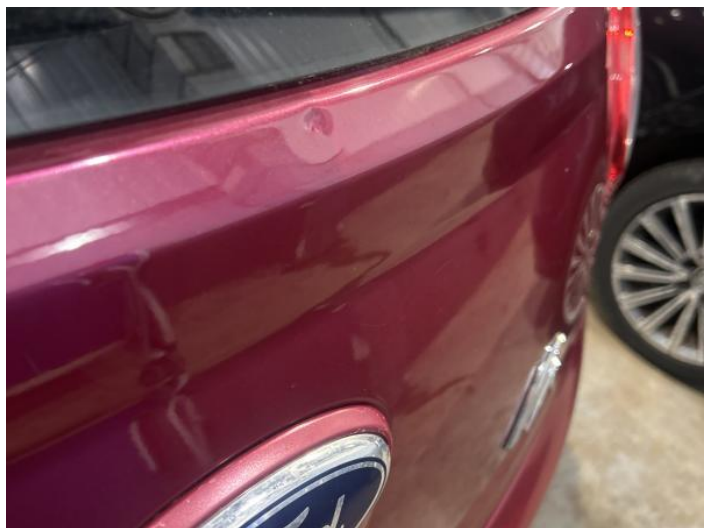
8: Tailgate  
Dented  
Between 10mm + 30mm

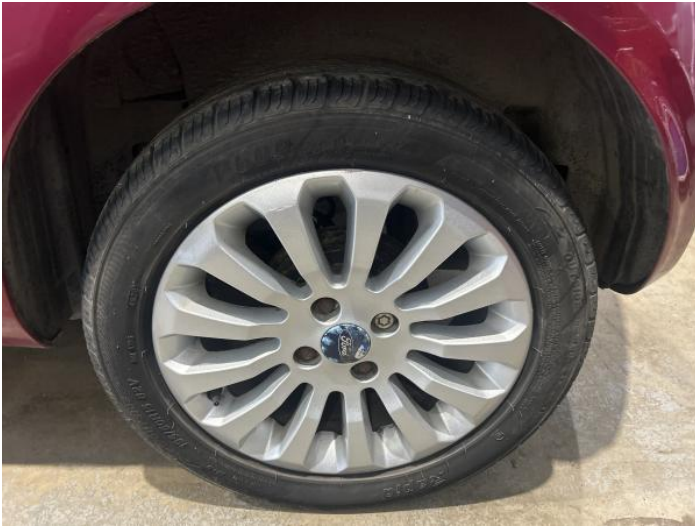
9: Wheel nsf  
Scratched  
Up To 50mm

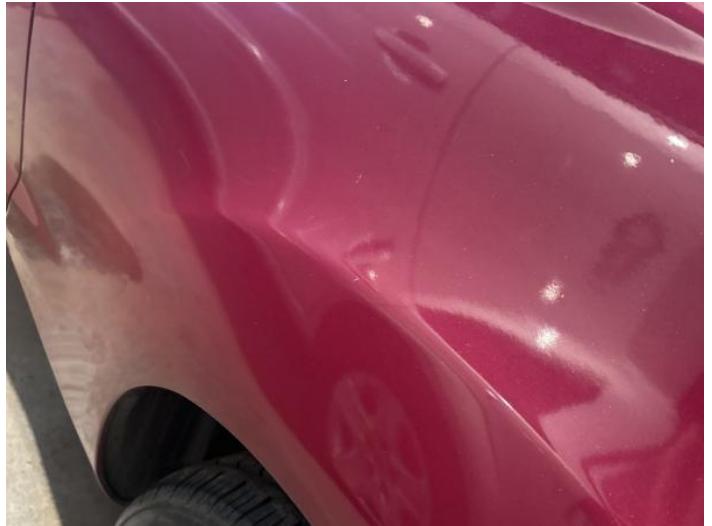
10: Qtr Panel nsf  
Poor Previous Repair  
Poor Paint

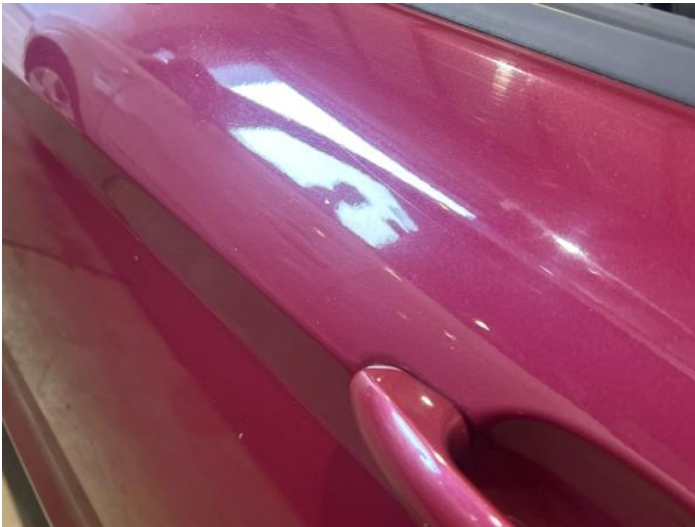
11: Door nsf  
Poor Previous Repair  
Poor Paint

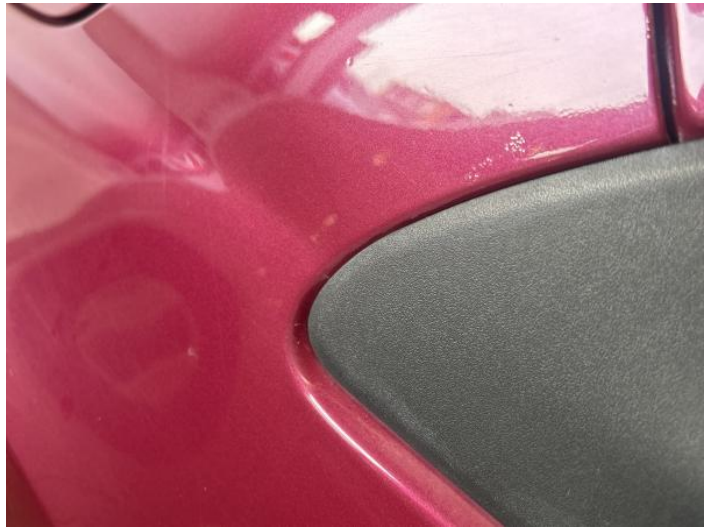
12: Wing nsf  
Poor Previous Repair  
Poor Paint

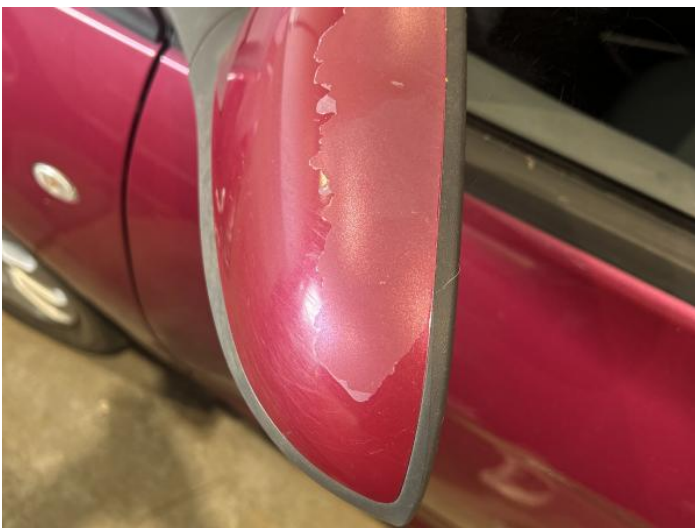
13: Door Mirror Assy nsf  
Scratched (Painted)  
Over 25mm Thru Paint

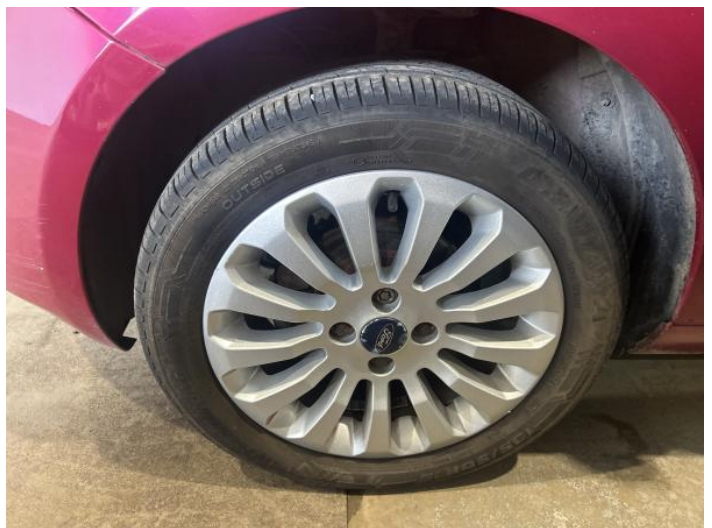
14: Wheel nsf  
Scratched  
Up To 50mm

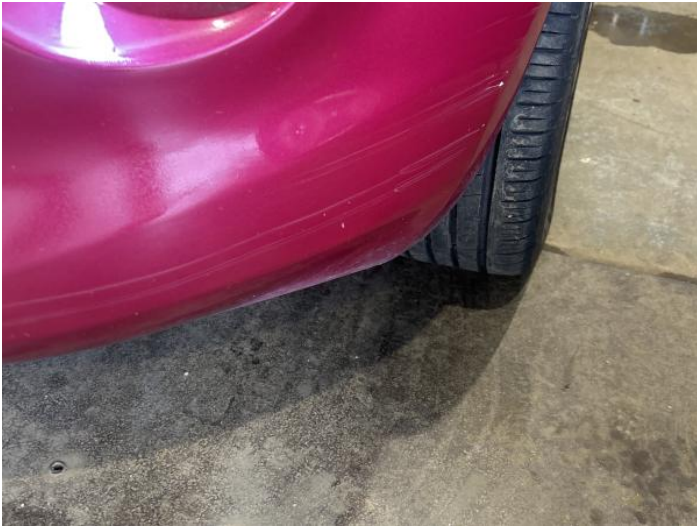
15: Bumper Front  
Scratched  
25 to 100mm Thru Paint

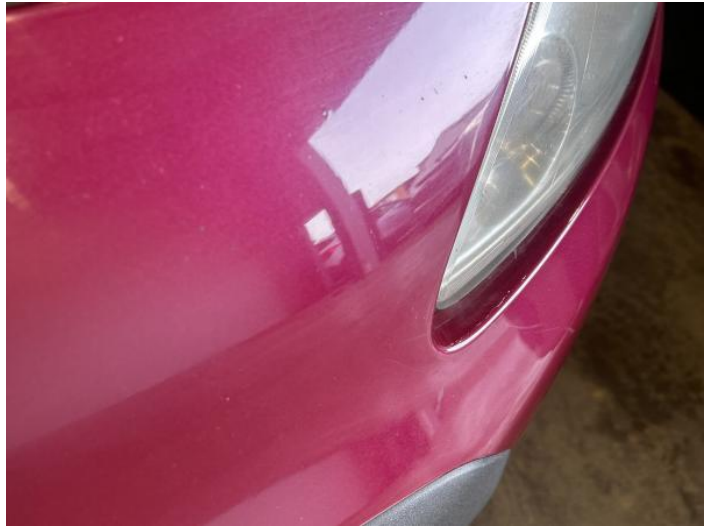
16: Bumper Front  
Chipped  
Multiple Chips

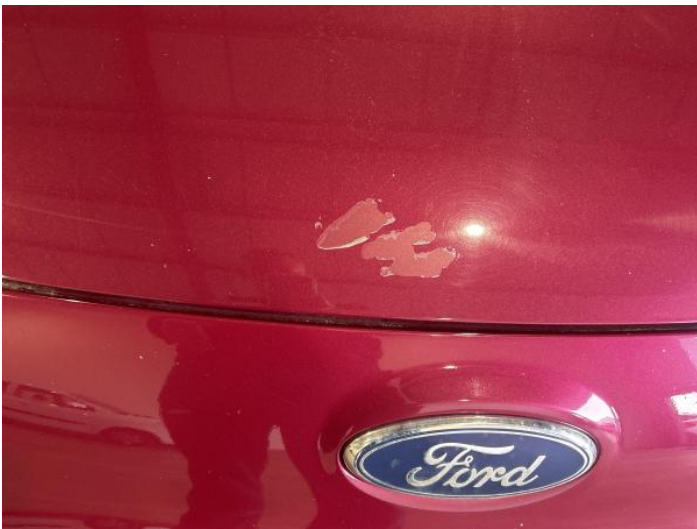
17: Bonnet  
Poor Previous Repair  
Paint Flake

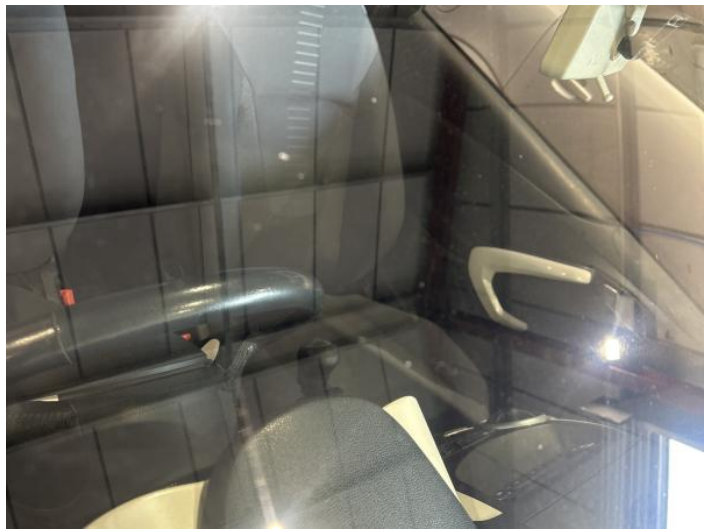
18: Screen Front  
Chipped  
Up To 10mm

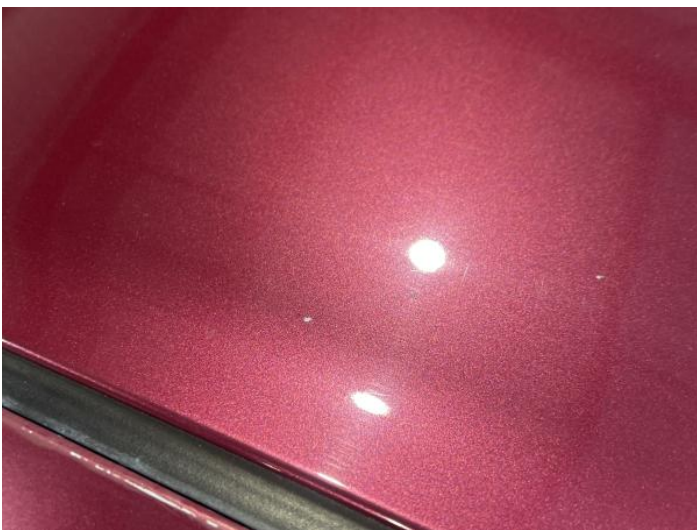
19: Roof  
Chipped  
1 To 5
