# VEHICLE INSPECTION REPORT

**GF60WFB**

## Volkswagen Golf 1.6 TDi 105 S 5dr

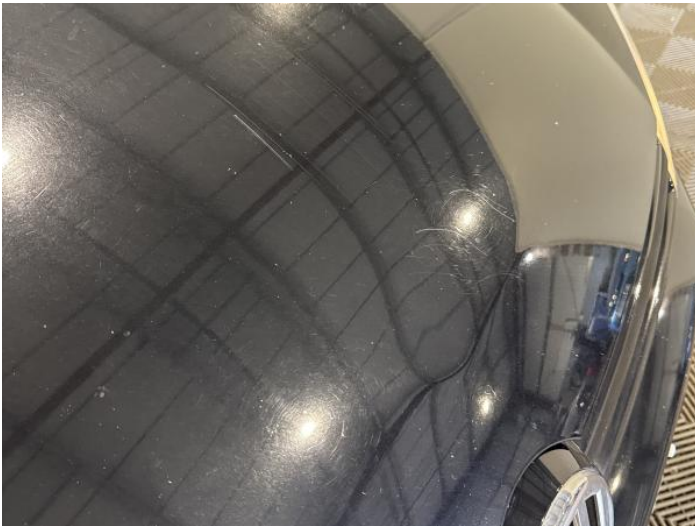
1: Bonnet  
Dented  
With Paint Damage

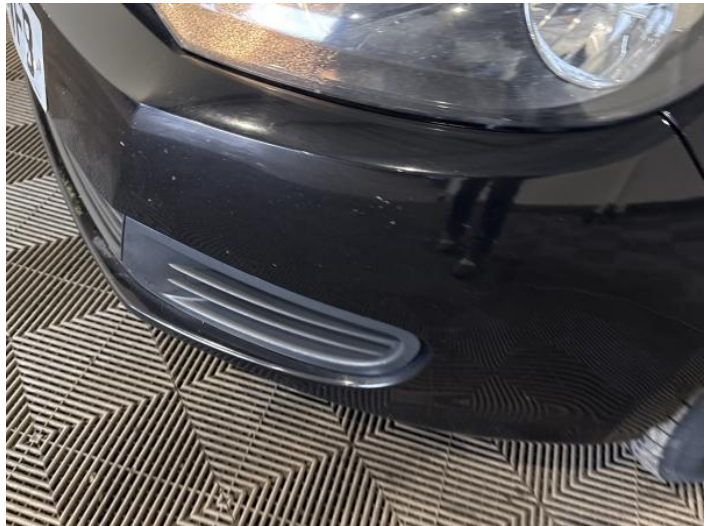
2: Bumper Front  
Scratched  
Over 100mm Thru Paint

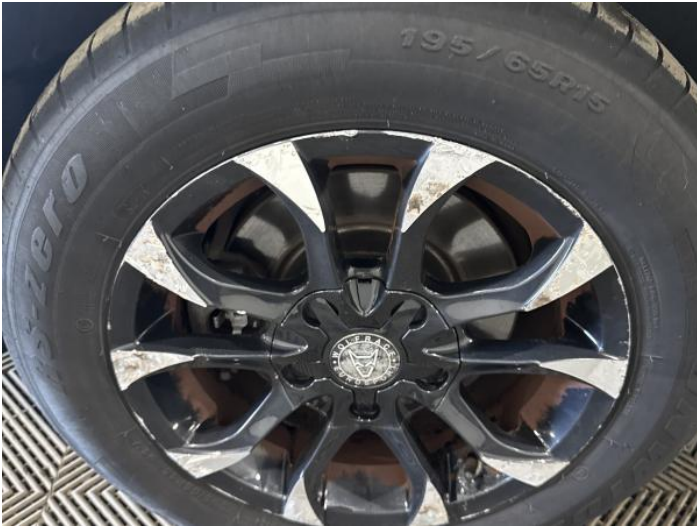
3: Wheel nsf  
Scratched  
Over 50mm

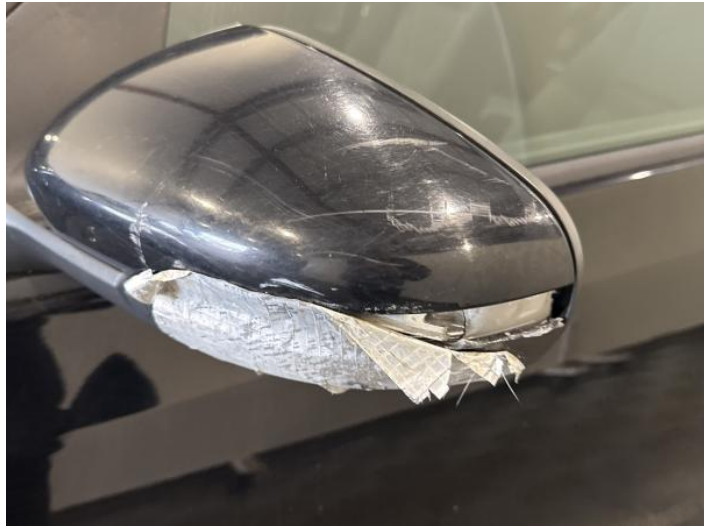
4: Door Mirror Assy nsf  
Broken  
Replace

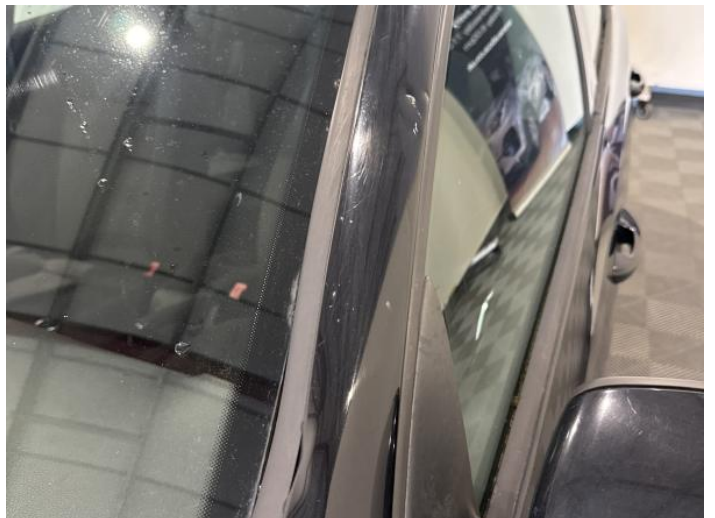
6: A Post ns  
Dented  
Over 30mm

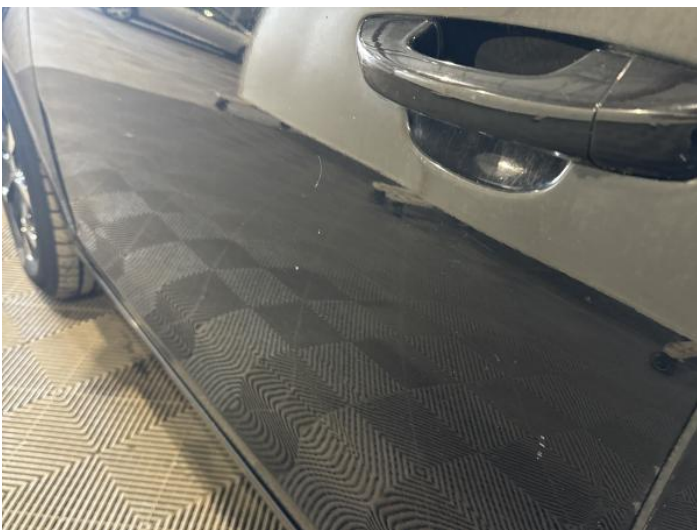
7: Door nsf  
Scratched  
Over 25mm Thru Paint

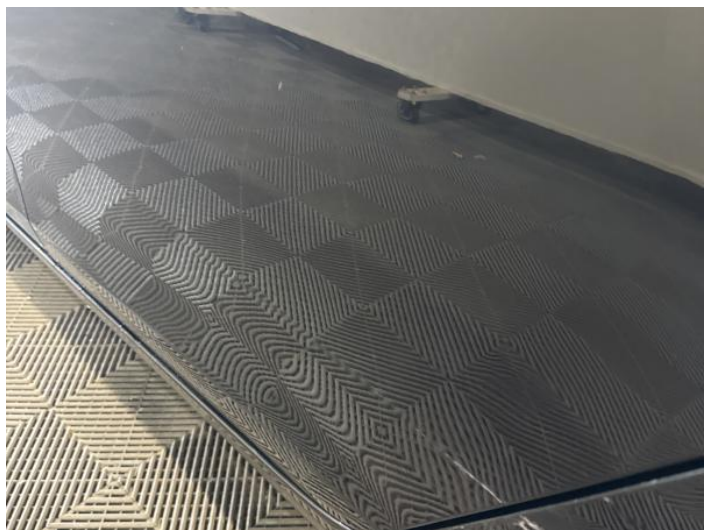
8: Door nsr  
Dented  
With Paint Damage

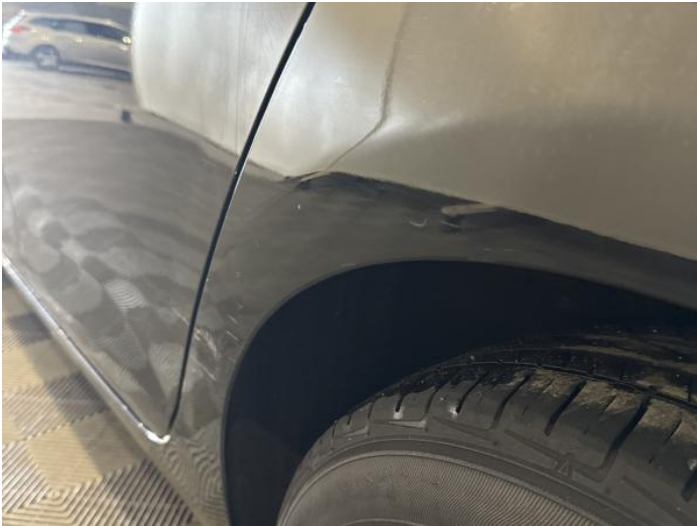
9: Qtr Panel nsr  
Dented  
With Paint Damage

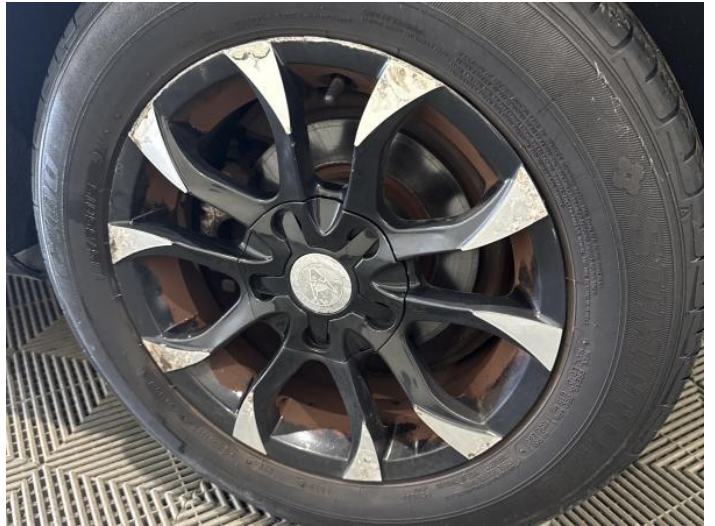
10: Wheel nsr  
Scratched  
Over 50mm

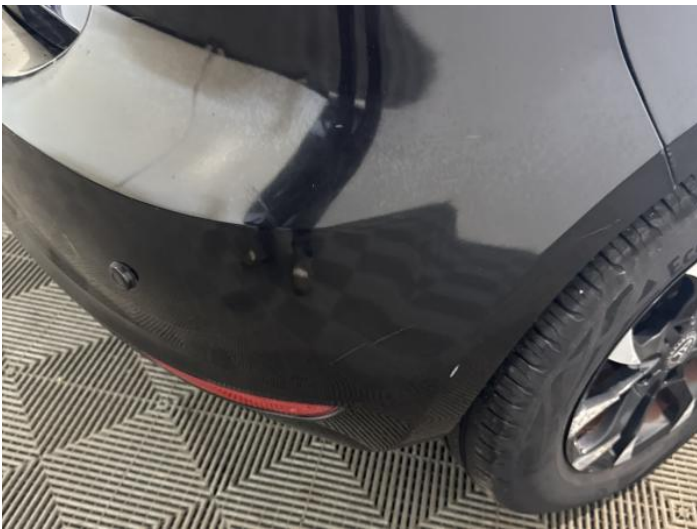
11: Bumper Rear  
Scratched  
Over 100mm Thru Paint

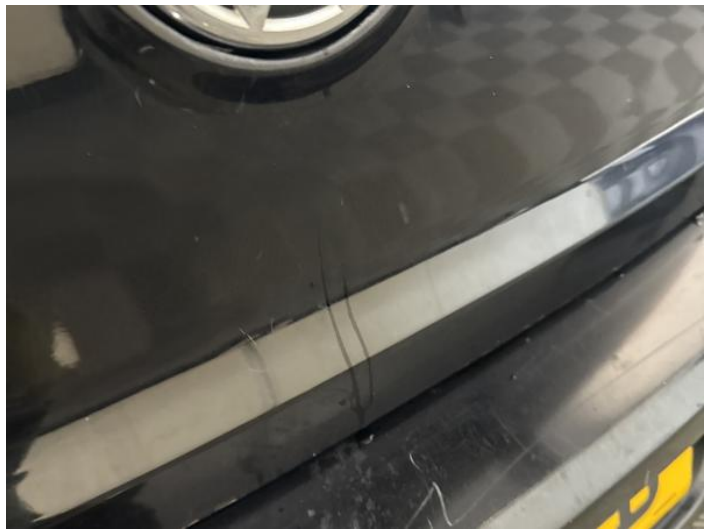
12: Tailgate  
Scratched  
Over 25mm Thru Paint

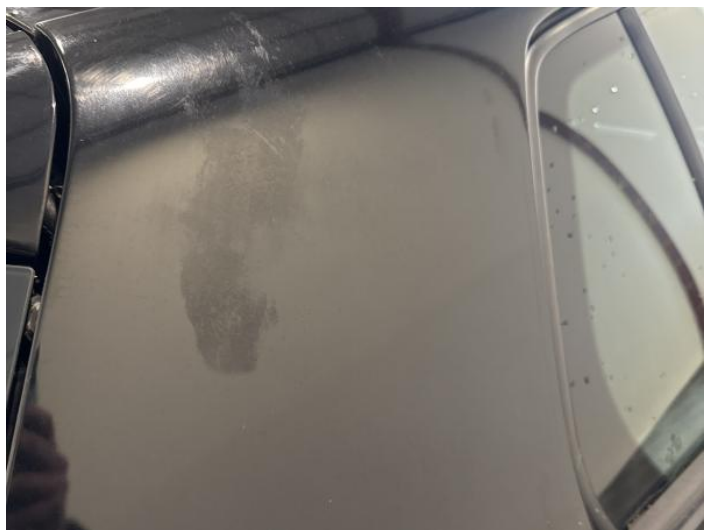
14: Qtr Panel osr  
Scratched  
Over 25mm Thru Paint

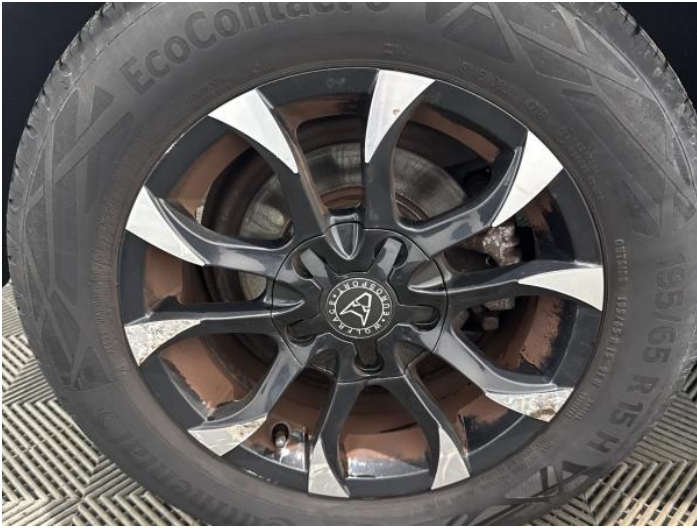
15: Wheel osr  
Scratched  
Over 50mm

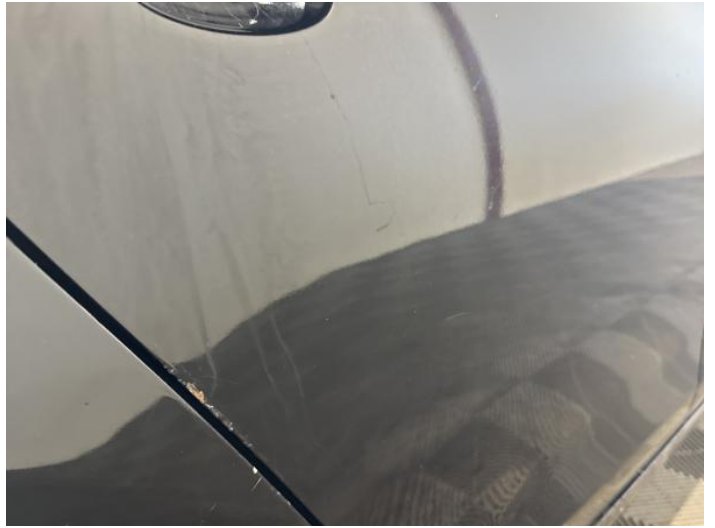
16: Door osr  
Scratched  
Rusted

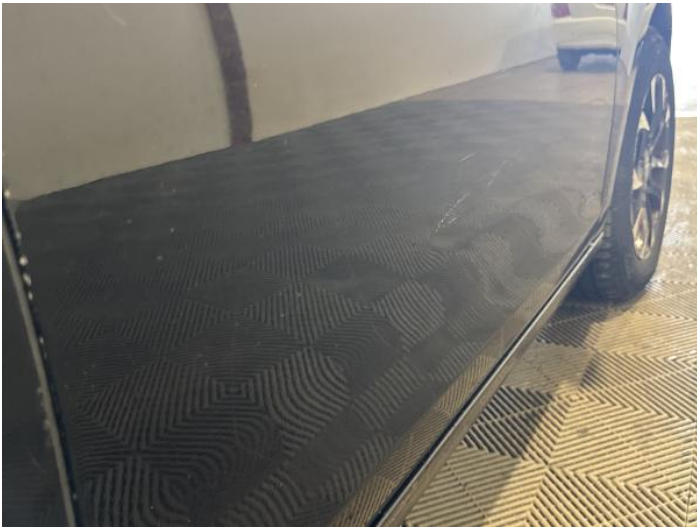
17: Door osf  
Dented  
With Paint Damage

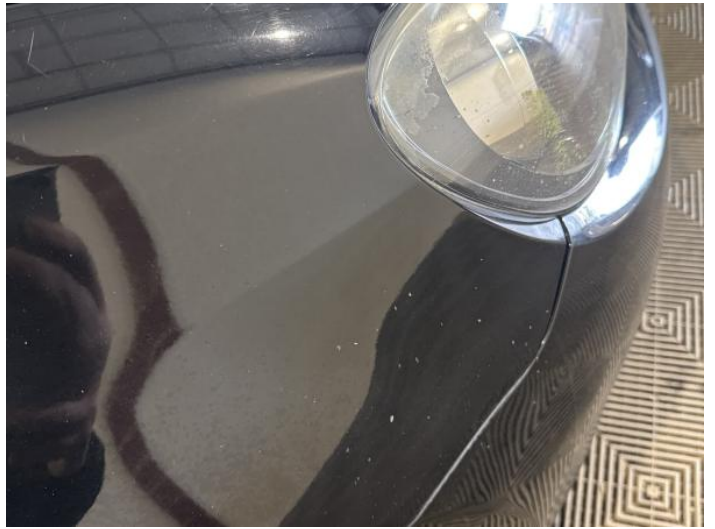
18: Wing osf  
Chipped  
Multiple Chips

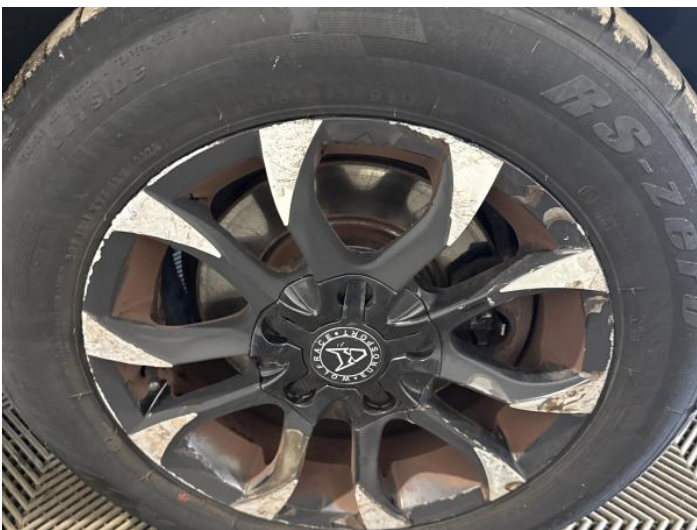
19: Wheel osf  
Scratched  
Over 50mm

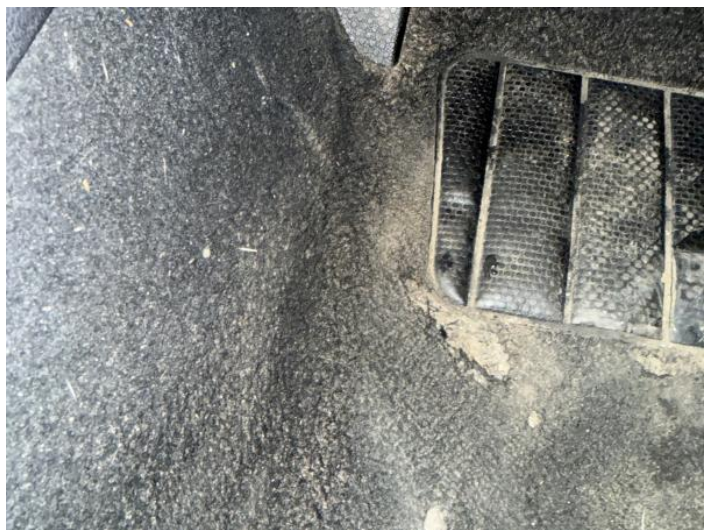
20: Carpets Front  
Scuffed  
Over 25mm

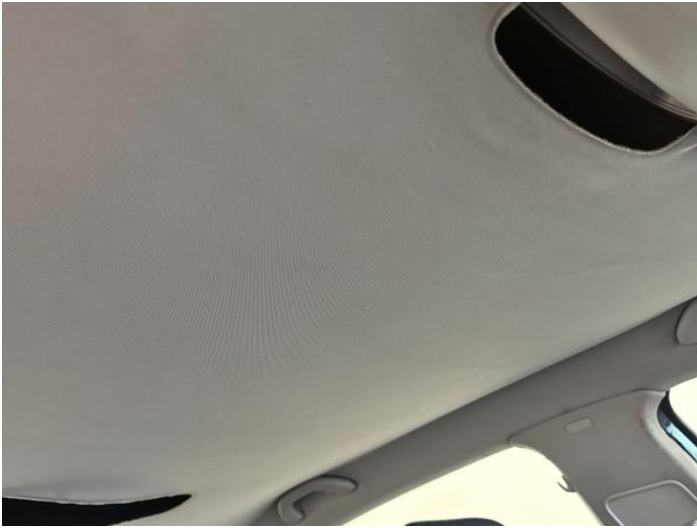
21: Roof Lining  
Scuffed  
Over 25mm
