VEHICLE INSPECTION REPORT

YK64XLP

Alfa Romeo Giulietta 1.6 JTDM-2 Distinctive 5dr

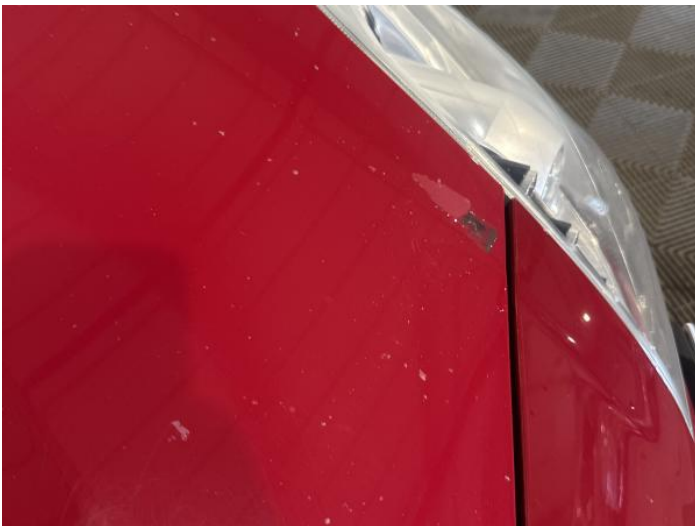
1: Bonnet
Poor Previous Repair
Paint Flake

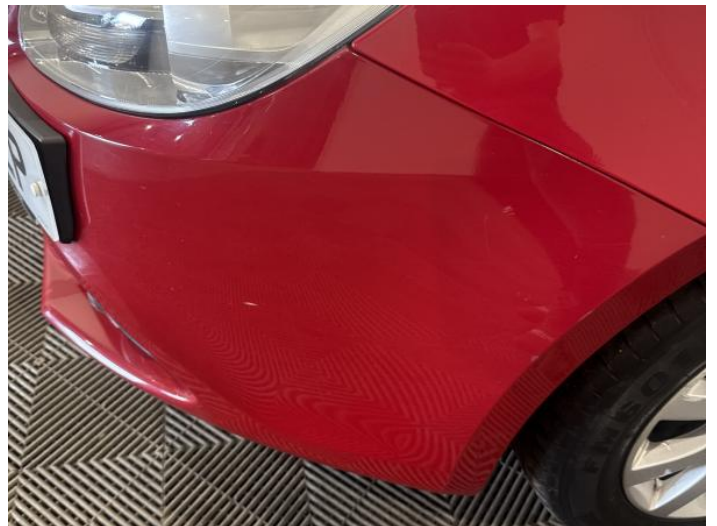
2: Bumper Front
Poor Previous Repair
Poor Colour

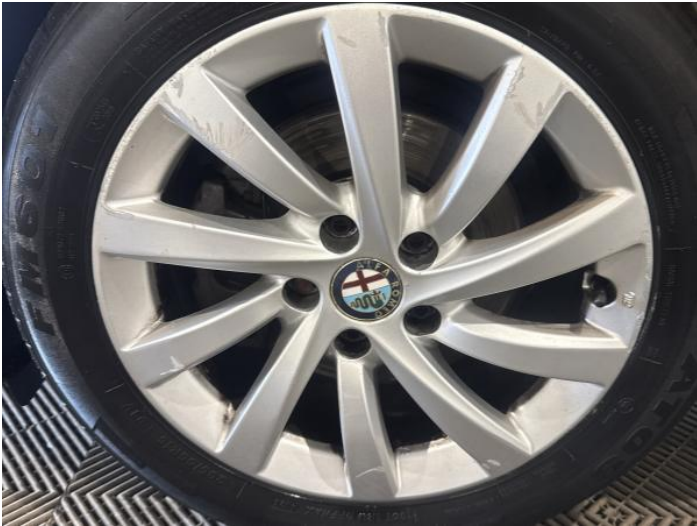
3: Wheel nsf
Scratched
Over 50mm

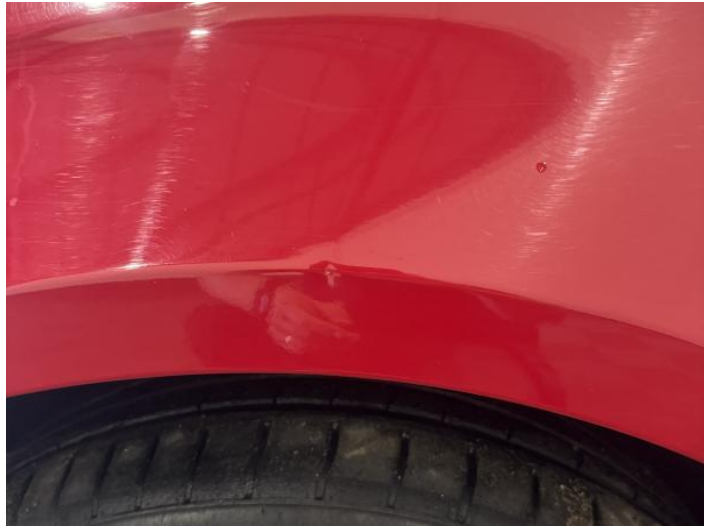
4: Wing osf
Dented
Between 10mm + 30mm

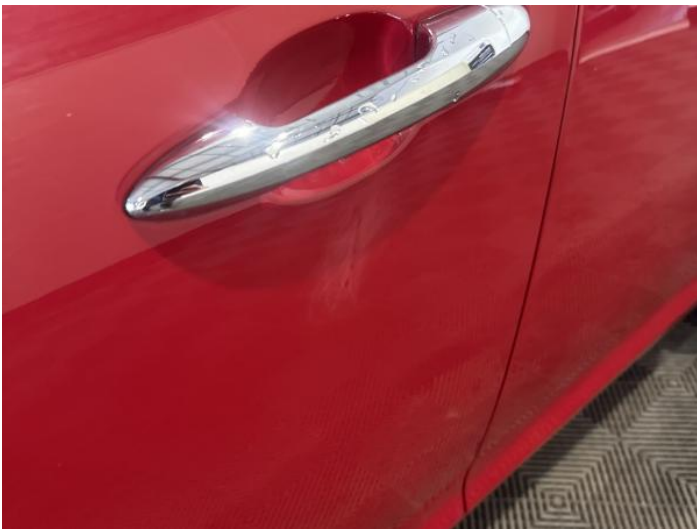
5: Door nsf
Scratched
Over 25mm Thru Paint

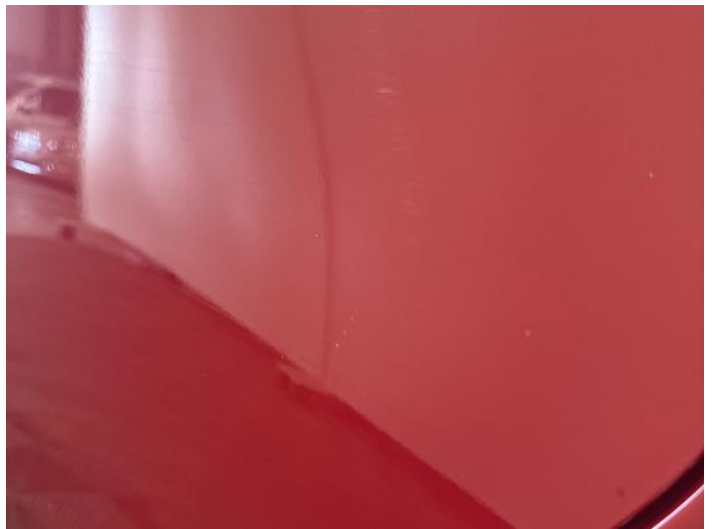
6: Door nsr
Chipped
1 To 5

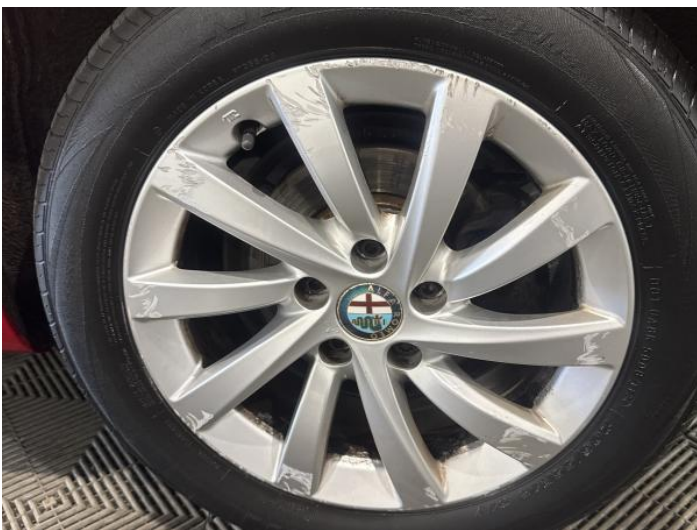
7: Wheel nsr
Scratched
Over 50mm

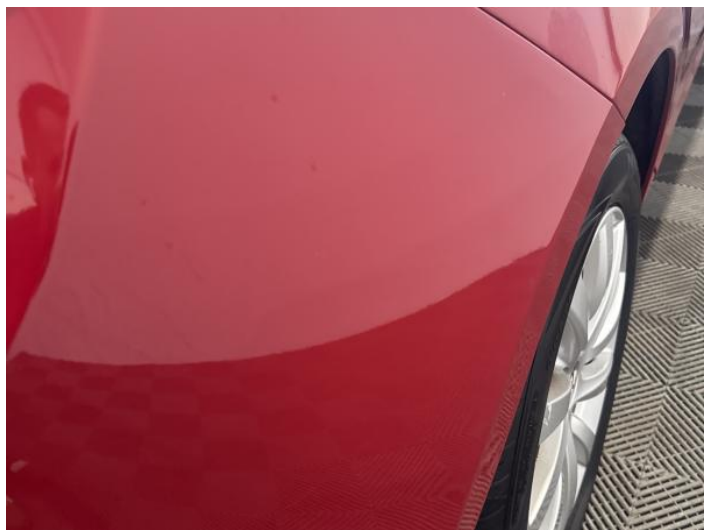
8: Bumper Rear
Chipped
1 To 5

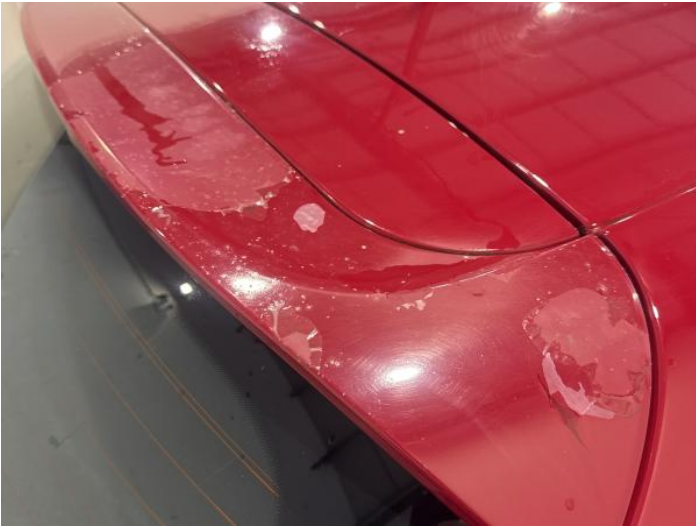
9: Spoiler Rear
Scratched (Painted)
Over 25mm Thru Paint

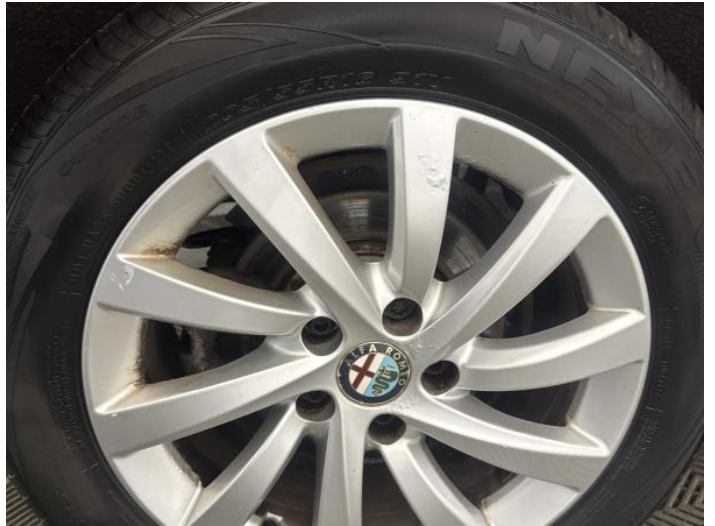
10: Wheel osr
Corroded
Light

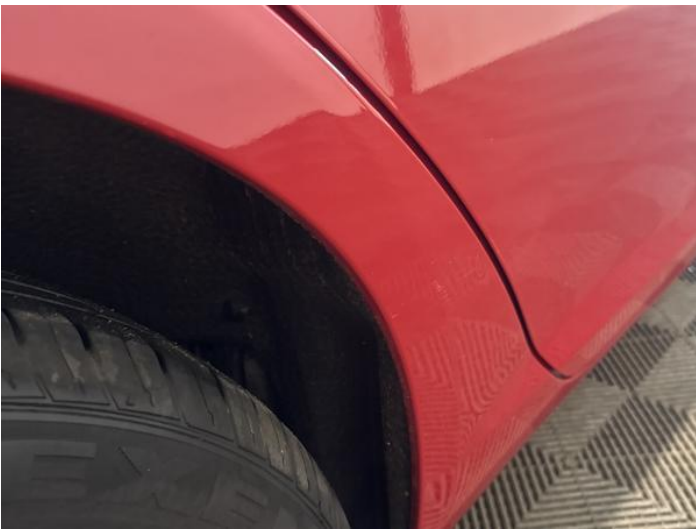
11: Qtr Panel osr
Scratched
Over 25mm Thru Paint

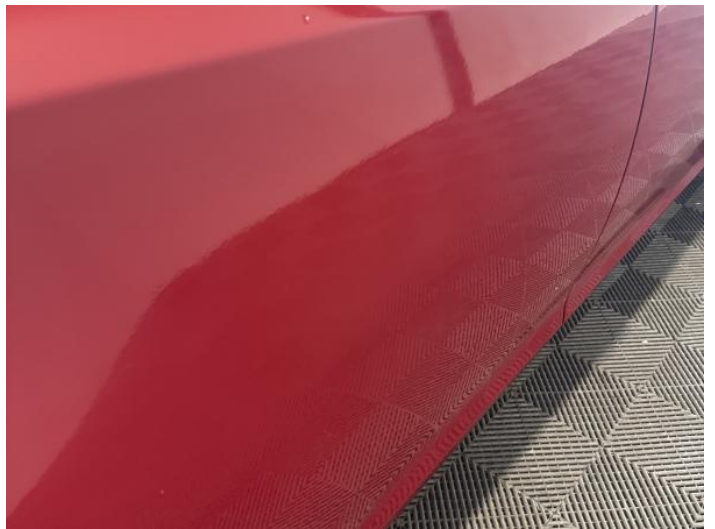
12: Door osr
Poor Previous Repair
Poor Paint

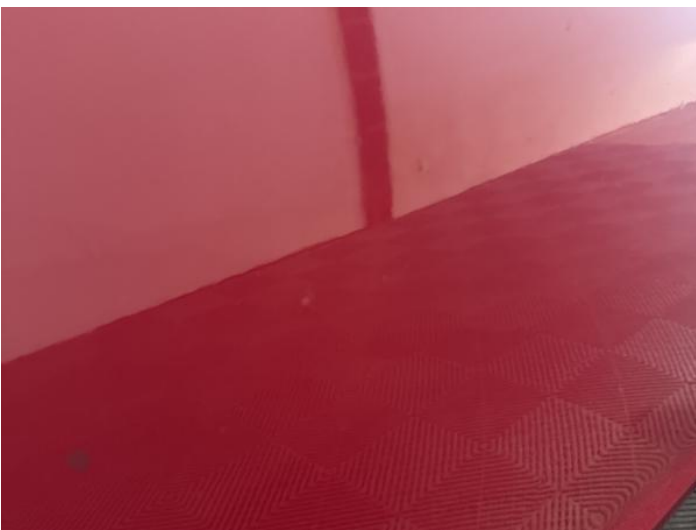
13: Door osf
Rusted
UpTo 5mm

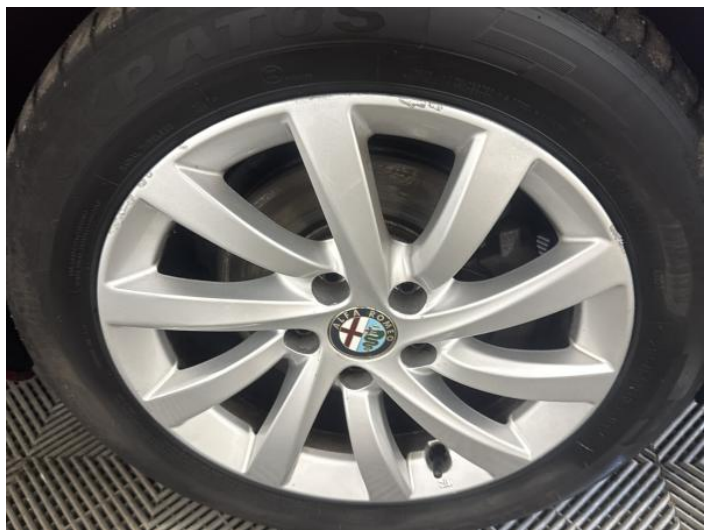
14: Wheel osf
Scratched
Over 50mm

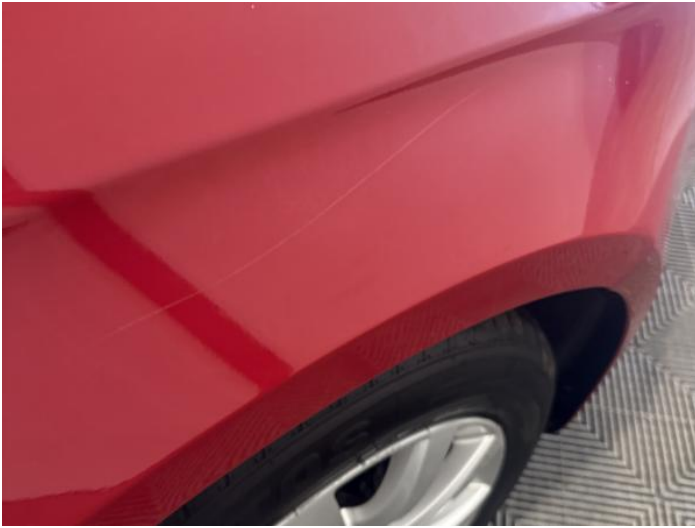
15: Wing osf
 Scratched
 Over 25mm Thru Paint

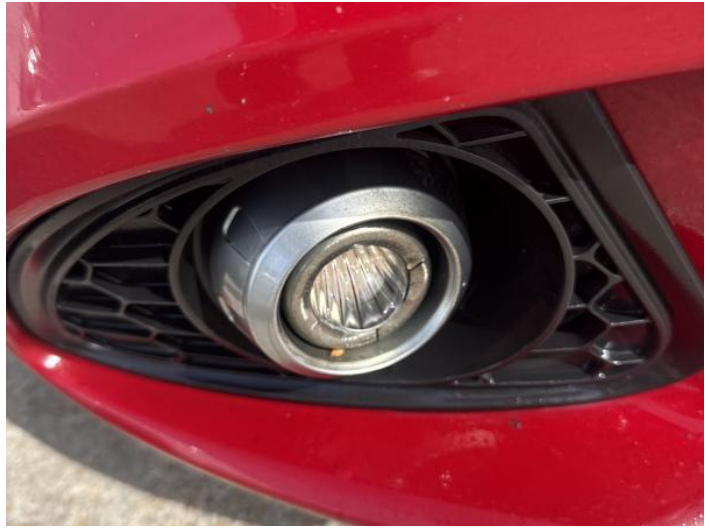
16: Fog Lamp Surround os
 Broken
 Replace
