VEHICLE INSPECTION REPORT

VF66DZM

Peugeot 2008 1.6 BlueHDi 100 Allure 5dr [Start Stop]

nama
GRADE
4

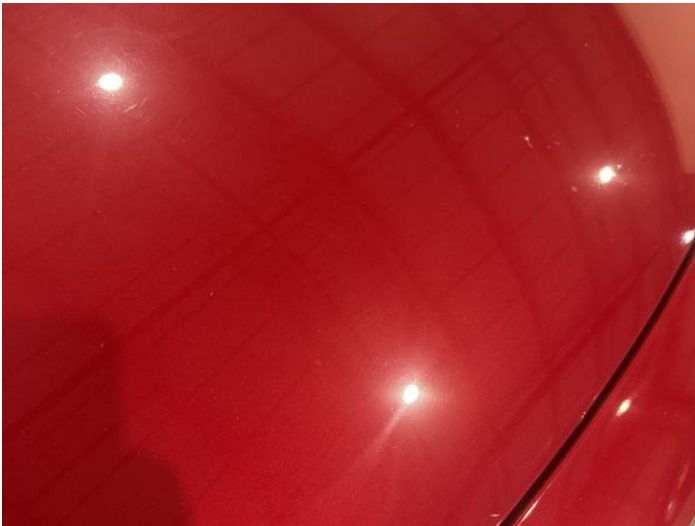
1: Bonnet
Chipped
Multiple Chips

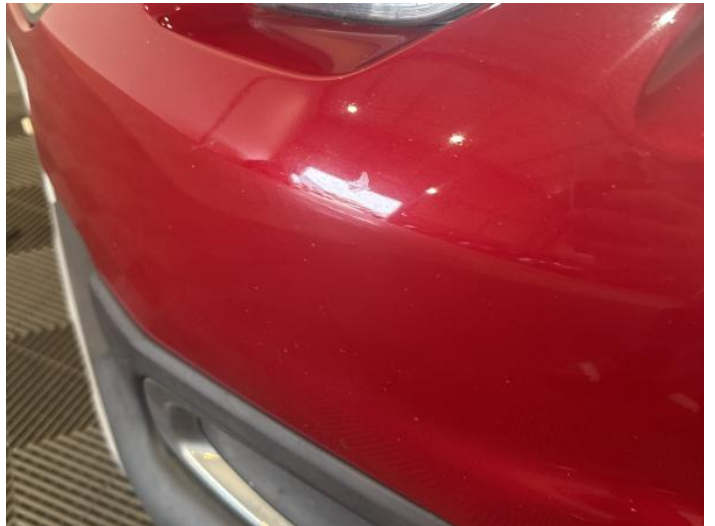
2: Bumper Front
Poor Previous Repair
Paint Flake

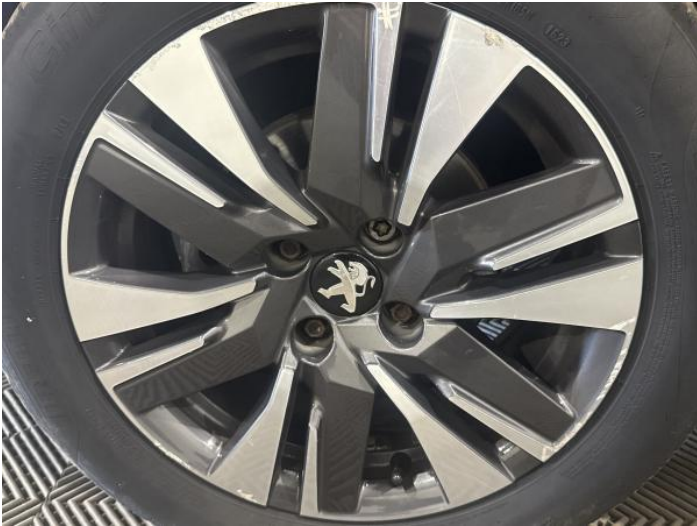
3: Wheel nsf
Scratched
Over 50mm

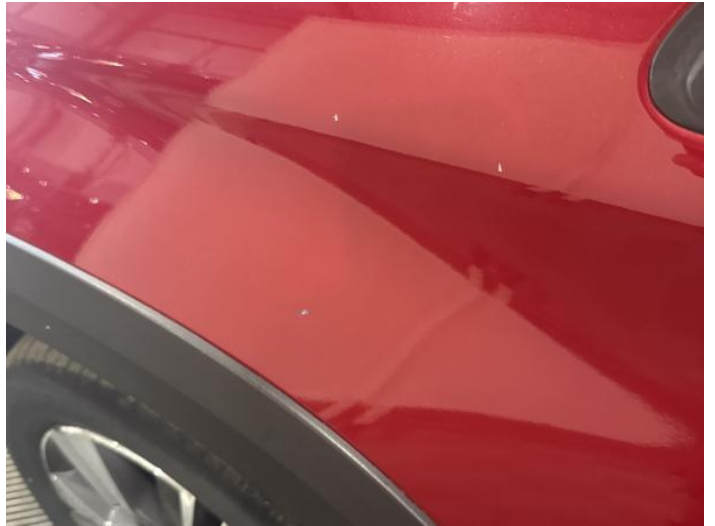
4: Wing nsf
Chipped
1 To 5

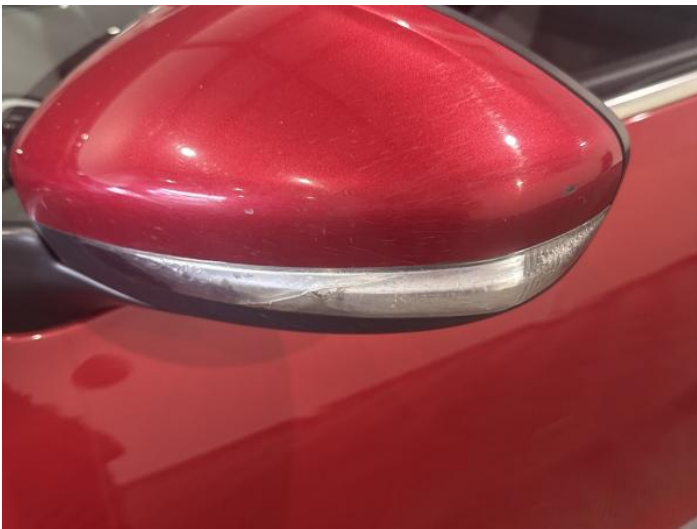
5: Flasher Side Repeater ns
Broken
Replace

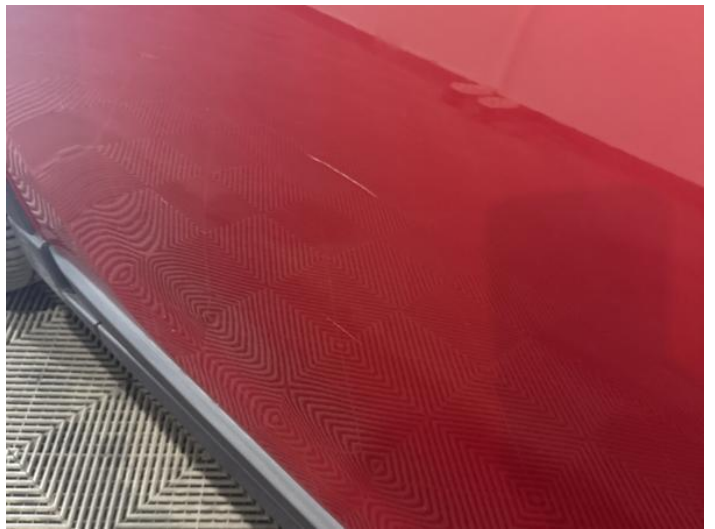
6: Door nsf
Scratched
Over 25mm Thru Paint

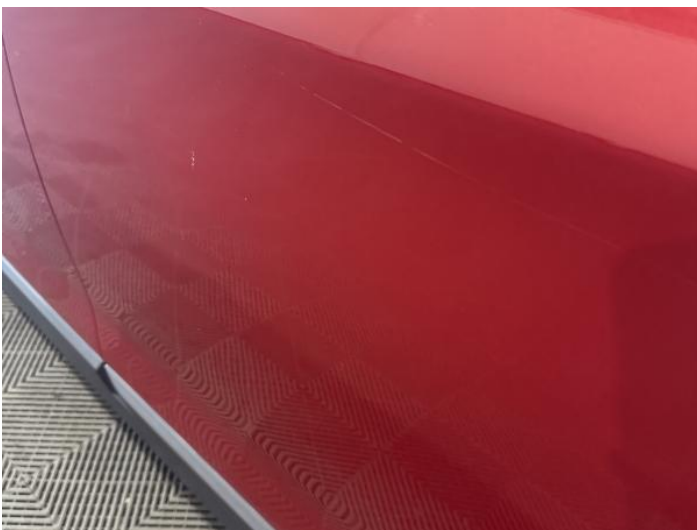
7: Door nsr
Scratched
Over 25mm Thru Paint

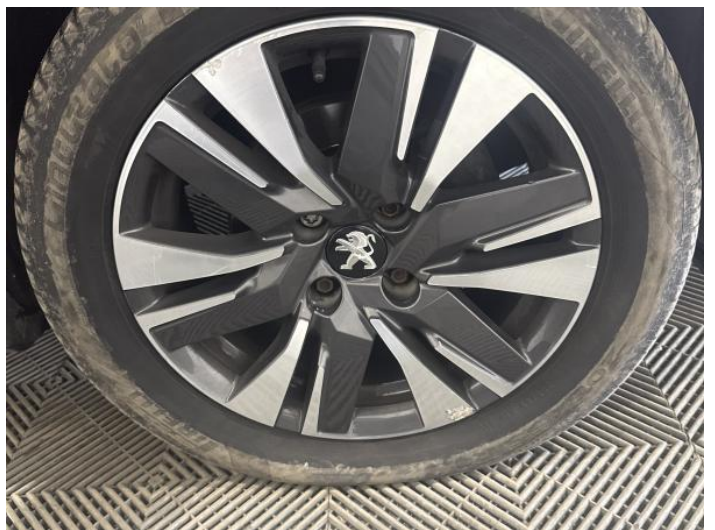
8: Tyre osf
Damaged
Replace

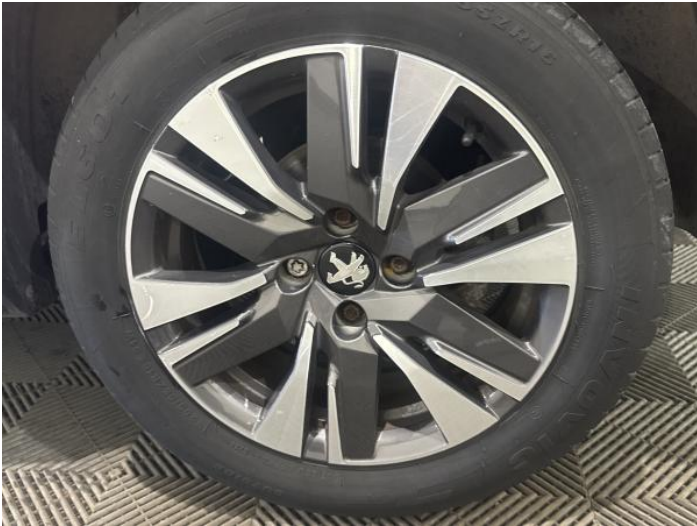
9: Wheel nsr
Scratched
Over 50mm

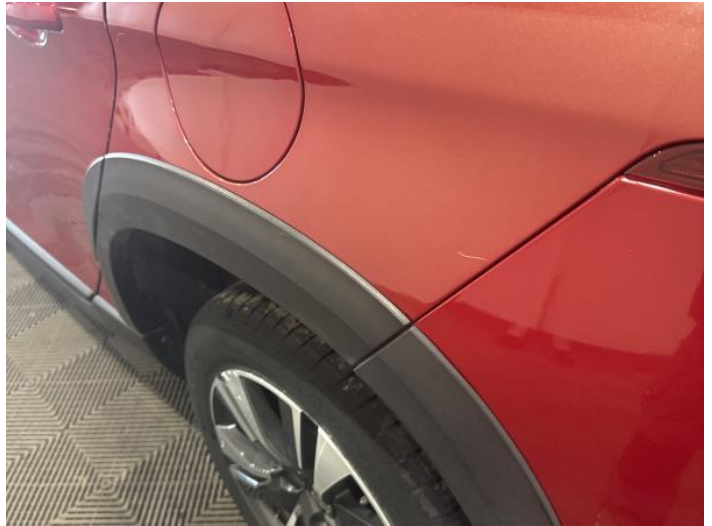
10: Qtr Panel nsr
Scratched
Over 25mm Thru Paint

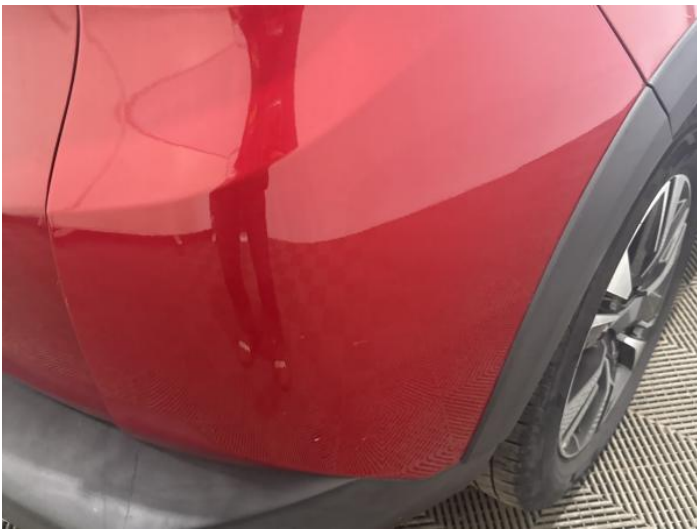
11: Bumper Rear Moulding
Scratched (Painted)
Over 25mm Thru Paint

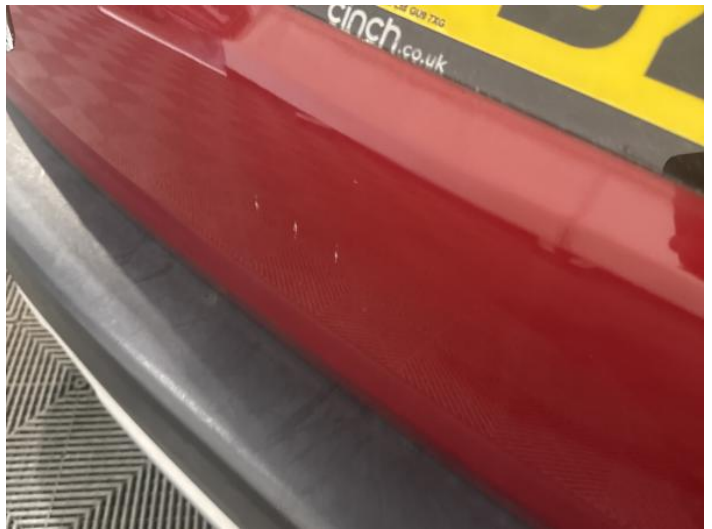
12: Tailgate
Scratched
Over 25mm Thru Paint

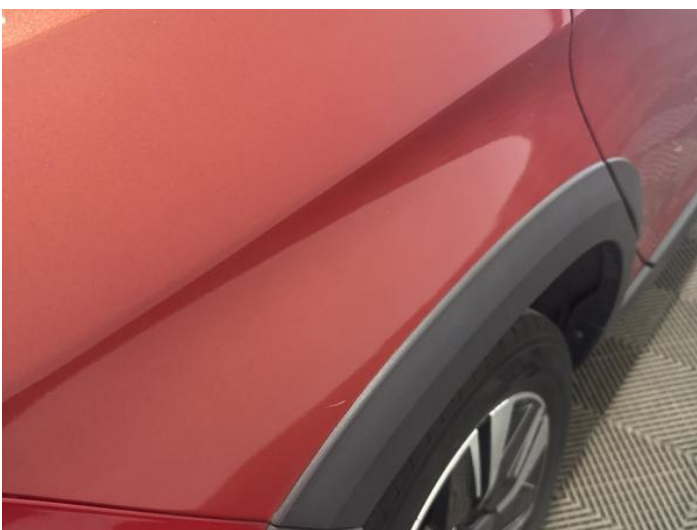
13: Qtr Panel osr
Scratched
Over 25mm Thru Paint

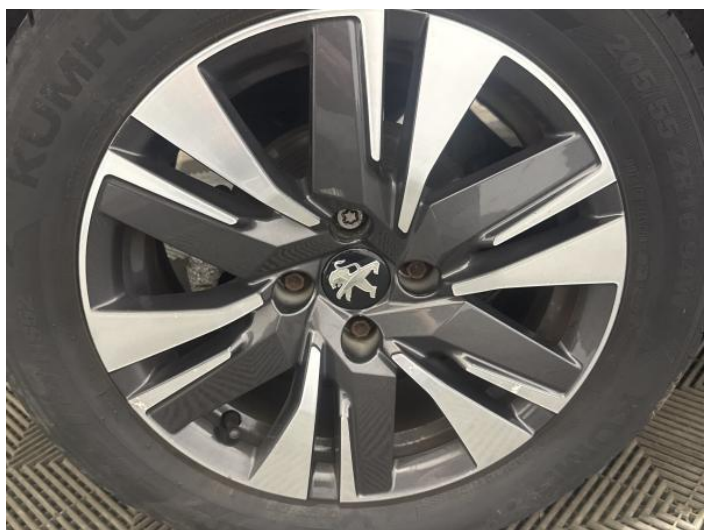
14: Wheel osr
Scratched
Up To 50mm

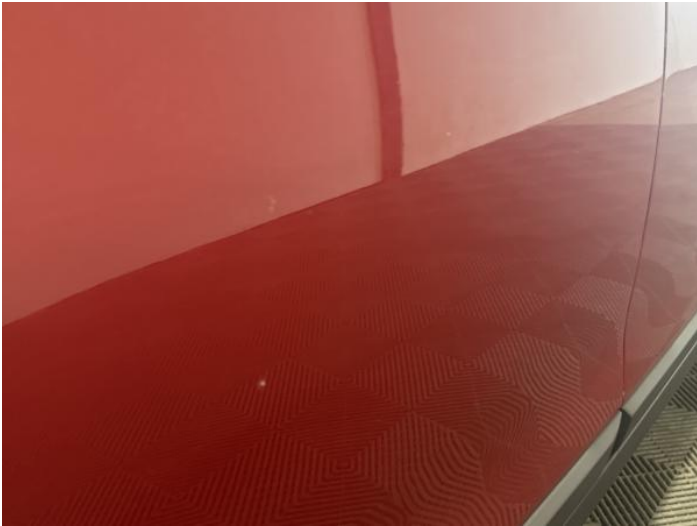
15: Door osr
Scratched
Over 25mm Thru Paint

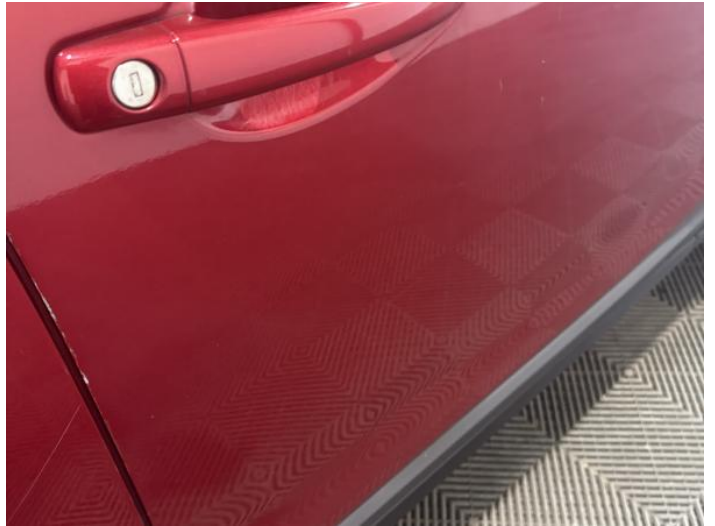
16: Door osf
Scratched
Over 25mm Thru Paint

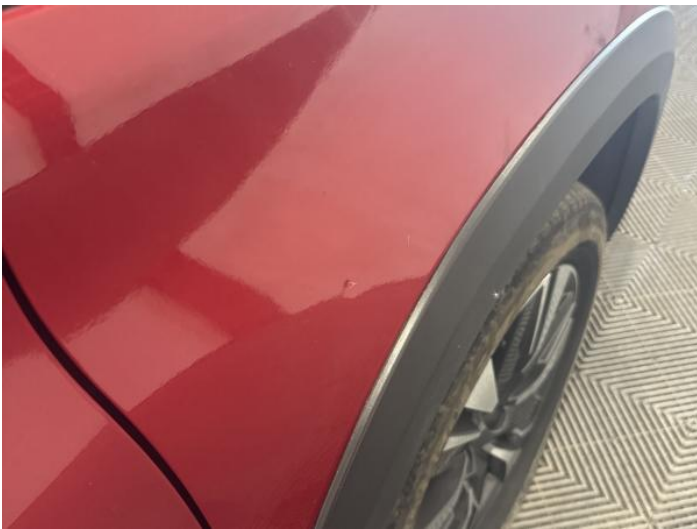
17: Wing osf
Dented
Between 10mm + 30mm

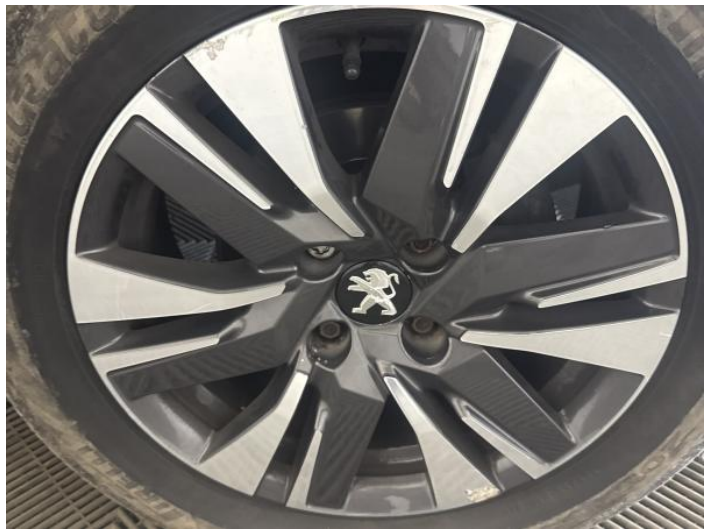
18: Wheel osf
Scratched
Over 50mm

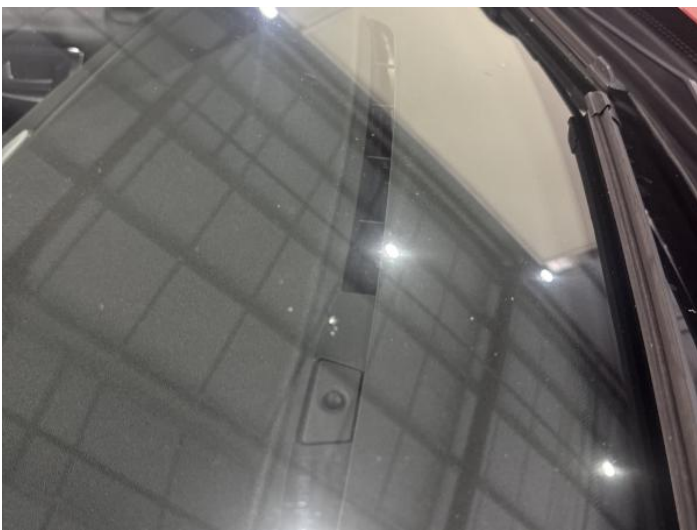
19: Screen Front
Chipped
UpTo 10mm

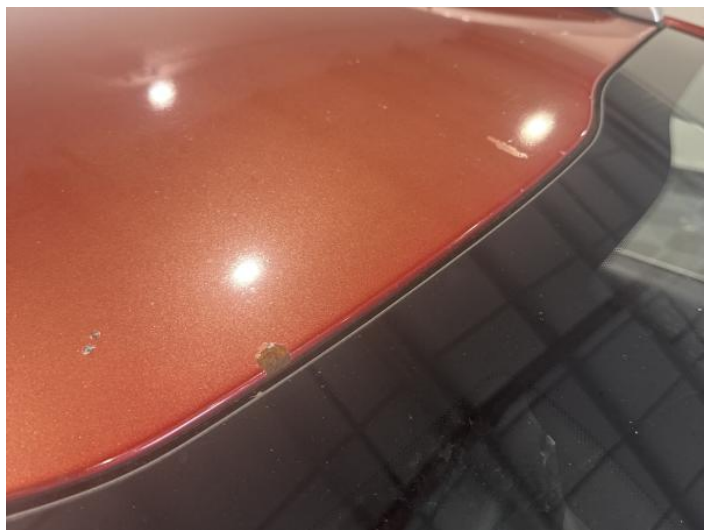
20: Roof
Poor Previous Repair
Paint Flake
