# VEHICLE INSPECTION REPORT

**GF12TYZ**

## Skoda Octavia 2.0 TDI CR SE Plus 5dr

nama  
GRADE  
**5**

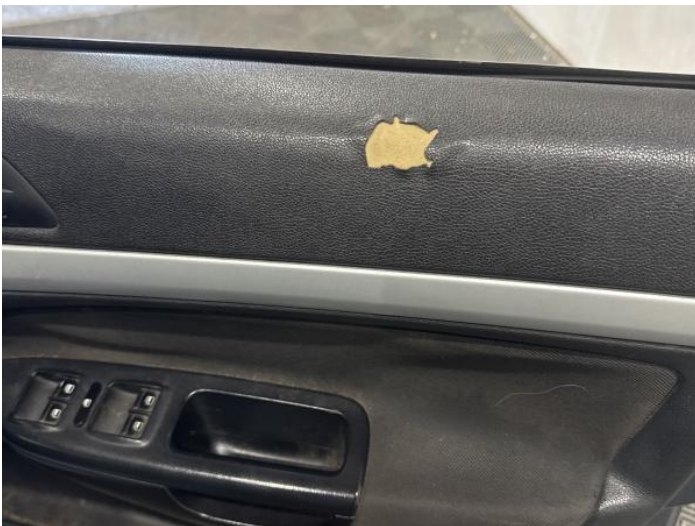
1: Door Pad osf  
Scuffed  
Over 25mm

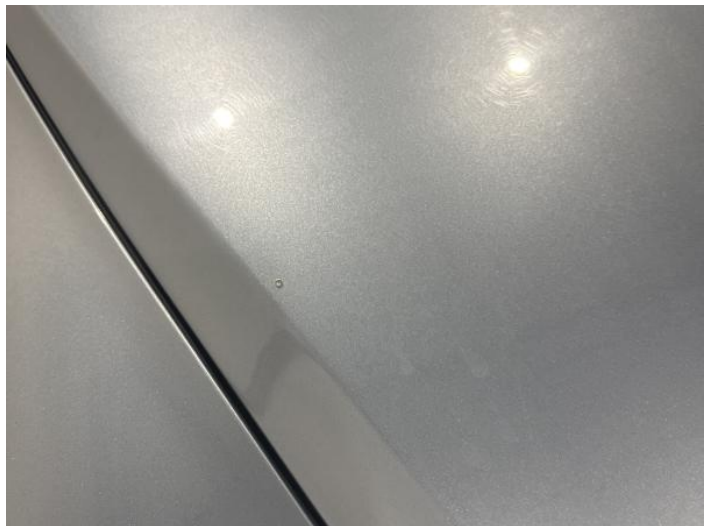
2: Bonnet  
Chipped  
Multiple Chips

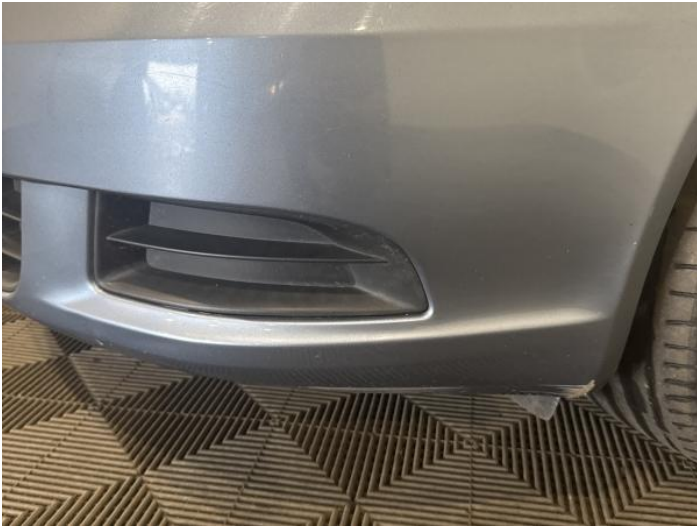
3: Bumper Front  
Scratched  
25 to 100mm Thru Paint

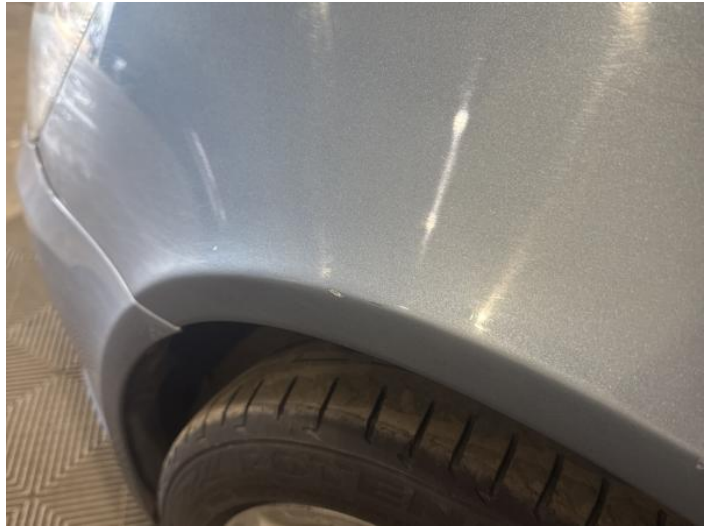
4: Wing nsf  
Chipped  
Over 5mm

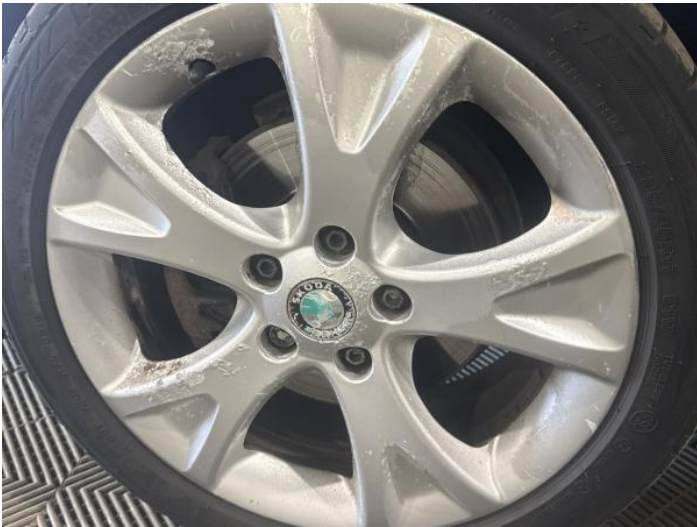
5: Wheel nsf  
Scratched  
Over 50mm

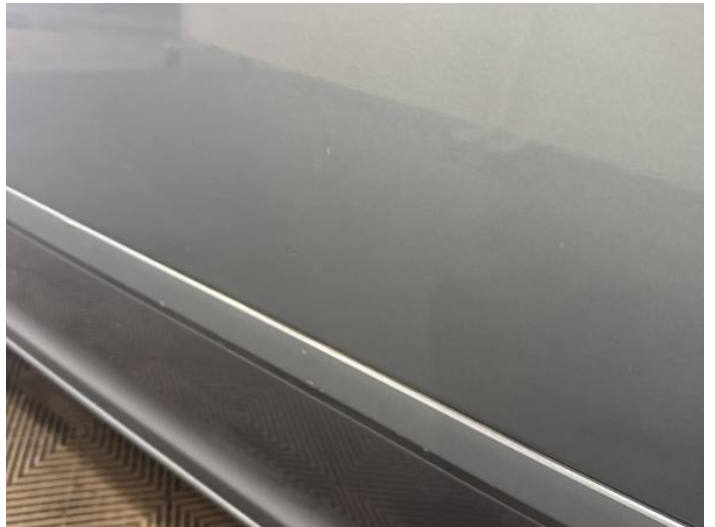
6: Door nsf  
Dented  
Over 30mm

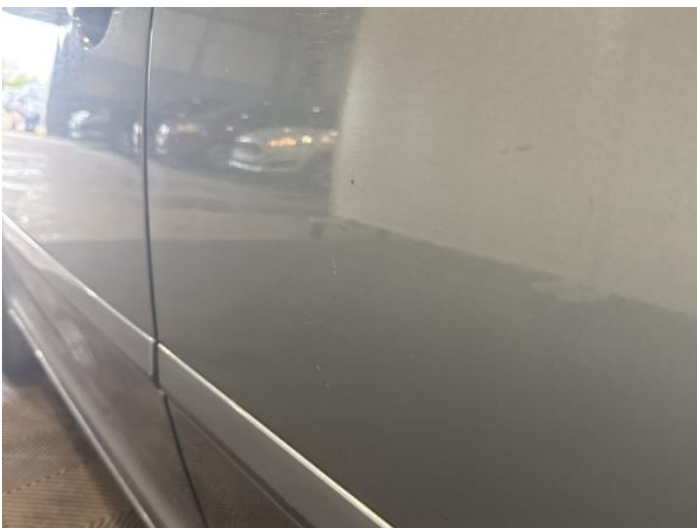
7: Door nsr  
Dented  
Over 30mm

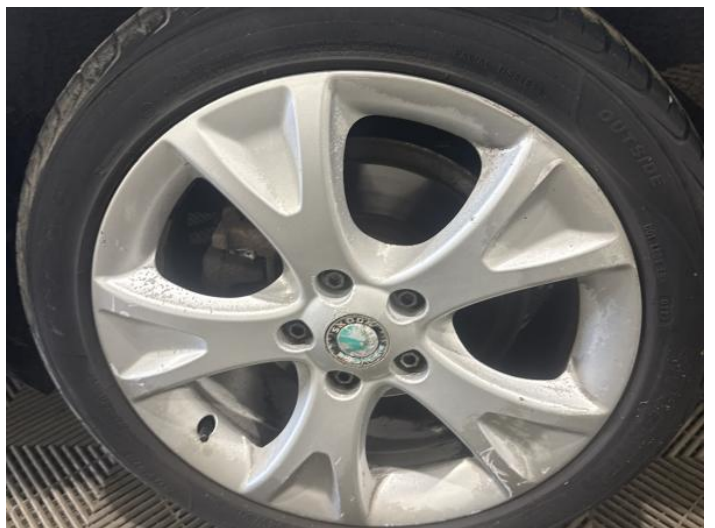
8: Wheel nsr  
Scratched  
Over 50mm

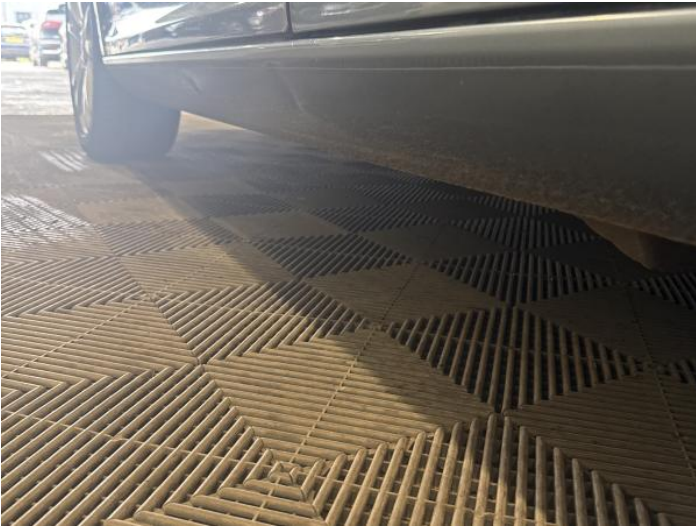
9: Sill ns  
Dented  
Over 30mm

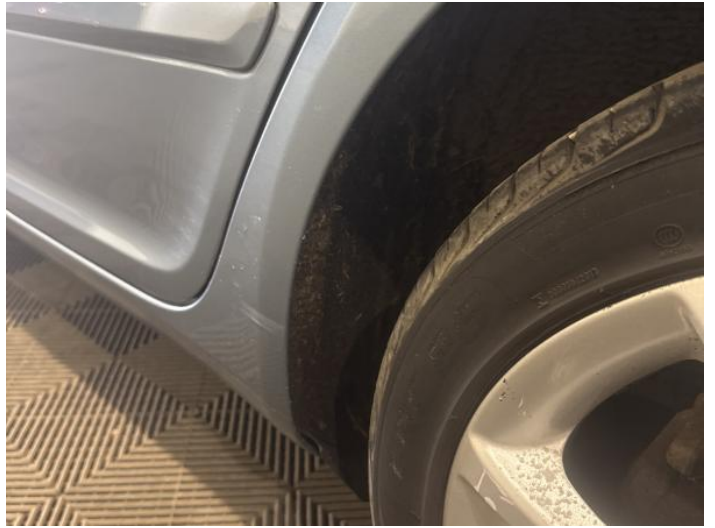
10: Qtr Panel nsr  
Scratched  
Over 25mm Thru Paint

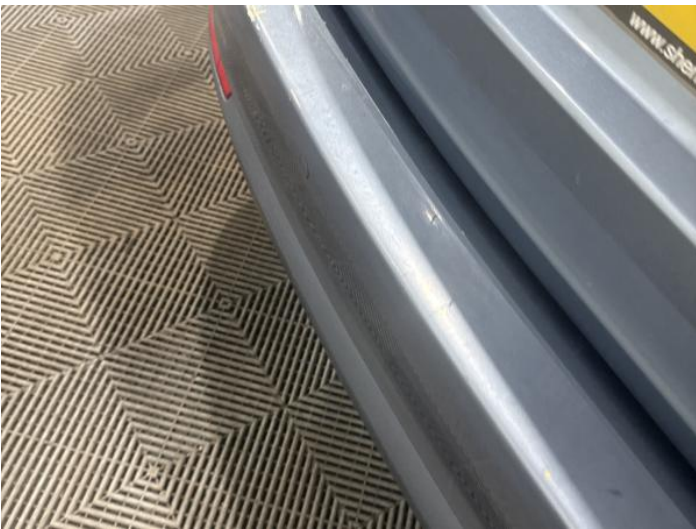
11: Bumper Rear  
Scratched  
25 to 100mm Thru Paint

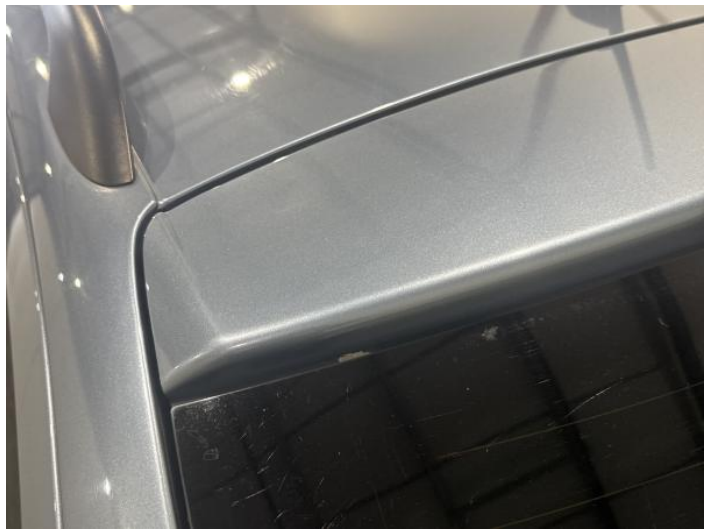
12: Tailgate  
Dented  
With Paint Damage

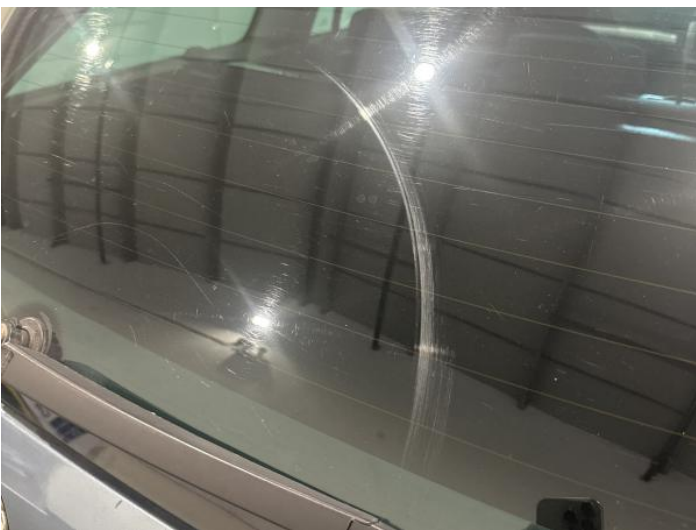
13: Screen Rear  
Scratched  
Over 30mm

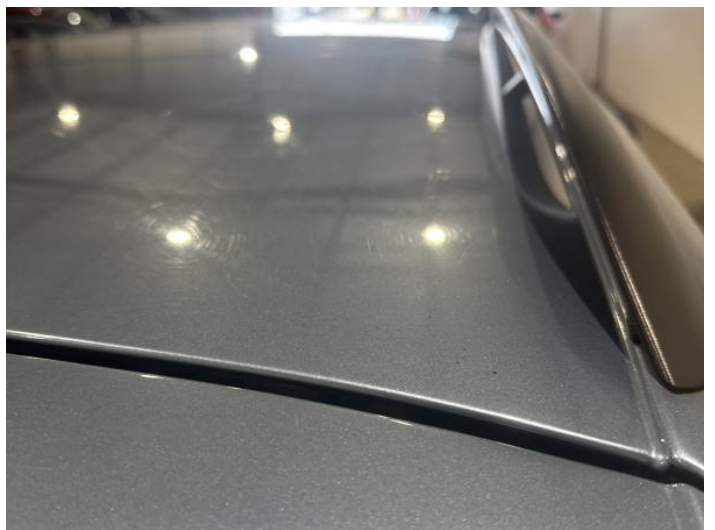
14: Roof  
Dented  
Over 30mm

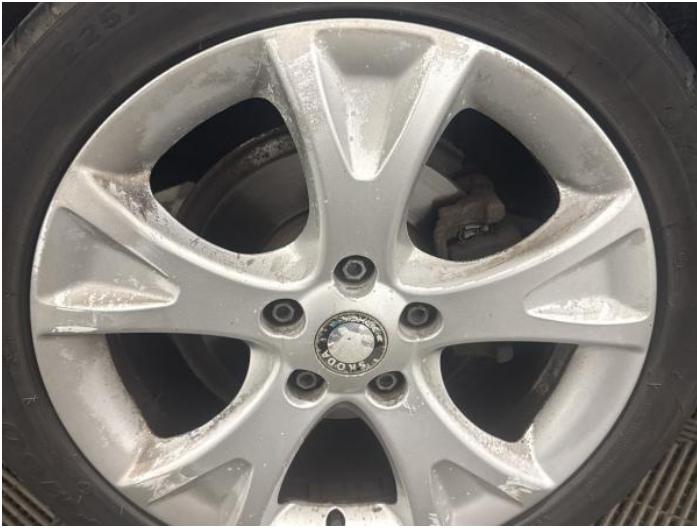
15: Wheel osr  
Scratched  
Over 50mm

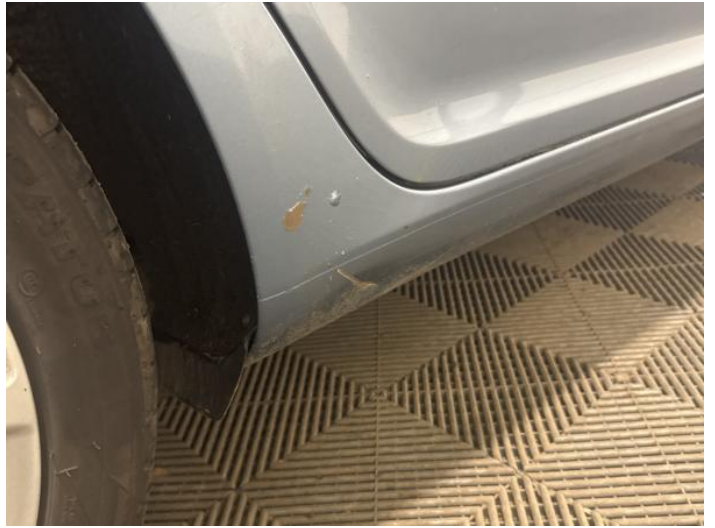
16: Qtr Panel osr  
Rusted  
Over 5mm

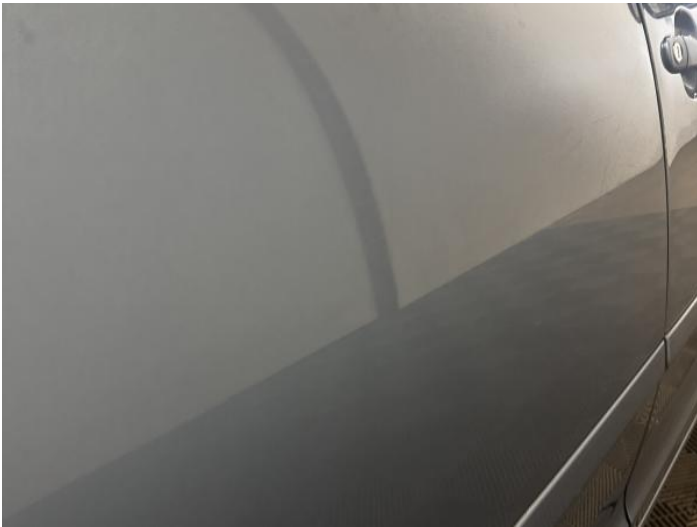
17: Door osr  
Dented  
With Paint Damage

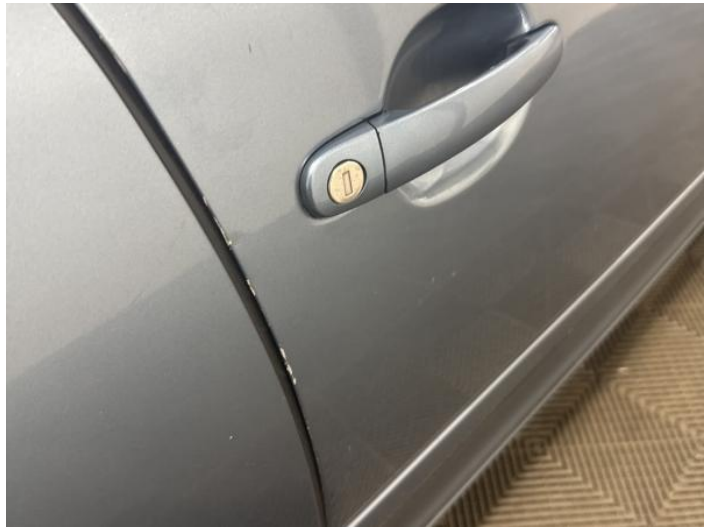
18: Door osf  
Chipped  
Edge Chip

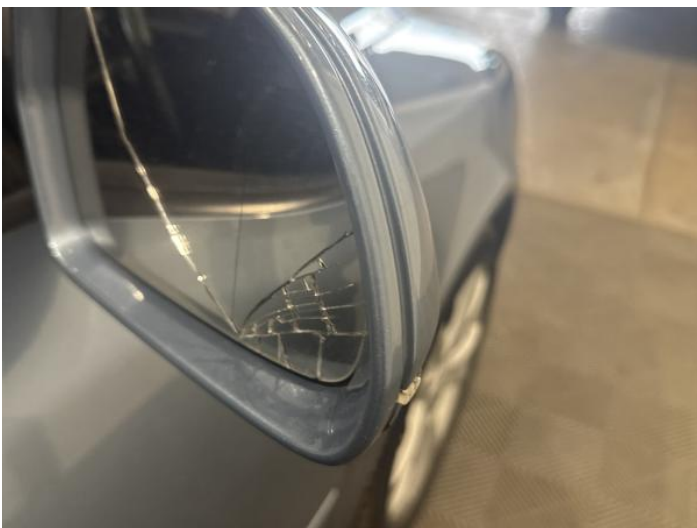
19: Door Mirror Glass os  
Broken  
Replace

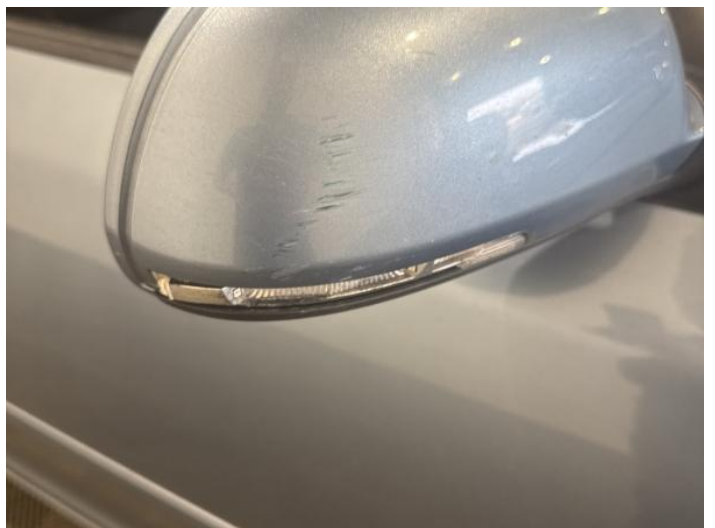
20: Flasher Side Repeater os  
Broken  
Replace

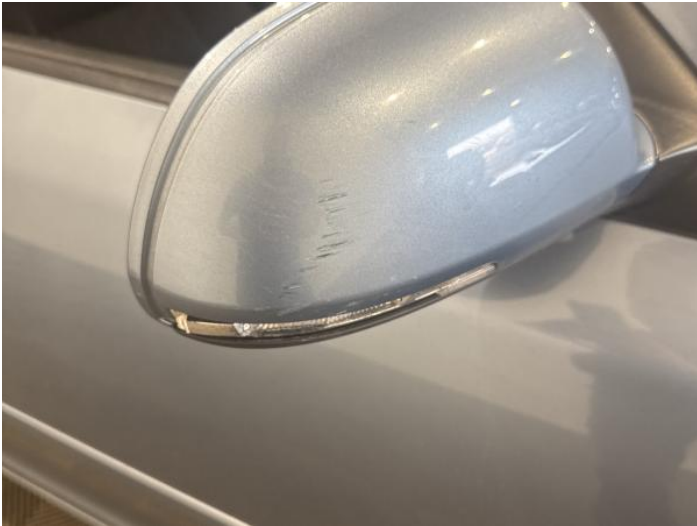
21: Door Mirror Assy osf  
Scratched (Painted)  
Over 25mm Thru Paint

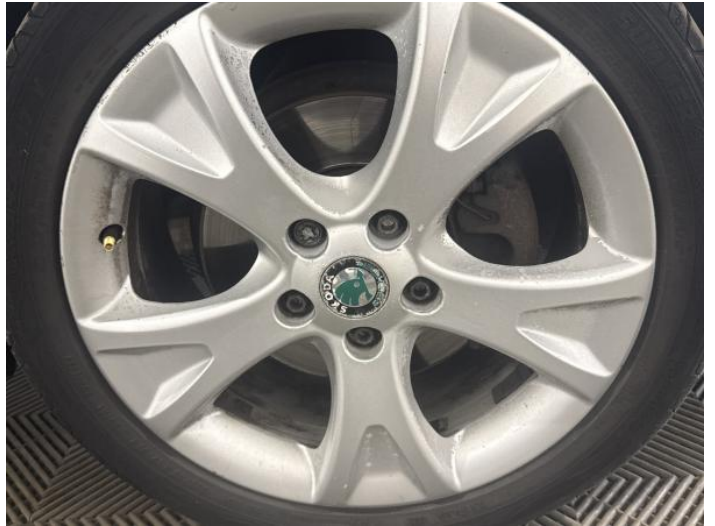
22: Wheel osf  
Scratched  
Over 50mm

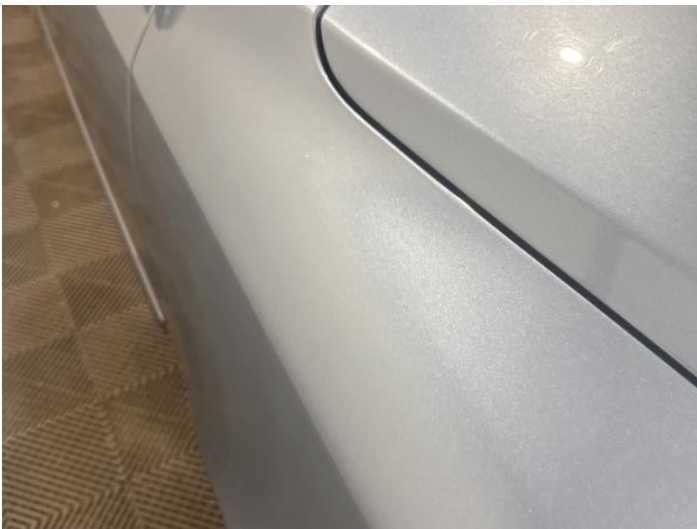
23: Wing osf  
Chipped  
1 To 5

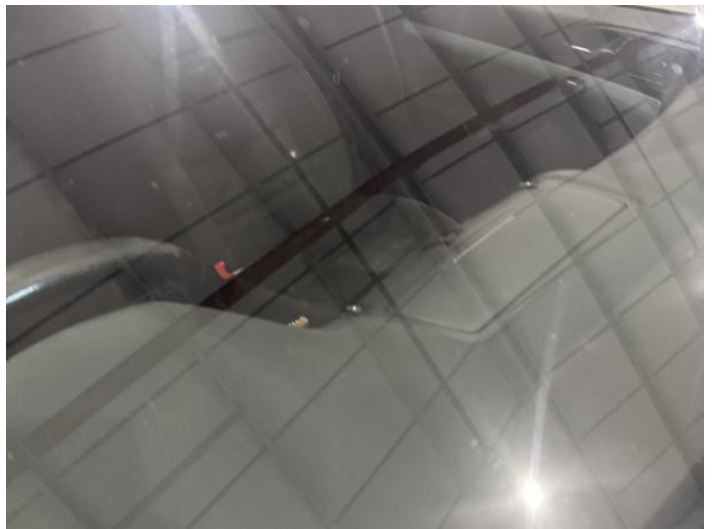
24: Screen Front  
Chipped  
Over 10mm

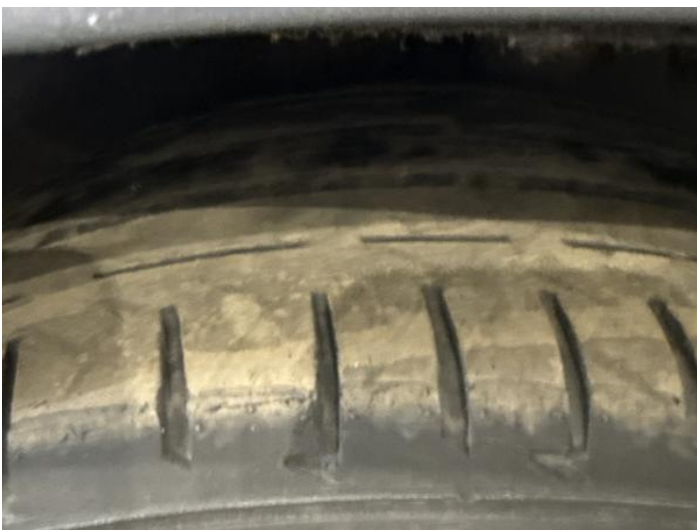
NSF	BRIDGESTONE	Damaged
NSR	BUDGET	5.0mm
OSF	BUDGET	3.0mm
OSR	BUDGET	5.0mm
Spare

25: Tyre nsf  
Damaged  
Replace

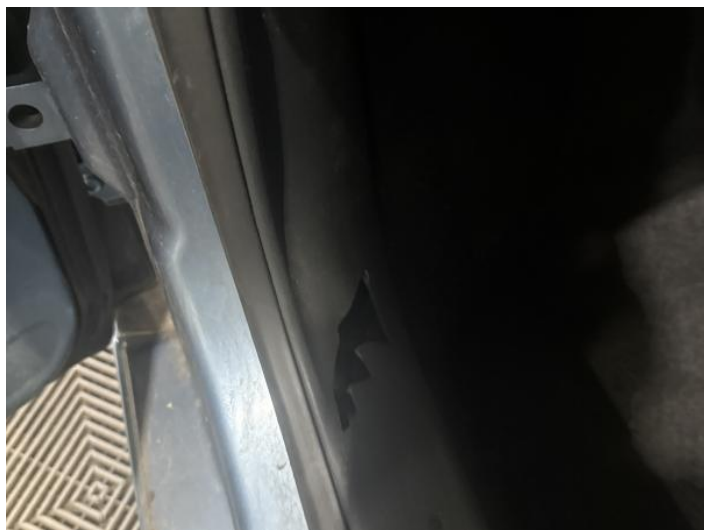
26: Fascia Trim  
Damaged  
Replace
