VEHICLE INSPECTION REPORT

BG64HFA

Subaru XV 2.0D SE Premium 5dr

nama
 GRADE
3

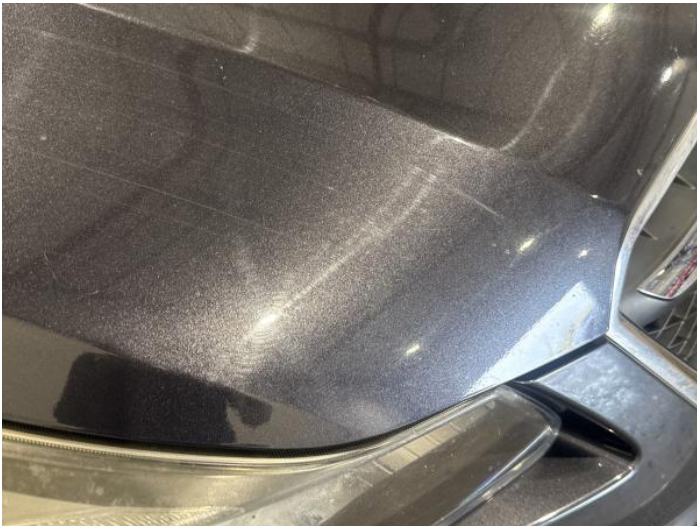
1: Bonnet
Scratched
Over 25mm Thru Paint

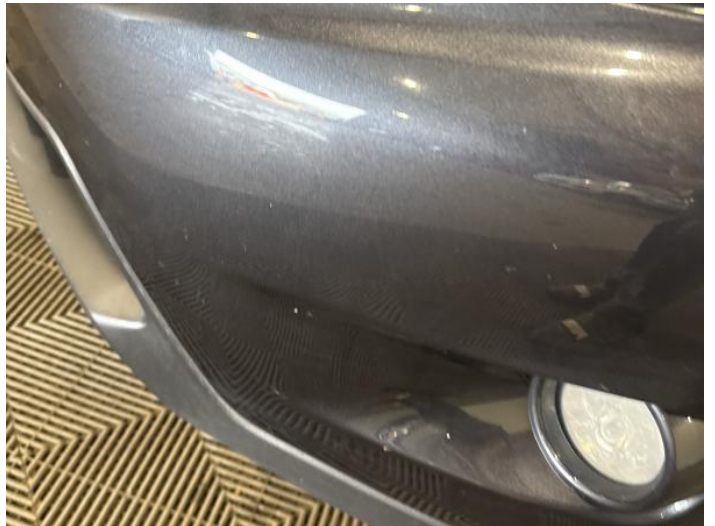
2: Bumper Front
Chipped
Multiple Chips

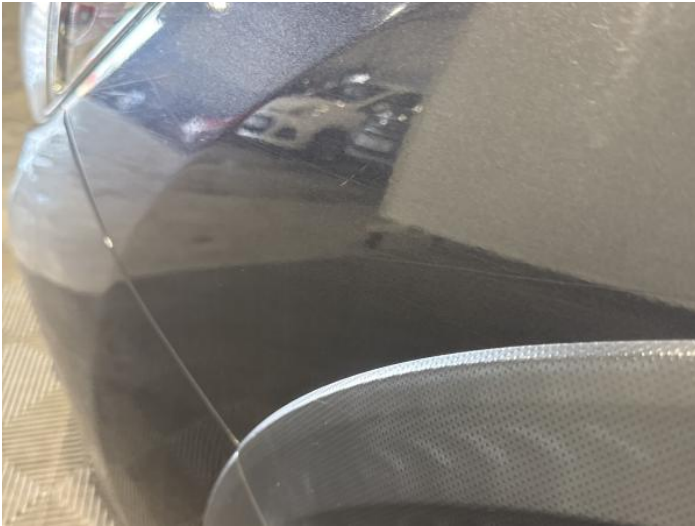
3: Wing nsf
Scratched
UpTo 25mm Thru Paint

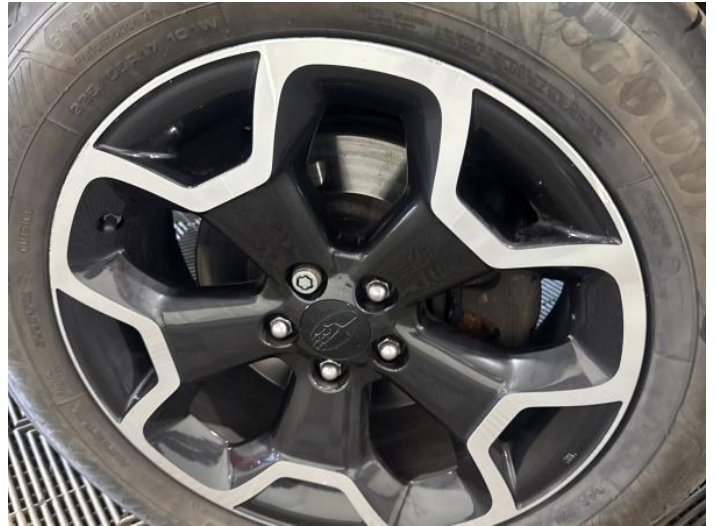
4: Wheel nsf
Scratched
Over 50mm

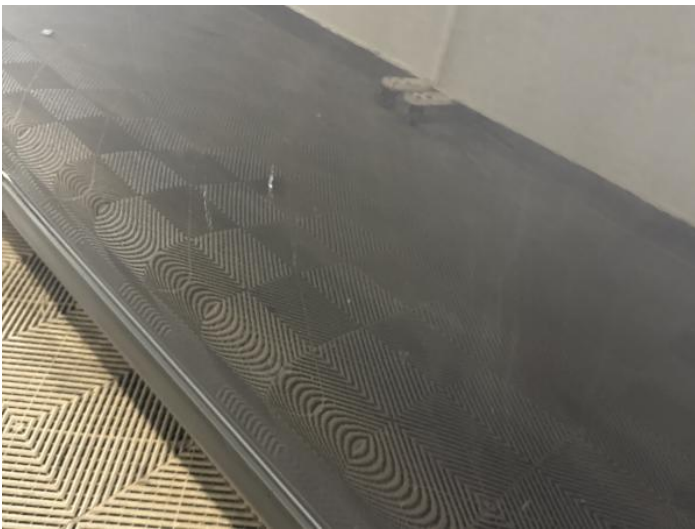
5: Door nsf
Scratched
Over 25mm Thru Paint

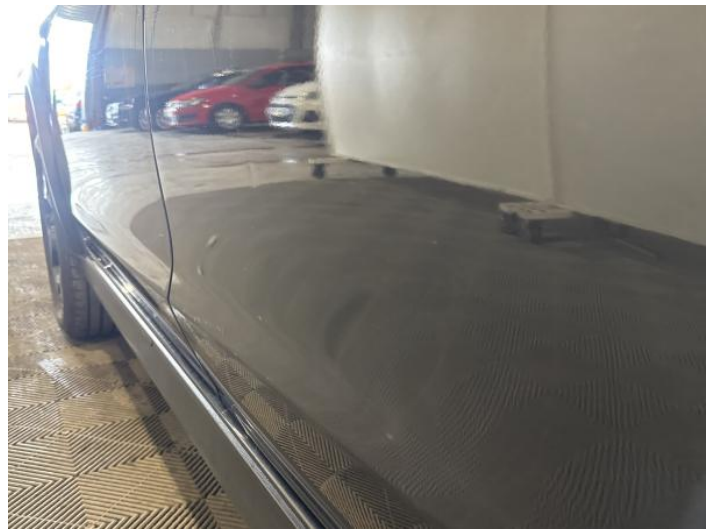
6: Door nsr
Dented
Between 10mm + 30mm

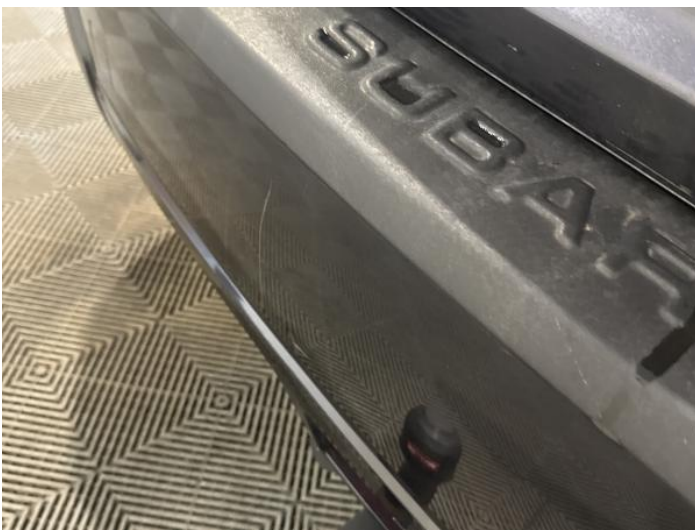
7: Bumper Rear
Scratched
25 to 100mm Thru Paint

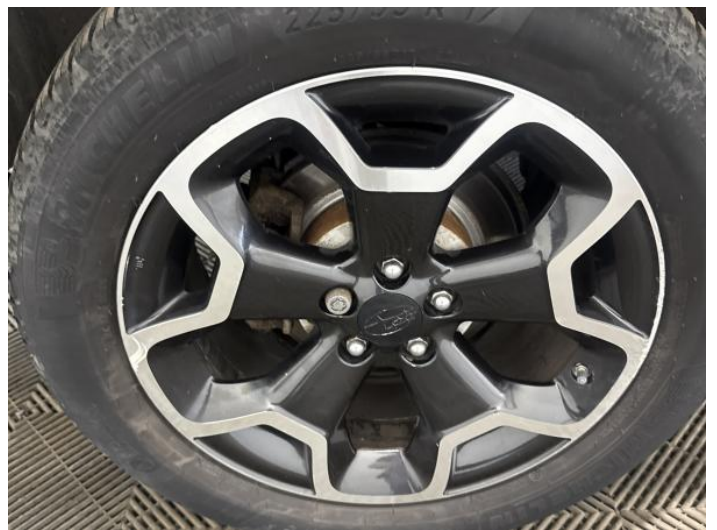
8: Wheel osr
Scratched
Over 50mm

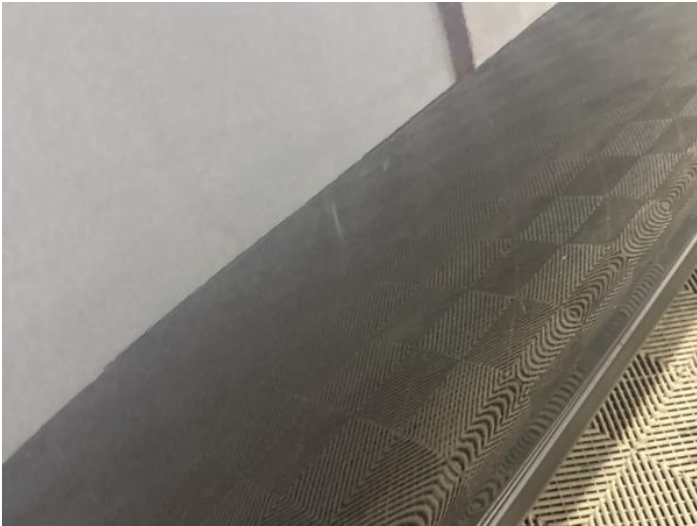
9: Door osr
 Scratched
 UpTo 25mm Thru Paint

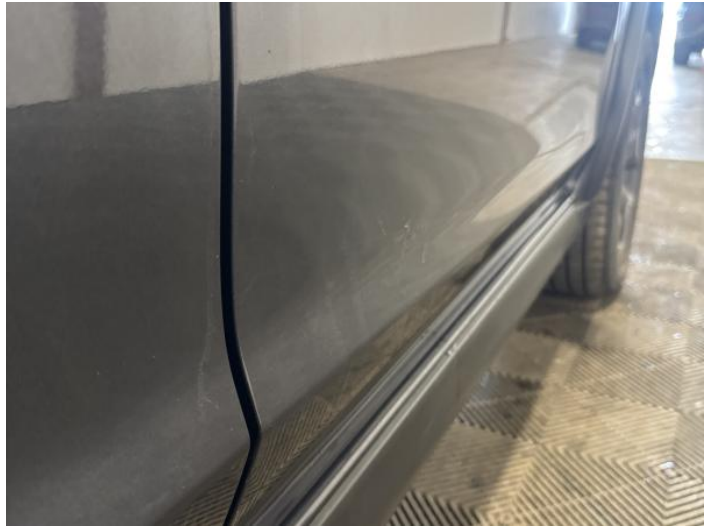
10: Door osf
 Dented
 Over 30mm

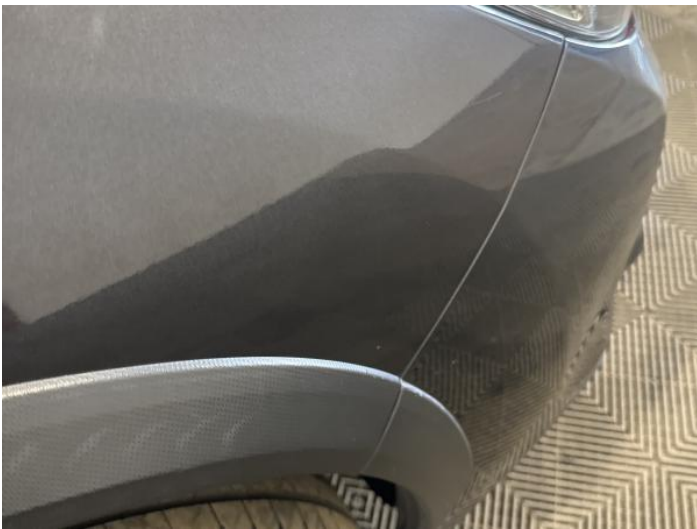
11: Wing osf
 Chipped
 1 To 5
