VEHICLE INSPECTION REPORT

FG18BZJ

Toyota Auris 1.8 Hybrid Excel TSS 5dr CVT [Leather]

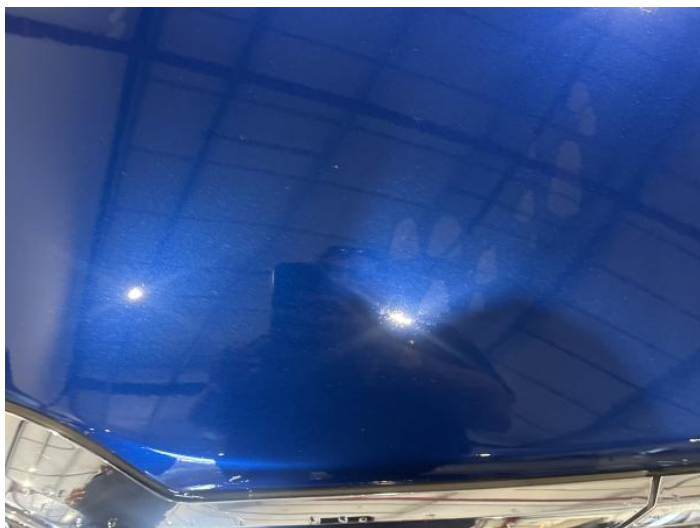
1: Bonnet
Chipped
1 To 5

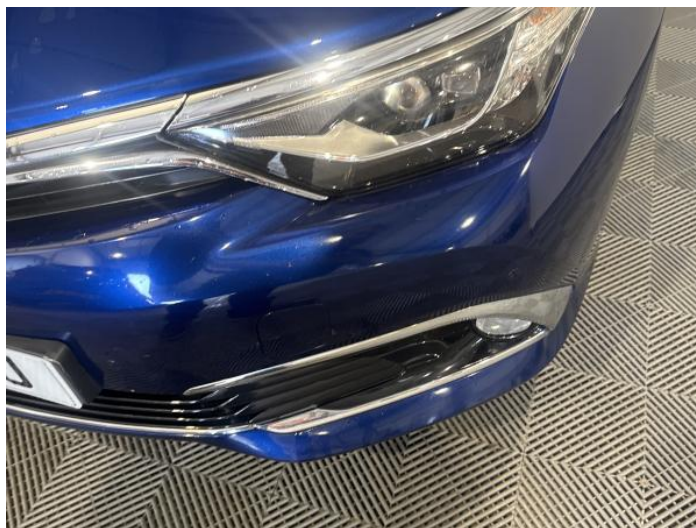
2: Bumper Front
Scratched
25 to 100mm Thru Paint

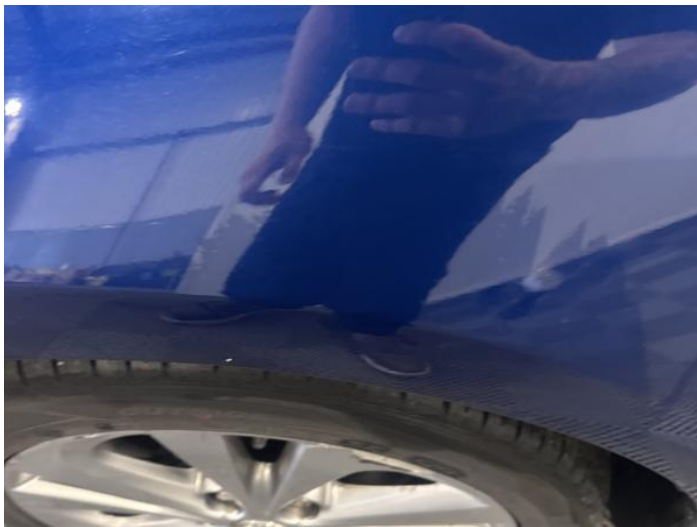
3: Wing nsf
Chipped
1 To 5

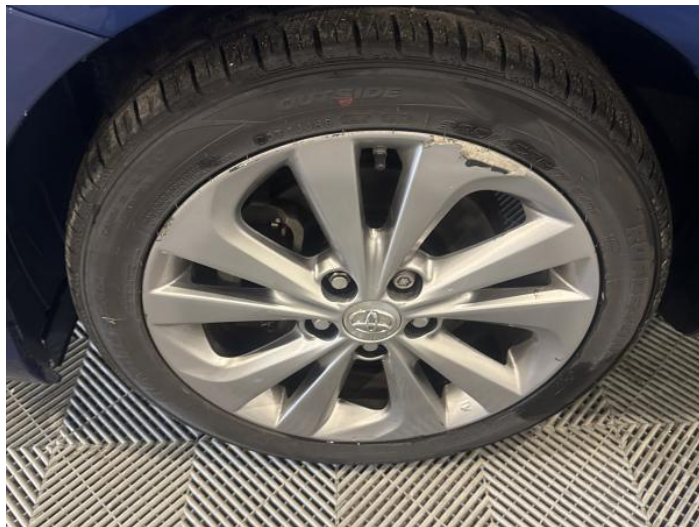
4: Wheel nsf
Scratched
Over 50mm

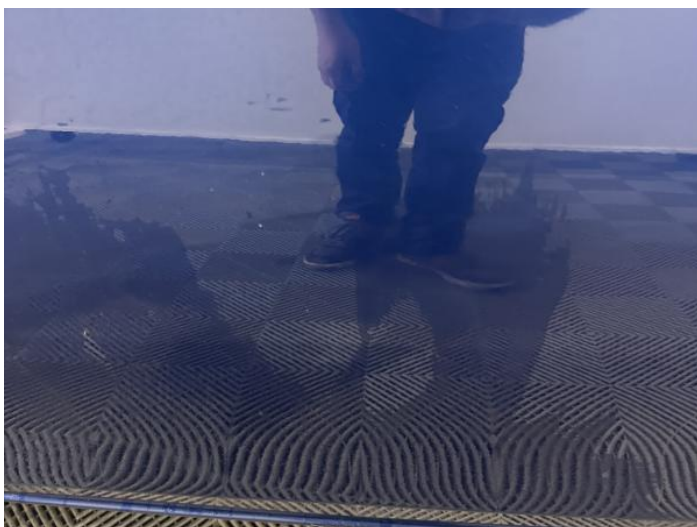
5: Door nsf
Chipped
1 To 5

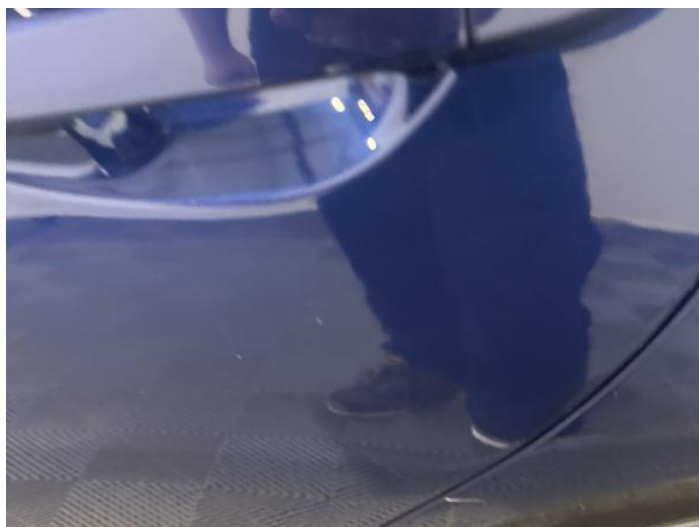
6: Door nsr
Chipped
1 To 5

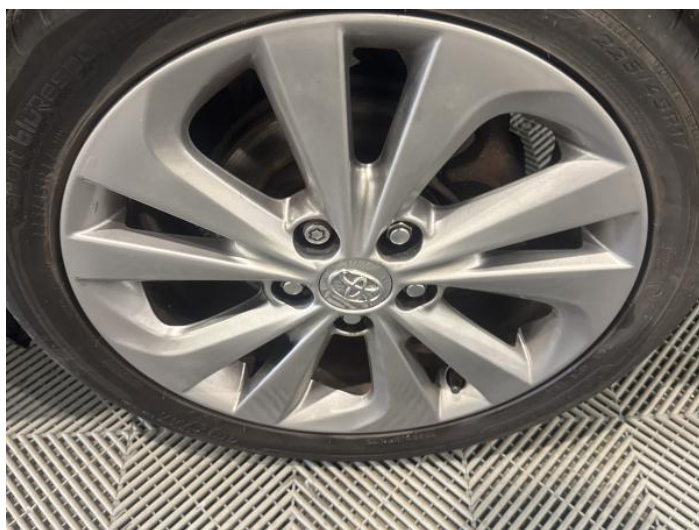
8: Wheel nsr
Scratched
Up To 50mm

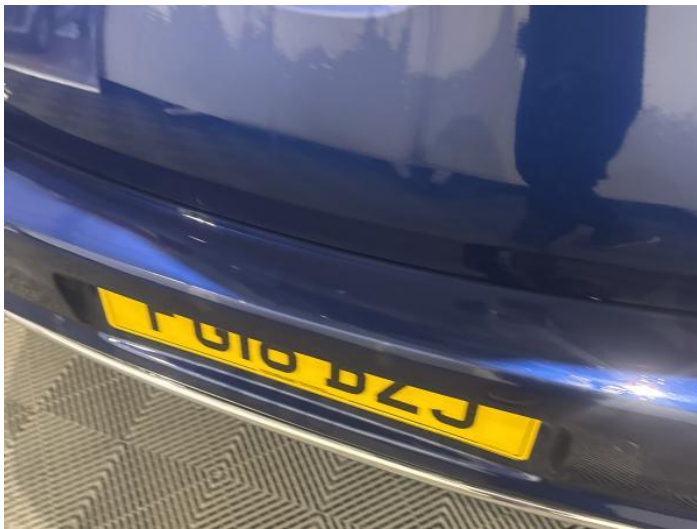
9: Bumper Rear
Scratched
25 to 100mm Thru Paint

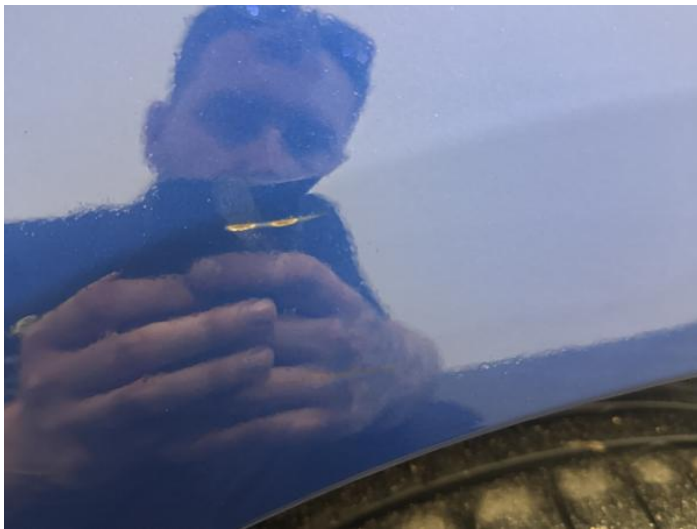
11: Qtr Panel osr
Scratched
UpTo 25mm Thru Paint

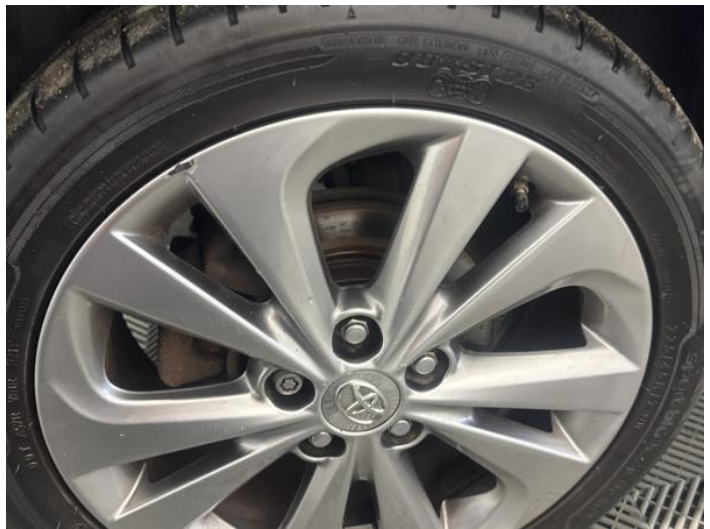
12: Wheel osr
Scratched
Up To 50mm

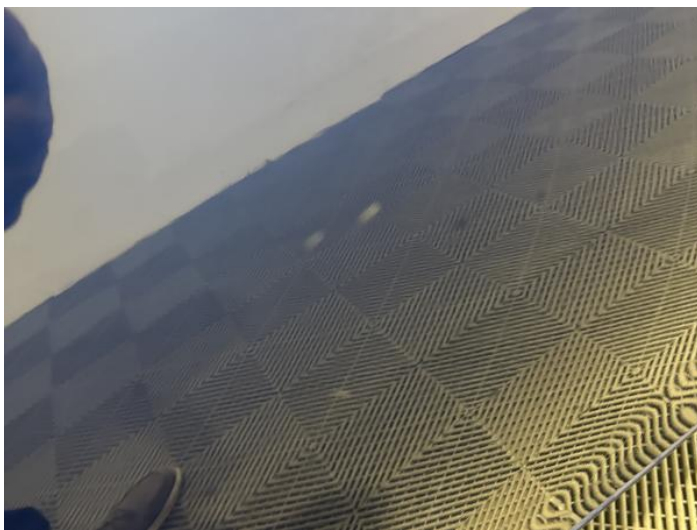
13: Door osr
Chipped
1 To 5

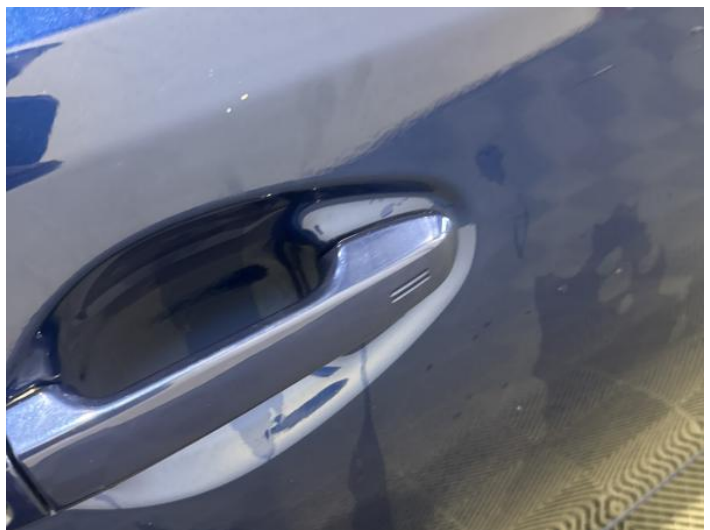
14: Door osf
Chipped
1 To 5

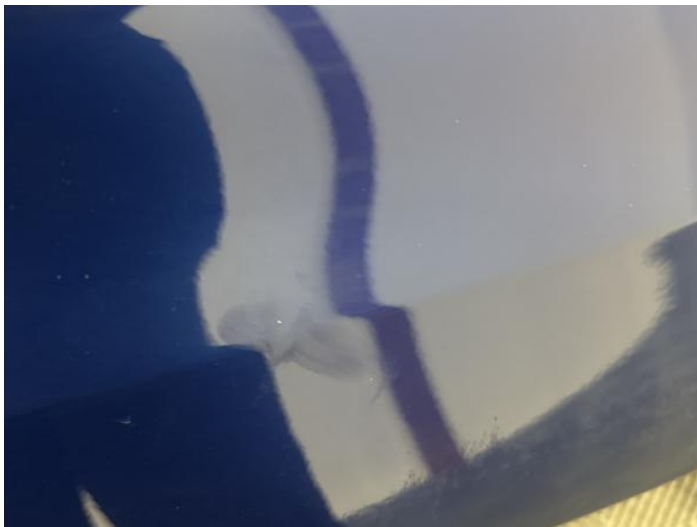
15: Wing osf
Chipped
1 To 5

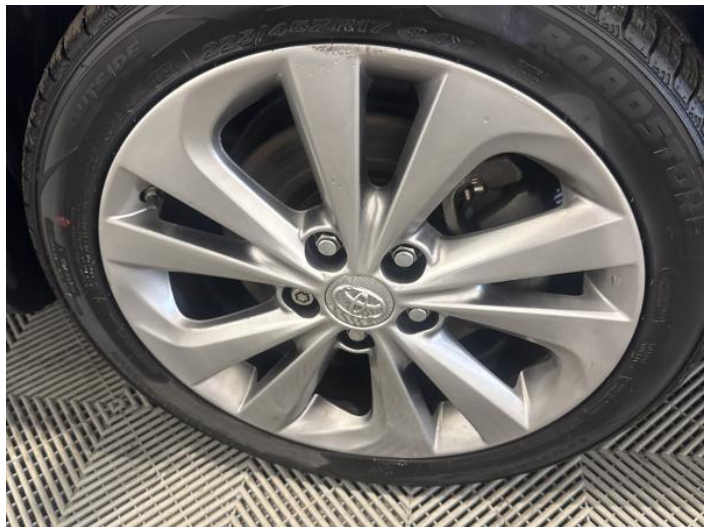
16: Wheel osf
Scratched
Up To 50mm
