VEHICLE INSPECTION REPORT

LM57KBJ

Volkswagen Golf 1.9 Match TDI 5dr

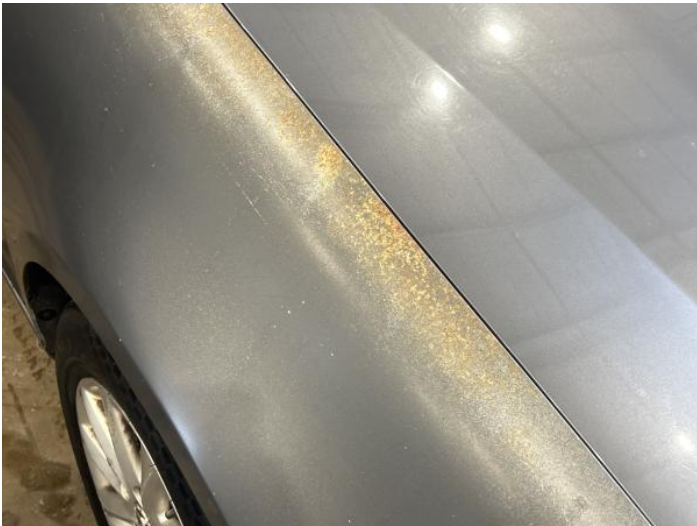
1: Wing of
Poor Previous Repair
Poor Paint

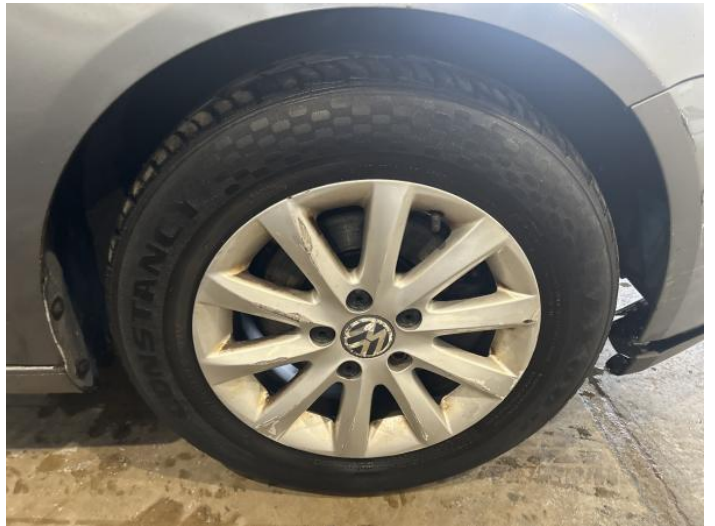
2: Wheel of
Scratched
Over 50mm

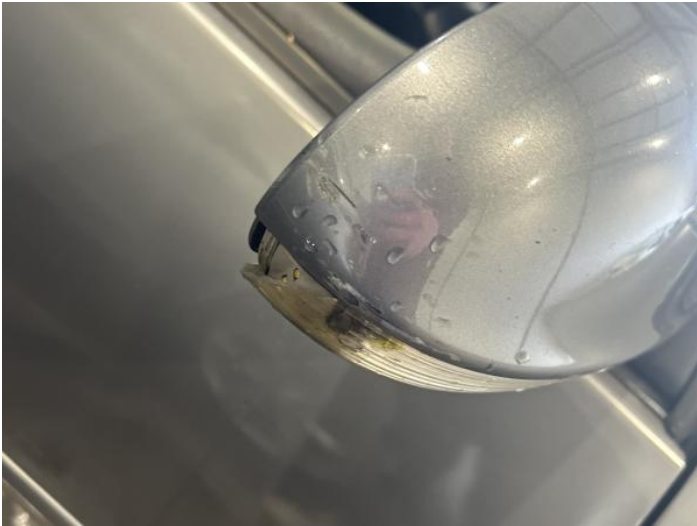
3: Door Mirror Assy osf
Broken
Replace

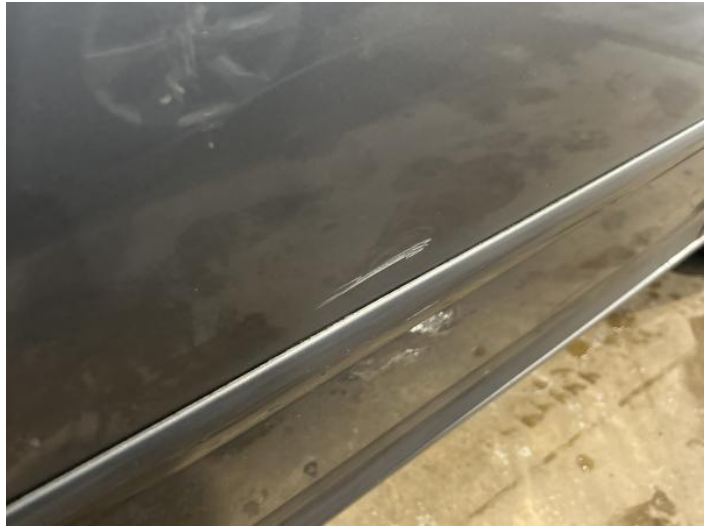
4: Door osf
Dented
With Paint Damage

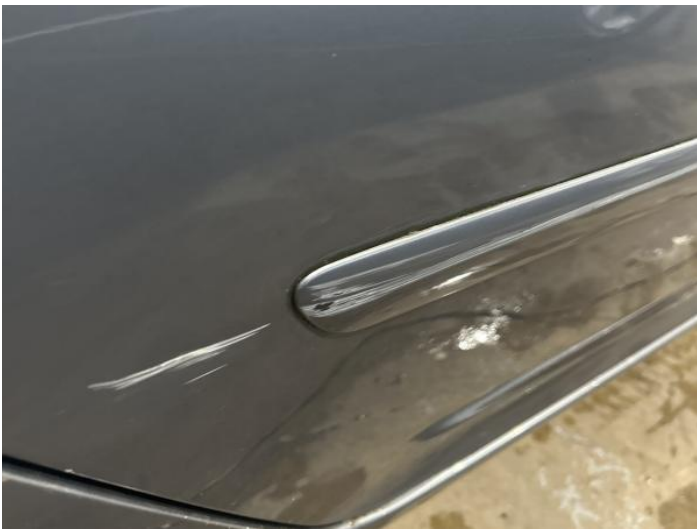
5: Door osr
Scratched
Over 25mm Thru Paint

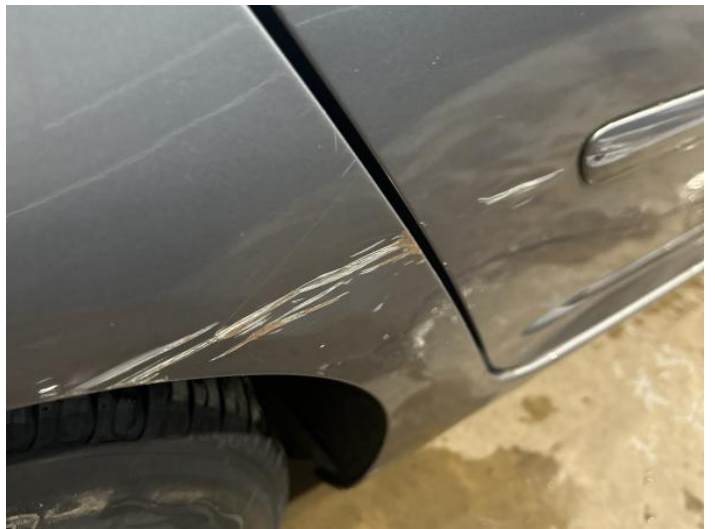
6: Qtr Panel osr
Dented
With Paint Damage

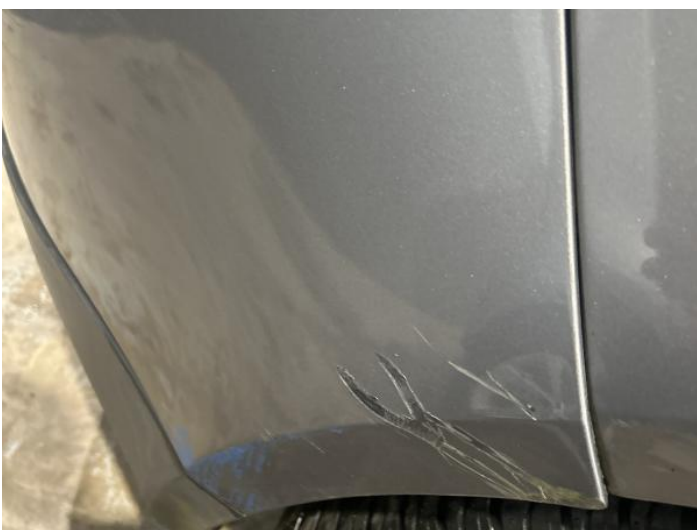
7: Bumper Rear
Scratched
Over 100mm Thru Paint

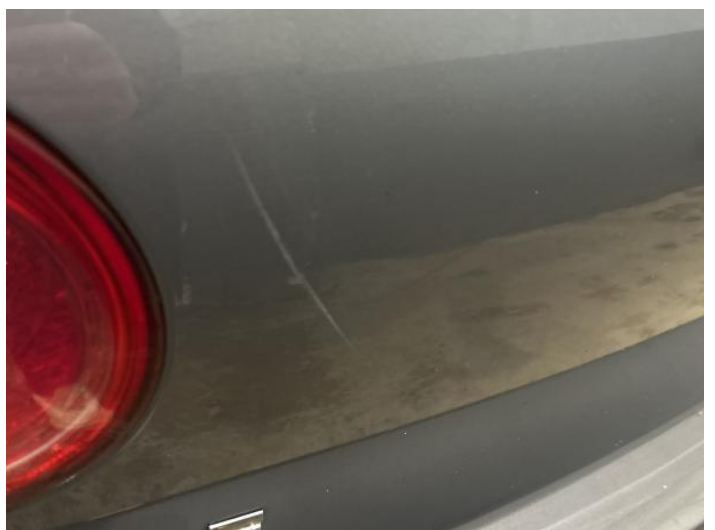
8: Tailgate
Scratched
Over 25mm Not Thru Paint

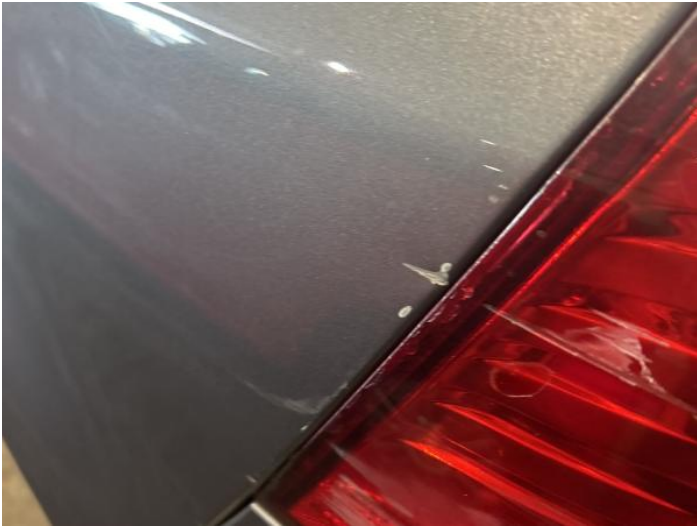
9: Qtr Panel nsr
Dented
With Paint Damage

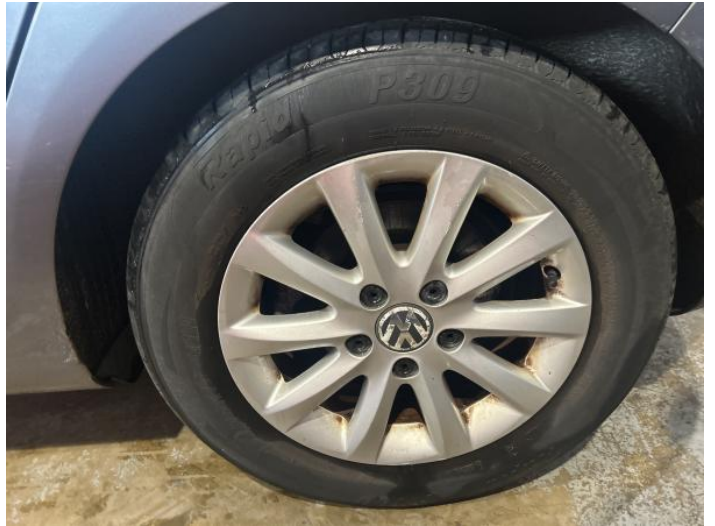
10: Wheel nsr
Scratched
Over 50mm

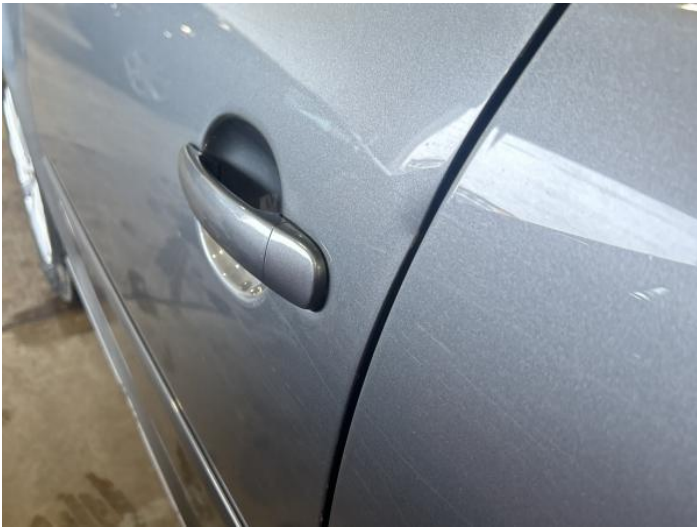
11: Door nsf
Dented
Over 30mm

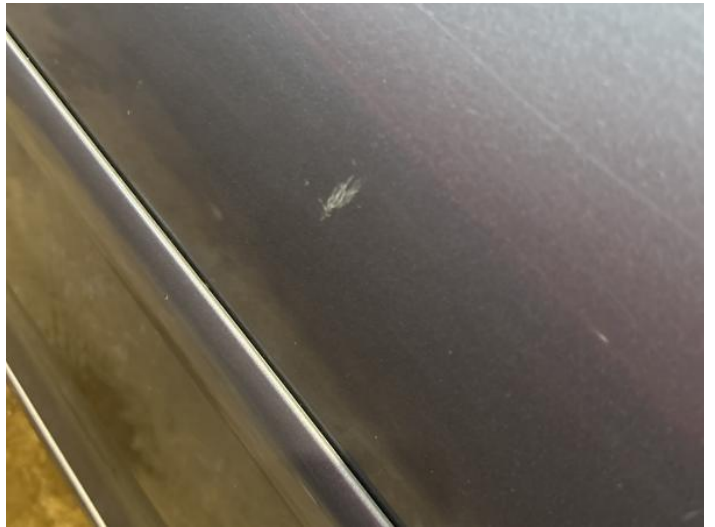
12: Door nsr
Scratched
UpTo 25mm Thru Paint

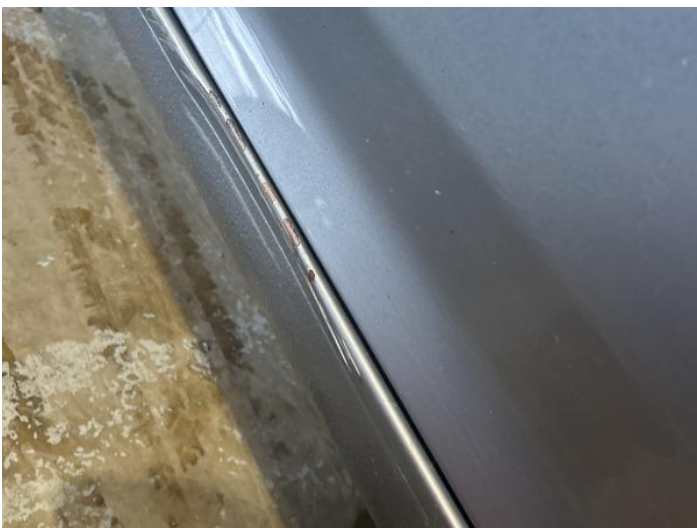
13: Sill ns
Dented
With Paint Damage

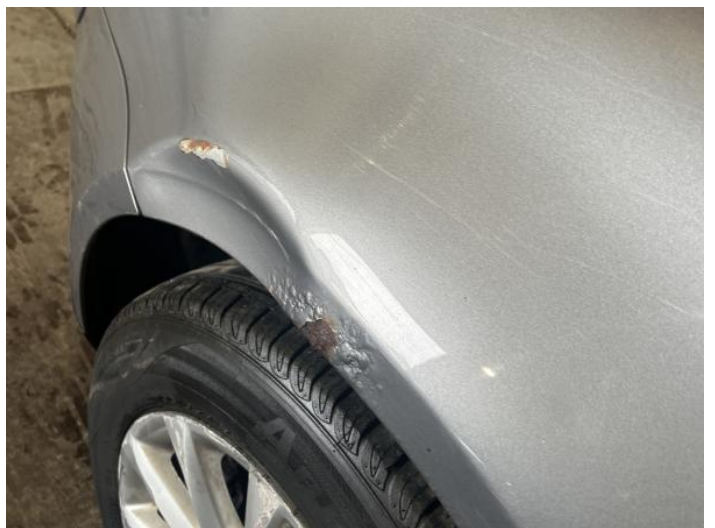
14: Wing nsf
Dented
With Paint Damage

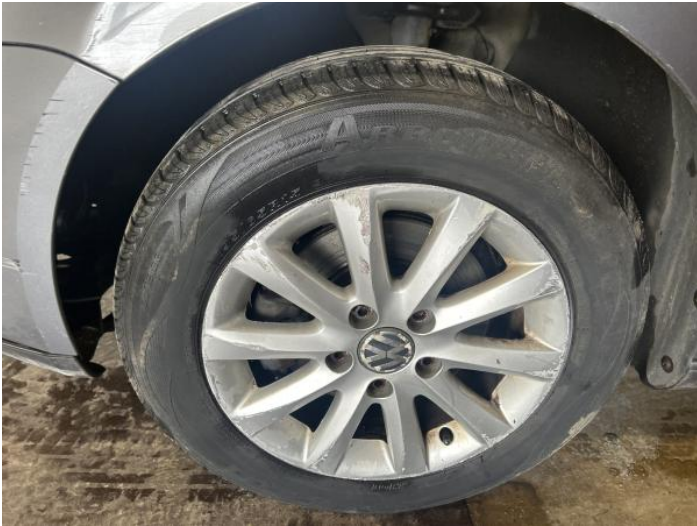
15: Wheel nsf
Scratched
Over 50mm

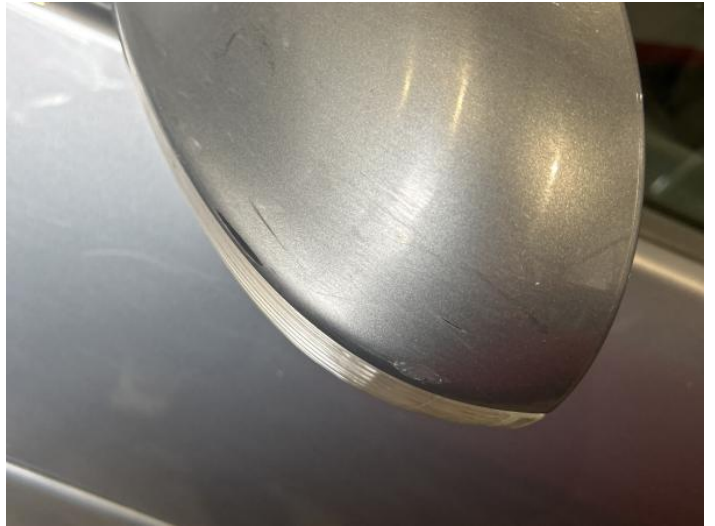
16: Door Mirror Assy nsf
Scratched (Painted)
UpTo 25mm Thru Paint

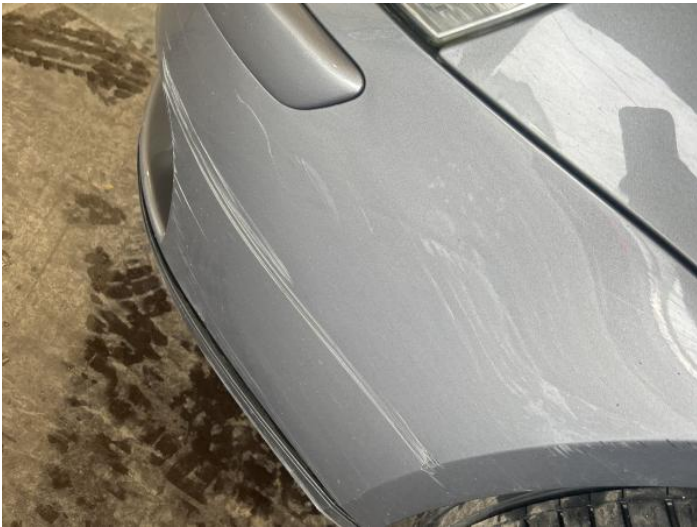
17: Bumper Front
Scratched
Over 100mm Thru Paint

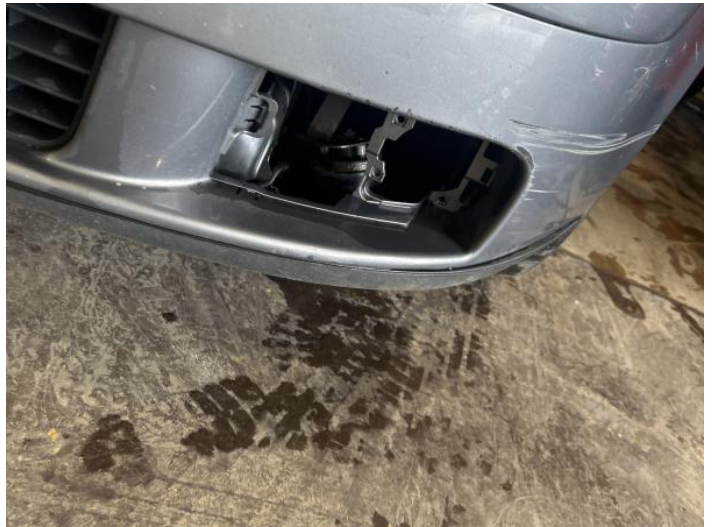
18: Fog Lamp Surround ns
Missing
Replace

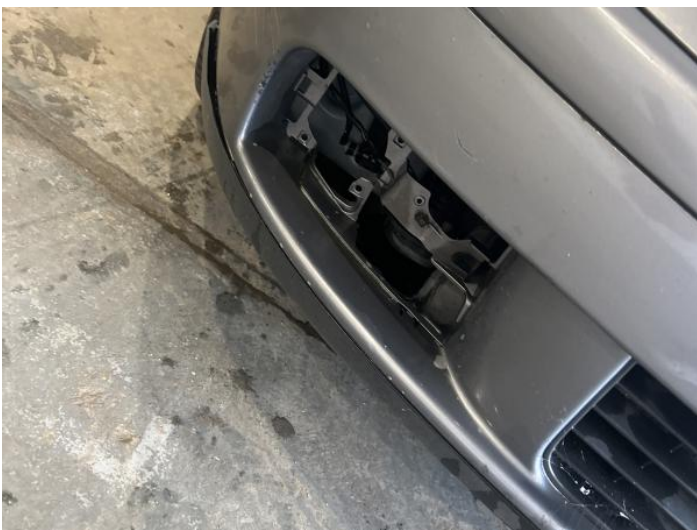
19: Fog Lamp Surround os
Missing
Replace

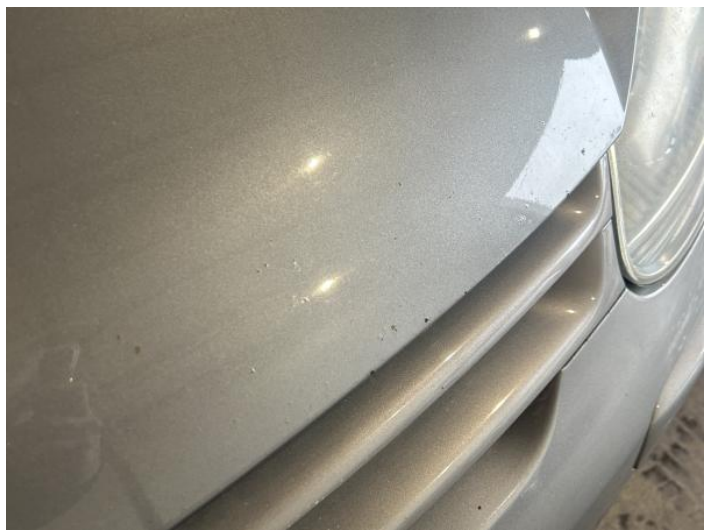
20: Bonnet
Chipped
Multiple Chips

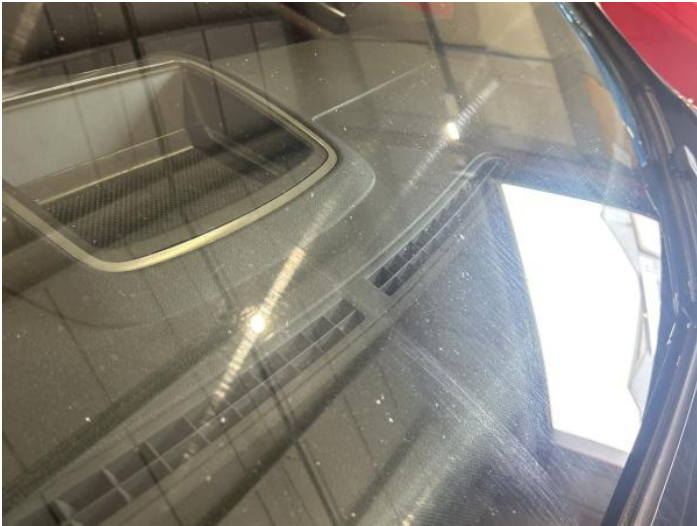
21: Screen Front
Chipped
UpTo 10mm

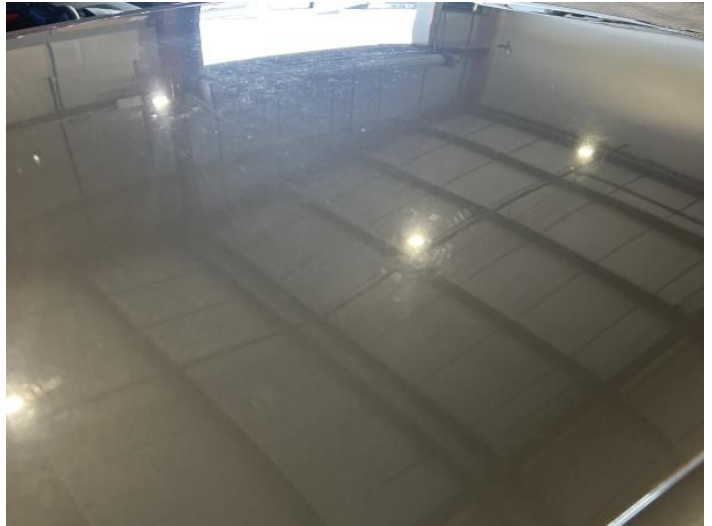
22: Roof
Scratched
Over 25mm Not Thru Paint

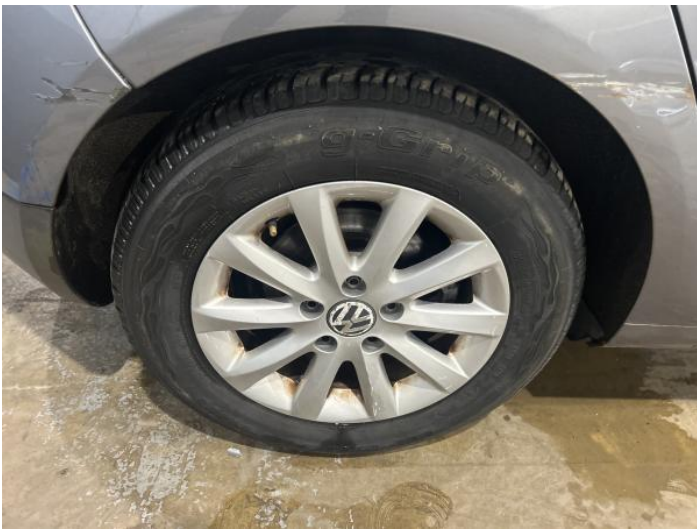
23: Wheel osr
Scratched
Over 50mm
