VEHICLE INSPECTION REPORT

GV11UJT

Ford Focus 1.6 125 Zetec 5dr

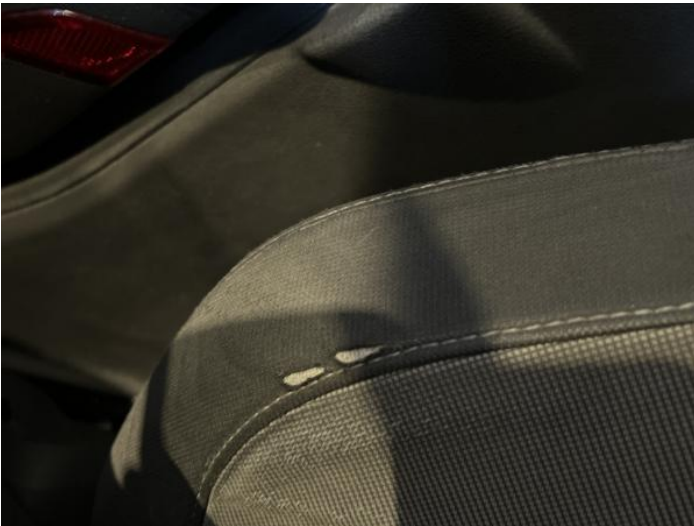
1: Seat Back Cover of
Holed
Up To 3mm

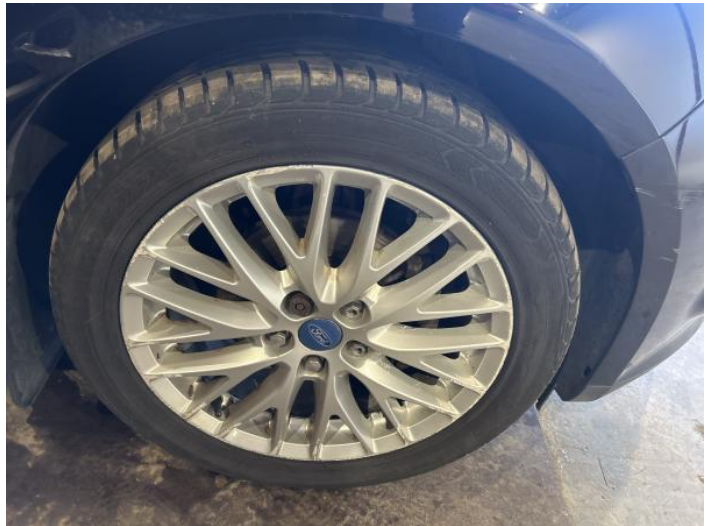
2: Wheel of
Scratched
Over 50mm

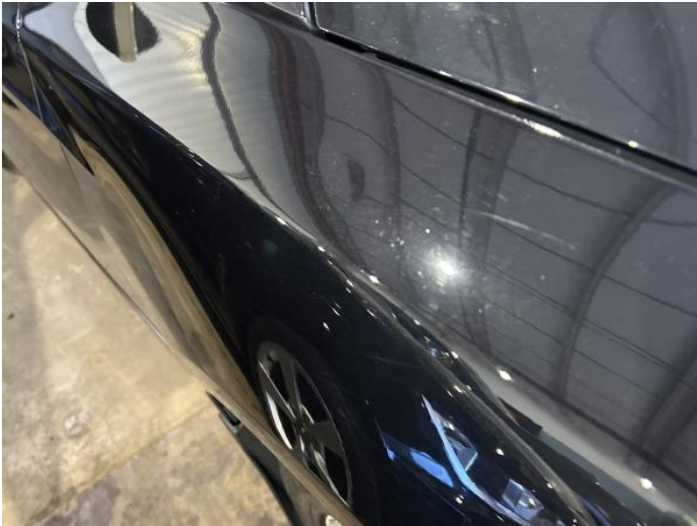
3: Wing osf
Dented
Between 10mm + 30mm

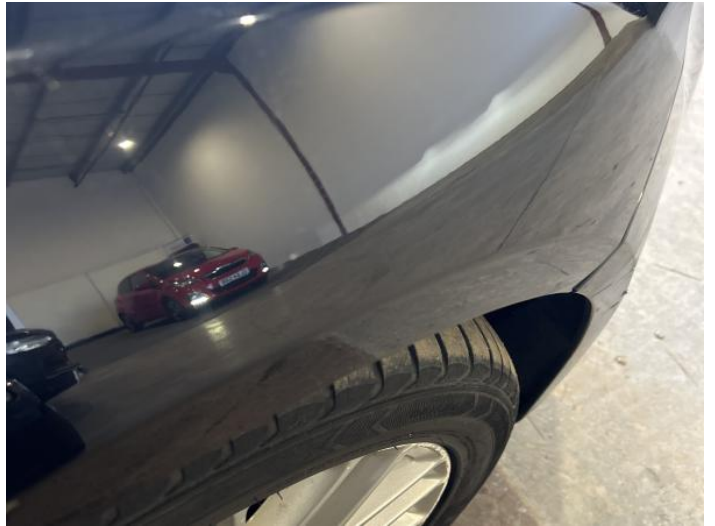
4: Wing osf
Chipped
1 To 5

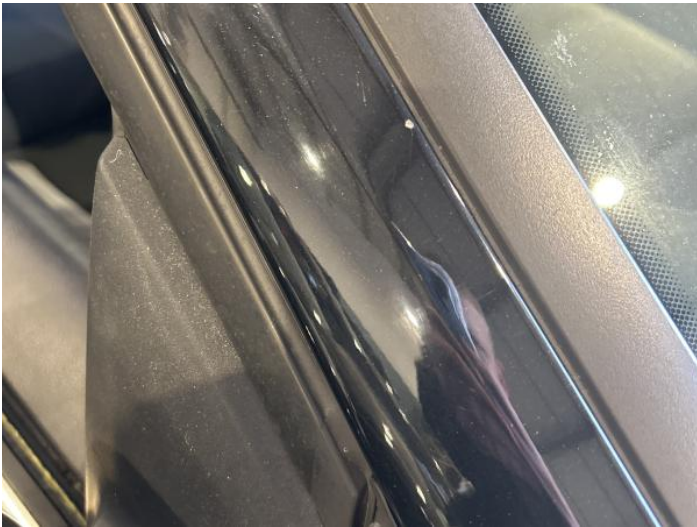
5: A Post os
Chipped
1 To 5

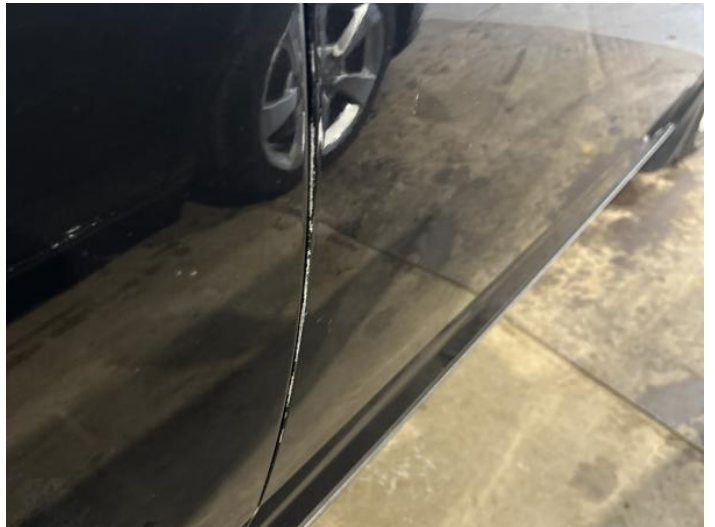
6: Door osf
Chipped
Edge Chip

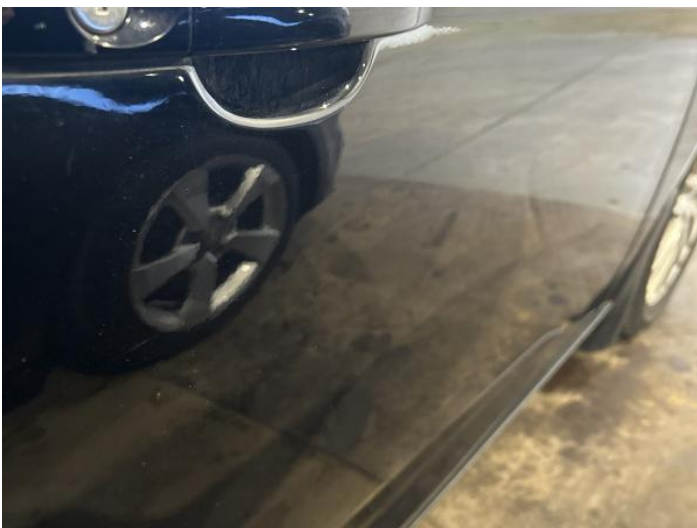
7: Door osf
Scratched
Over 25mm Not Thru Paint

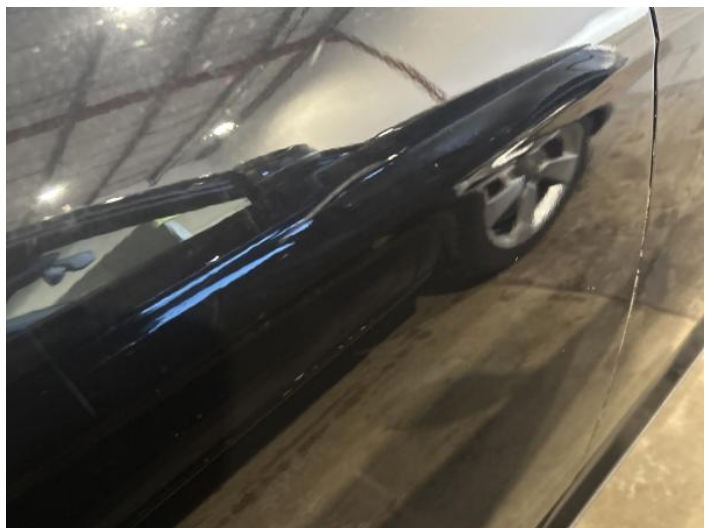
8: Door osr
Scratched
Over 25mm Not Thru Paint

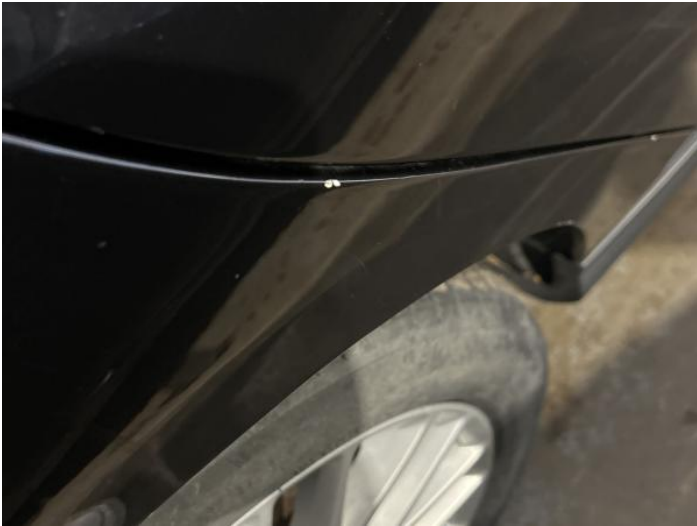
9: Qtr Panel osr
Chipped
1 To 5

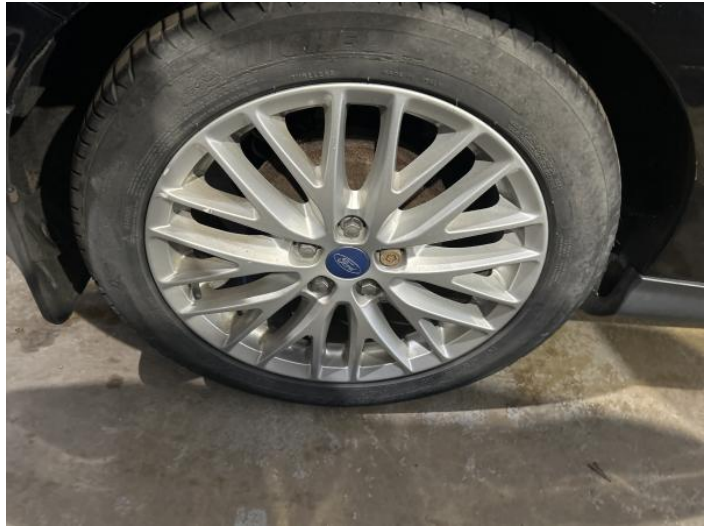
10: Wheel osr
Scratched
Up To 50mm

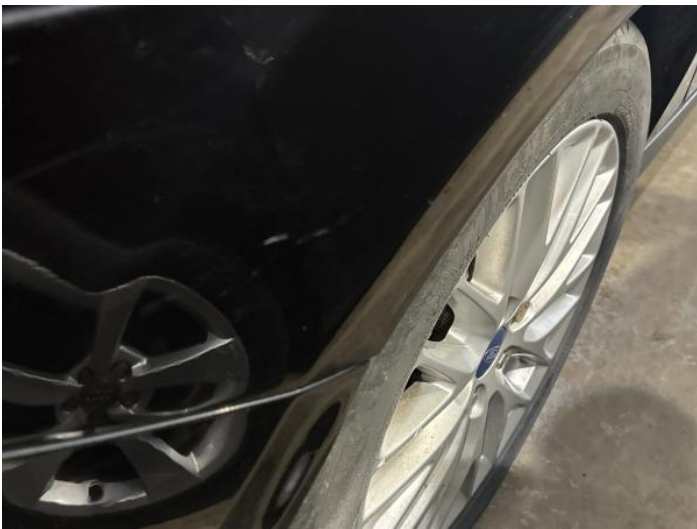
11: Qtr Panel osr
Scratched
Over 25mm Not Thru Paint

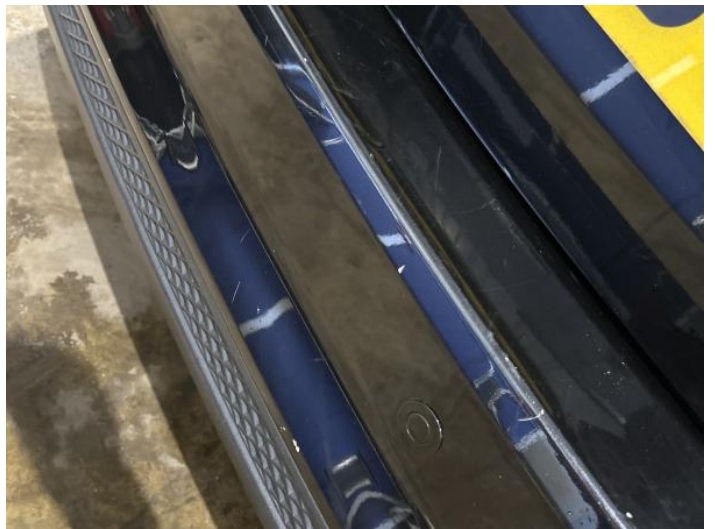
12: Bumper Rear
Scratched
Over 100mm Thru Paint

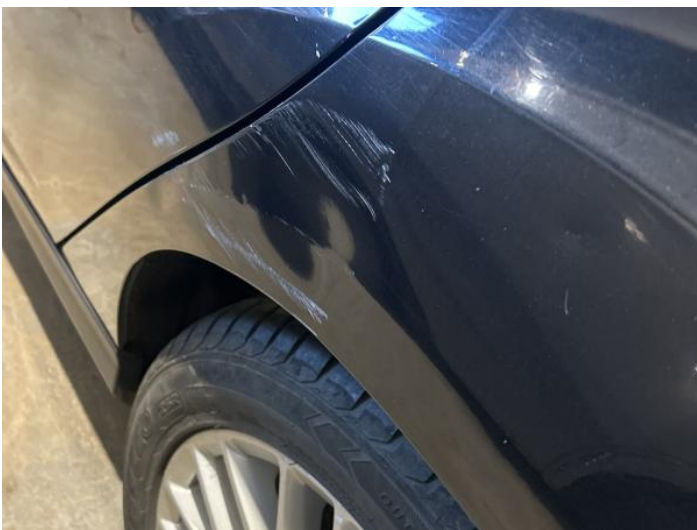
13: Qtr Panel nsr
Dented
With Paint Damage

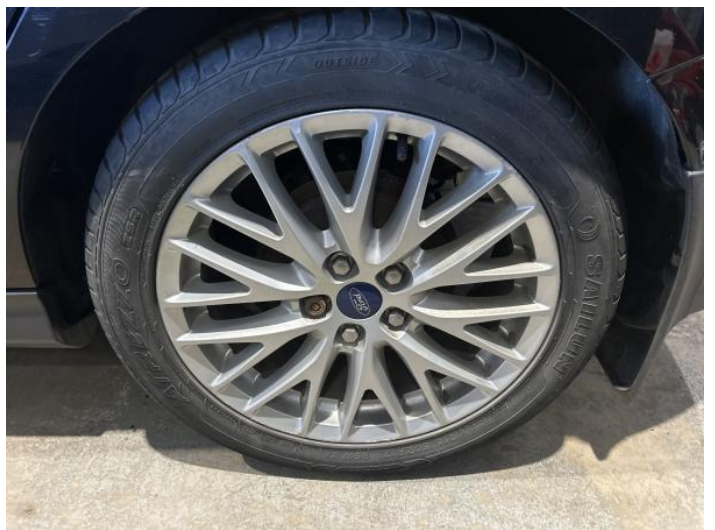
14: Wheel nsr
Scratched
Over 50mm

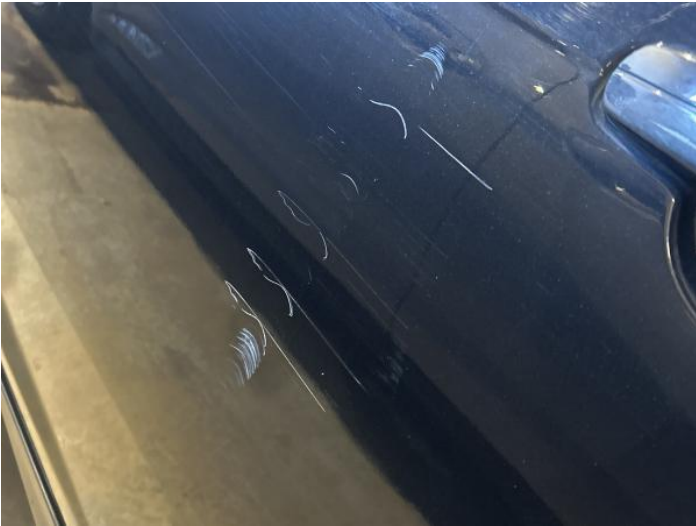
15: Door nsr
Scratched
Over 25mm Thru Paint

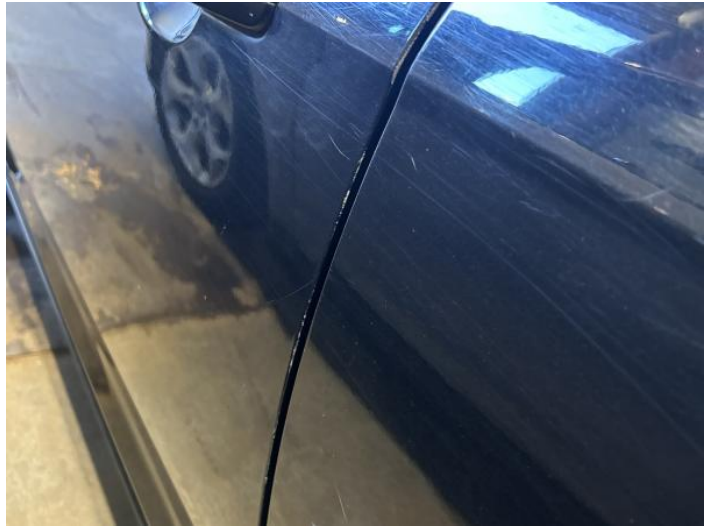
16: Door nsf
Chipped
Edge Chip

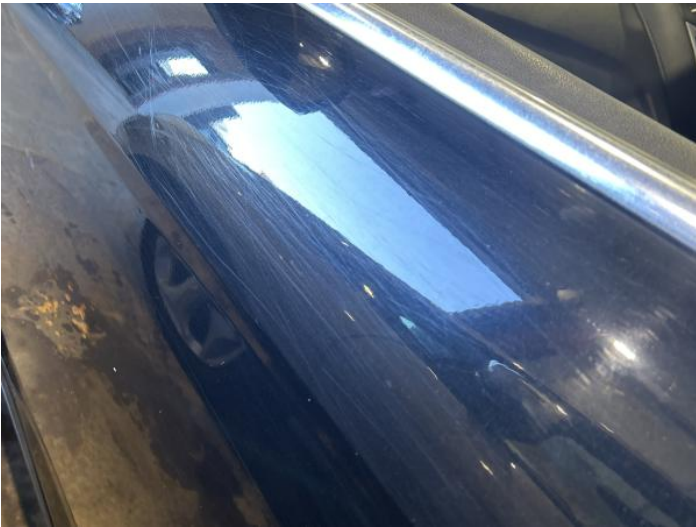
17: Door nsf
Scratched
Over 25mm Not Thru Paint

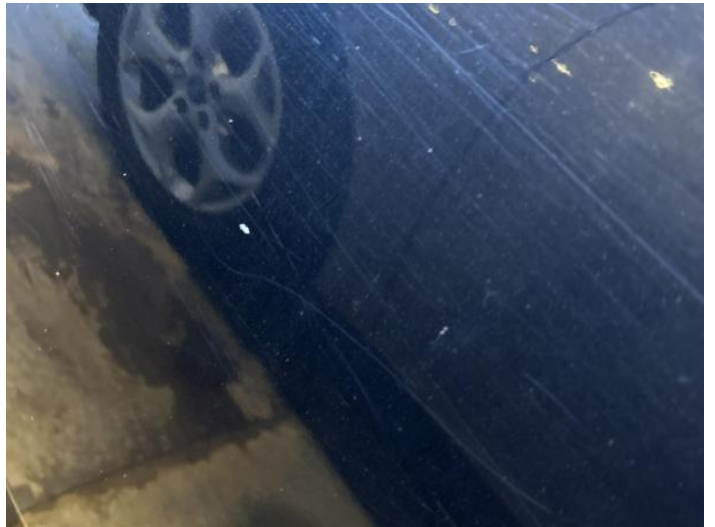
18: Door nsf
Chipped
1 To 5

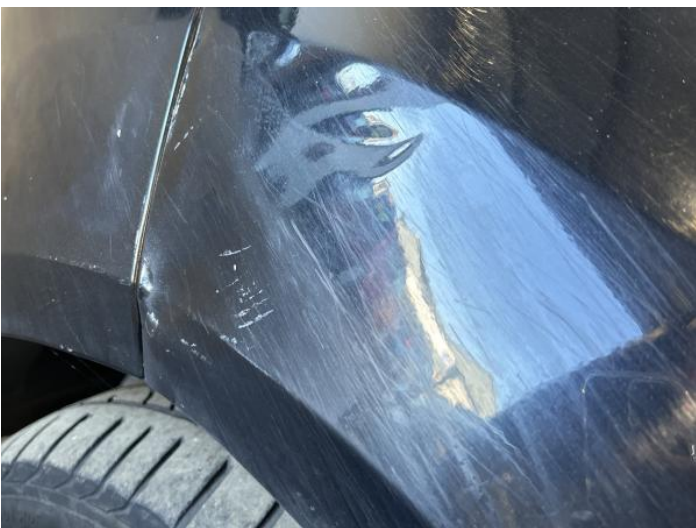
19: Wing nsf
Dented
With Paint Damage

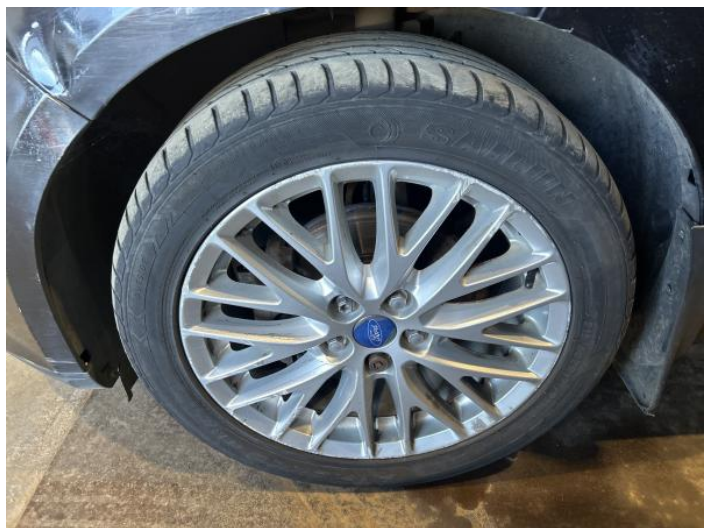
20: Wheel nsf
Scratched
Over 50mm

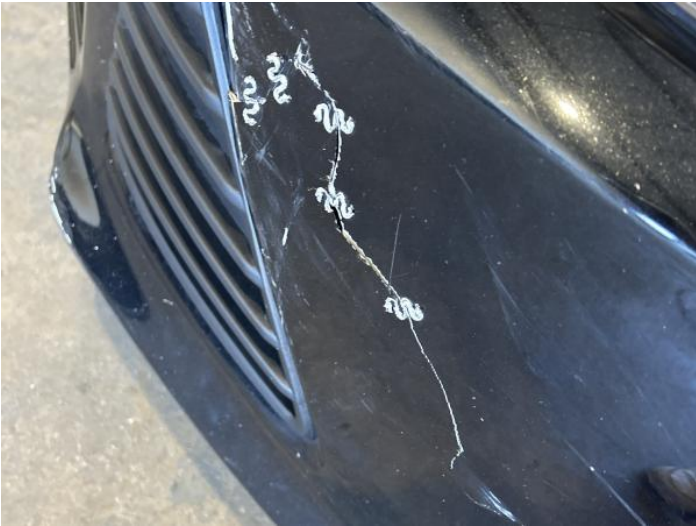
21: Bumper Front
Cracked
Over 25mm

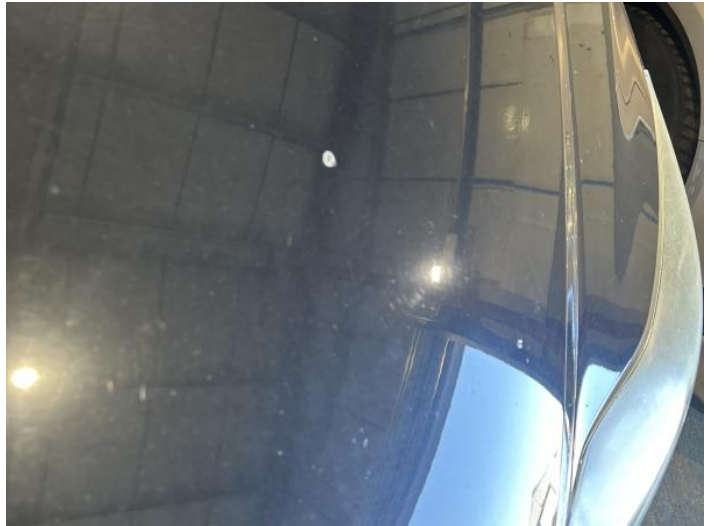
22: Bonnet
Dented
Over 30mm

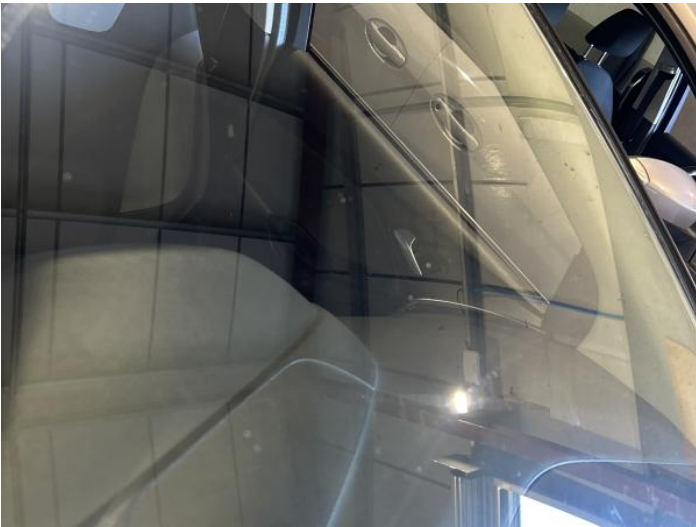
23: Screen Front
Chipped
UpTo 10mm

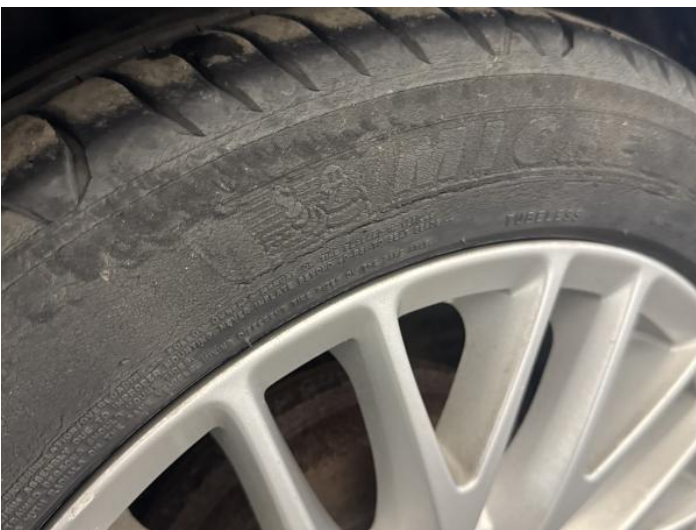
NSF	SAILUN	5.0mm
NSR	SAILUN	5.0mm
OSF	SAILUN	5.0mm
OSR	MICHELIN	Damaged
Spare

25: Tyre osr
Damaged
Replace
