# VEHICLE INSPECTION REPORT

**LV70RGX**

## Mercedes-Benz A Class A180 AMG Line Executive 5dr Auto

nama  
GRADE  
**2**

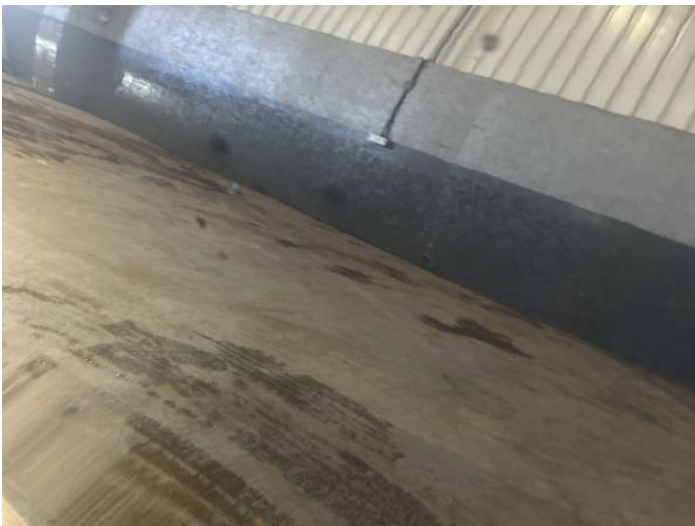
1: Door osr  
Scratched  
Over 25mm Not Thru Paint

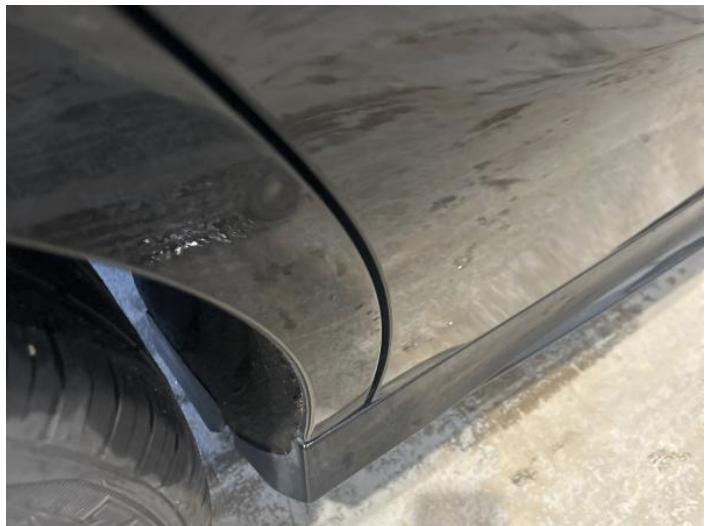
2: Qtr Panel osr  
Dented  
2 Or Less UpTo 10mm

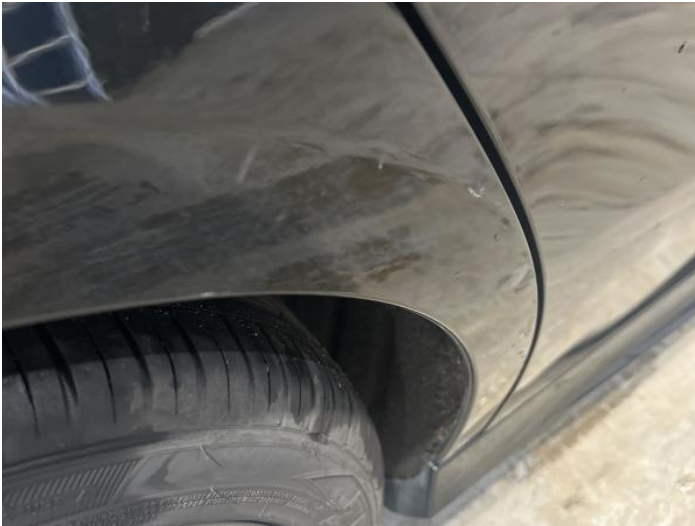
3: Qtr Panel osr  
Scratched  
UpTo 25mm Not Thru Paint

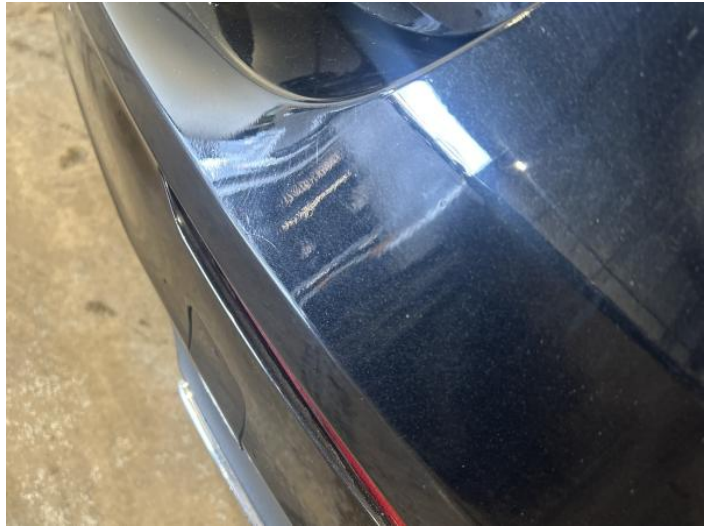
4: Bumper Rear  
Poor Previous Repair  
Poor Paint

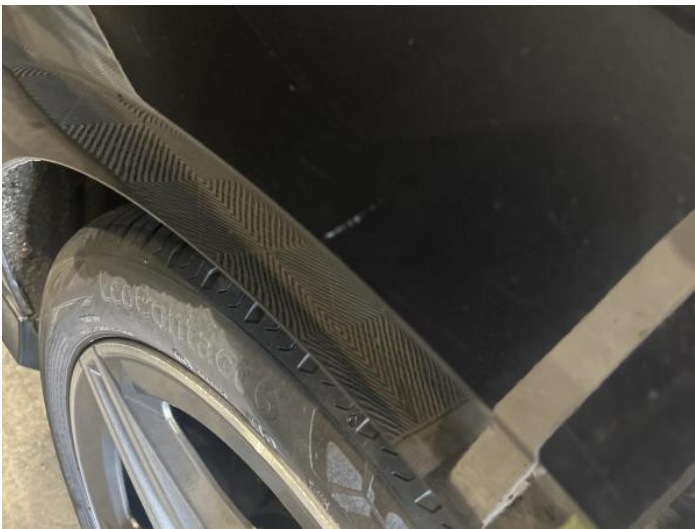
5: Qtr Panel nsr  
Scratched  
UpTo 25mm Not Thru Paint

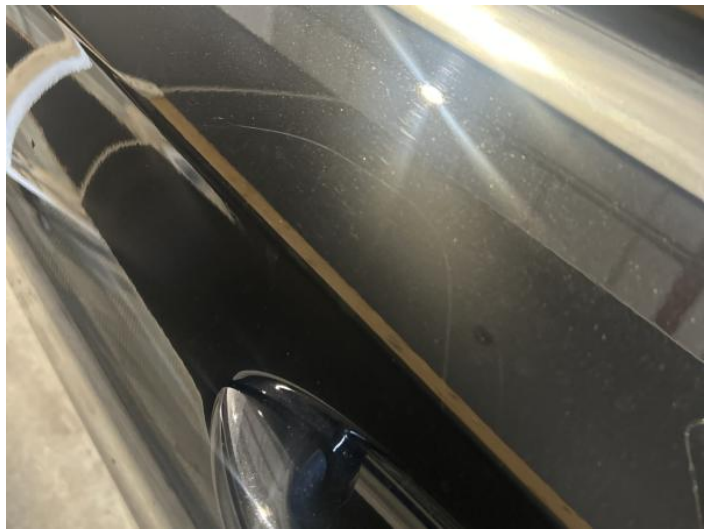
6: Door nsr  
Scratched  
Over 25mm Not Thru Paint

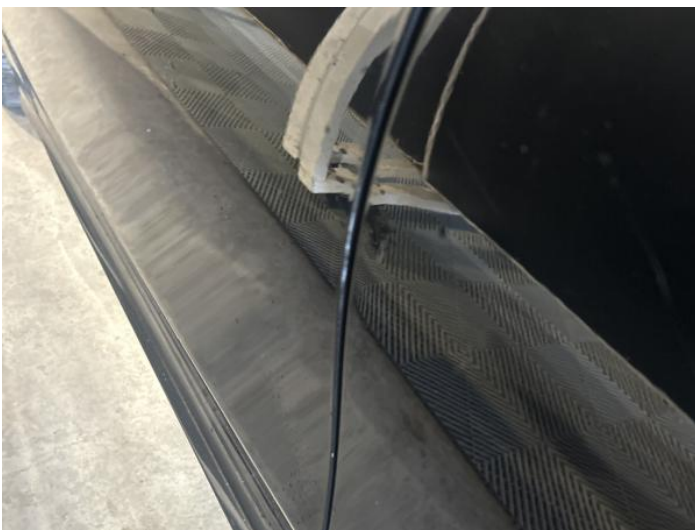
7: Door nsf  
Chipped  
Edge Chip

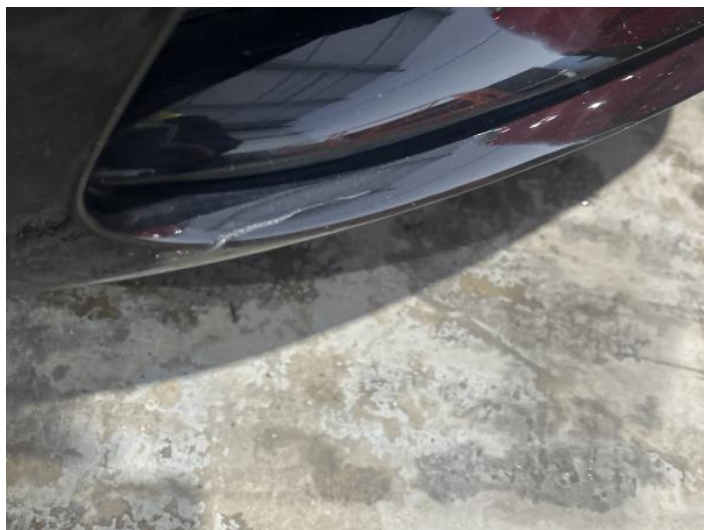
8: Bumper Front  
Scratched  
25 to 100mm Thru Paint

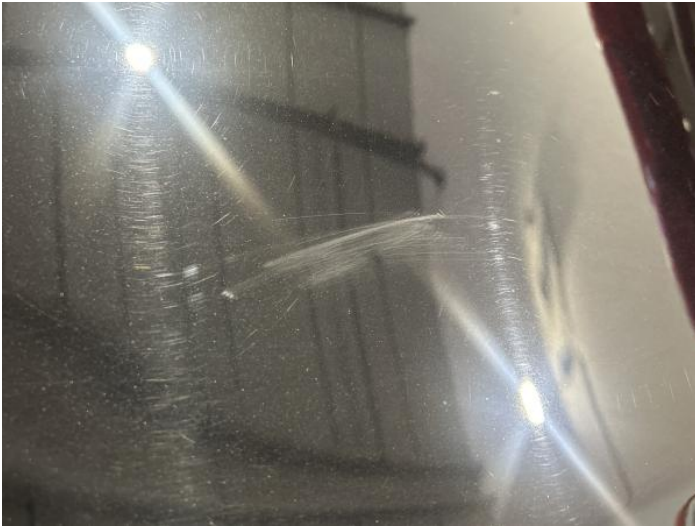
9: Bonnet  
 Scratched  
 Over 25mm Not Thru Paint

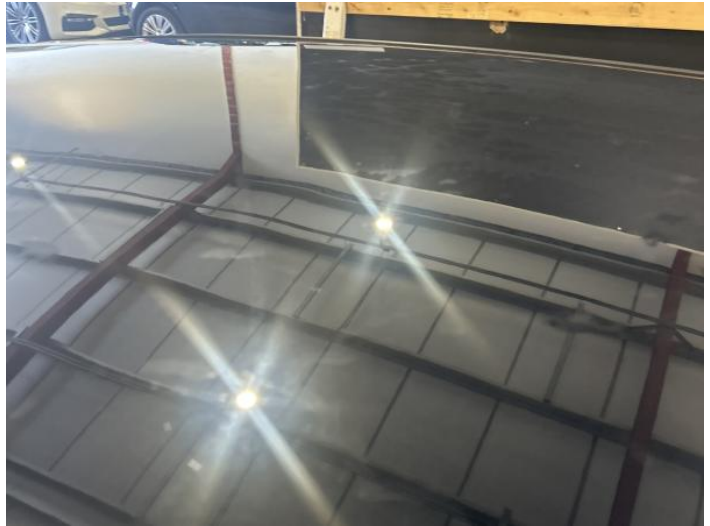
10: Roof  
 Dented  
 Between 10mm + 30mm
