VEHICLE INSPECTION REPORT

GU58JPO

Honda Civic 1.8 i-VTEC SE 5dr

nama
GRADE
4

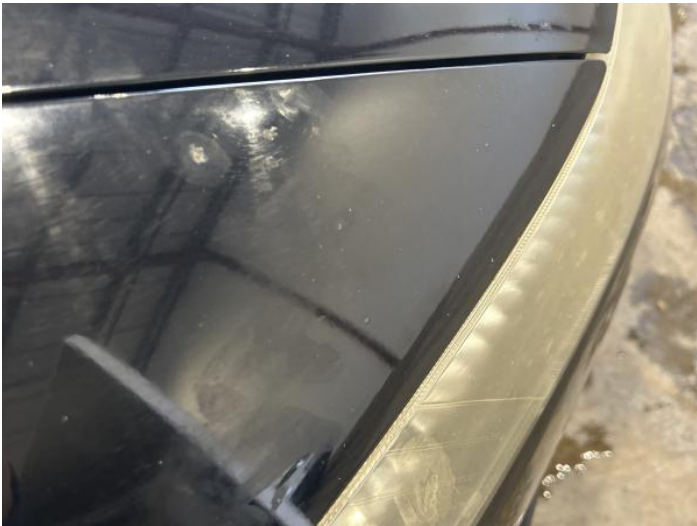
1: Wing ofsf
Chipped
Multiple Chips

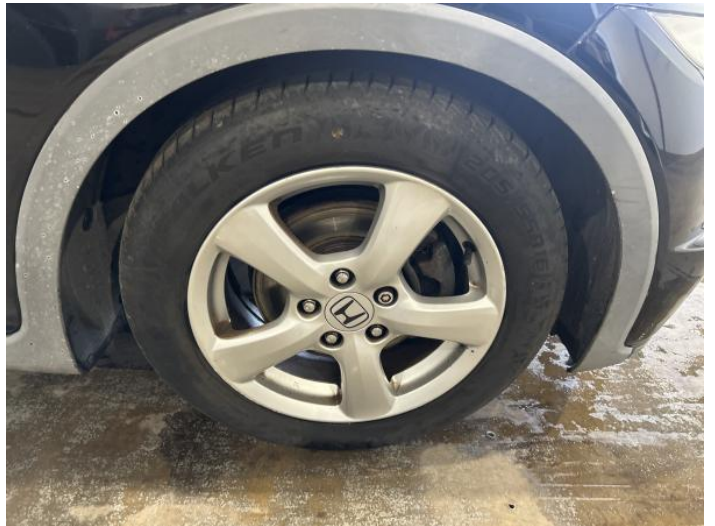
2: Wheel ofsf
Scratched
Over 50mm

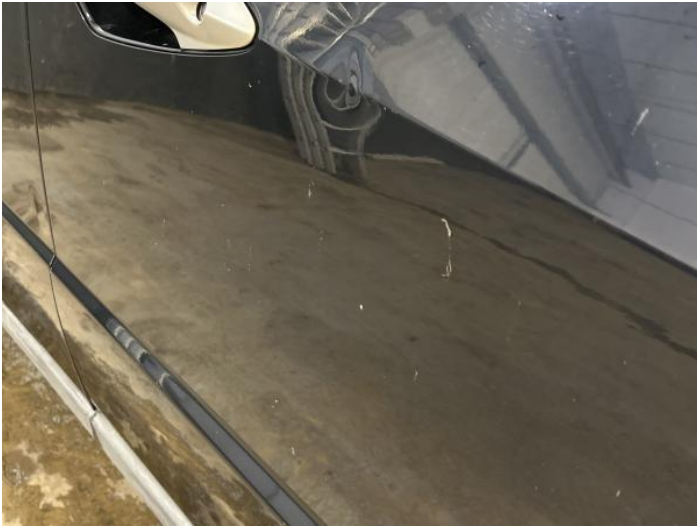
3: Door osf
Dented
With Paint Damage

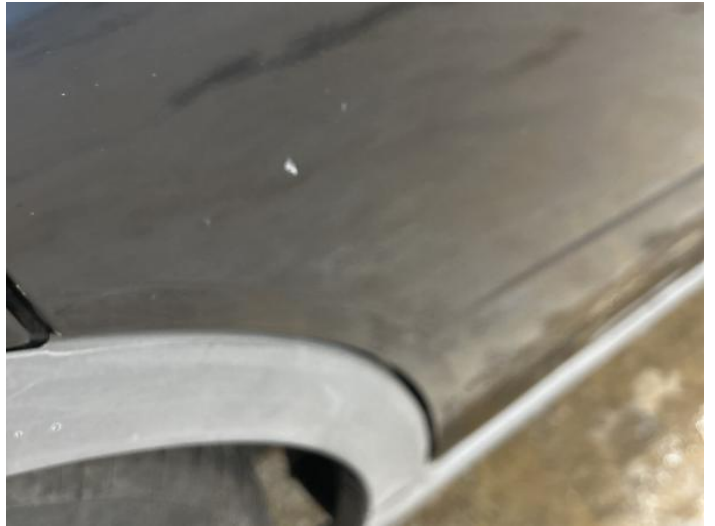
4: Door osr
Chipped
1 To 5

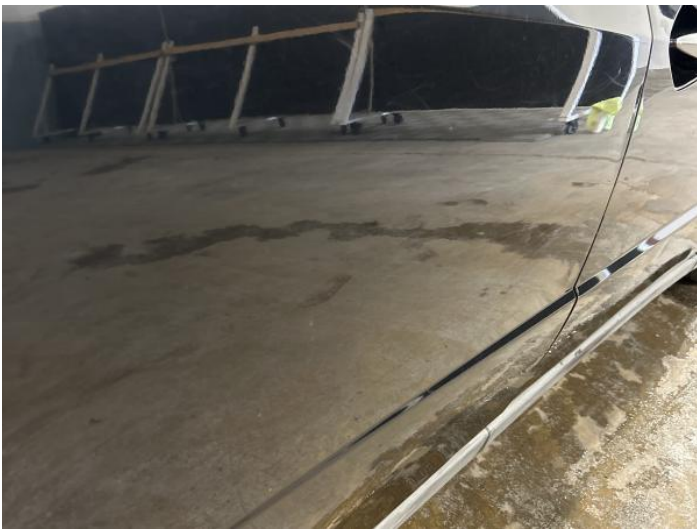
5: Door osr
Scratched
Over 25mm Not Thru Paint

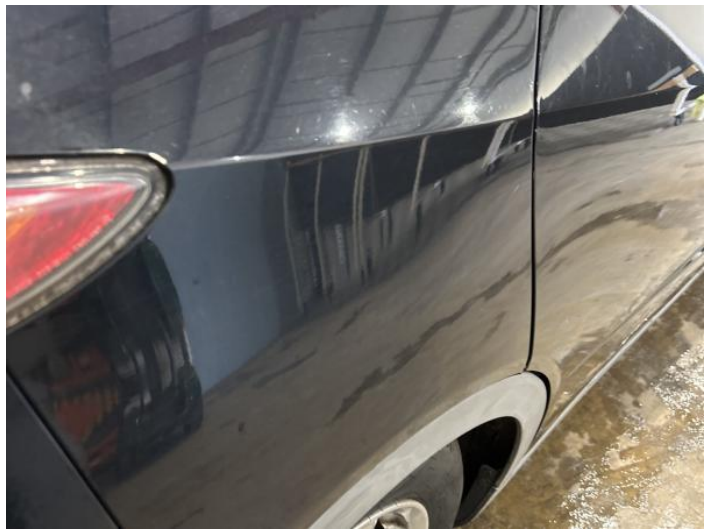
6: Qtr Panel osr
Scratched
Over 25mm Not Thru Paint

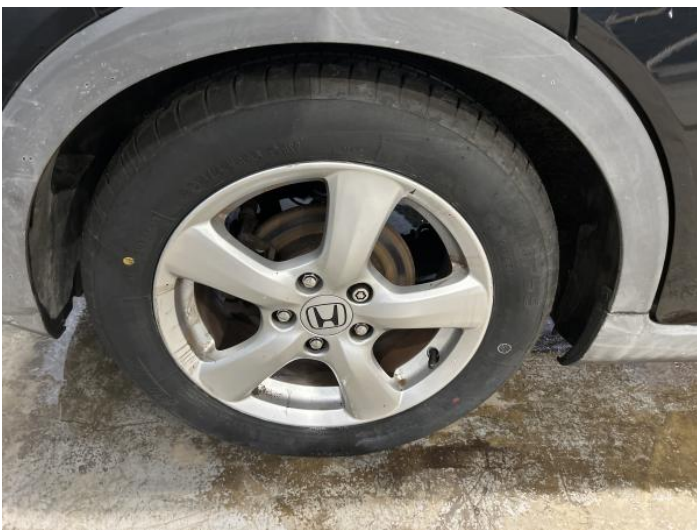
7: Wheel osr
Scratched
Up To 50mm

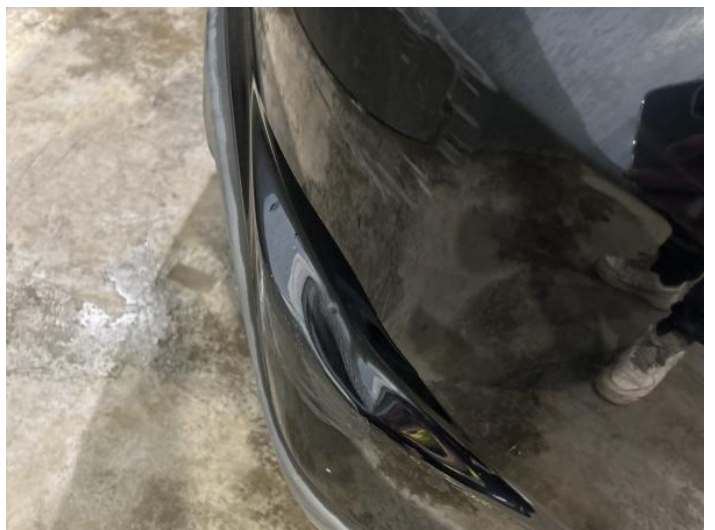
8: Bumper Rear
Dented
With Paint Damage

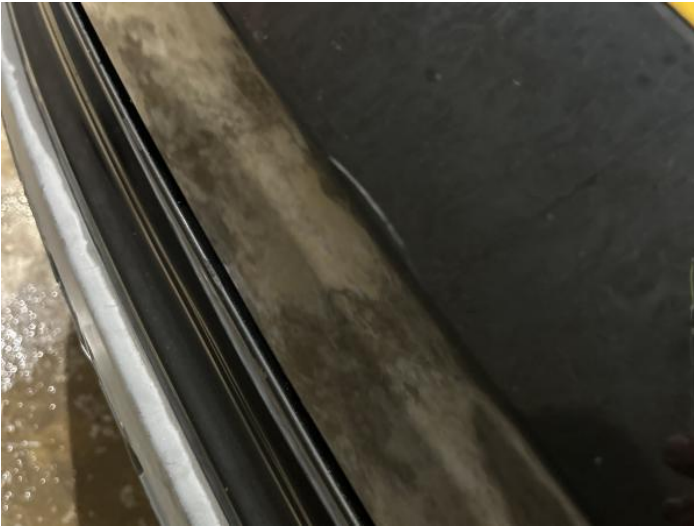
9: Tailgate
Scratched
UpTo 25mm Not Thru Paint

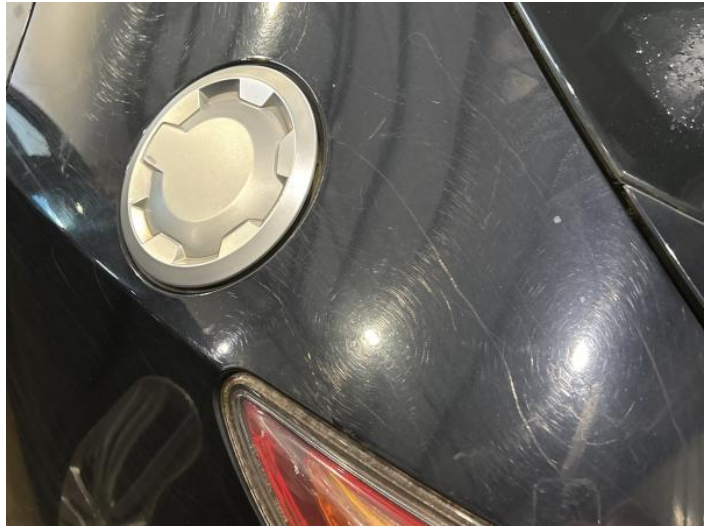
10: Qtr Panel nsr
Scratched
Over 25mm Not Thru Paint

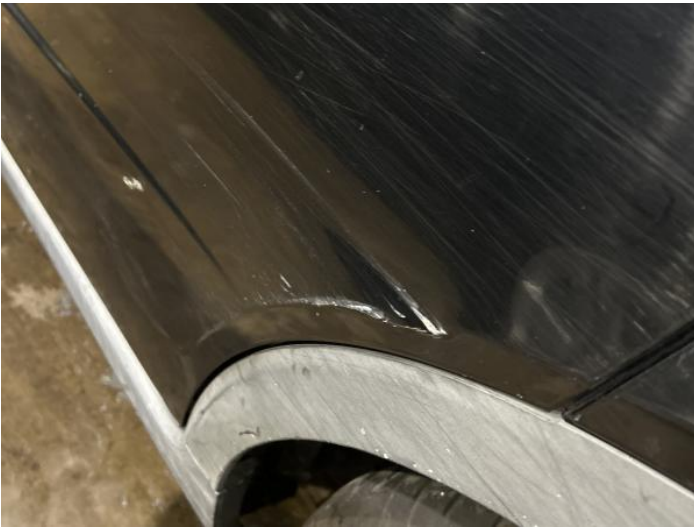
11: Door nsr
Dented
With Paint Damage

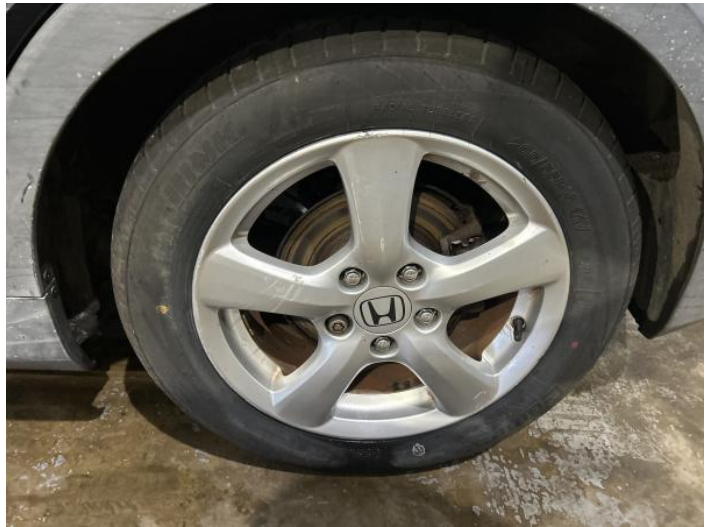
12: Wheel nsr
Scratched
Over 50mm

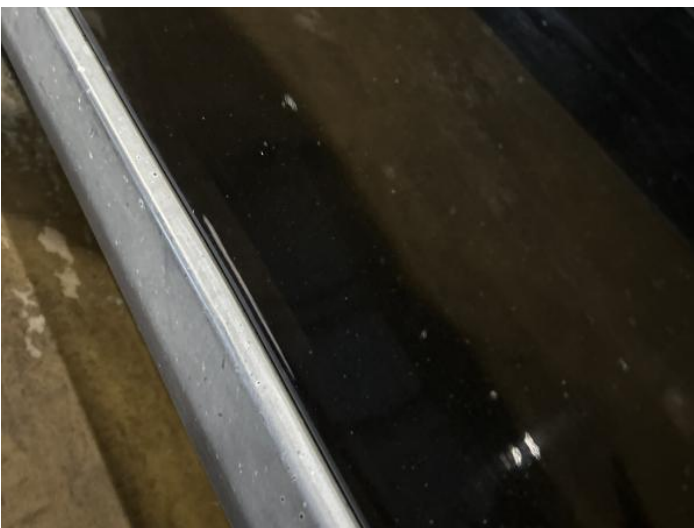
13: Door nsf
Scratched
Over 25mm Thru Paint

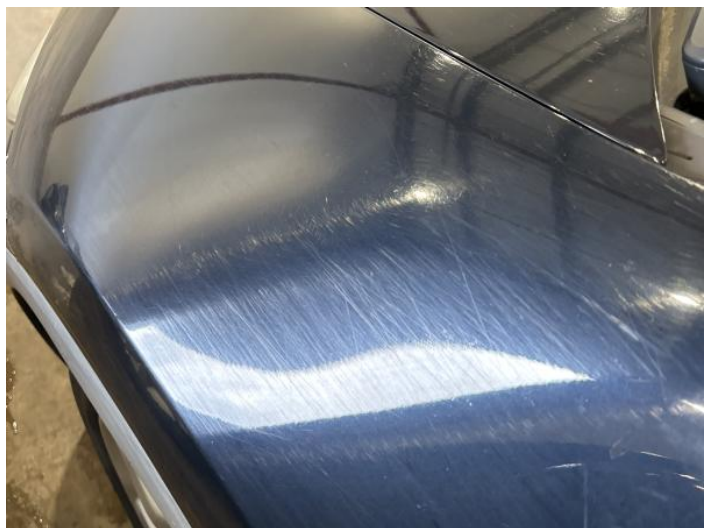
14: Wing nsf
Scratched
Over 25mm Not Thru Paint

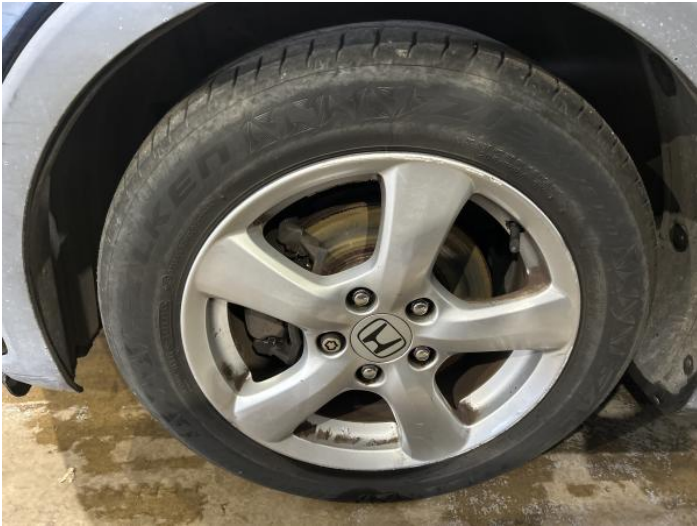
15: Wheel nsf
Scratched
Over 50mm

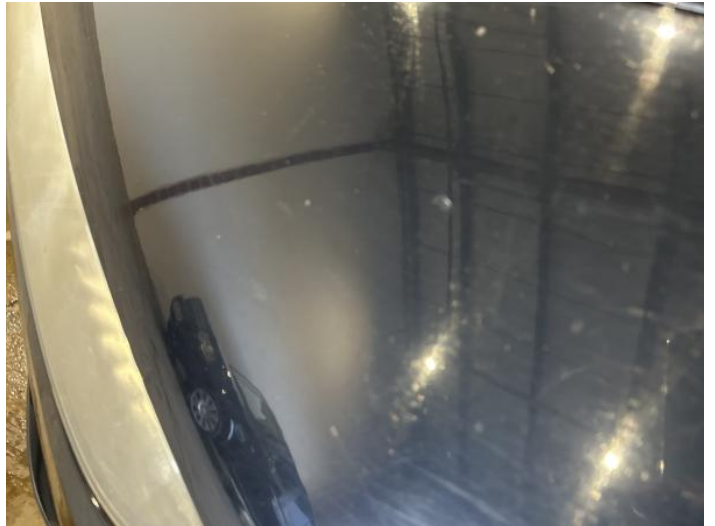
16: Wing nsf
Chipped
1 To 5

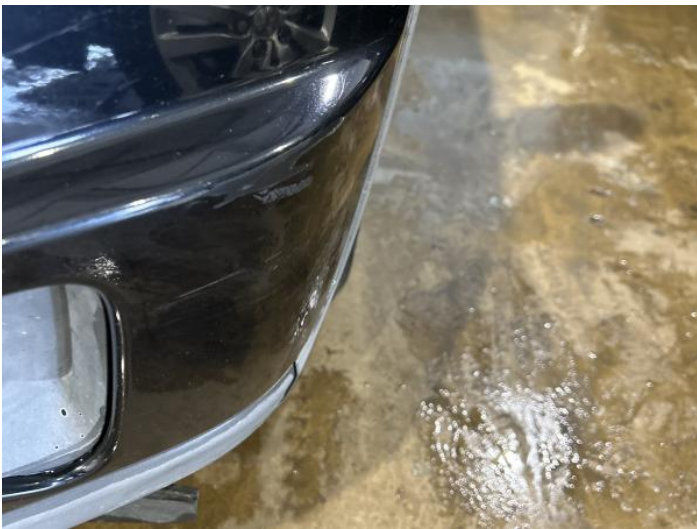
17: Bumper Front
Scratched
Over 100mm Thru Paint

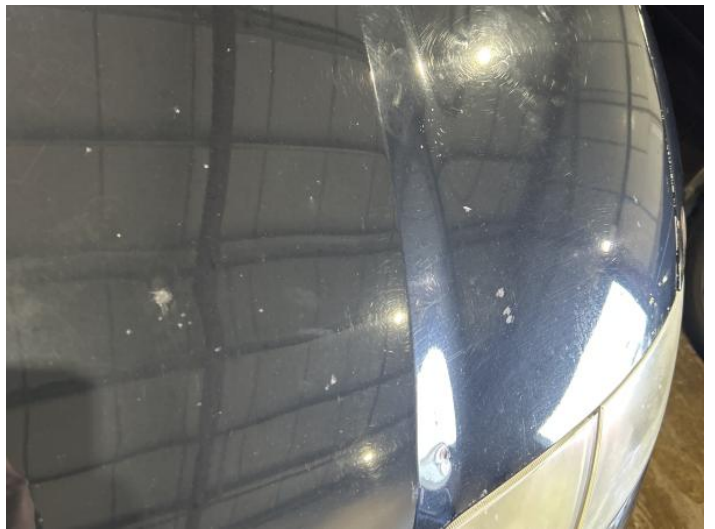
18: Bonnet
Chipped
Multiple Chips

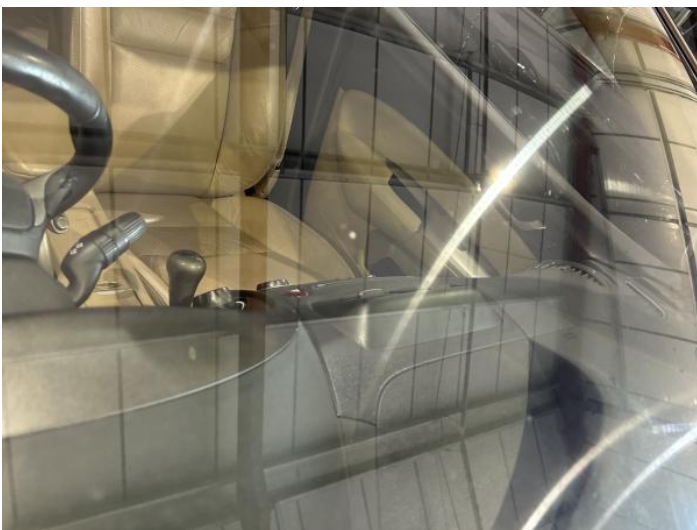
19: Screen Front
Chipped
UpTo 10mm

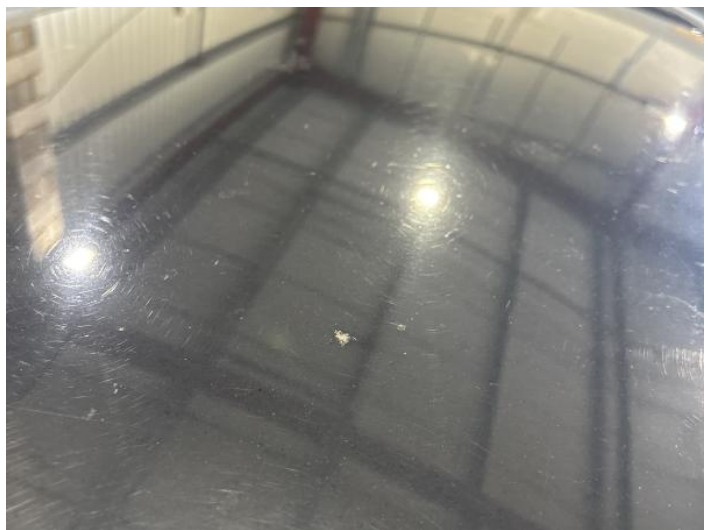
20: Roof
Chipped
1 To 5

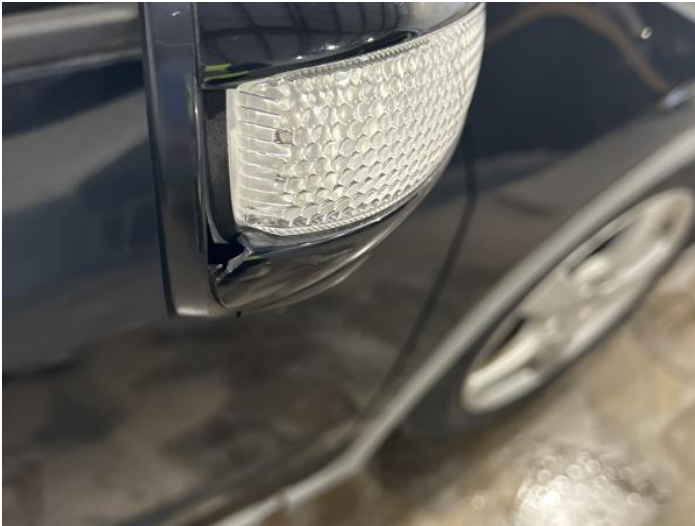
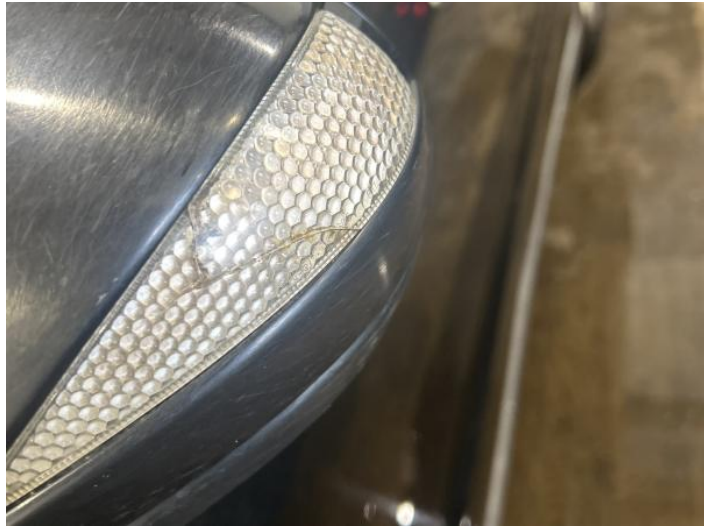
21: Door Mirror Assy osf
Broken
Replace
